# Exterior Renovations,

Fine Arts Building  
University of Connecticut  
Storrs, CT  
28 June 2011

SGH Project 110416

In May 2011, we completed the condition assessment of the Fine Arts Building. Our review focused on the ribbed-concrete-block veneer walls and various fenestrations, the concrete terraces, low-slope built-up membrane roofs, batten-seam metal panel roofs and soffits, and the sloped glazing system. Additionally, we reviewed the existing landscaping, site drainage, and performed a site survey. The attached report provides a summary of our observations, discussion of our findings, and our recommendations for remedial work. Photographs are included in Appendix A.

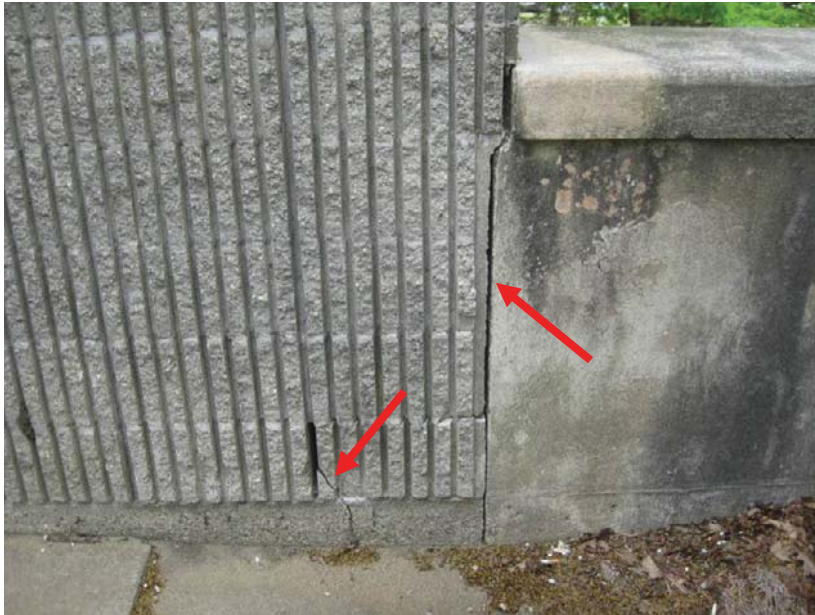
**Photo 21**

Cracking and damaged masonry at terrace side of west elevation retaining wall.

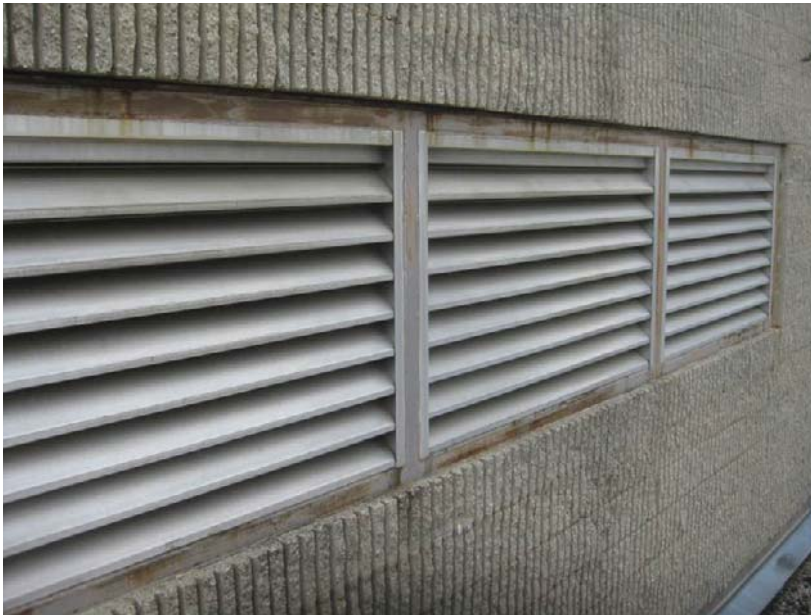
**Photo 32**

Hard, cracked, and crazed sealant at ground-level louver perimeter on the west elevation.

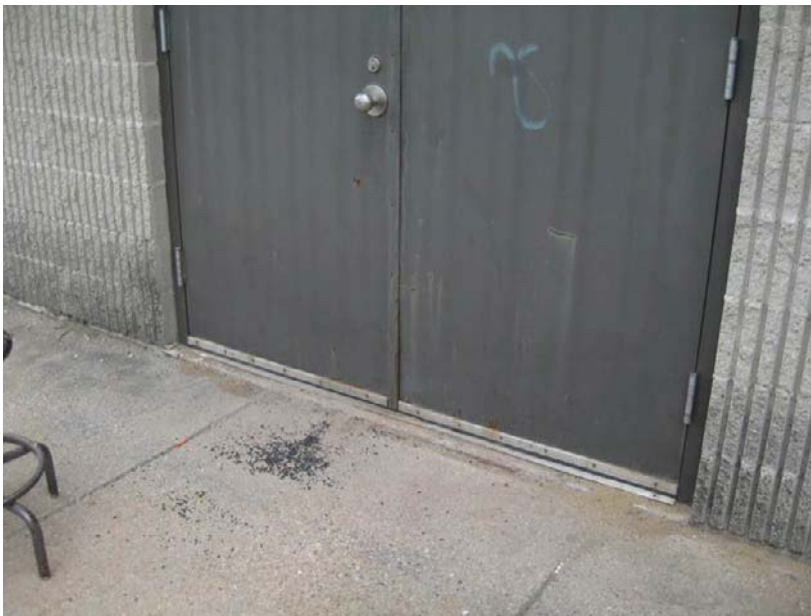
**Photo 34**

Damaged door on the south elevation.

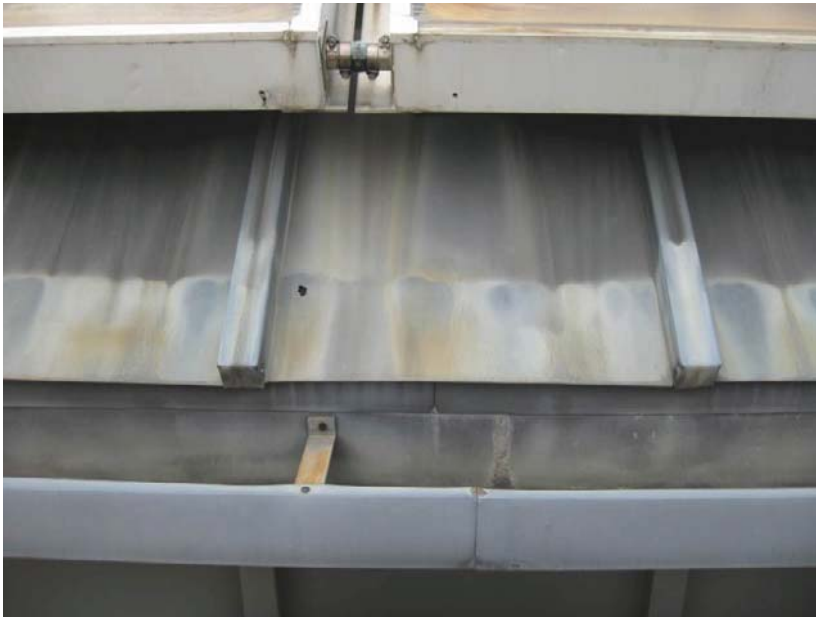
**Photo 46**

Hole in the batten-seam metal panel on the south elevation.

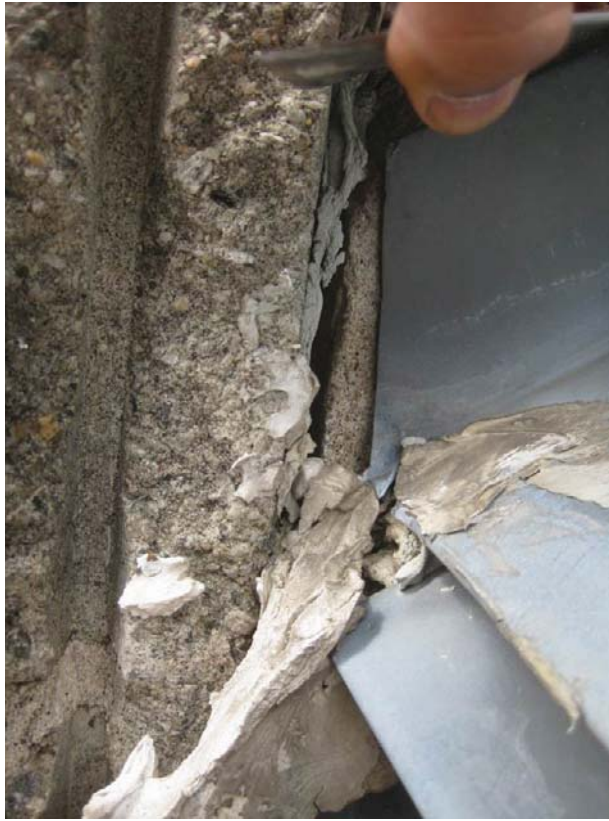
**Photo 49**

Open voids in batten-seam metal panel transition on the west elevation.

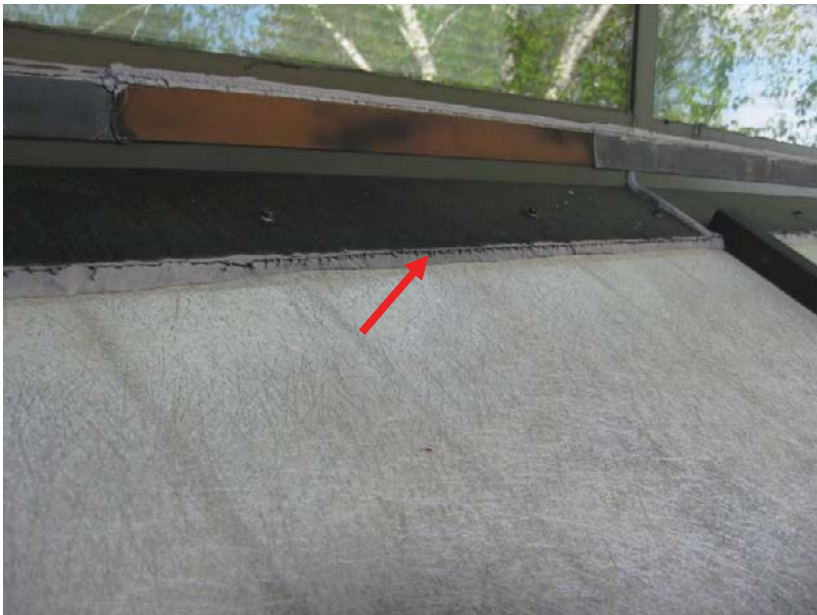
**Photo 52**

Fiber reinforcement is exposed in worn areas of existing Kalwall panels.

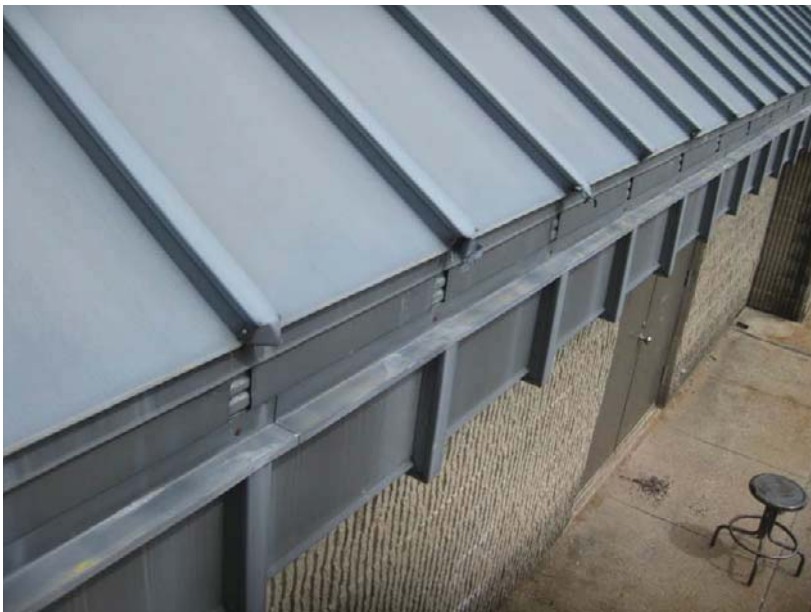
**Photo 56**

Collapsed gutters on the north elevation.

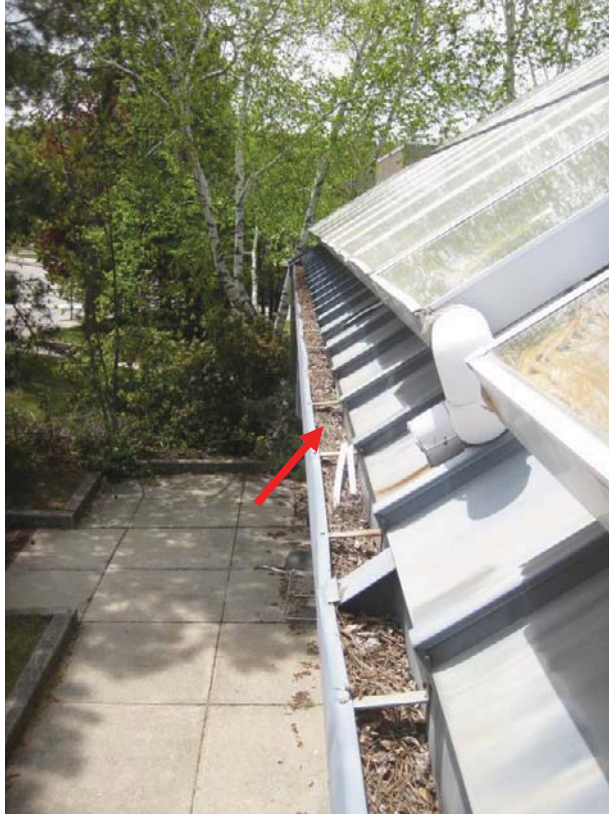
**Photo 57**

Missing gutters and down leaders on the west elevation.

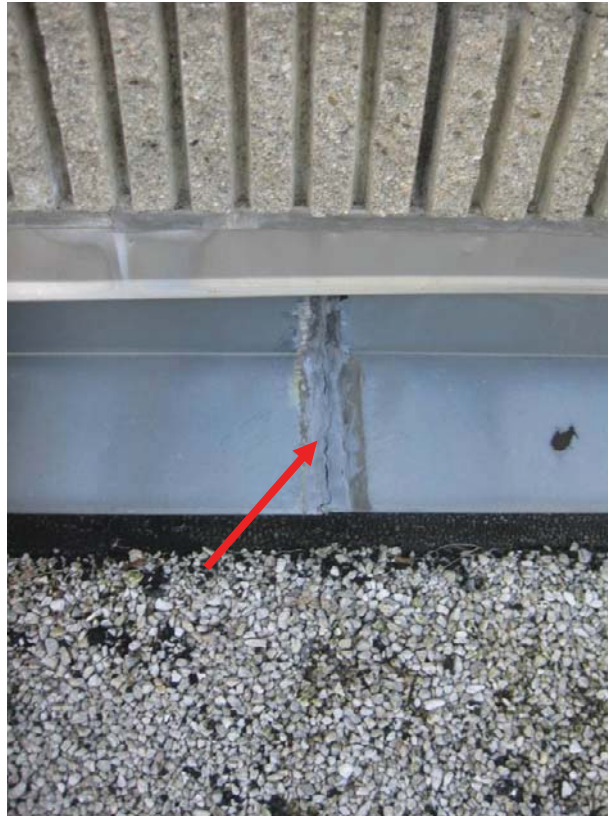
**Photo 75**

Previous BUR perimeter flashing cut and repair.

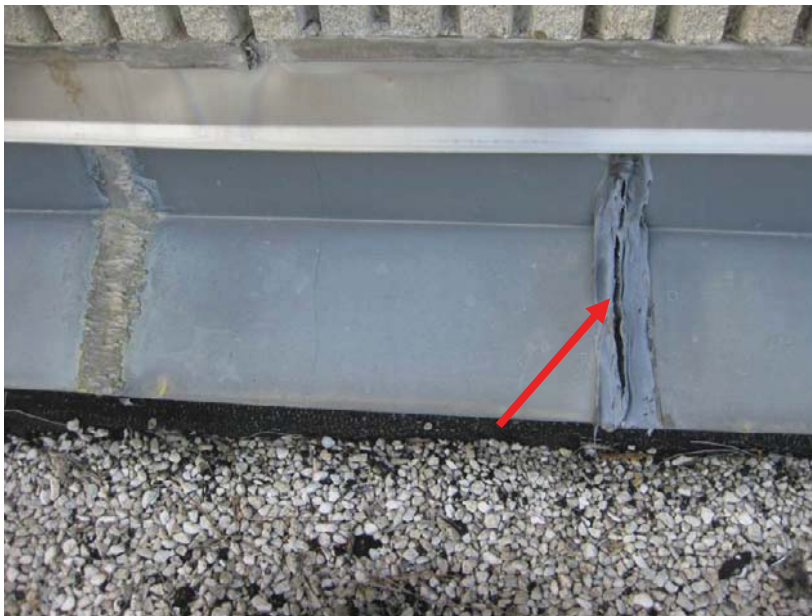
**Photo 76**

Cracked metal skirt flashing at BUR rising masonry wall.

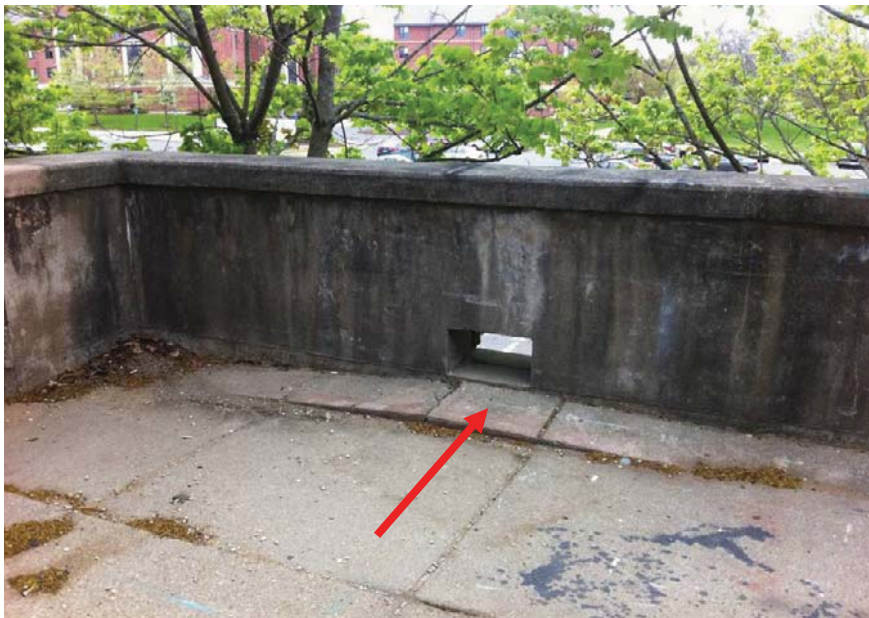
**Photo 78**

Slab settlement at north terrace.

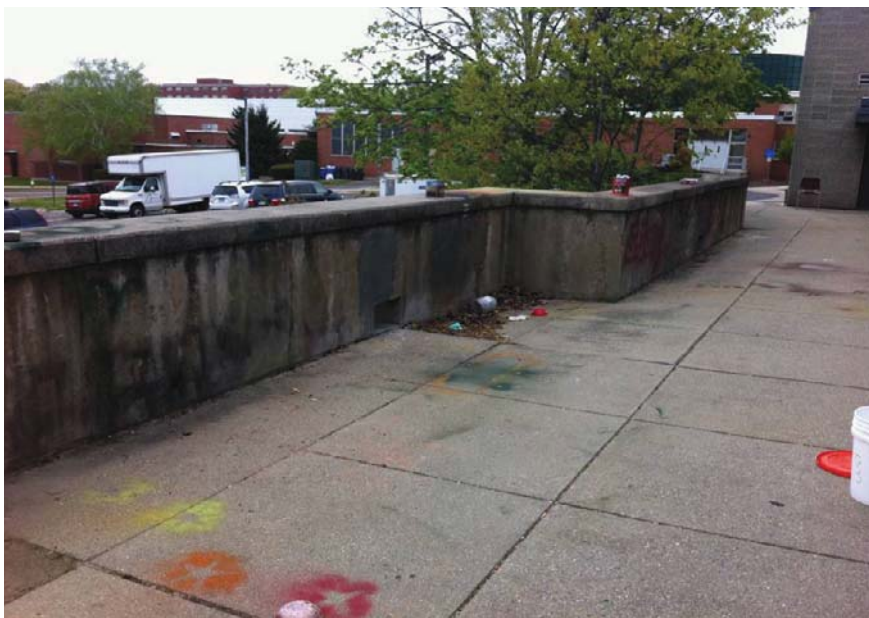
**Photo 79**

- Distorted sections of concrete and cracking indicate frost heaving of the terrace paving at several scupper locations (Photo 79). The terrace paving contains several cracks varying in width from about 0.5 to 1.5 in.; in some cases, cracked portions of the paving settled and heaved relative to each other causing tripping hazards.

Frost heaving at scupper locations in north terrace.

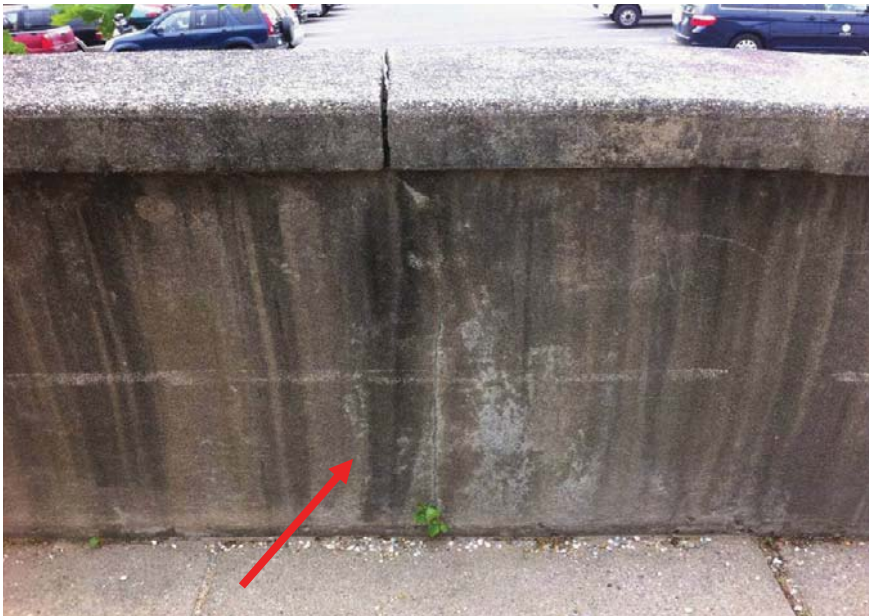
**Photo 80**

Surface wear and weathering at north terrace.

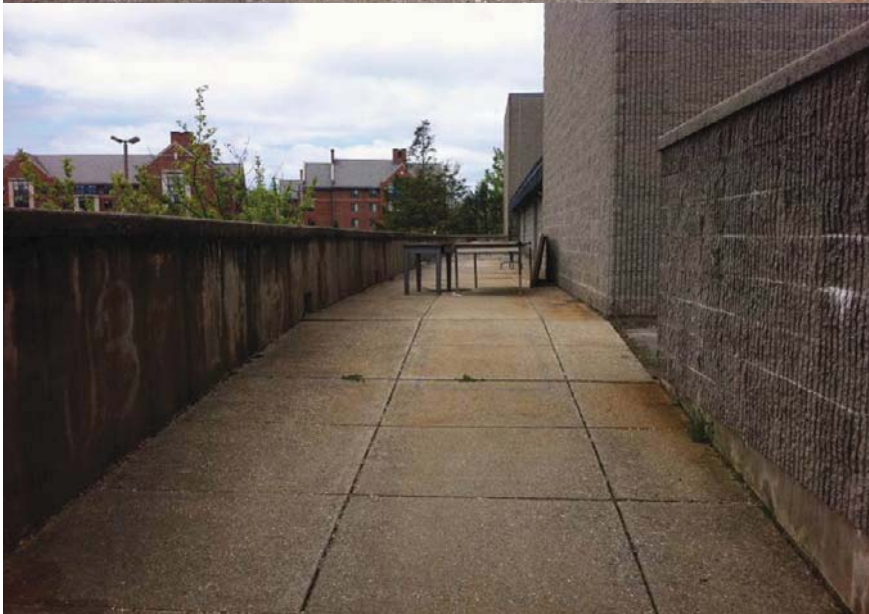
**Photo 82**

Minor settlement of west terrace

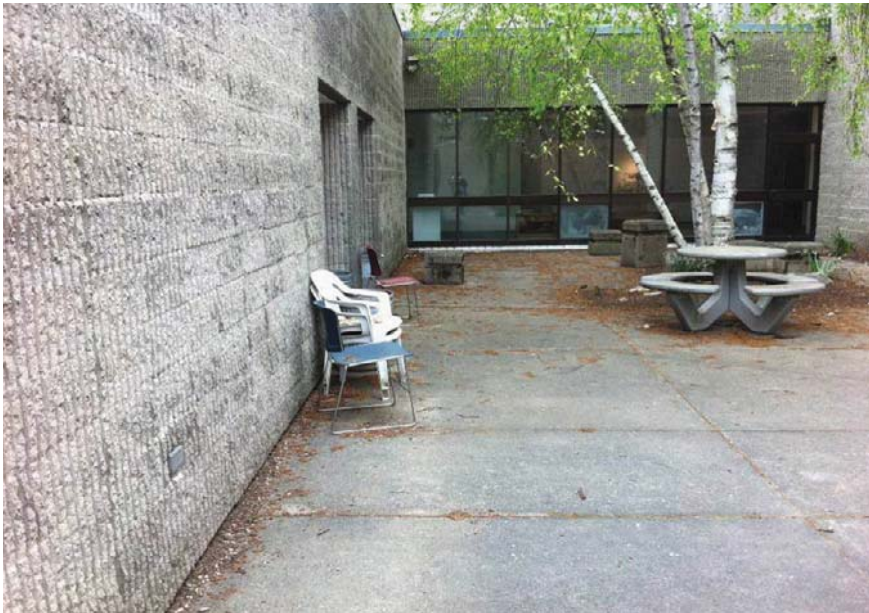
**Photo 86**

Settlement in northwest section of Courtyard Area 1.

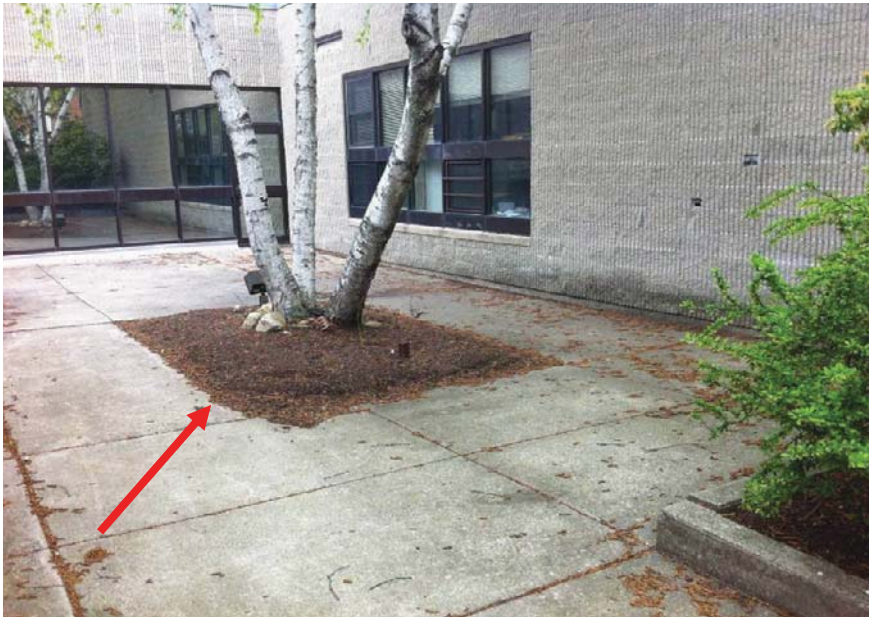
**Photo 89**

Settlement at east building face, staining at building in Courtyard Area 2.

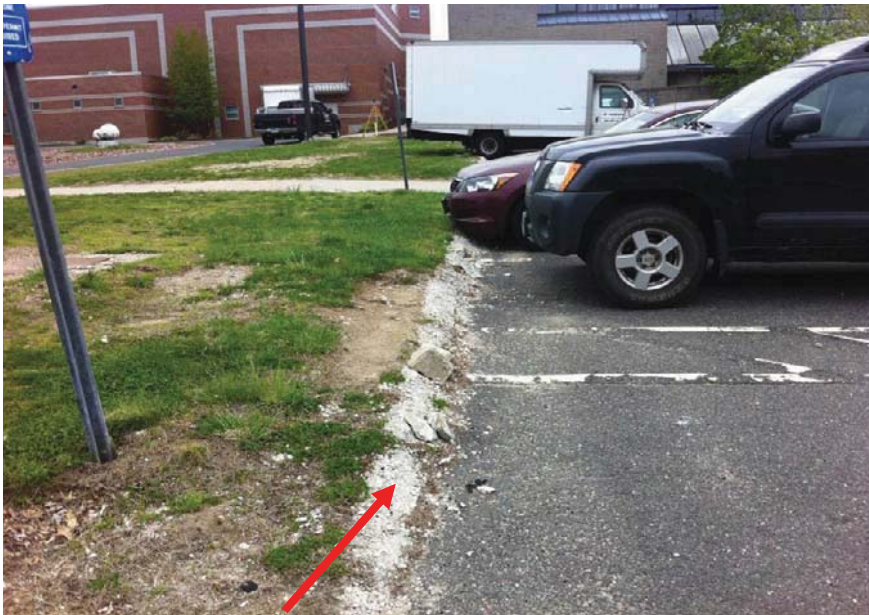
**Photo 90**

Berm missing around landscaped island at Courtyard Area 2.

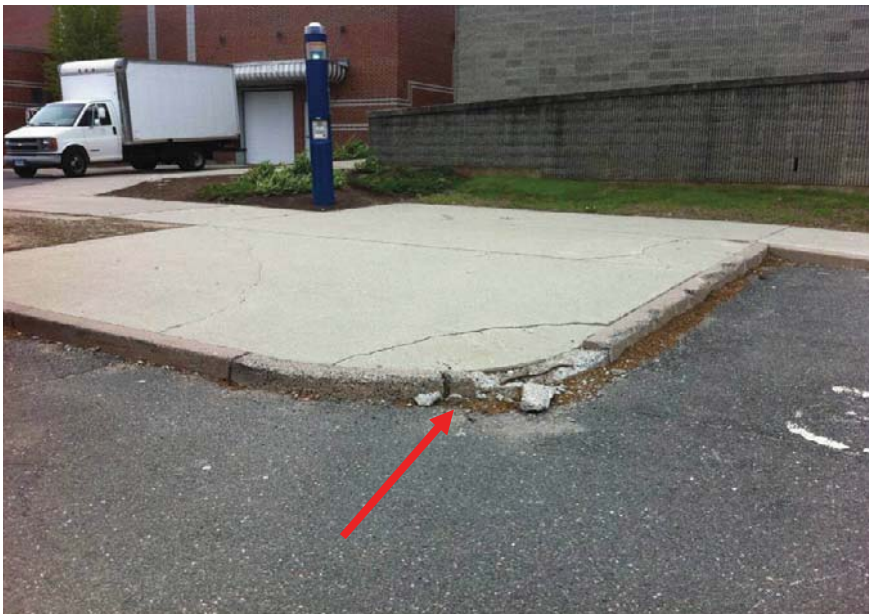
**Photo 91**

Deteriorated curbing in easterly corner of parking lot, labeled as NP-C1 on the Key Plan.

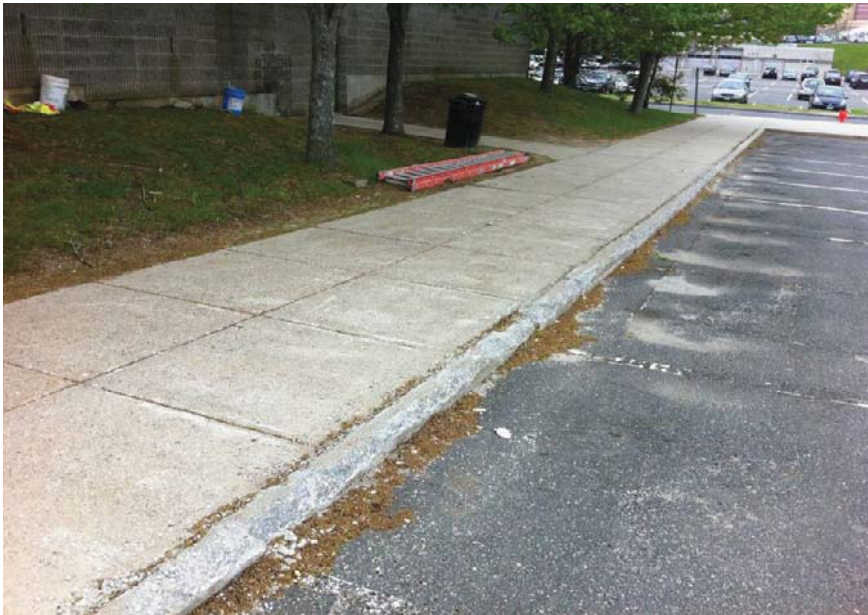
**Photo 92**

Broken curb and exposed rebar at northeasterly parking area, labeled as NP-C2 on the Key Plan.

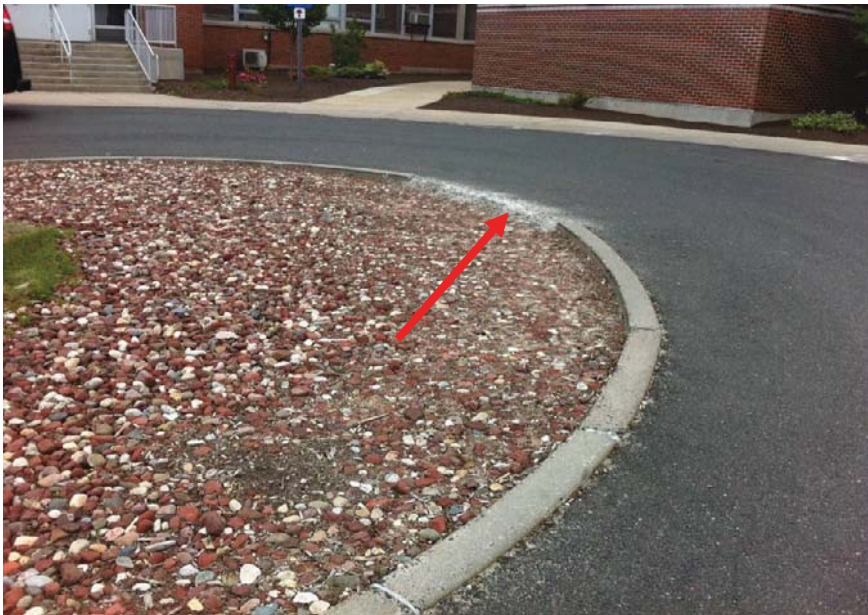
**Photo 93**

Curb running along north face of building, labeled as NP-C3 on the Key Plan.

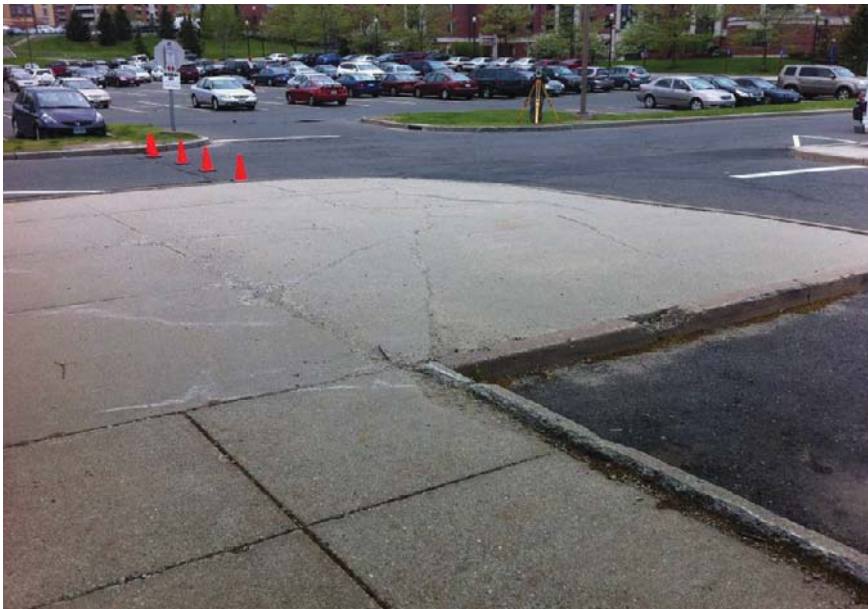
**Photo 96**

Sidewalk and ramp deterioration and cracking, labeled as NB-S1 on the Key Plan.

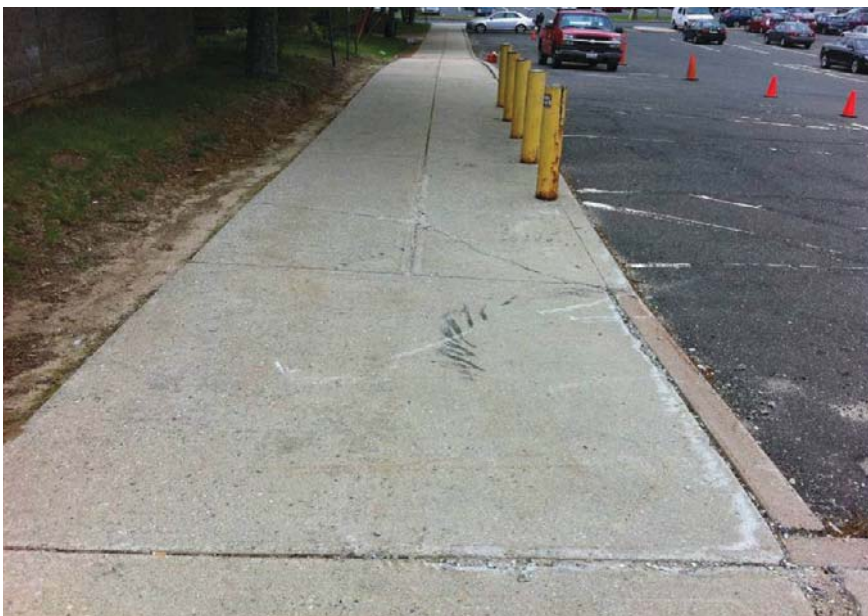
**Photo 97**

Distress and cracking in sidewalk area at northwesterly building corner, labeled as NB-S2 on the Key Plan.

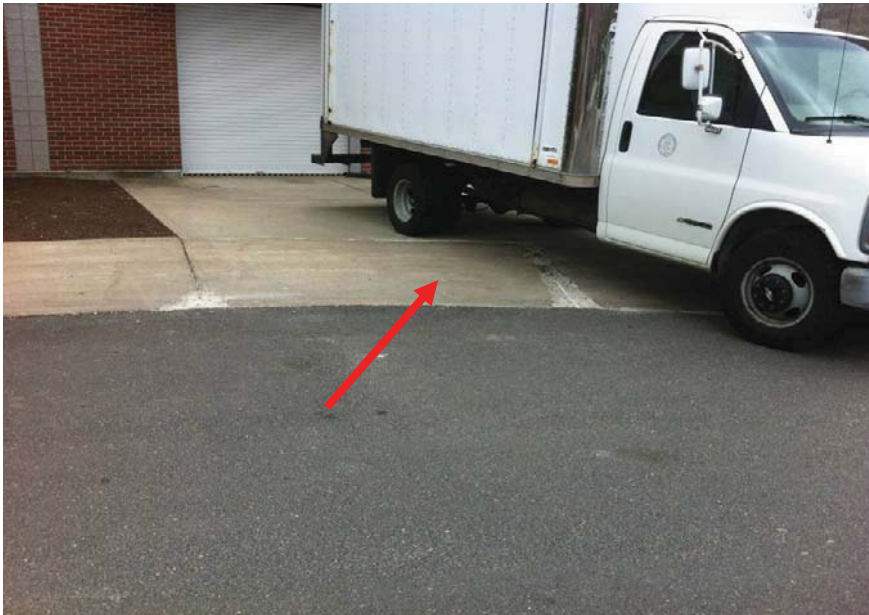
**Photo 98**

Multiple low-severity cracks at sidewalk along north building face, labeled as NB-S3 on the Key Plan.

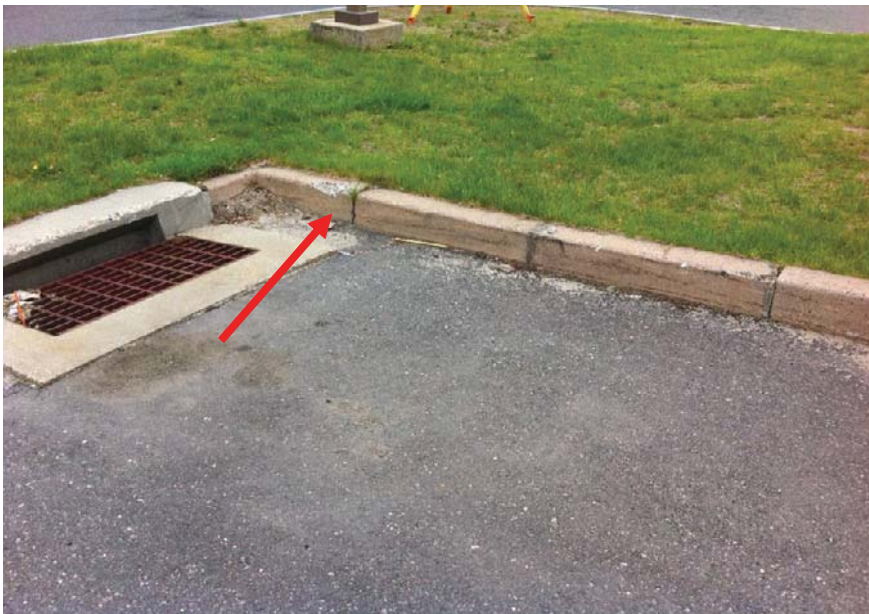
**Photo 100**

Section of broken curb in west parking lot, labeled as WP-C1 on the Key Plan.

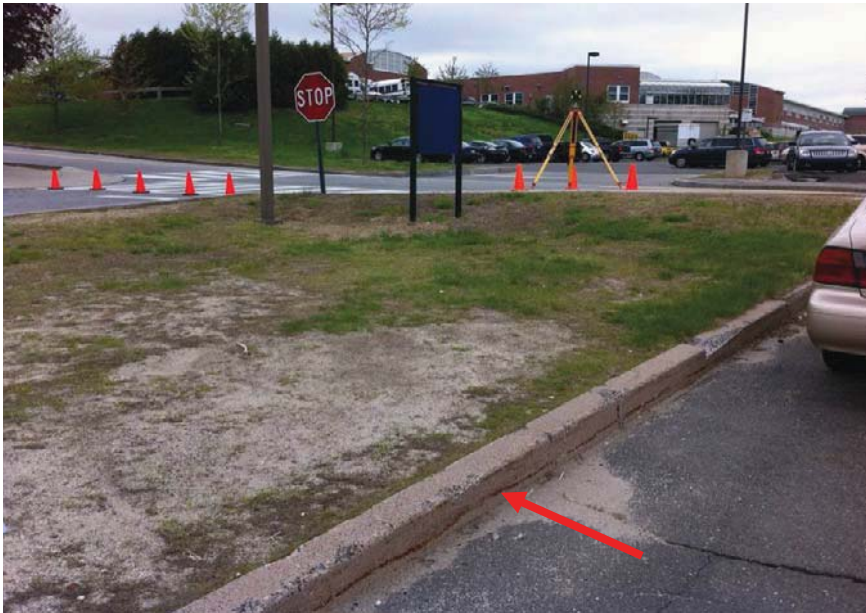
**Photo 101**

Minor chips in curbing in west parking lot, labeled as WP-C2.

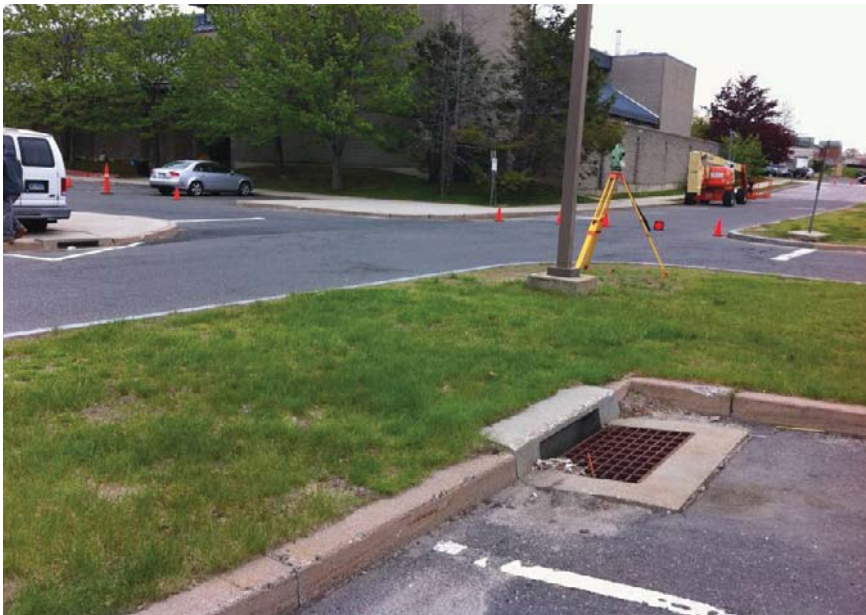
**Photo 102**

Minor chips and cracks in west parking lot, labeled as WP-C3.

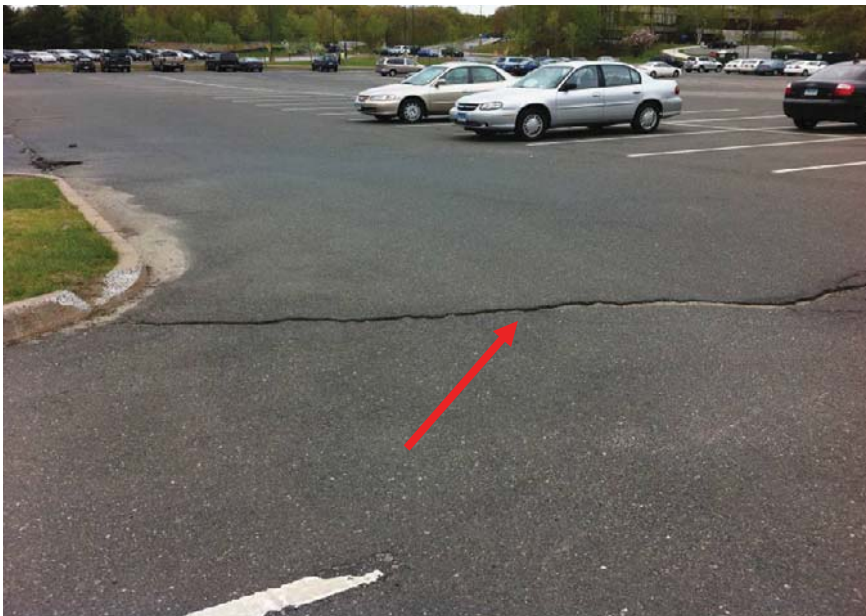
**Photo 103**

Low-severity bump and sagging in west parking lot, labeled as WP-P1 on the Key Plan.

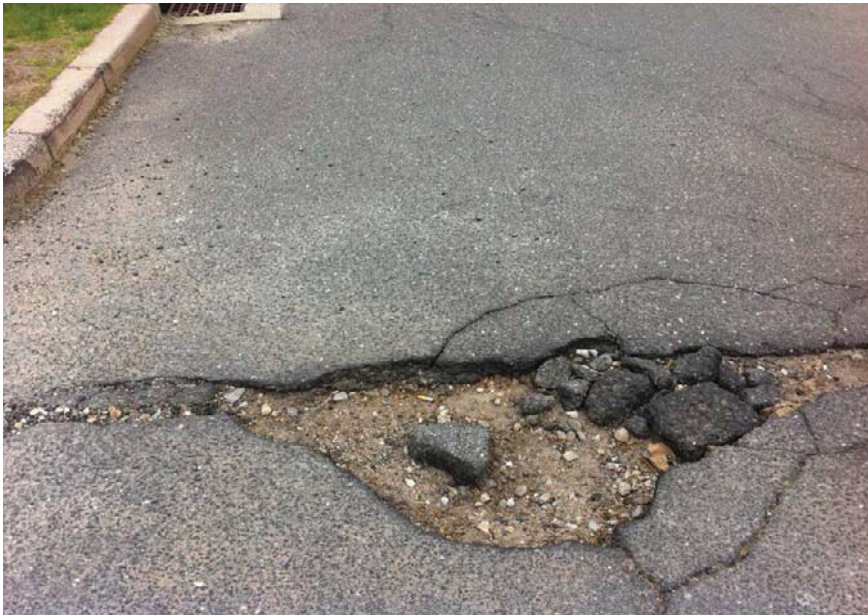
**Photo 104**

Medium-severity crack at west parking lot, labeled as WP-P2 on the Key Plan.

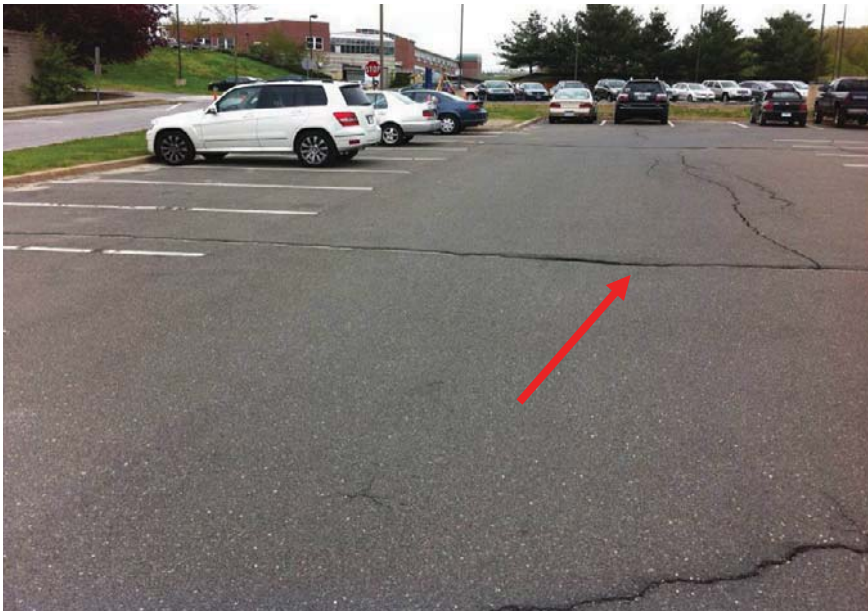
**Photo 105**

Medium severity pothole at west parking entrance, labeled as WP-P3 on the Key Plan.

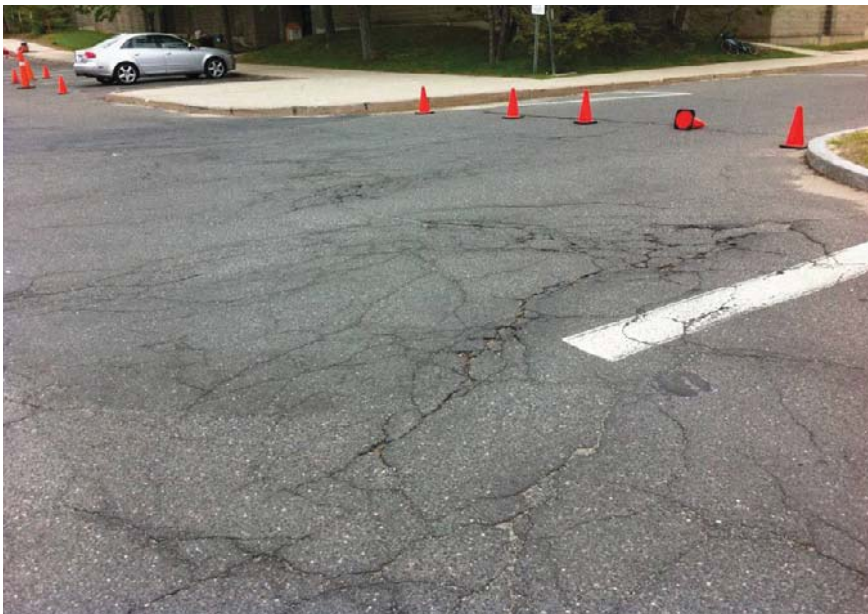
**Photo 106**

Medium-severity cracking in west parking lot, labeled as WP-P4 on the Key Plan.

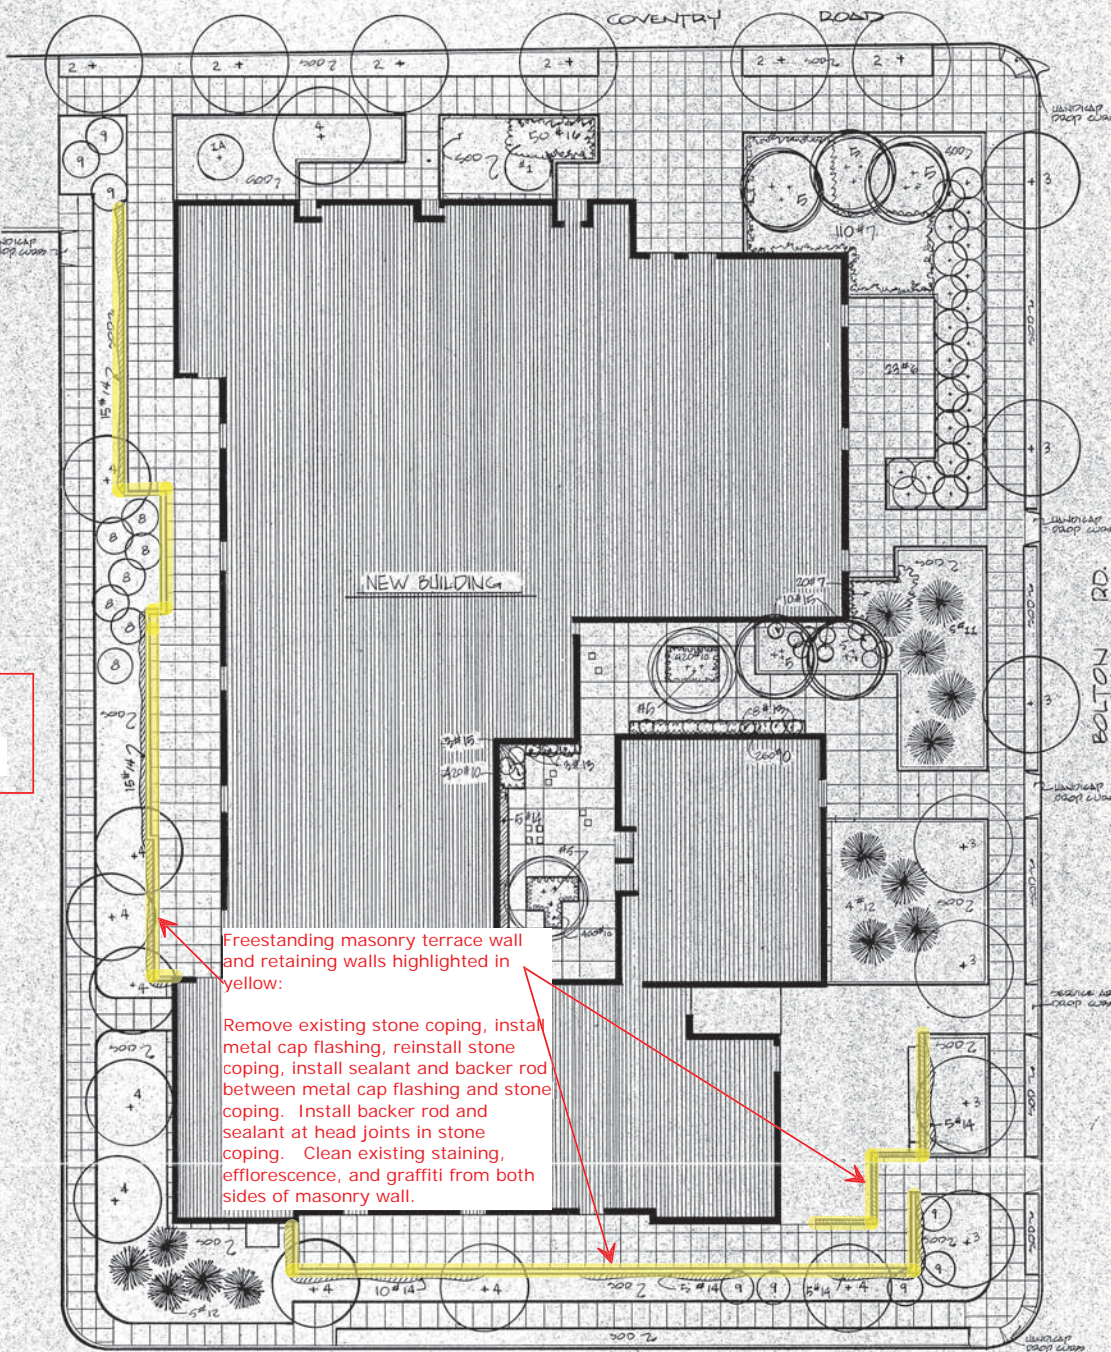
Freestanding masonry terrace wall and retaining walls highlighted in yellow:

Remove existing stone coping, install metal cap flashing, reinstall stone coping, install sealant and backer rod between metal cap flashing and stone coping. Install backer rod and sealant at head joints in stone coping. Clean existing staining, efflorescence, and graffiti from both sides of masonry wall.
