NEPA ENVIRONMENTAL REVIEW REPORT

**Community Development Block Grant – Disaster Recovery
Owner Occupied Rehabilitation and Rebuilding Program**

**Site ID No. 1419
14 Hawthorne Street South (Unit A)
Greenwich, Connecticut**

June 2014

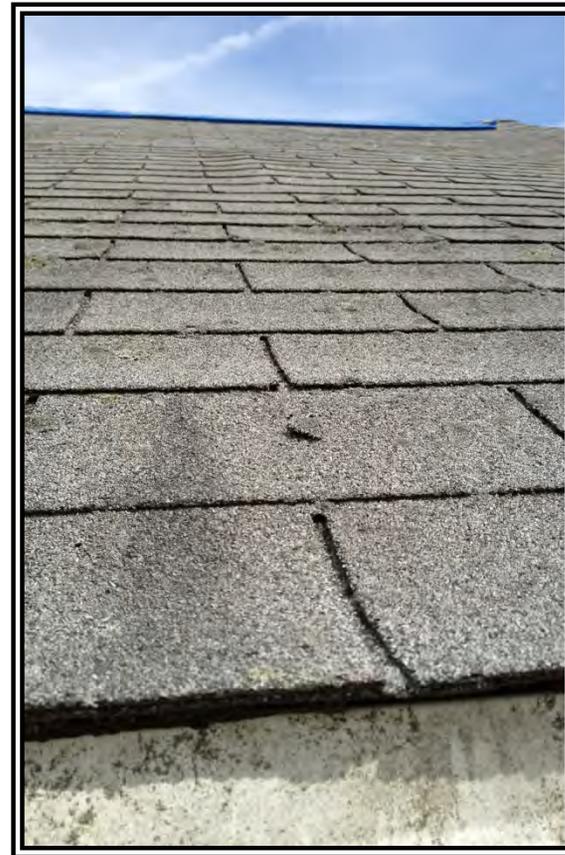
Photograph 2
Roof to be replaced

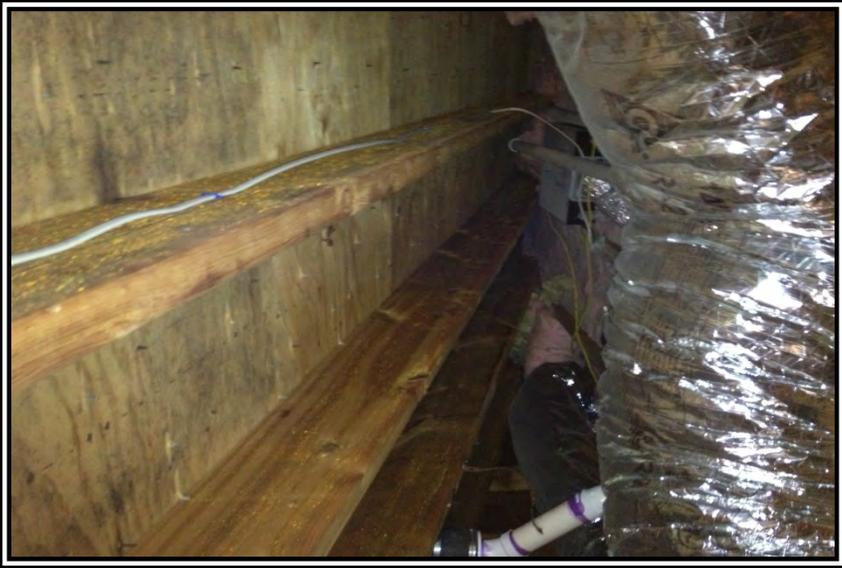
Triton completed a visual mold inspection of the work area on May 7, 2014. Mold was observed on the underside of the plywood roof deck in the attic. Photographs of the apparent mold are provided in Appendix B.

Photograph 4
Black mold on roof decking in attic

Mold was observed within the work zone on the underside of the plywood roof deck in the attic. Mold may be present in other interior areas that could not be observed during the inspection (i.e. behind walls). To protect occupant and worker health, the mold within the work zone must be abated. Any porous materials containing visible mold that are encountered during the renovation should be removed in accordance local, state, and federal regulations including, but not limited to, with the guidelines put forward in the most recent version of the *Institute for Inspection, Cleaning, and Restoration Certificate (IICRC) Standard and Reference Guide for Mold Remediation* as well as the *Connecticut Guidelines for Mold Abatement Contractors*. The abatement contractor must provide credentials/adequate qualification documentation and a work plan for abatement work with its bid for review by Merritt and Triton. Clearance testing requirements will be determined by Merritt, the homeowner, and the State of Connecticut.

2. Mold – Mold was observed the underside of the plywood roof deck in the attic. Additional mold impacted surfaces may be encountered during renovation in spaces that were inaccessible or not apparent during the inspection. To protect occupant and worker health, the mold must be abated by a qualified contractor. As such, Triton recommends that a competent person be present during the renovation work who is capable of identifying potential additional suspect materials. General precautions should be taken during the renovation process to avoid the potential spread of mold spores and to mitigate health and safety concerns.

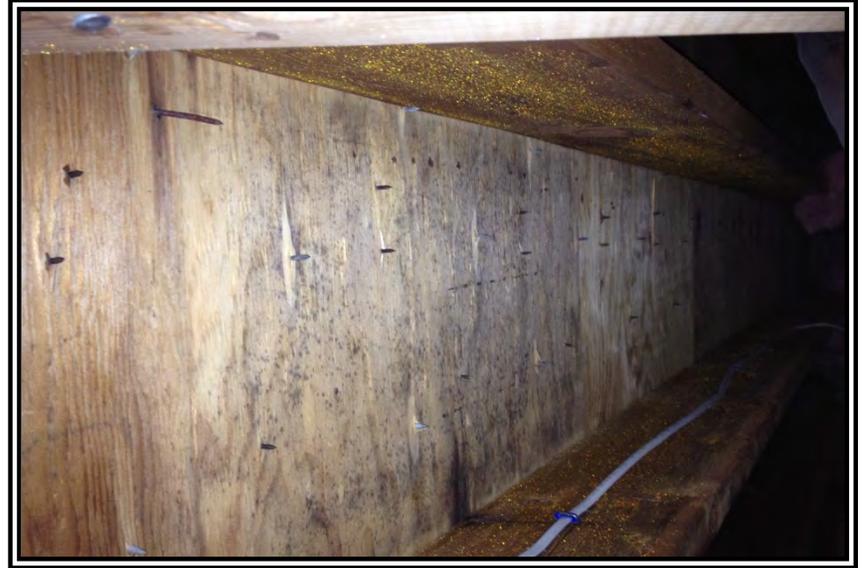
Photograph 5
Black mold on roof decking in attic
