# **NEPA ENVIRONMENTAL REVIEW REPORT**

**Community Development Block Grant – Disaster Recovery  
Owner Occupied Rehabilitation and Rebuilding Program**

**Site ID No. 1476  
29 Lincoln Avenue  
Norwalk, Connecticut**

**June 2014**

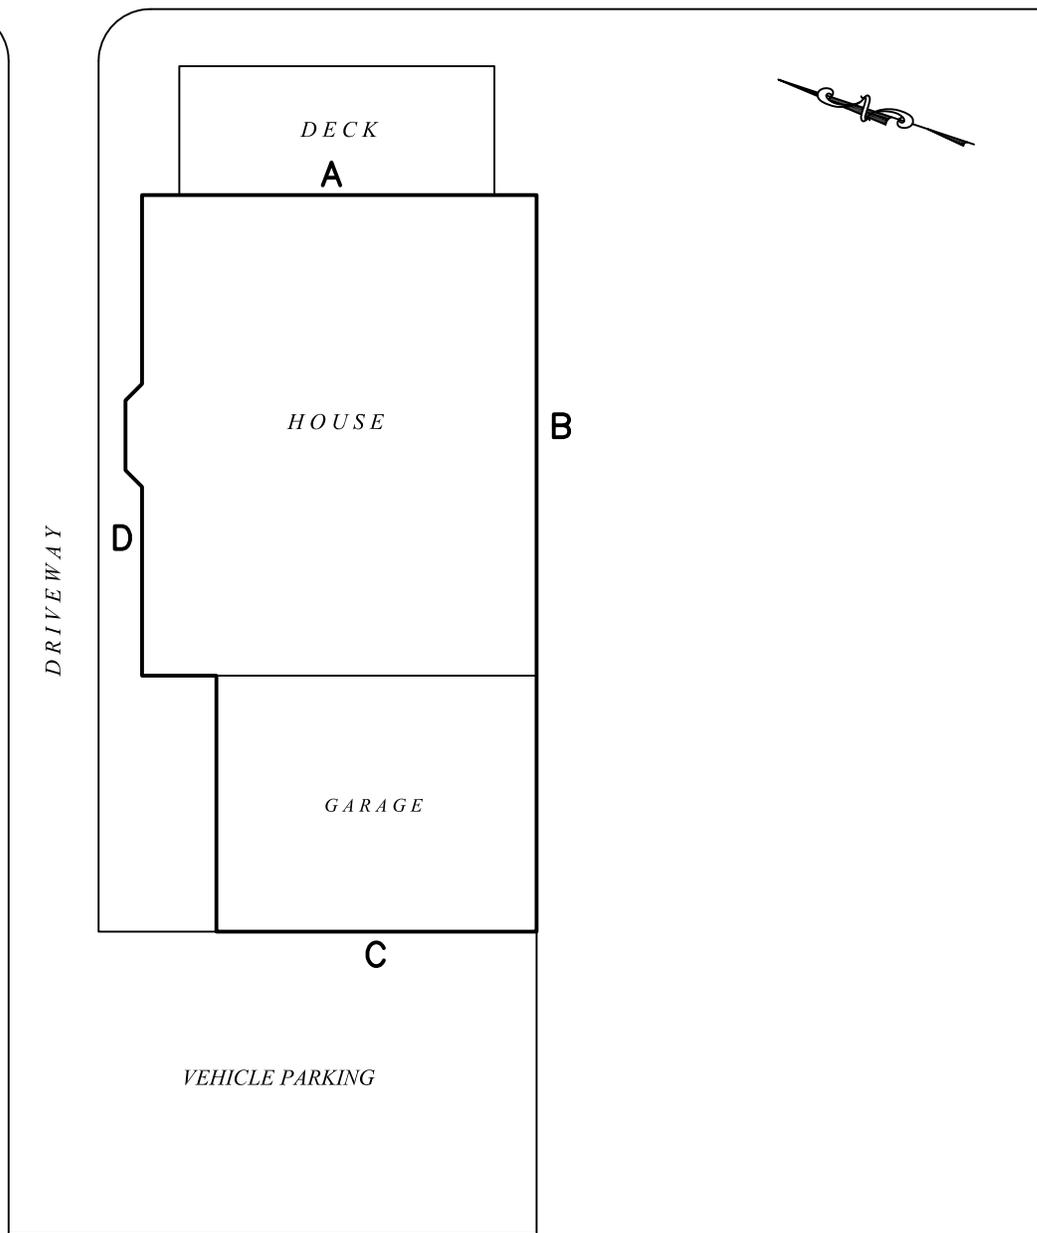
FIGURE 2

XRF readings were taken at a total of 11 locations of six distinct building materials on the exterior of the structure. Appendix C contains a spreadsheet summarizing the results. The results of the XRF testing indicate that several of the exterior painted building materials tested contained lead concentrations greater than the action level of 1 mg/cm<sup>2</sup> (0.5% by weight), including the brown wooden siding on the southern side of the structure and yellow trim on the eastern and western sides of the structure. The materials containing lead based paint above the action level are summarized in the table below. The approximate locations of these materials are shown on the Figure 2 diagram.

Material	Location	Side	Color	Approx. Quantity	Concentration (mg/cm <sup>2</sup> )
Trim	Eastern and western sides	A, C	Yellow	24 LF	15.3 and 19.5
Wooden siding	Southern exterior wall	B	Brown	800 SF	1.7 and 4.2

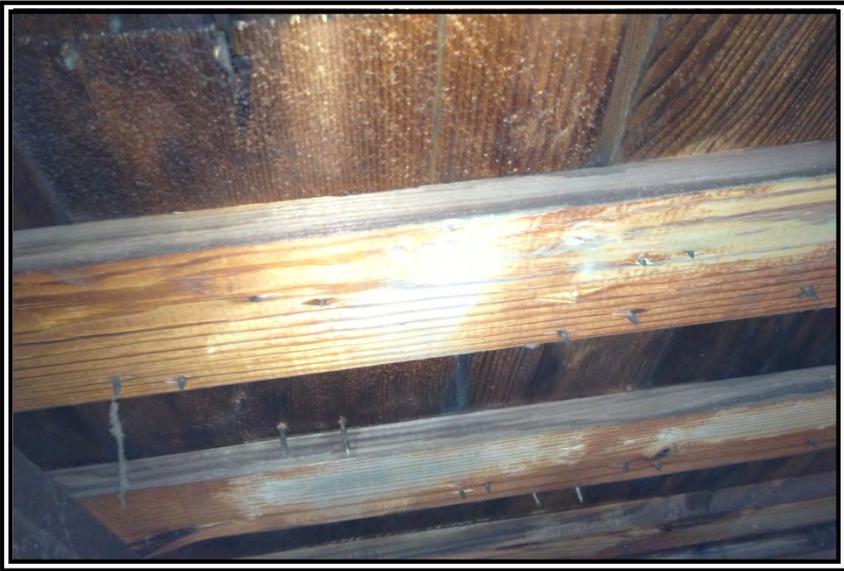
Triton completed a visual mold inspection of the work area on April 8, 2014. Mold was observed on various wooden surfaces through the attic including the wooden plank flooring and the solid wooden sheathing roof materials. Photographs of the apparent mold are provided in Appendix B. Triton was not allowed access to any other interior areas of the dwelling other than the attic during the site inspection. As such, mold may be present in areas of the attic or the remainder of the dwelling that could not be observed during the inspection (i.e. behind walls).

**Photograph 3**  
**Black mold on roof sheaths in attic**

Mold was observed on various wooden surfaces throughout the attic and may be present in other interior areas that could not be observed during the inspection (i.e. behind walls or in finished spaces of the dwelling). To protect occupant and worker health, the mold within the work zone must be abated. Any porous materials containing visible mold that are encountered during the renovation should be removed in accordance local, state, and federal regulations including, but not limited to, with the guidelines put forward in the most recent version of the *Institute for Inspection, Cleaning, and Restoration Certificate (IICRC) Standard and Reference Guide for Mold Remediation* as well as the *Connecticut Guidelines for Mold Abatement Contractors*. The abatement contractor must provide credentials/adequate qualification documentation and a work plan for abatement work with its bid for review by Merritt and Triton. Pre-abatement air testing will be completed by

3. Mold – Mold was observed on various wooden surfaces throughout the attic and may be present in areas that could not be observed during the inspection (i.e. behind walls or alternate finished areas). Additional mold impacts surfaces may be encountered during renovation in spaces that were inaccessible or not apparent during the inspection. To protect occupant and worker health, the mold must be abated by a qualified contractor. Pre-abatement air testing will be completed by Triton to establish a baseline. Triton recommends that a competent person be present during the renovation work who is capable of identifying potential additional suspect materials. General precautions should be taken during the renovation process to avoid the potential spread of mold spores and to mitigate health and safety concerns. Clearance testing will be completed (and compared against the baseline) to evaluate the efficacy of the abatement.

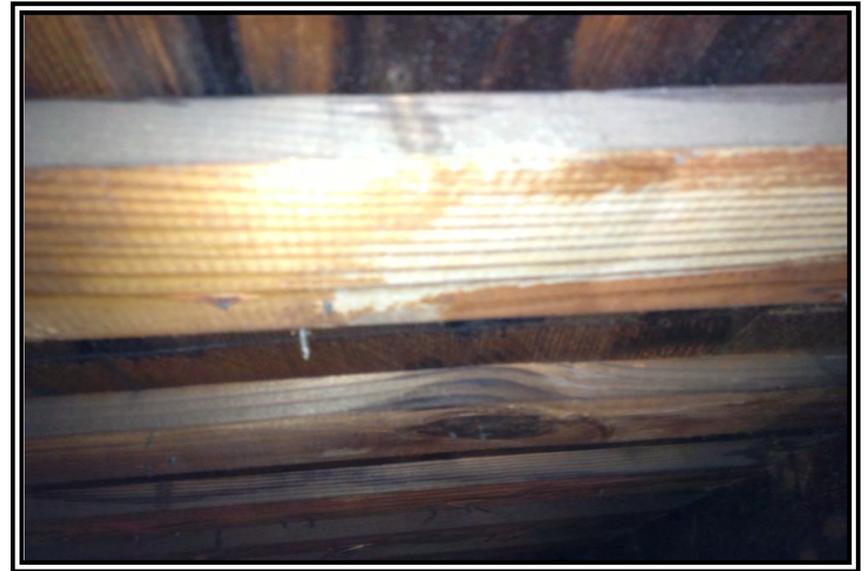
**Photograph 4**  
**Black mold on roof sheaths in attic**

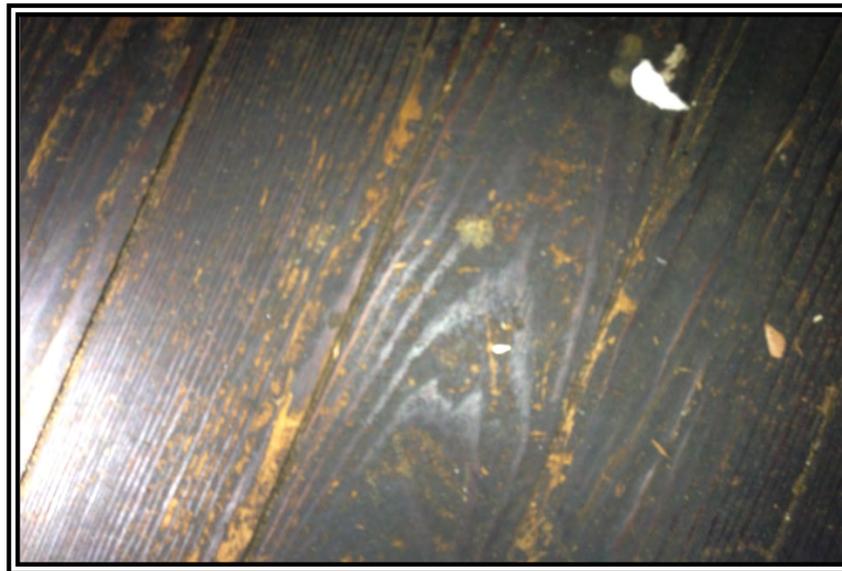
**Photograph 5**  
**Black mold on attic floor planks.**
