**PROJECT 1533 - 2210 PARK AVENUE,
BRIDGEPORT, CONNECTICUT 06604**

**SCHEMATIC
ROOF LAYOUT**

JOB NO.	DRAWING NUMBER	SHEET
33-262-1533	BASEMAP 33-262-1533.dwg	A-2.0

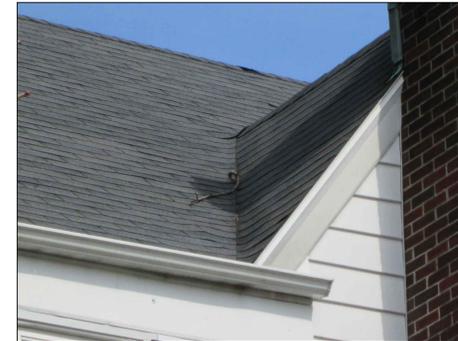
PHOTO 4
(DAMAGED PORTION OF ROOF FACING FRONT OF HOUSE LEFT OF CHIMNEY TO BE REPAIRED) (N.T.S.)

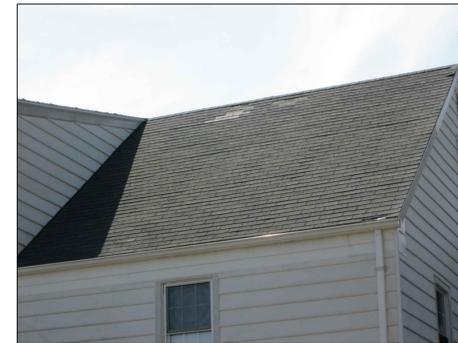
PHOTO 5
(DAMAGED PORTION OF ROOF ABOVE SECOND FLOOR FACING REAR OF HOUSE TO BE REPLACED) (N.T.S.)

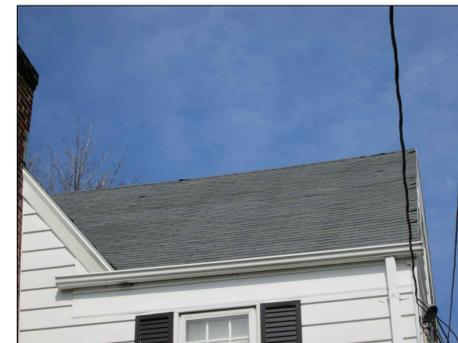
PHOTO 6
(DAMAGED PORTIONS OF ROOF ABOVE SECOND FLOOR FACING FRONT OF HOUSE TO BE REPLACED) (N.T.S.)
