**SITE 008 – 411 BLOHM STREET, WEST HAVEN, CT  
APPLICATION #2140  
CS#183-77, 4/25/2014 and 5/16/2014**

**ASBESTOS PRE-RENOVATION INSPECTION  
SITE 008 – 411 BLOHM STREET, WEST HAVEN, CT  
APPLICATION #2140  
CS#183-77, 4/25/2014, Page 1 of 4**

**LEAD BASED PAINT PRE-RENOVATION XRF SCREENING  
SITE 008 – 411 BLOHM STREET, WEST HAVEN, CT  
APPLICATION #2140  
CS#183-77, 4/25/2014, Page 1 of 4**

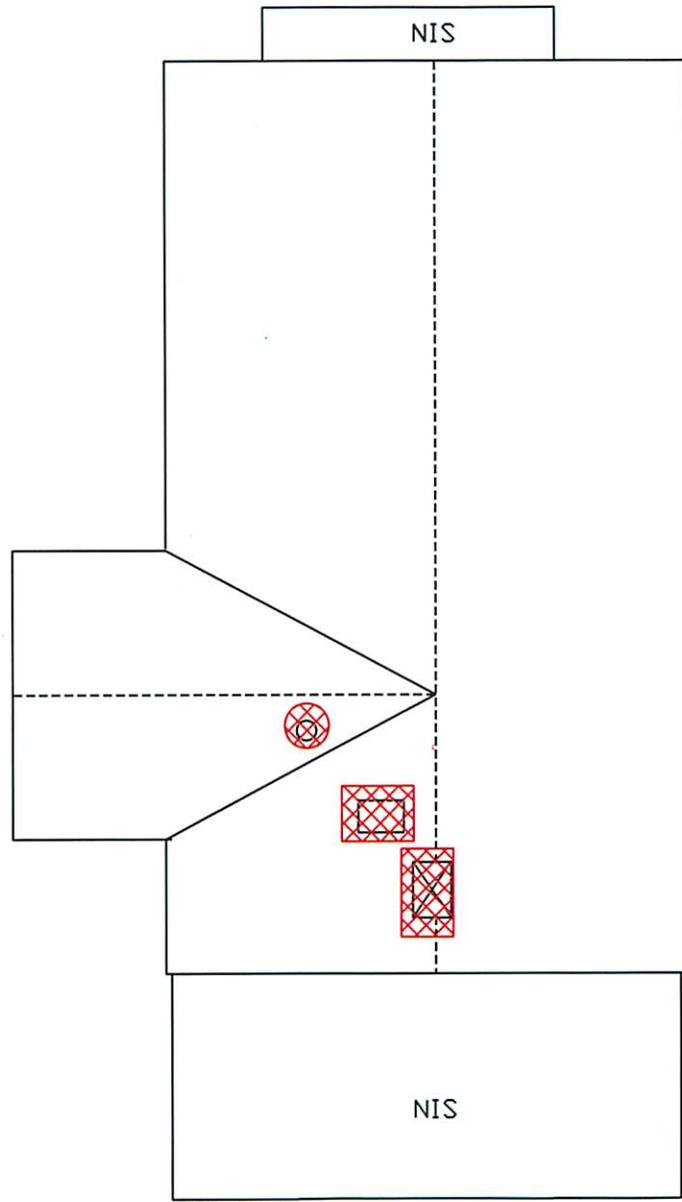
CHEMSCOPE NUMBER: CS# 183-77	DRAWING NUMBER
SCALE: NOT TO SCALE	<b>1A</b>
DATE: 4/25/14

<b>MATERIAL</b>	<b>LOCATION</b>	<b>~FOOTAGE</b>
<b>Black ACM roof flashing tar</b> (at penetrations, roof joints, patch areas, etc.)	<b>Upper Roof</b>	<b>10 sq ft</b>

ACM Roof Flashing

Since Intact Incidental ACM roofing, which includes cements, coatings, mastics, and flashings, was detected within the scope of this inspection, the removal is to be by individuals with a minimum of OSHA 8-hour roof training. The Intact Incidental ACM roofing is currently non-friable and as long as it stays non-friable by utilizing the manual methods outlined in OSHA 1926.1101(g)(11)(iii) notification to the CT DPH is not required. The recommended manual methods outlined by OSHA include but not be limited to the use of spud, spade, flat-blade or slicing tools, such as axes, mattocks, pry bars, spud bars, crow bars, shovels, flat-blade knives, and utility knives, to slice, cut, strip-off, shear-under, or pry-up the material.

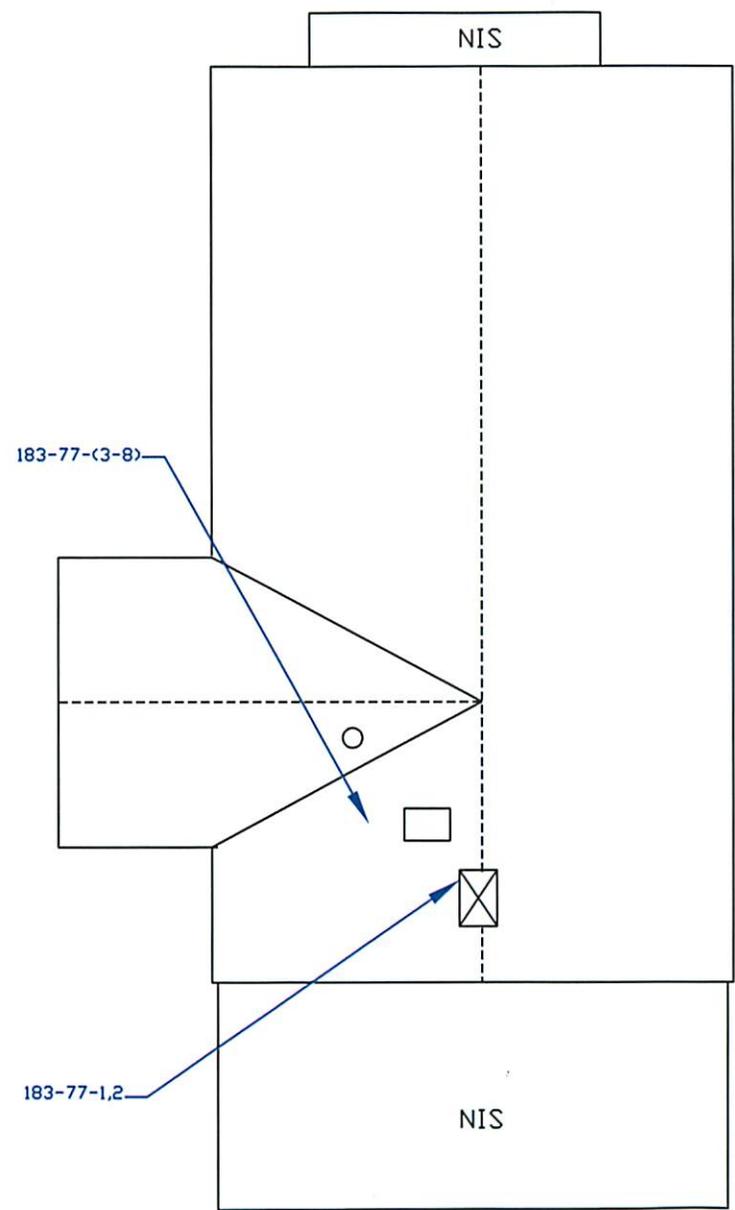
CHEMSCOPE NUMBER: CS# 183-77	DRAWING NUMBER
SCALE NOT TO SCALE	<b>1 B</b>
DATE 4/25/14

*183-77-1 Black sticky fibrous flashing tar (at chimney penetration) / Upper Roof*

*29% Chrysotile Asbestos  
23% Non- Fibrous Particles  
48% Volatile on Ignition*

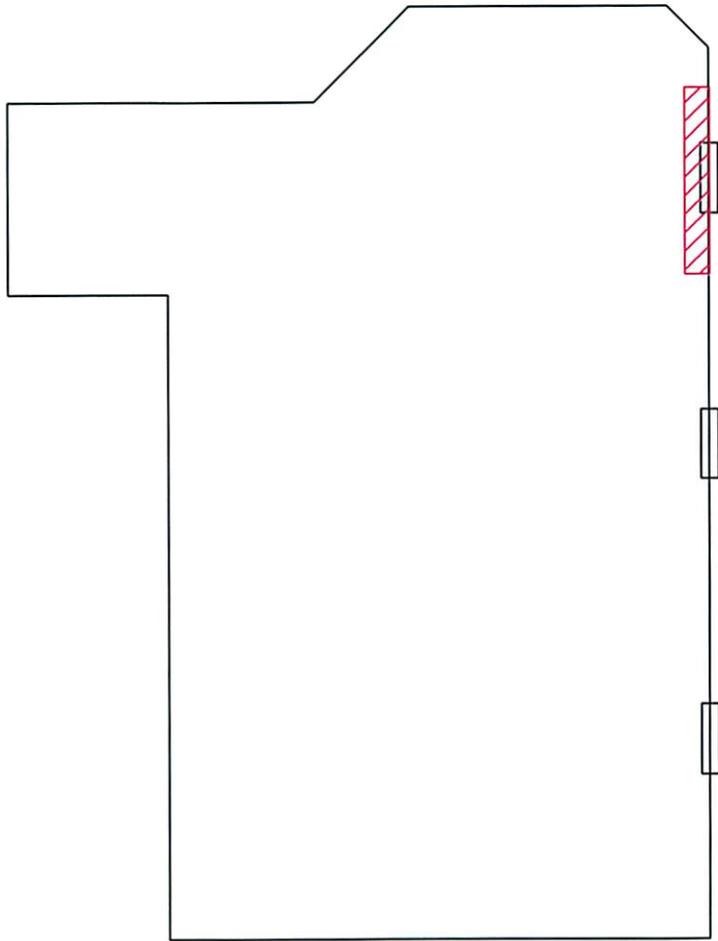
Site 008  
411 Blohm Street, West Haven, CT  
BASEMENT  
CS# 183-77, 4-25-14

**Lead as defined by OSHA and Toxic levels of lead based paint (as defined by USC Title 15 – Chapter 53- Toxic Substance Control) was not detected within scope of inspection.**

No further action is required at this time as Lead Based Paint was not detected within the scope of the inspection and you are exempt from evaluating the construction waste as hazardous waste. However, please keep in mind, lead related work must be done according to applicable regulations (OSHA 1926.62 and USC Title 15 – Chapter 53- Toxic Substance Control) with properly trained personnel using proper work practices and procedures including proper disposal of hazardous lead waste (CT DEEP) and proper precautions to avoid contaminating the building and exposing those present to lead dust or fumes. Before cutting or welding and preparation work, any lead-based paint identified above should be handled with proper precautions to avoid contaminating adjacent areas and exposing those present to lead dust or fumes.
