June 23, 2014

**RE: Environmental Assessment Report
Department of Housing
CDBG-DR – Sandy Disaster Recovery Program
20 Arthur Street, New Haven
Application #2135
Eagle Project No. 14-020.12T12**

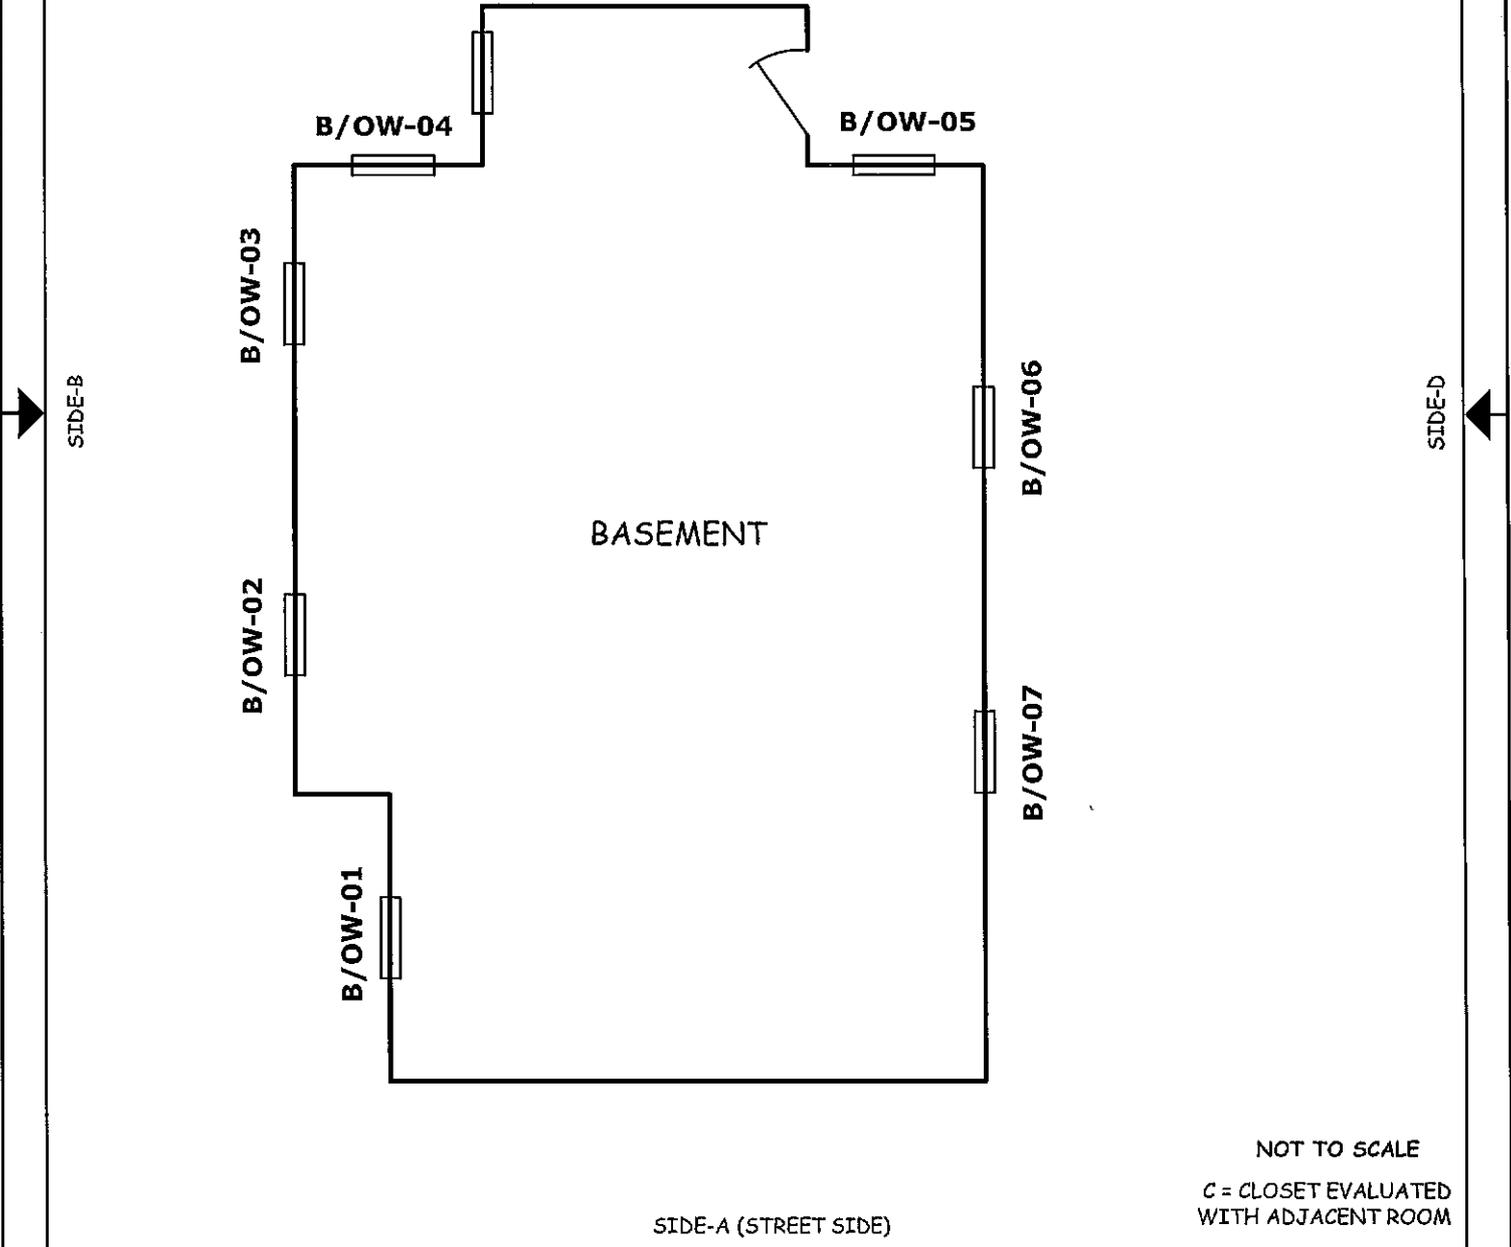
= NUMBER AND LOCATION OF DUST SAMPLES

BOLD TEXT INDICATES A DUST-LEAD HAZARD FOUND

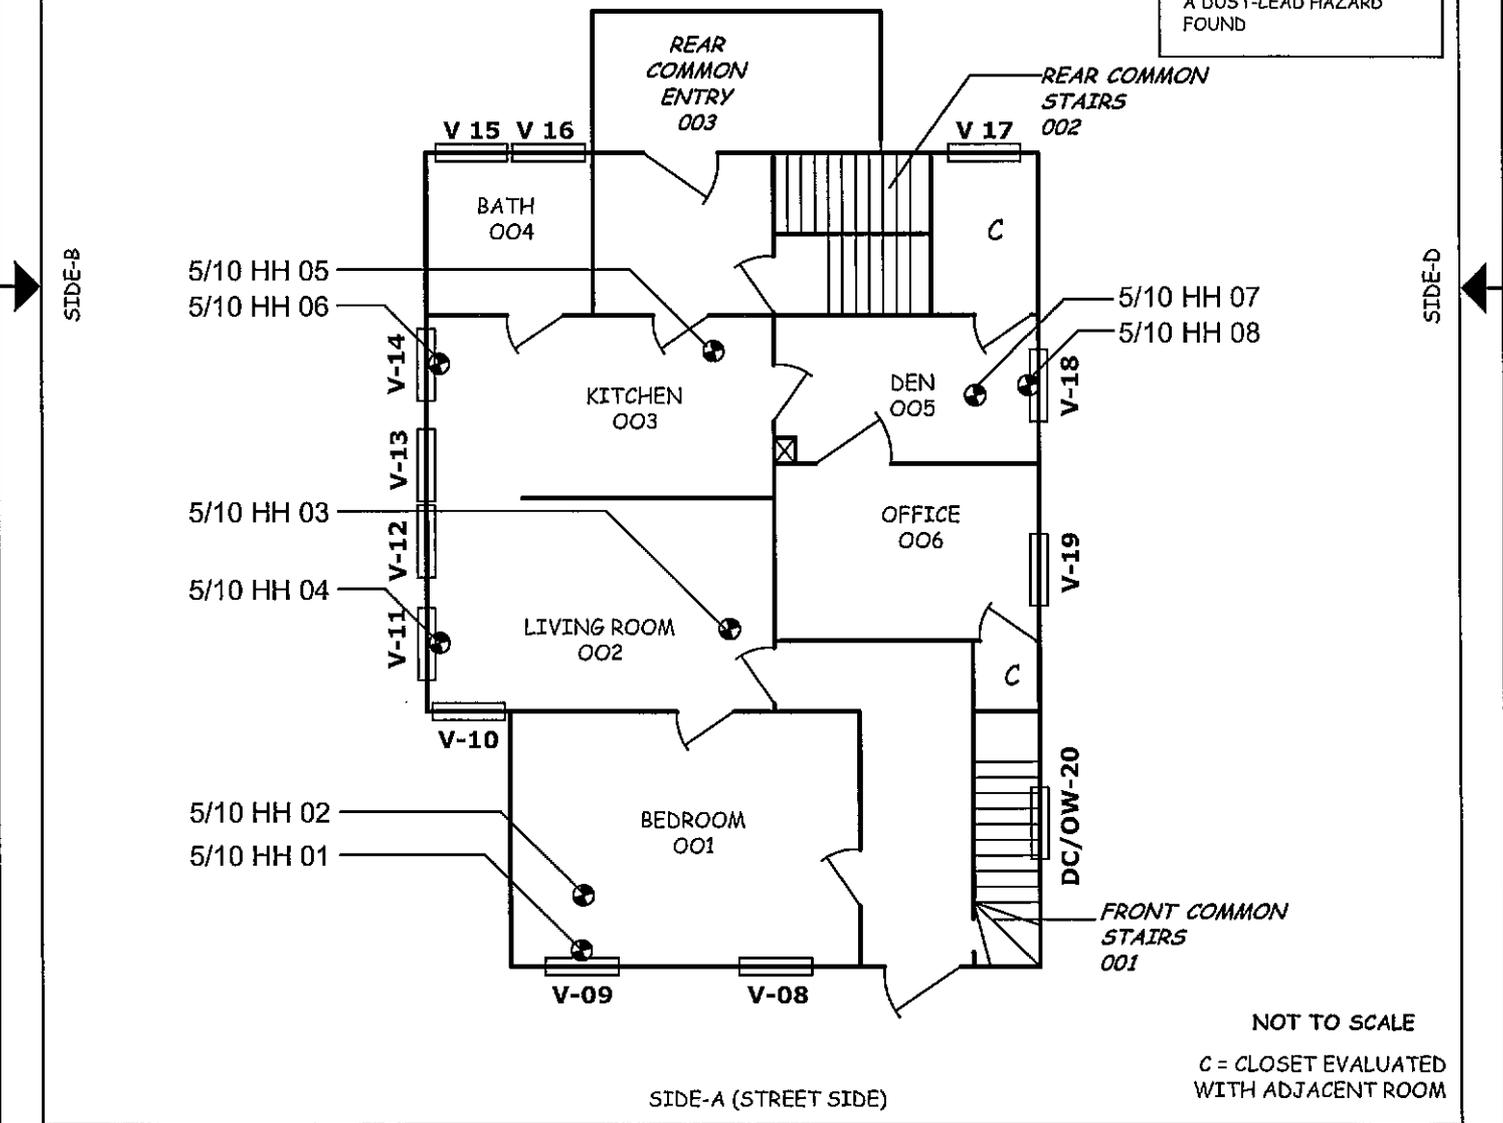
= NUMBER AND LOCATION OF DUST SAMPLES

BOLD TEXT INDICATES A DUST-LEAD HAZARD FOUND

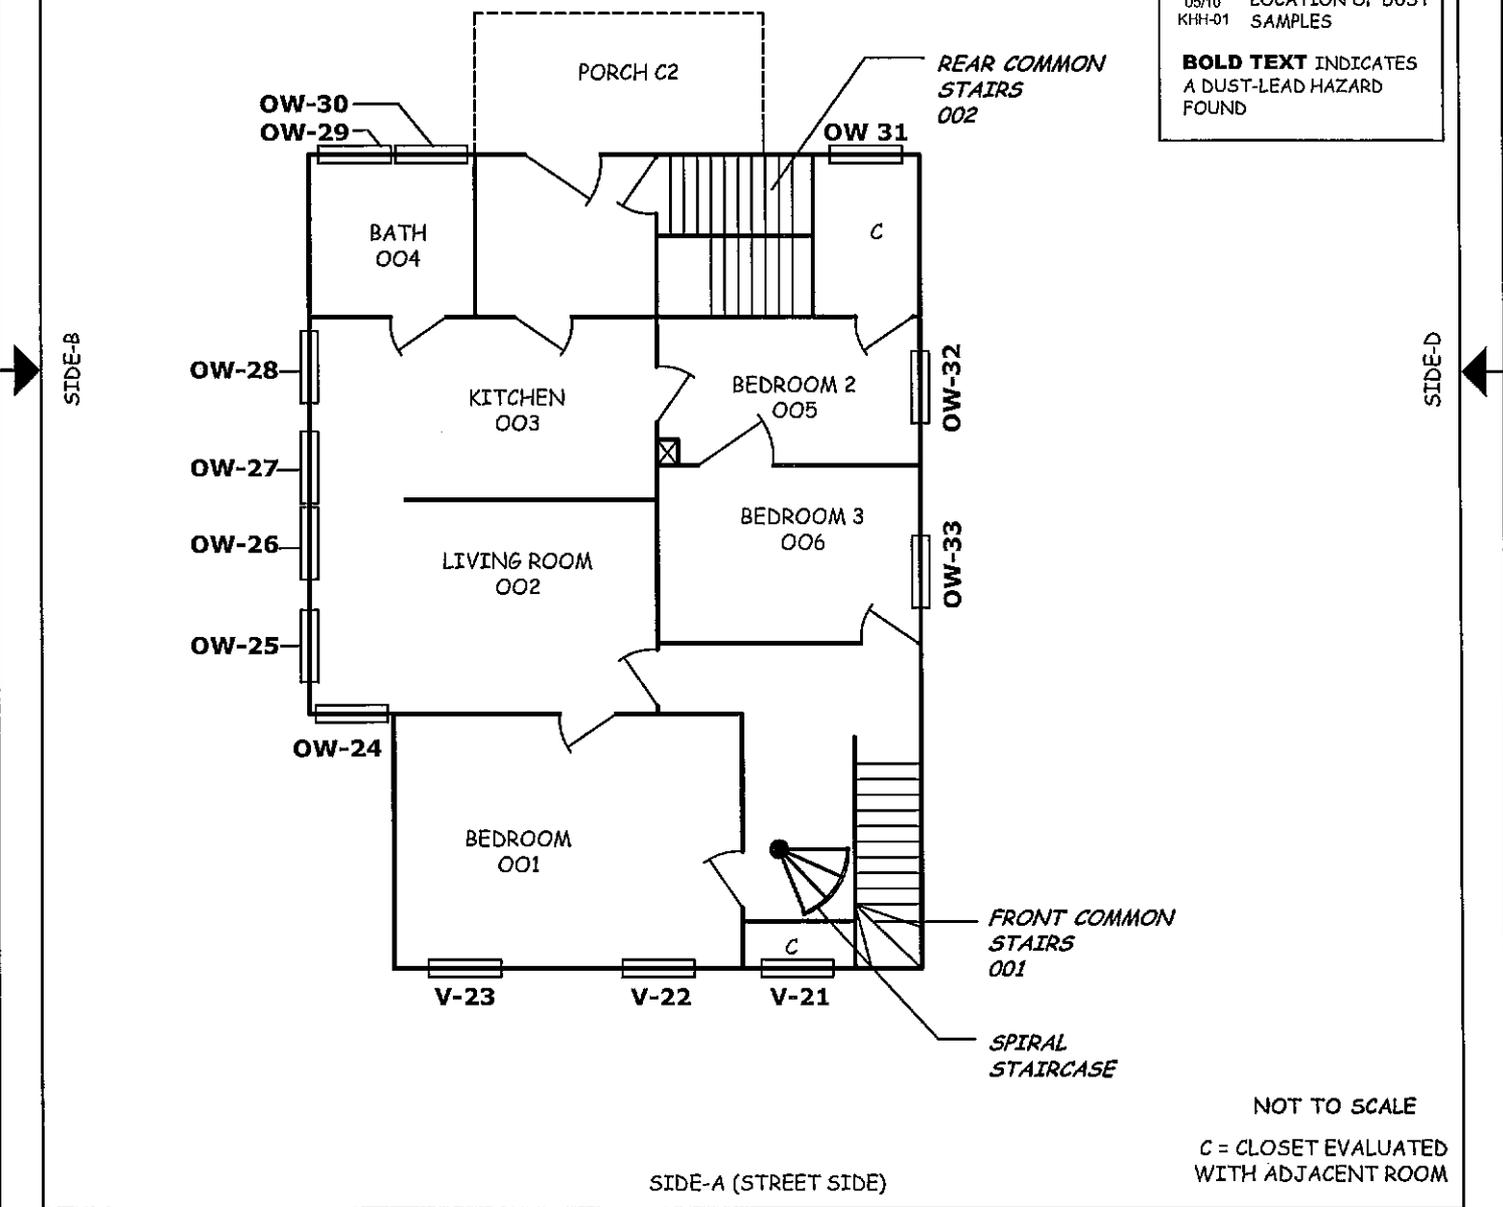
= NUMBER AND LOCATION OF DUST SAMPLES

BOLD TEXT INDICATES A DUST-LEAD HAZARD FOUND
