EAGLE
Environmental, Inc.

July 24, 2014

RE: Environmental Assessment Report
Department of Housing
CDBG-DR – Sandy Disaster Recovery Program
2 Apple Tree Lane
West Mystic, Connecticut 06512
Application #2011
Eagle Project No. 14-028.12T17

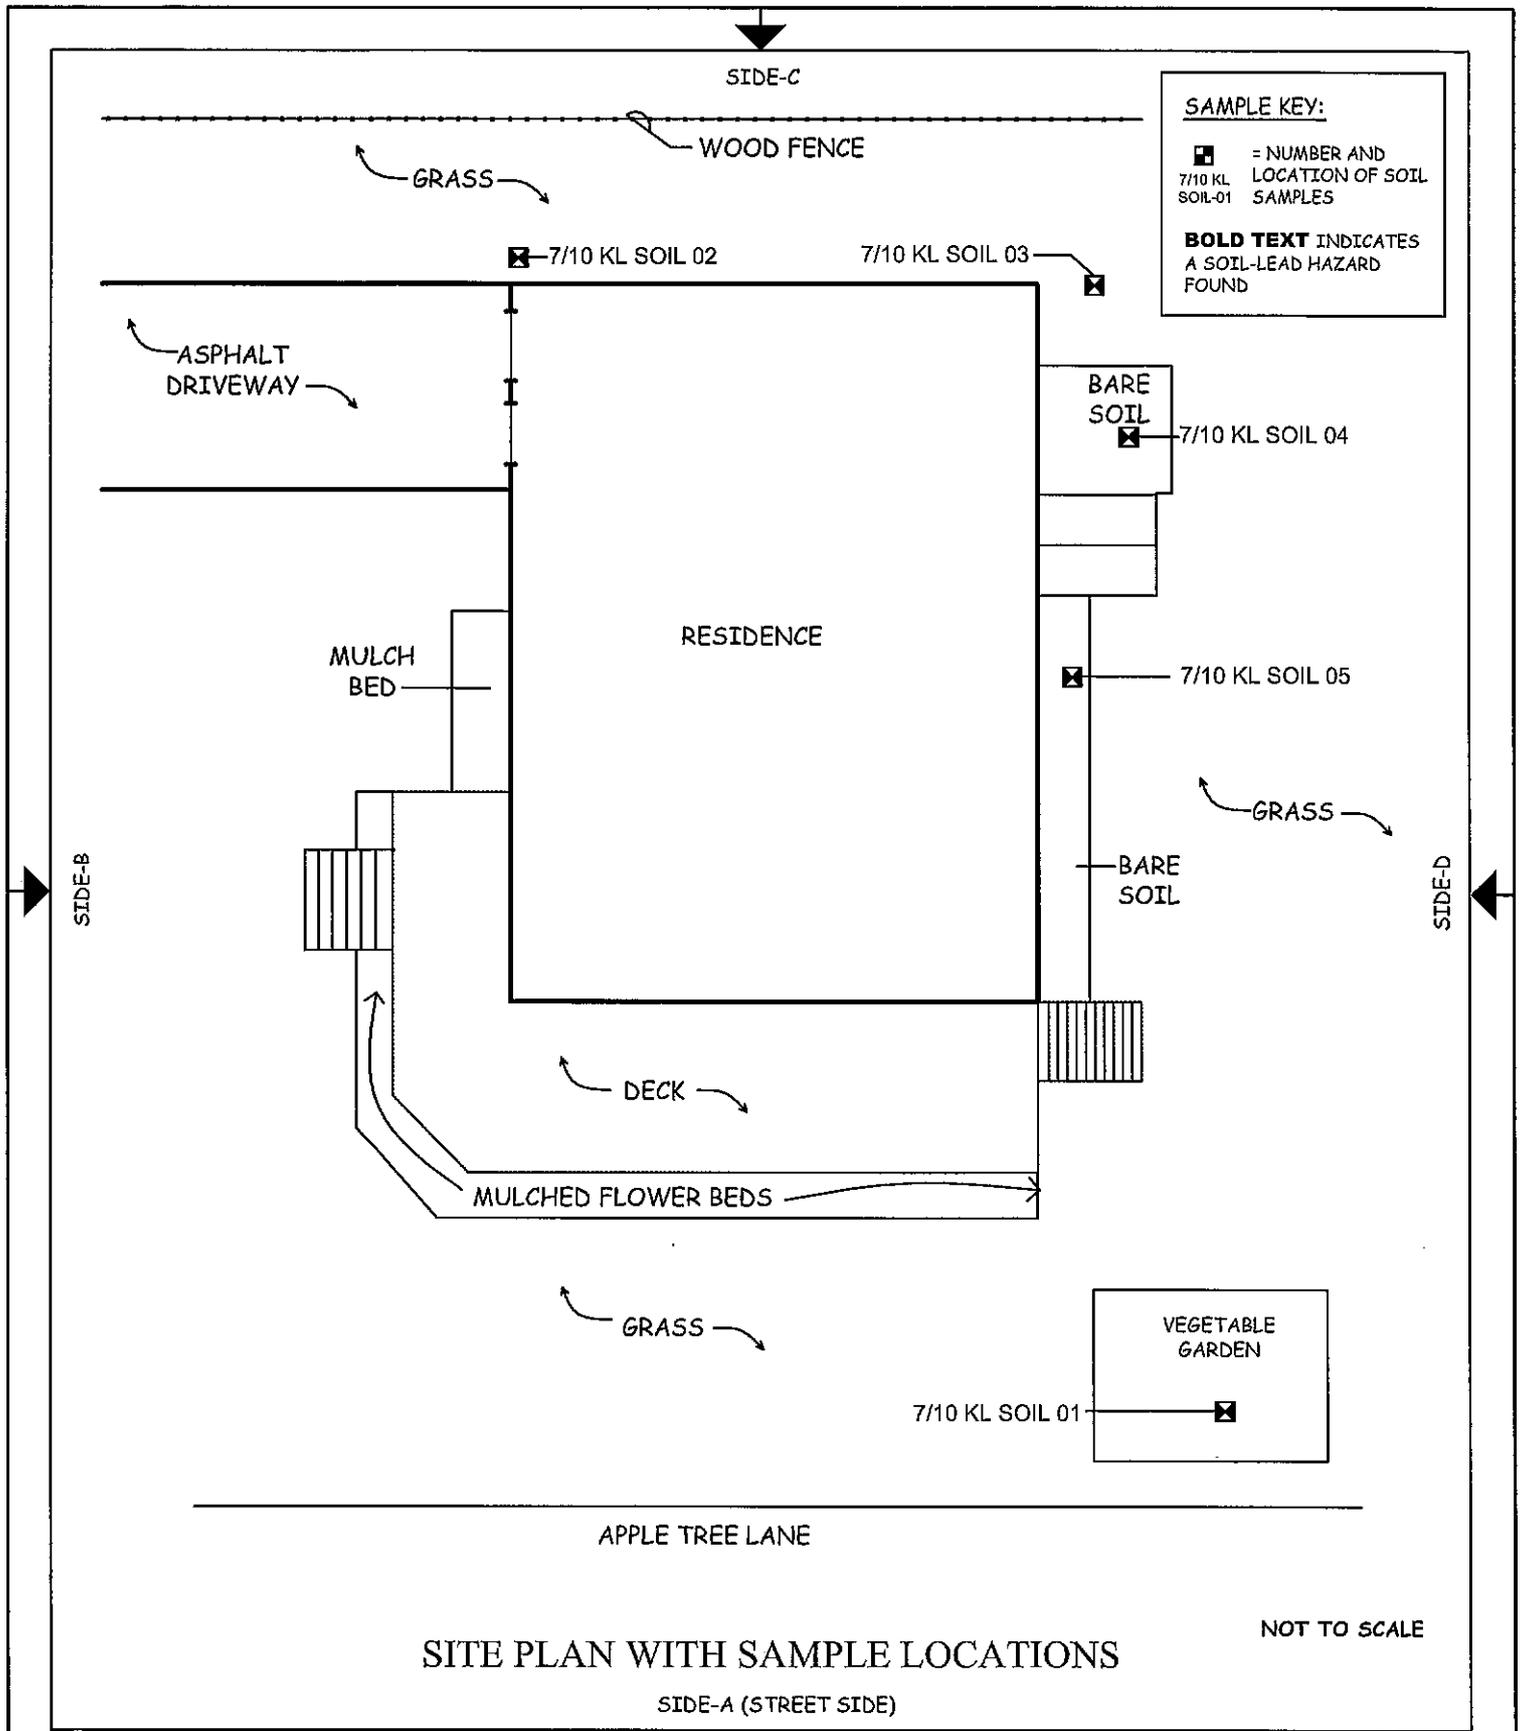
SP-1

Five (5) soil samples were collected from bare areas of soil and gardens from around the site-building. No soil-lead hazards were identified at the sampled locations. The homeowner should maintain the grounds in their current condition.

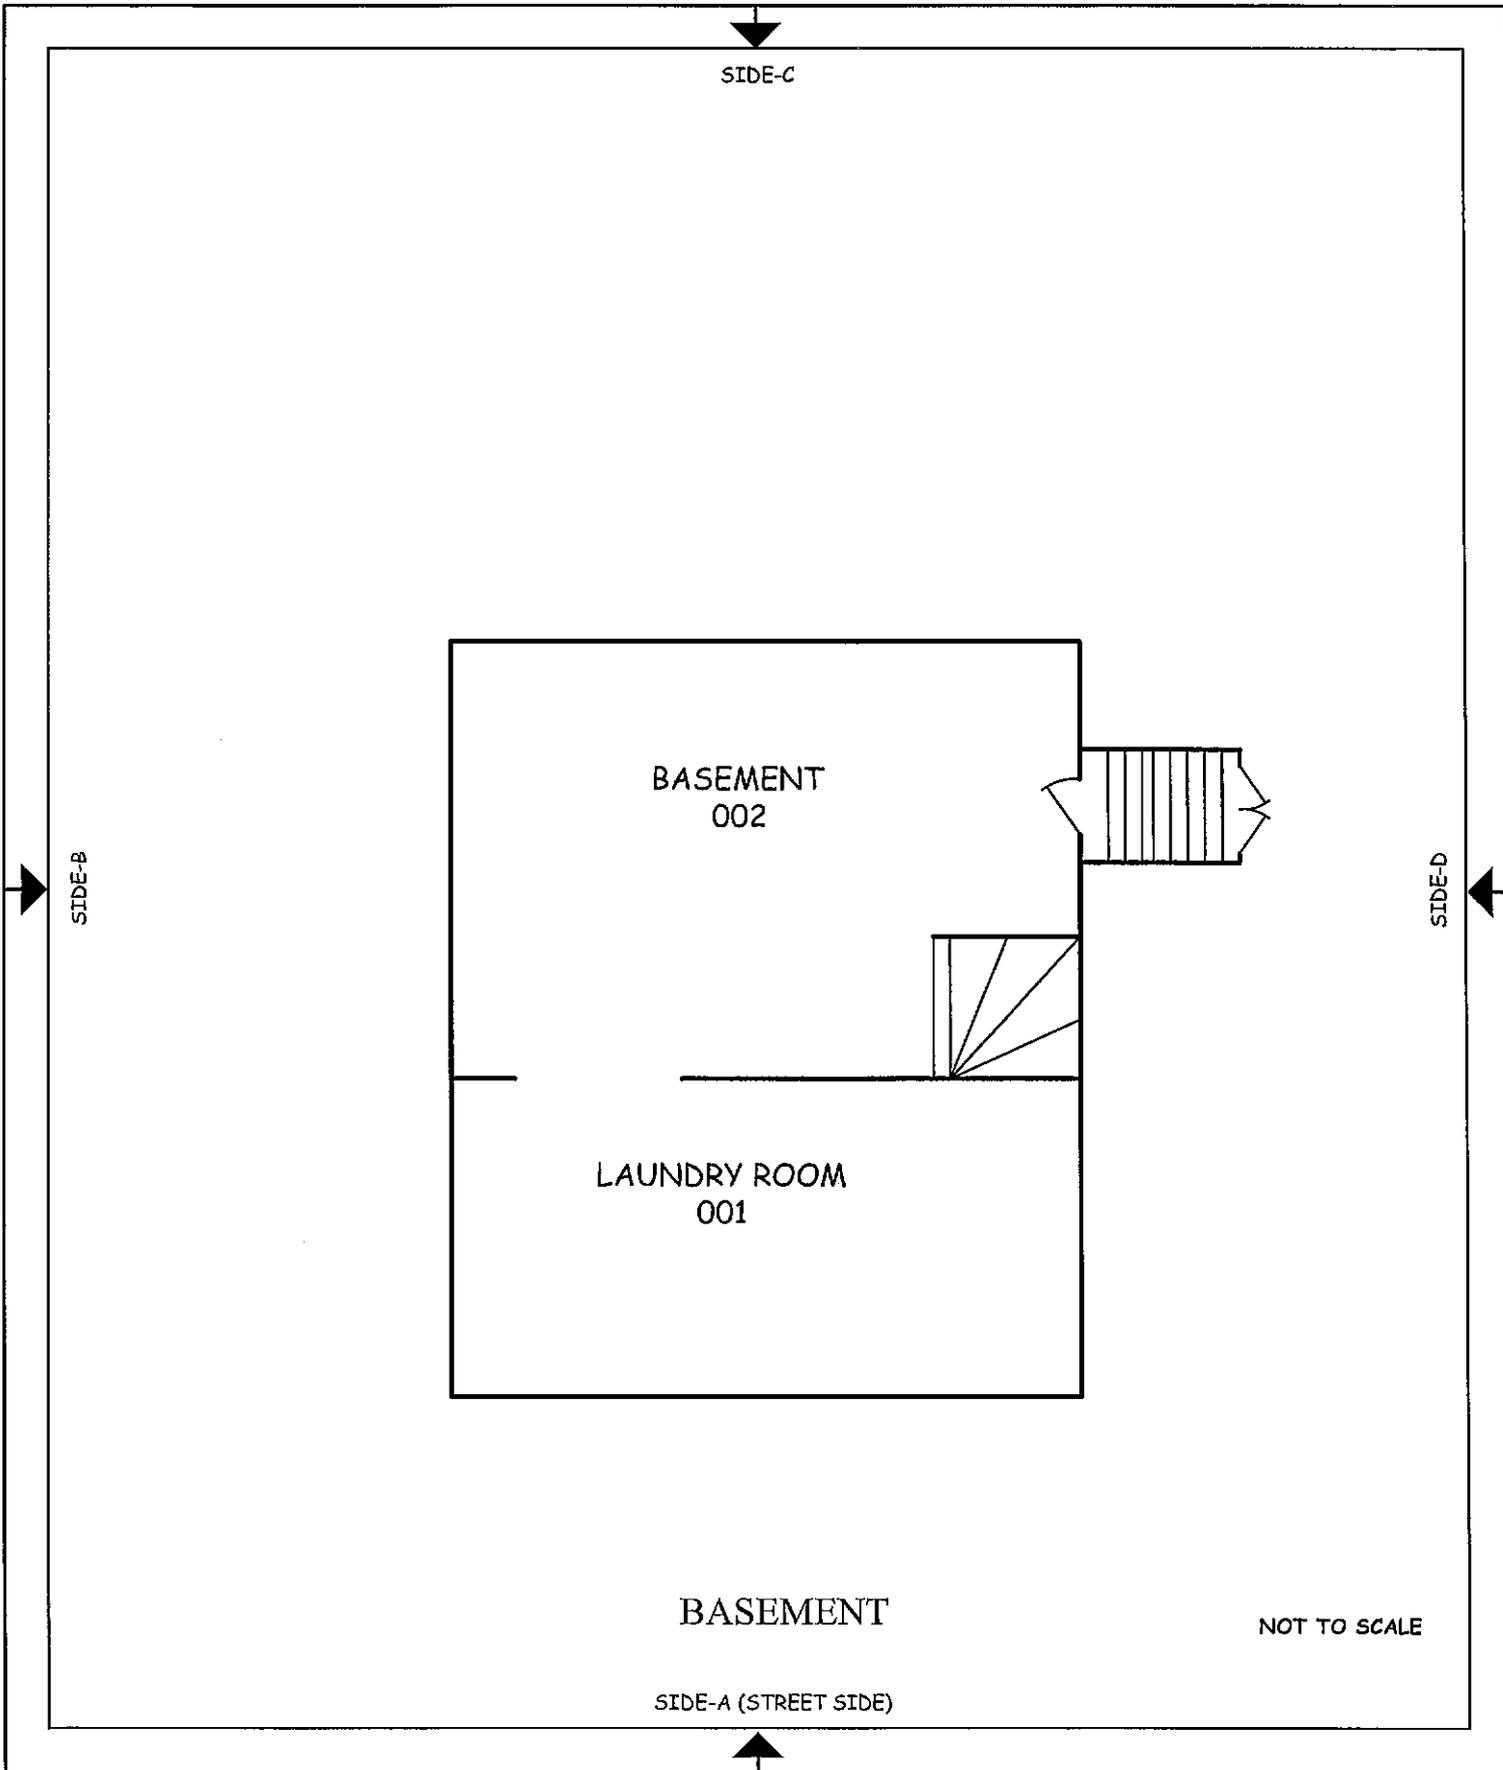
FP-1

- Breeching insulation in Room 001 (Laundry Room)

- 4.4 The physical inspection identified visible black mold spore growth on the on the wall studs and insulation in the basement area (Rooms 001-002). The gypsum board ceiling has minor water stains which are likely caused from the basement flooding. There is a strong, pungent odor within the basement area as well.

A licensed Asbestos Abatement Contractor shall remove the breeching insulation prior to the basement being filled in. The Asbestos Abatement Contractor will comply with the US Department of Labor's Occupational Safety and Health Administration (OSHA), the USEPA National Emission Standard for Hazardous Air Pollutants, the CT DEEP regulated waste disposal regulations and the State of Connecticut Standard for Asbestos Abatement.
