STRUCTURE NO. 03312

INTERSTATE-84 EB

ROUTE 72, QUINN RV, B&M, RT

Routine & Special Inspection

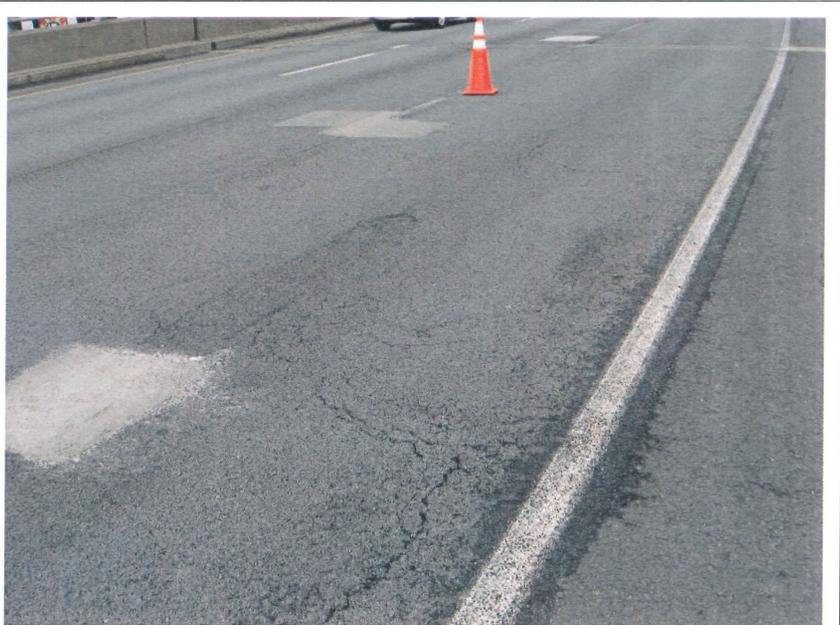
Photo # 8: Overlay in Span 5. Note the cracks and random patches in the overlay.

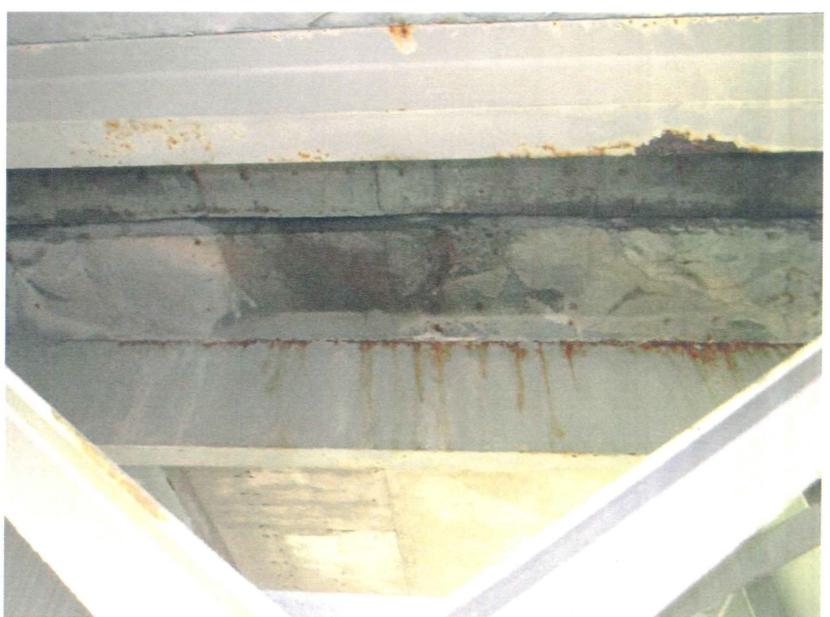
Photo # 12: Hollow area/spall with exposed rebar in the deck end at Pier 1 in Bay 5 of Span 2.

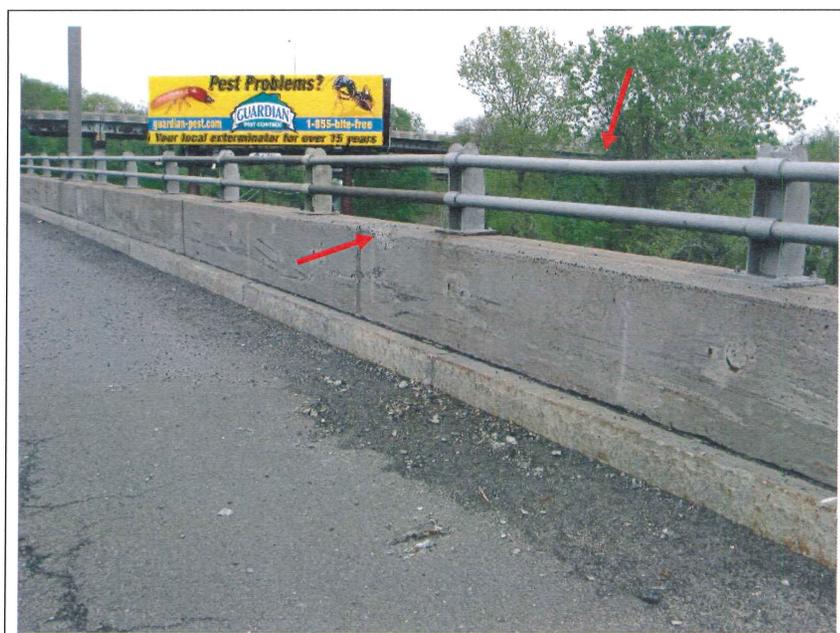
CURBS:	7	<p>There are vertical faced granite curbs along both parapets, which exhibit minor edge spalls and scrapes at random locations.</p> <p>Average South Curb Reveal: 8" Average North Curb Reveal: 7 1/4"</p> <p>See Field Notes Sheet 9 through 12 and Photo Nos. 13 and 14.</p>
MEDIAN:	N	-
SIDEWALKS:	7	<p>There is a concrete safety walk along the north fascia only, which exhibits areas of light scaling and random hairline cracks. See Field Notes Sheets 9, 10 and 11 and Photo No. 14.</p>
PARAPET:	6	<p>There are concrete parapets along both fasciae, which exhibit random shallow rebar, scrapes and hairline cracks with efflorescence. There are isolated hollow areas up to 1.5' x 6" and spalls up to 2' x 1' x 2 1/2" deep. See Field Notes Sheets 9, 10 and 11 and Photo Nos. 13 and 14.</p>
RAILING:	6	<p>There are double pipe metal bridge railing on top of both parapets, which exhibit random areas of light to heavy rust. A few rails are bent and posts exhibit dents due to impact damage at random locations. Random posts exhibit gaps up to 1/2" high under the base plates. Isolated anchor bolt nuts are missing or not fully engaged due to short bolts. The south railing near Pier 6 has an isolated 2" x 1" rusted through hole in the lower rail. See Field Notes Sheets 9, 10 and 11 and Photo Nos. 13, 14 and 15.</p>

Photo # 13: Curb, parapet and railing along the south fascia in Span 4. Note the spall, scrapes in the parapet and bent top railing.

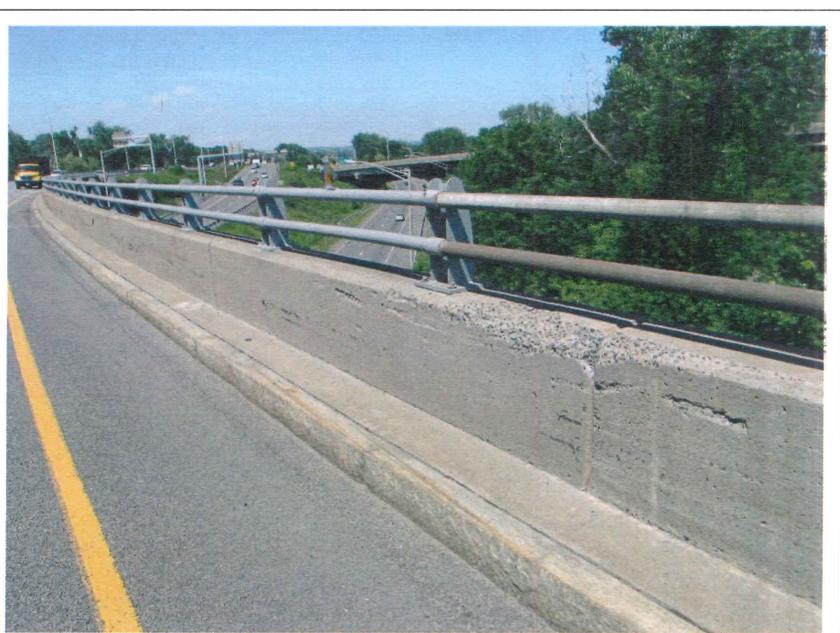
Photo # 14: Curb, safetywalk, parapet along the north fascia in Span 4. Note the spall and gouges in the parapet.

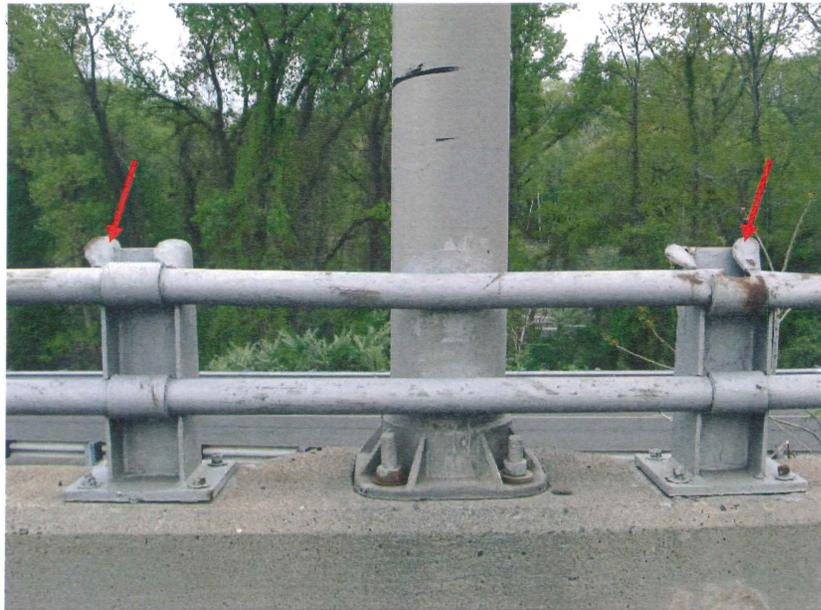
Photo # 15: Collision damage in the railing posts along the east fascia in Span 1. Also note the missing anchor bolt covers of the light standard.

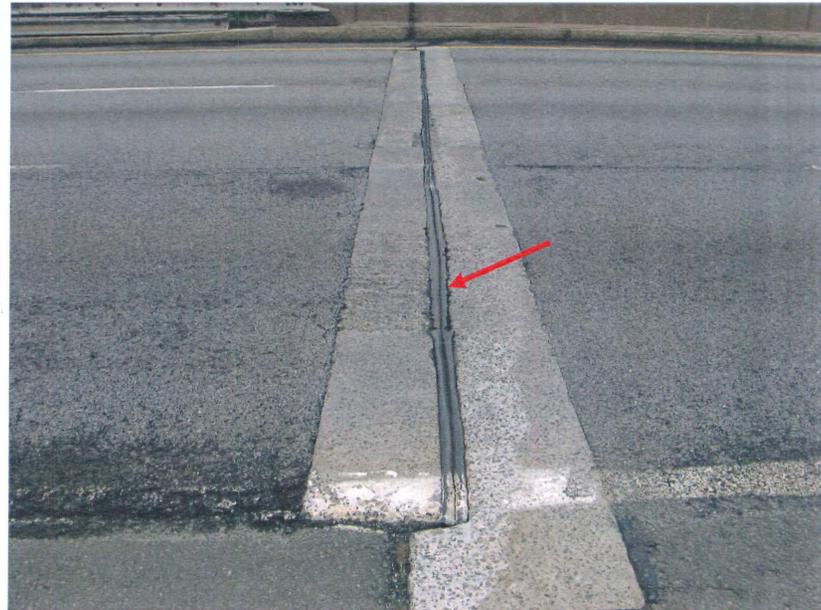
PAINT:	7	<p>Less than 10% of the railing paint is deteriorated. See above item entitled "RAILING".</p>
FENCE:	N	-
DRAINS:	7	<p>PVC deck weep pipes: No significant deficiencies noted. Scupper grates exhibit light accumulation of debris. See Field Notes Sheets 9, 10, 11, 32, 36 through 44.</p>
LIGHTING STANDARD:	7	<p>There are light standards mounted on the east parapet in Spans 1, 4 and 6, which exhibit missing anchor bolt covers and missing screws in handhole cover (but taped). The junction box covers have up to 10 of 12 screws missing (but secure). See Field Notes Sheets 9, 10 and 11 and Photo No. 15.</p>
UTILITIES TYPE/SIZE:	N	-
CONSTR JOINTS:	N	-
EXPANSION JOINTS:	5	<p>There are compression seal joints at the abutments and piers. The joint seals are depressed at random locations up to 1 1/2" deep and exhibit light accumulation of sand at random locations. There is a total of 5' of separated/torn seals in the deck joints at the West Abutment and Pier 2. The</p>

Photo # 16: Deck joint at the West Abutment. Note the separated joint seal.

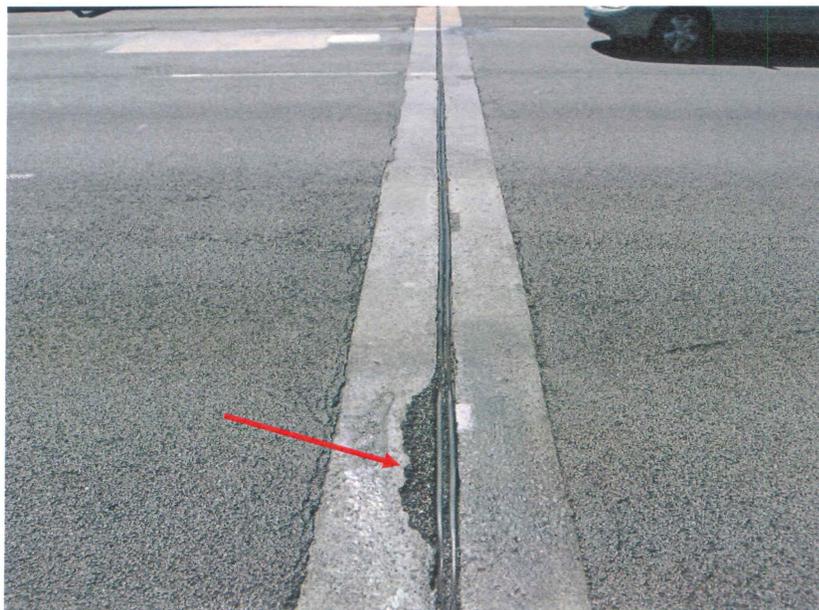
concrete header of deck joint at Pier 4 and the East Abutment has minor spalls up to a 2.5' x 5" x 1/2" deep. Previously noted spalls in the concrete headers of Piers 2 and 3 have been repaired since the last inspection. The deck joints at the abutments do not fully extend to the south parapet and the overlay exhibits minor potholes and filled with sand. Areas of active leakage were noted below at random locations. See Field Notes Sheet 9, 10 and 11 and Photo Nos. 16 through 19.

Photo # 19: Deck joint at Pier 4. Note the spall in the concrete header.

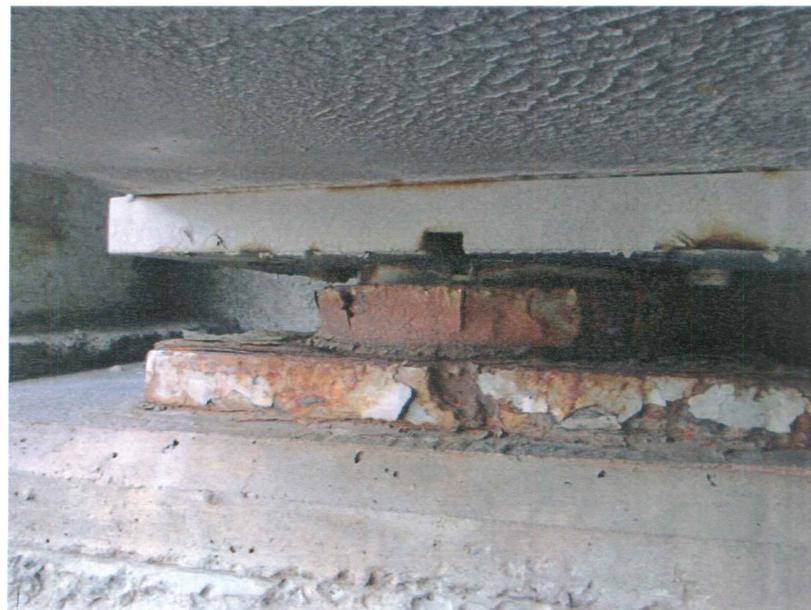
Girder Pot Bearings:
 There are guided expansion pot bearings at both abutments, at Pier 1 in Span 2, Pier 3 in Span 3, Pier 4 in Span 4, Pier 5 in Span 5, Pier 6 in Span 6 and Pier 7 in Span 7. The expansion bearings exhibit areas of peeling paint with light to heavy rust with laminar rust and minor section losses. Random expansion bearings have teflon shavings at the top of the piston. Lateral measurements were taken at the keys at all bearings. Expansion bearings exhibit evidence of movement.

Photo # 20: Expansion pot bearing for Girder G1 at the East Abutment. Note the areas of peeling paint with rust.

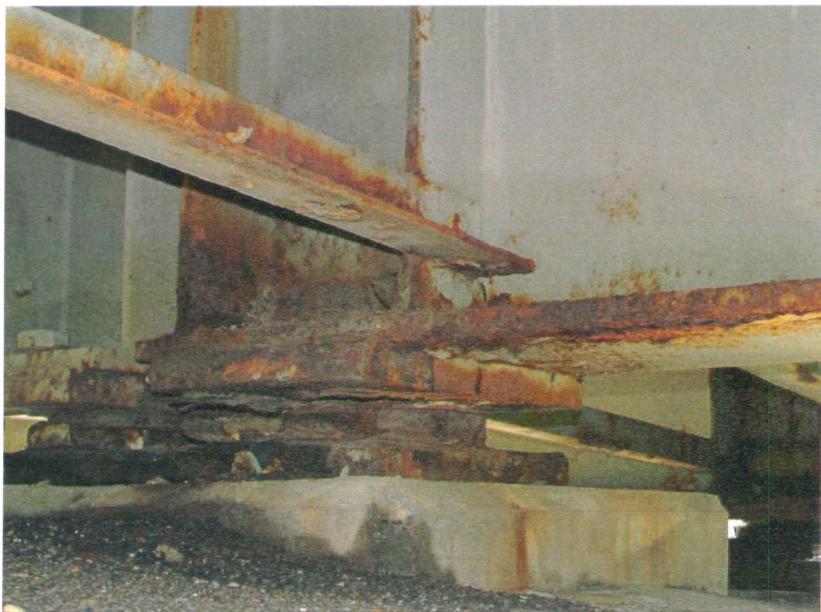
There are fixed pot bearings at both abutments, at Pier 1 in Span 1, Pier 2 in Spans 2 and 3, Pier 3 in Span 4, Pier 4 in Span 5, Pier 5 in Span 6, Pier 6 in Span 7 and Pier 7 in Span 8. The fixed bearings exhibit peeling paint with light to heavy rust with laminar rust and minor section losses.

Photo # 21: Fixed pot bearing for Girder G2 at Pier 7 in Span 8. Note the areas of peeling paint with rust.

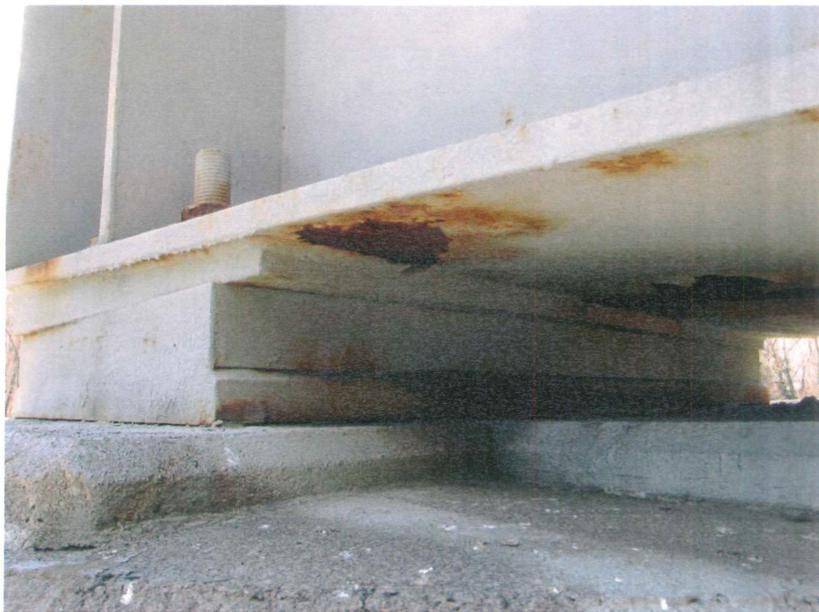
Cap Girder Bearings at Pier 2:
 There is a sliding expansion bearing at the south column of Pier 2, which exhibits tilted anchor bolts, the bearing plates are slightly rotationally misaligned, and there is up to 3/16" gap/impacted rust between the sliding and masonry plates. Bearing measurements did not change since the last inspection (10 degrees Fahrenheit difference in temperature). However, since it is a short span between Pier 2 Columns, minimal movement is expected. There is a fixed bearing at the north column of Pier 2, which exhibits light rust, isolated areas of laminar rust, bent/tipped anchor bolts, one missing nut, and backed off anchor bolt nuts, one shimmed with several spacers.

Photo # 22: Expansion bearing for cap girder at the south column of Pier 2. Note that the bearing plates are slightly misaligned.

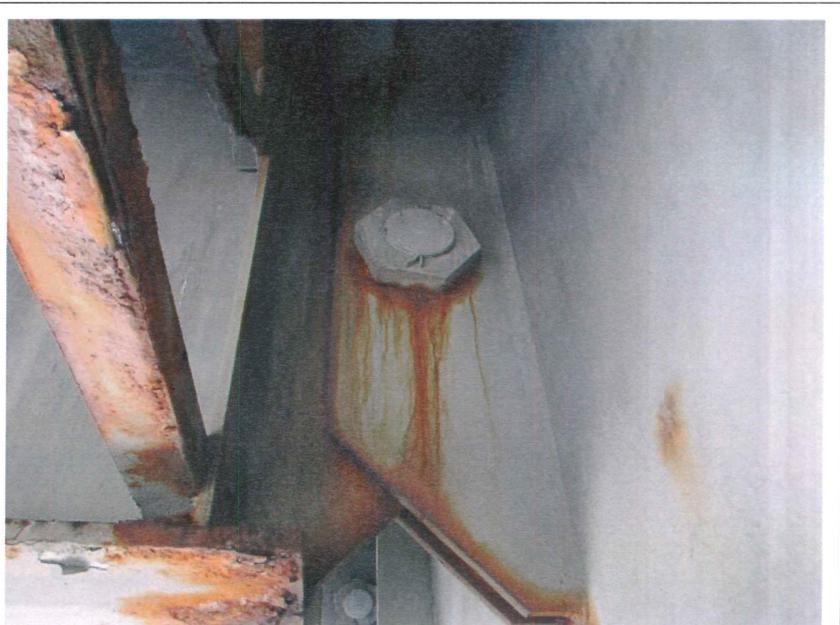
Fixed Hinges at Pier 2 in Spans 2 and 3:
 There are areas of up to 9/16" impacted rust and/or gaps between the hinge plates and the girder webs. There is also bleeding rust at the hinge plate/web junctions. There are gaps up to 1/4" between the pin nuts and the hinge plates at isolated locations. Isolated nuts exhibit evidence of movement in the past. All cotter pins are in place. All measurements were within 1/16" of previous measurements, except the "V" measurements for Girders G5 and G7 in Span 3 where the "V" measurement decreased by 1" (possibly due to the fact that measurements were taken on the wrong side of the girder and measurements were taken on both sides of the girders at these locations of discrepancies in measurements). There is no signs of distress were noted at the time of inspection. Also note that all pins were ultrasonically tested as part of previous inspection, and no defects were noted.

Photo # 24: North side of the hinge for Girder G4 at Pier 2 in Span 3. Note the areas of rust around the nut and bleeding rust on the hinge plate.

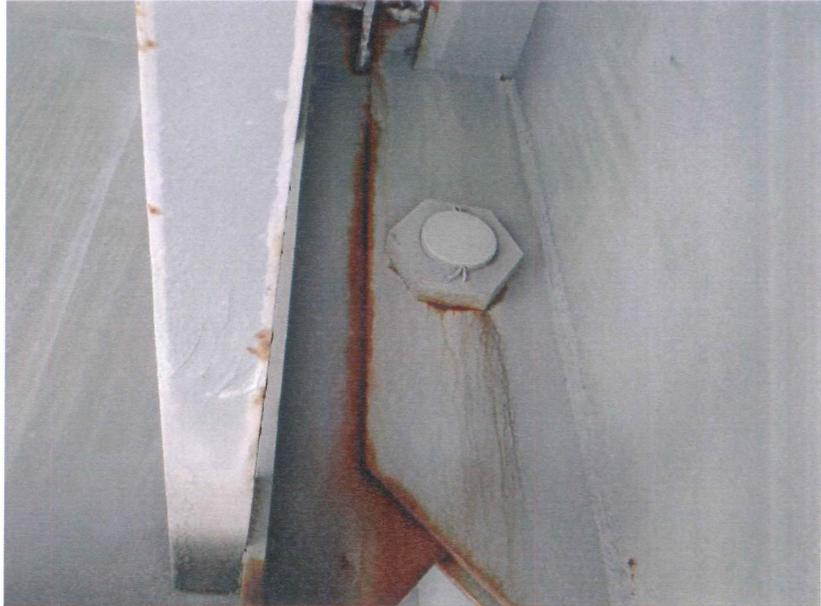
<p>remaining.</p> <p>Girder G1 previously had section losses with rusted through holes at the pier locations that resulted in isolated locations of stiffener and web buckling. Welded repair plates had been installed previously in the web at all locations with heavy section losses. At some locations, all stiffeners have not been repaired, however the addition of plates at other stiffeners and the webs is considered to restore the original overall cross section. At Pier 6, bearing stiffeners exhibit section losses up to knife edge remaining with buckled webs and bearing stiffeners (but welded plates added to the web over bearing area should have arrested these conditions). Also, there is section losses up to 1.5' long x 3 1/2" high x 1/4" deep along the bottom of web in front of the bearing (less than 5% loss in shear). Girder G1 at Pier 1 in Spans 1 and 2 exhibits section loss in the bearing stiffeners up to full height x full width x 1/4" remaining with an isolated 1/4" diameter rust hole, resulting in up to 15.6% loss in web bearing area (buckling) (no repairs at these locations). Random bearing stiffeners and web ends at other locations exhibit section loss up to 1/8" deep.</p> <p>Webs near the hinges: Girder webs have areas of heavy rust with laminar rust with section losses on both sides of the webs adjacent to the hinge connections to the steel pier cap at Pier 2. The worst loss was noted in Girder G1 web in Span 3, which has up to 1/8" deep section loss on both sides of the web adjacent to the hinge, resulting in approximately 14% web loss in the critical area. Also, the bottom edge of the Girder G1 web in Span 3 at Pier 2 has up to 1/4" deep estimated loss along the bottom edge between the hinge plates. Note that there is impacted rust between the girder web plates and hinge plates (difficult to remove) which may be concealing additional section loss.</p> <p>See Field Notes Sheets 32 through 44 and Photo Nos. 25 through 33.</p>

Photo # 26: South side of the hinge for Girder G6 at Pier 2 in Span 2. Note the areas of rust in the girder web and evidence of movement of the nut.

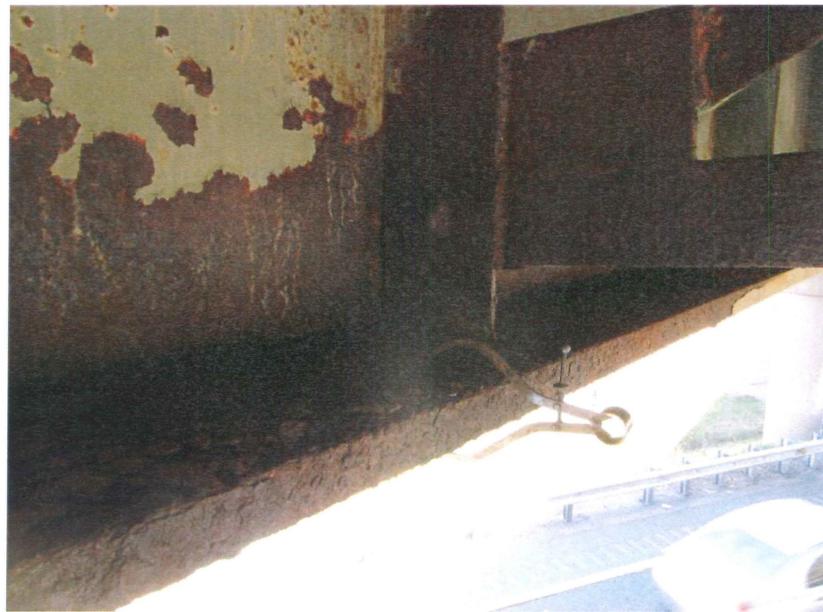
Photo # 27: South side of Girder G1 in Span 2 at the 2nd cross frame from Pier 1. Note the section loss in the bottom flange. Typical condition.

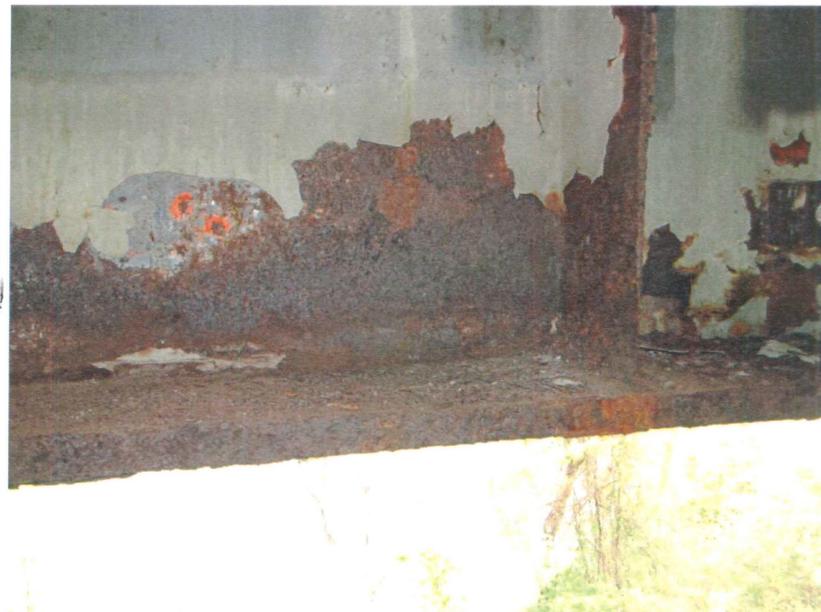
Photo # 28: South side of Girder G1 in Span 8 on the west side of 2nd cross frame from Pier 7. Note the section loss in the bottom flange and bottom of web stiffener.

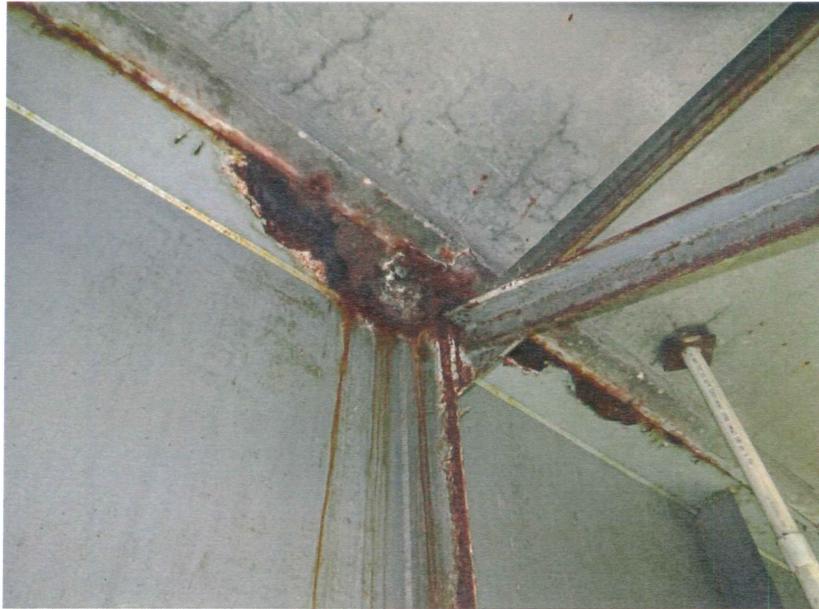
Photo # 29: South side of Girder G1 in Span 5 at the 2nd cross frame from Pier 4. Note the heavy rust with section loss in the top flange.

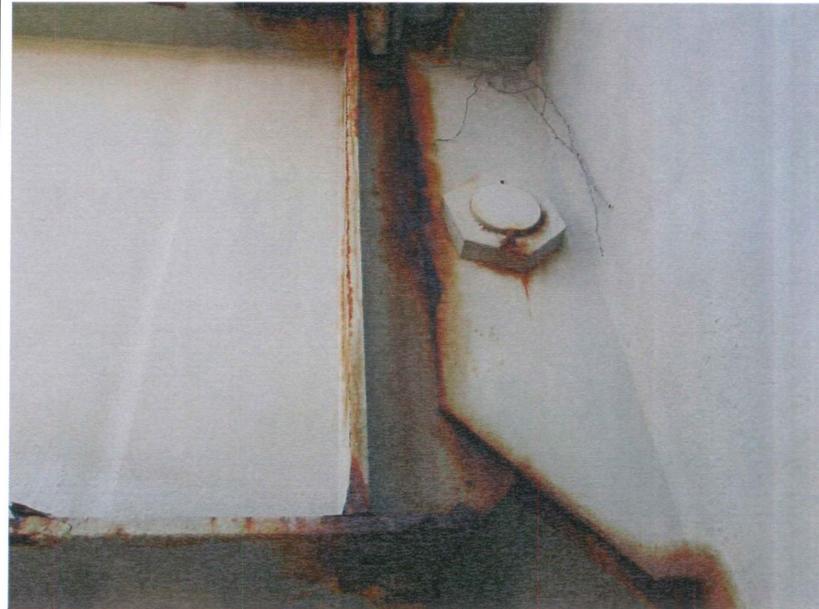
Photo # 30: North side of Girder G1 hinge connection to Pier 2 cap girder in Span 3. Note the areas of heavy rust with section loss.

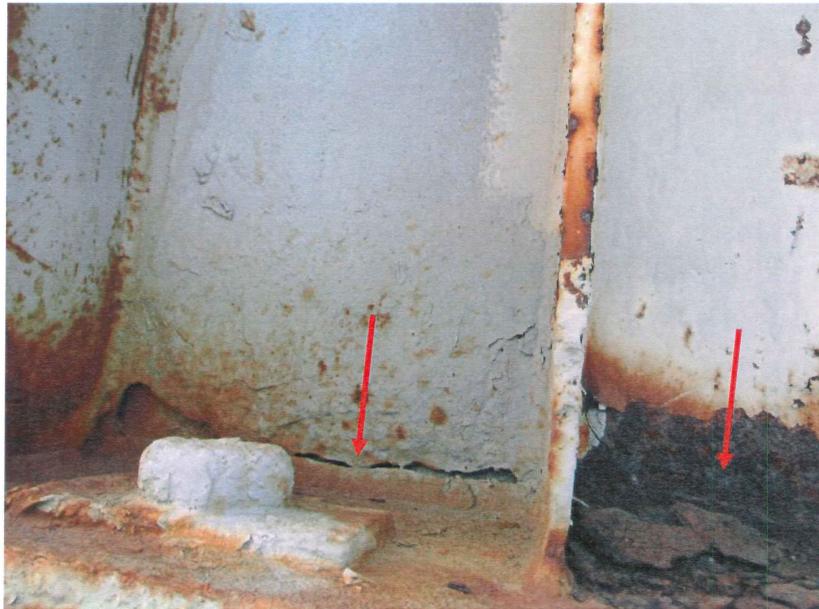
Photo # 31: North side of Girder G1 at Pier 6 in Span 6. Note the section loss with rust hole in the web, but repair plate was previously added at this location. Also note the section loss along the bottom of web in front of the bearing.

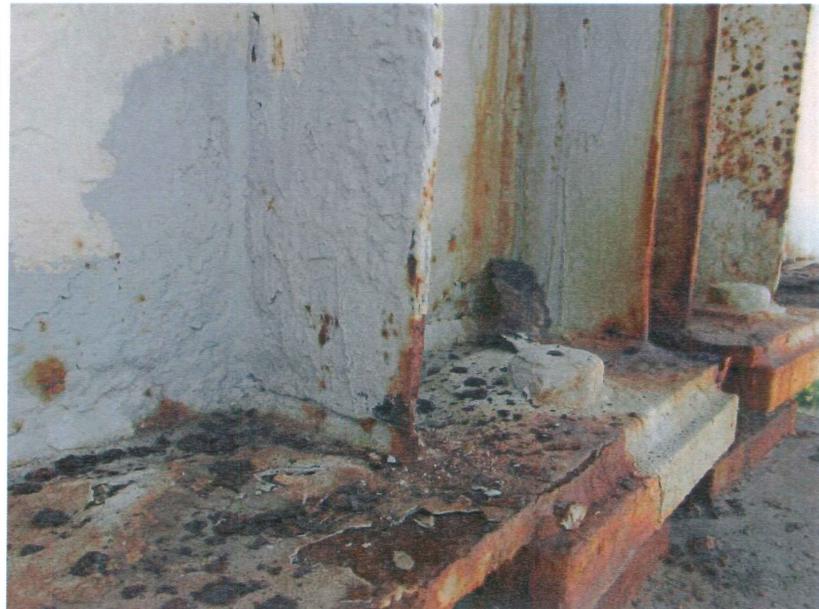
Photo # 32: North side of Girder G1 at Pier 6 in Span 7. Note the section loss and buckling in the bearing stiffeners (web plate previously added at this location).

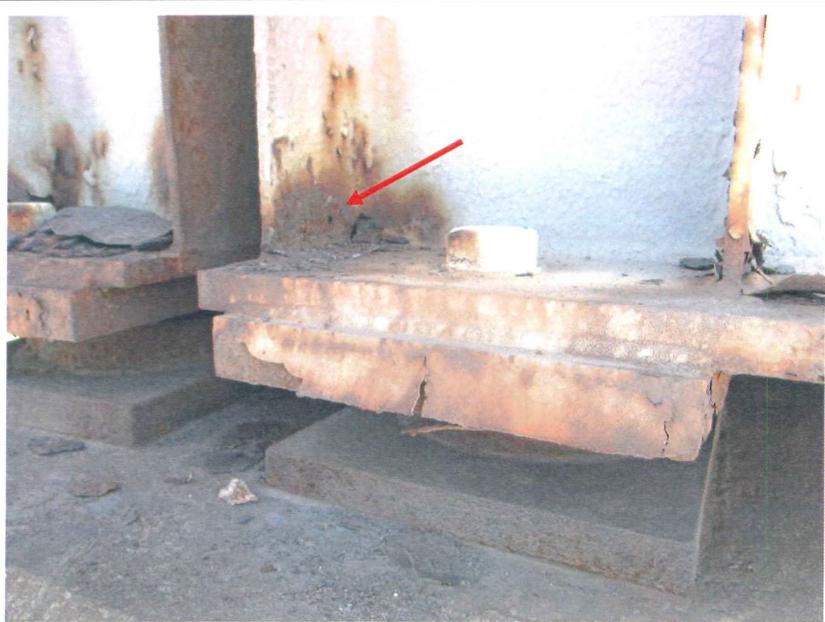
Photo # 33: North side of Girder G1 at Pier 1 in Span 1. Note the section loss in the bearing stiffener with a 1/4" diameter rust hole.

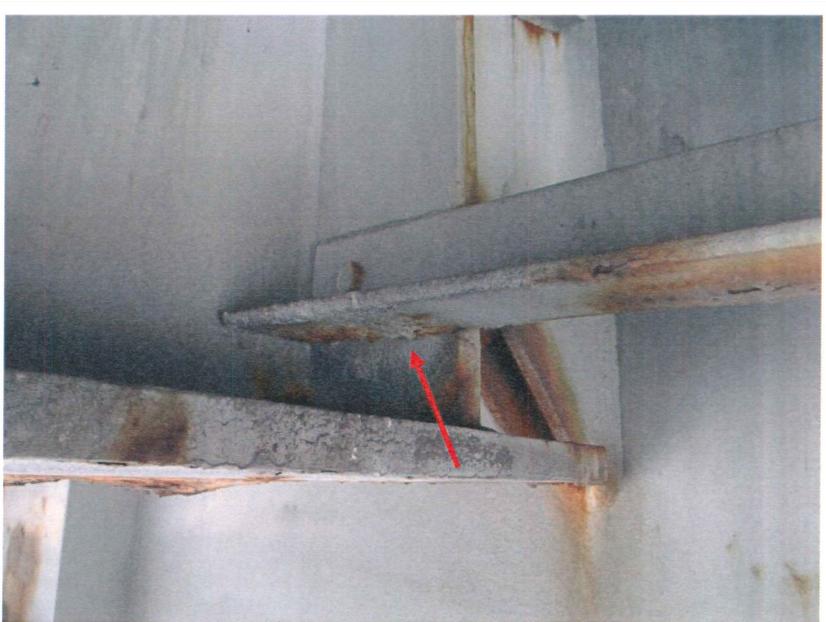
FLOOR BEAMS:	N	-
TRUSSES-GENERAL:	N	-
TRUSSES-PORTALS:	N	-
TRUSSES-BRACING:	N	-
PAINT:	5	Less than 50% of the painted surfaces have deterioration. See above items entitled "BEARING DEVICES" and "GIRDERS".
RUST:	4	See above items entitled "BEARING DEVICES" and "GIRDERS".
MACHINERY MOV SPAN:	N	-
RIVETS & BOLTS:	7	Bolted retrofits are in place at random previously cracked cross frame weld locations. These bolts exhibit areas of light rust. See Field Notes Sheet 32 through 44.
WELDS - CRACKS:	5	<p>There is a total of 57 cracked, broken, missing, short, not fused or otherwise significantly sloppy welds at the connection between cross frames and web stiffeners. The defective welds are primarily the bottom horizontal welds between bottom member of cross frames and girder web stiffeners. There are isolated locations of previously added bolted retrofits at the locations of cracked welds (old repair). See attached crack schedule sheet for the summary of defective welds.</p> <p>Bottom flange transitions along the girders and fracture critical cap girders at Pier 2 were checked hands-on and no significant deficiencies were noted. No deficiencies were noted to the weep pipe support bracket welds in the webs (fatigue category 'E'). No deficiencies were noted to the stitch welded web stiffeners near the girder ends (most likely jacking stiffeners).</p>

See Field Notes Sheets 32, 33, 36 through 44 and Photo Nos. 34 through 37.
TIMBER DECAY:	N	-
CONCRETE CRACKING:	N	-
COLLISION DAMAGE:	8	-
MEMBER ALIGNMENT:	6	See above items entitled "BEARING DEVICES".
DEFLECT. UNDER LOAD:	N	(N) Normal, (E) Excessive
VIBRATION UNDER LOAD:	N	(N) Normal, (E) Excessive
STAND PIPES:	N	-
BARREL LADDERS:	N	-

Photo # 34: North side of Girder G3 at Pier 2 in Span 3. Note the missing bottom horizontal weld at the connection between the cross frame and web stiffener.

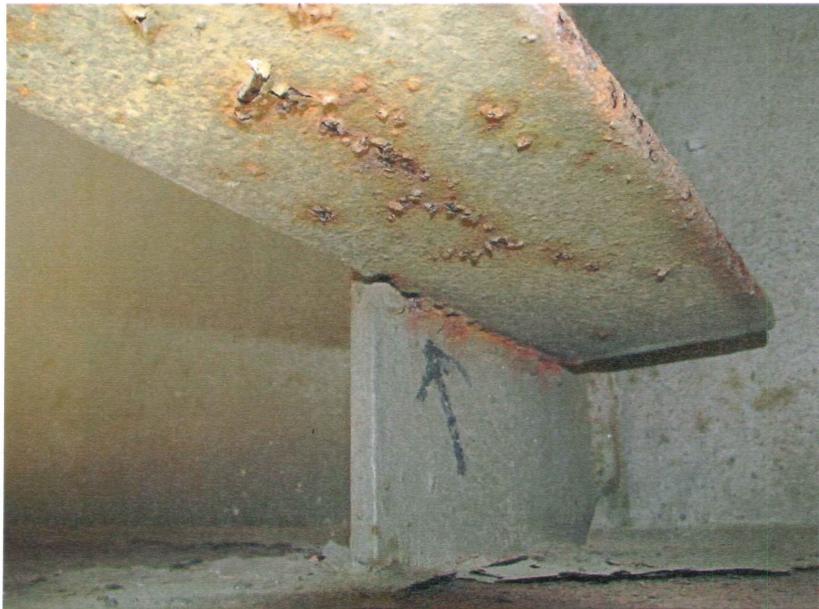
Photo # 35: South side of Girder G6 in Span 2 at the 1st cross frame from Pier 2. Note the cracked bottom horizontal weld (extends 1/4" at bottom of vertical weld on the back).

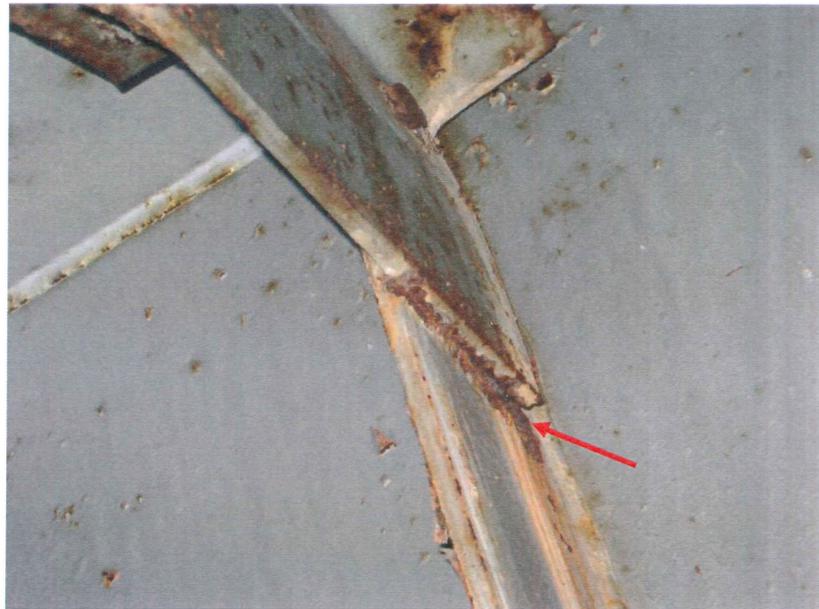
Photo # 36: South side of Girder G1 in Span 4 at the 1st cross frame from Pier 4. Note the cracked top horizontal weld at the cross frame connection to the web stiffener.

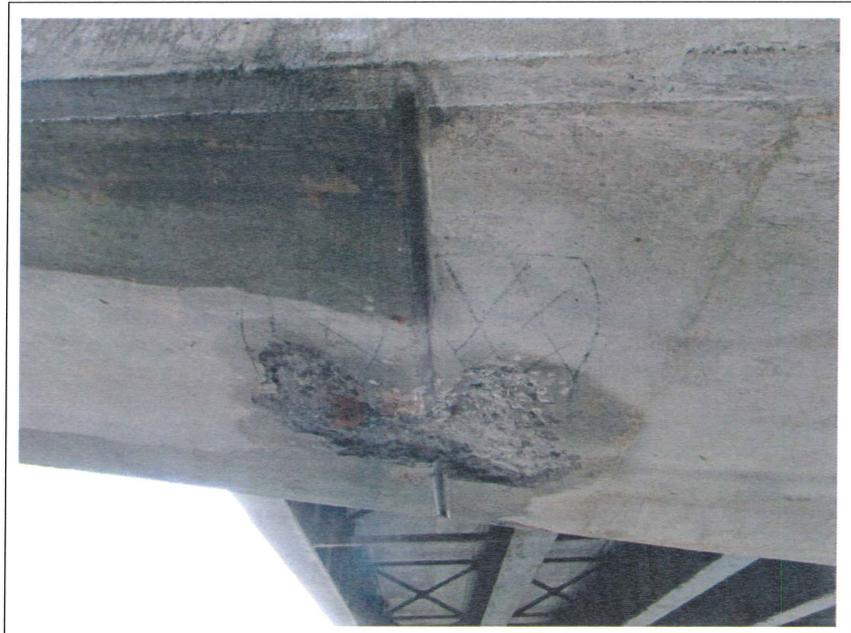
Photo # 41: Hollow area and spall at the underside of Pier 3 cap in Bay 1 (over left lane of Route 72 WB).

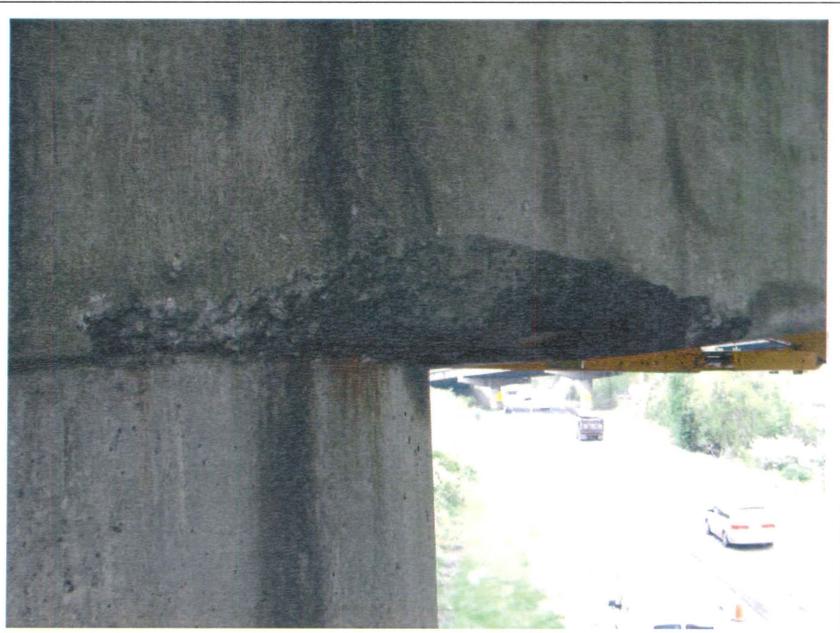
Photo # 42: Spall on the east face of Pier 3 cap below Bay 3.

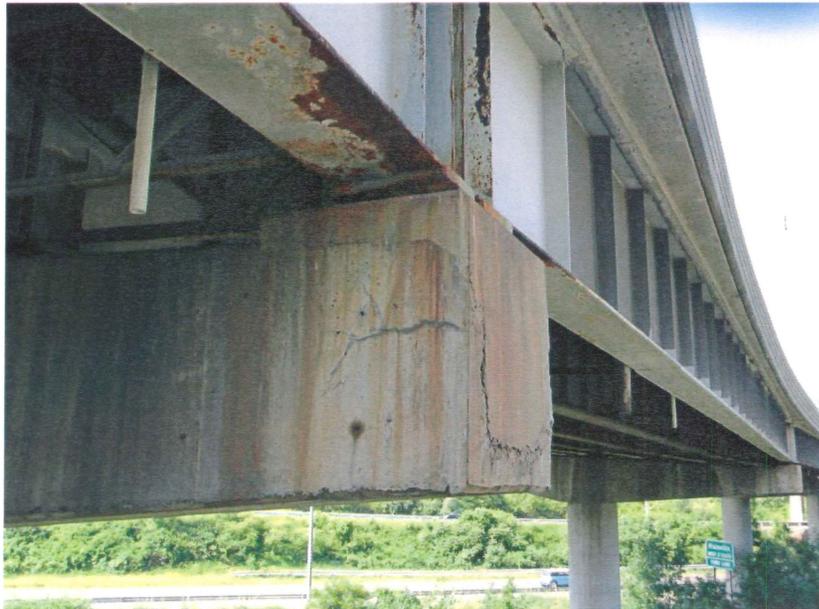
Photo # 43: East face of Pier 6 cap at the north end. Note the crack on the face and crack along the edge of patch.

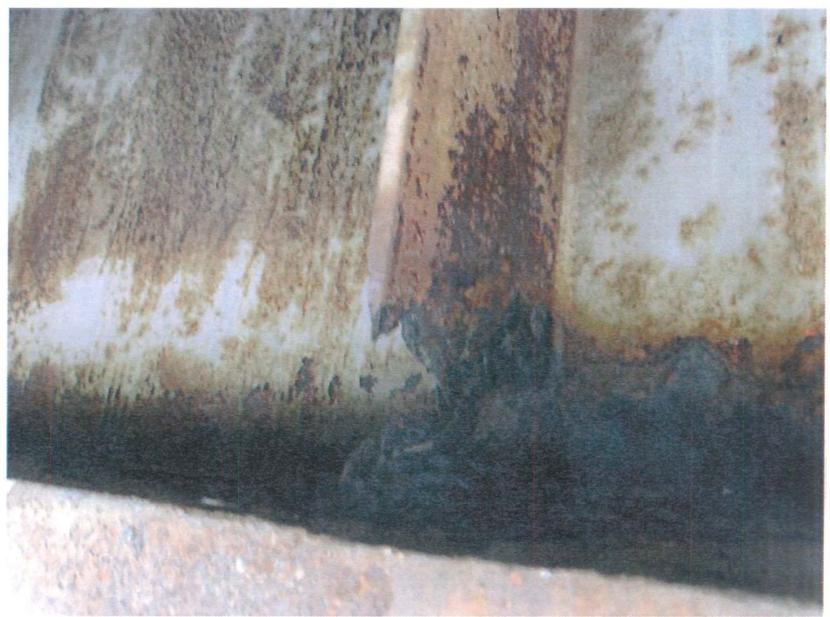
<p>The pier cap end faces adjacent to the grout pockets exhibit cracks up to 3/16" wide with rust and efflorescence, hollow areas and spalls up to 2' x 9" x 1 1/2" deep. Random pedestals have hairline cracks, some of which extend from the caps. See Field Notes Sheets 50, 51, 52 and 55 through 64 and Photo Nos. 40 through 43.</p> <p>Steel pier cap at pier 2: Cap girder webs have areas of heavy rust with up to 1/16" deep section loss, resulting in less than 5% web loss. Random web stiffeners exhibit section loss at the bottom up to 3/16" deep and isolated web stiffener with section loss down to knife edge remaining section loss and a 3" diameter rust hole (located away from the bearing). The girder bottom flanges have areas of active rust with up to 5 1/2" wide x 3/16" deep section losses, resulting in up to 4.7% bottom flange loss. Inside faces of the cap have peeling paint with active rust. See Field Notes Sheets 53 and 54 and Photo Nos. 44, 45 and 46.</p>

Photo # 46: Section loss with rust hole at the bottom of interior web stiffener in Bay 6 on the west side of east cap girder at Pier 2.

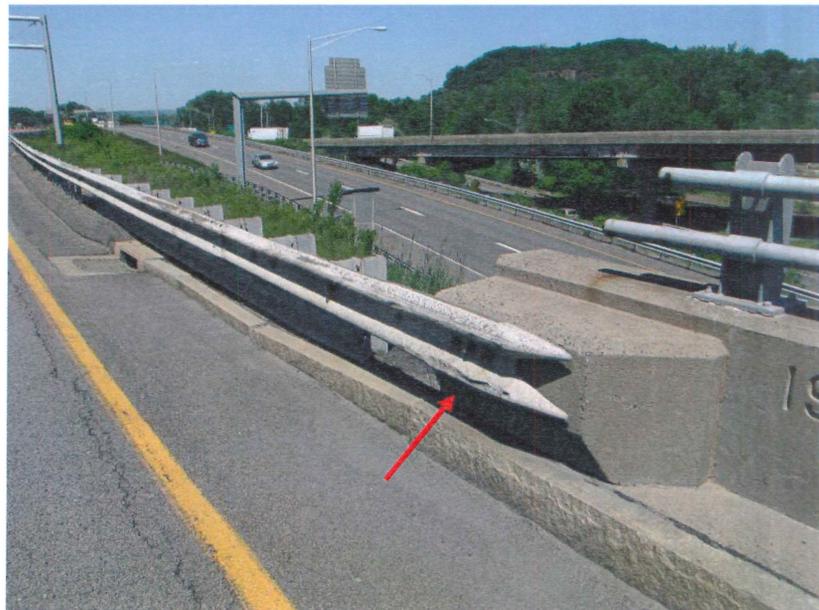
Photo # 50: Approach guiderail at the southwest corner. Note the collision damage.

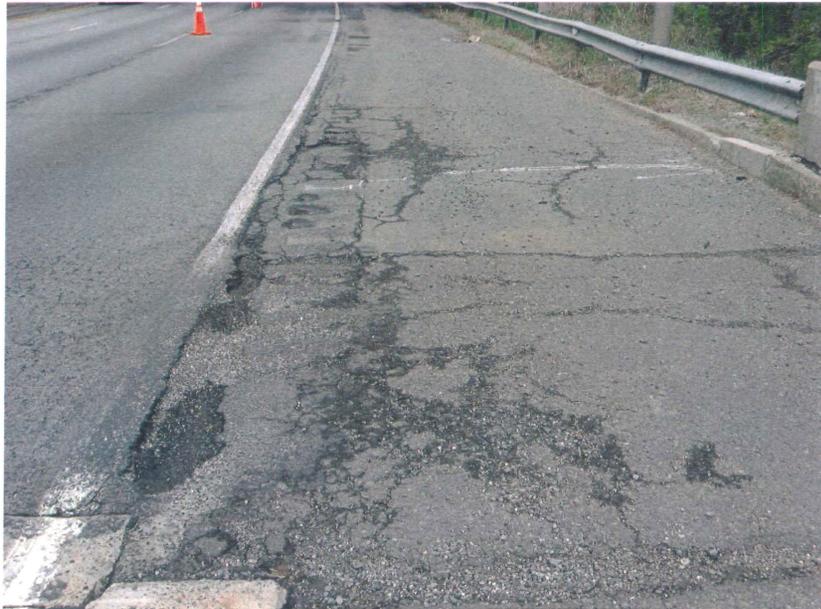
Photo # 51: East approach pavement in the right shoulder. Note the random cracks and potholes.

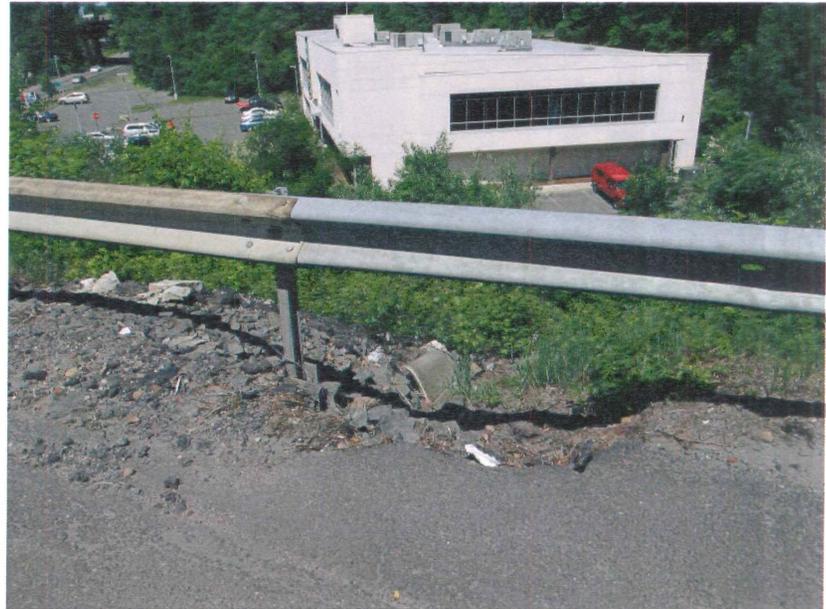
Photo # 52: Erosion along the northeast approach embankment.
