STRUCTURE NO. 03313

I-84 TR 815
over
I-84EB, RTE 72, 372, B&M RR
NEW BRITAIN

Routine & Special Inspection
on
4/22/2014

ROUTINE AND SPECIAL INSPECTION

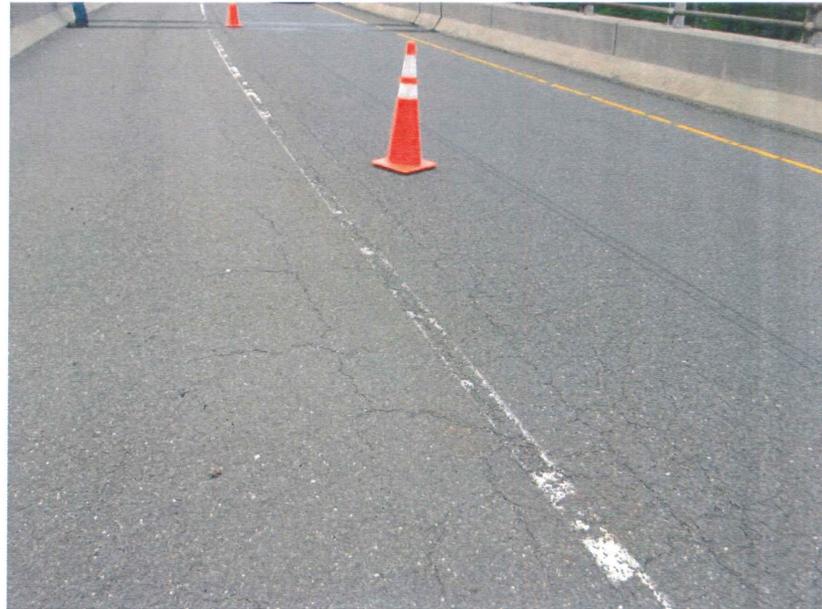
Photo # 8: Overlay in Span 1. Note the areas of map cracking.

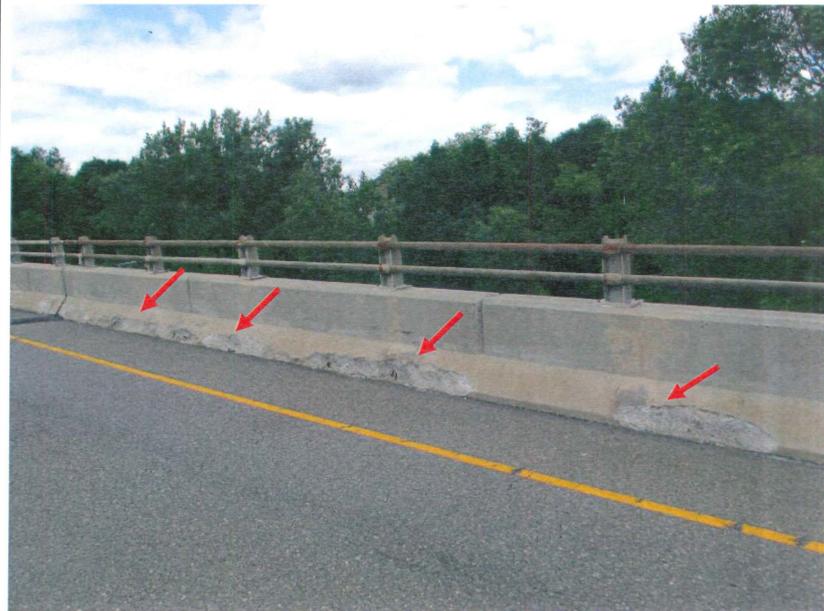
<p>large areas of severe scaling up 1' high x 4-1/2" deep with and without exposed rebar, the maximum of which is noted along the east curb in Spans 5 and 6.</p> <p>The transition curb sections at the southwest approach are misaligned by up to 3.5" and curbs in the southwest and southeast approach have random spalls up to 3" deep. Transition curbs at the northwest have been removed from their original position and are laying on the approach embankment.</p> <p>Average West Curb Reveal: 2-3/4" Average East Curb Reveal: 2-1/2"</p> <p>See Field Notes Sheets 8 through 13 and Photo Nos. 11 and 12.</p>
MEDIAN:	N	-
SIDEWALKS:	N	-
PARAPET:	7	There are concrete parapets along both fasciae, which exhibit areas of light scaling, scrapes, vertical hairline cracks with efflorescence, areas of hairline map cracking and random areas of shallow rebar up to 8" long. See Field Notes Sheets 8 through 12 and Photo Nos. 11 and 12.

Photo # 12: Curb, parapet and railing along the east fascia in Span 5. Note the areas of severe scaling in the curb.

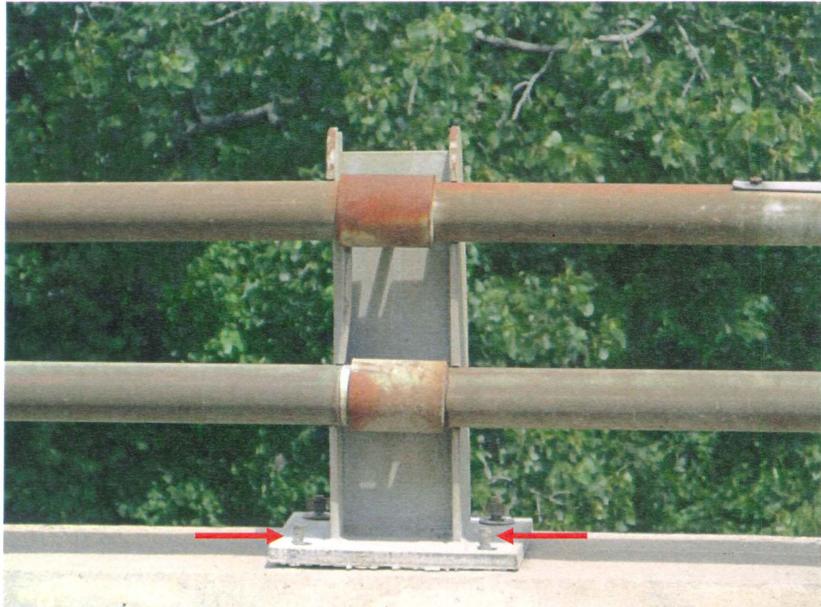
2. There are four bent pipe sections located in Spans 1, 6 and 7. The posts are slightly tilted at these locations. The 5th post from Pier 6 in Span 7 at the east railing has two missing nuts and two nuts backed off 1/4". These conditions have been previously submitted for repair under Item No. 2 of BMM No. 06-085 and have not been addressed.

Photo # 13: 5th railing post from Pier 6 in Span 7 along the east fascia. Note the missing nuts.

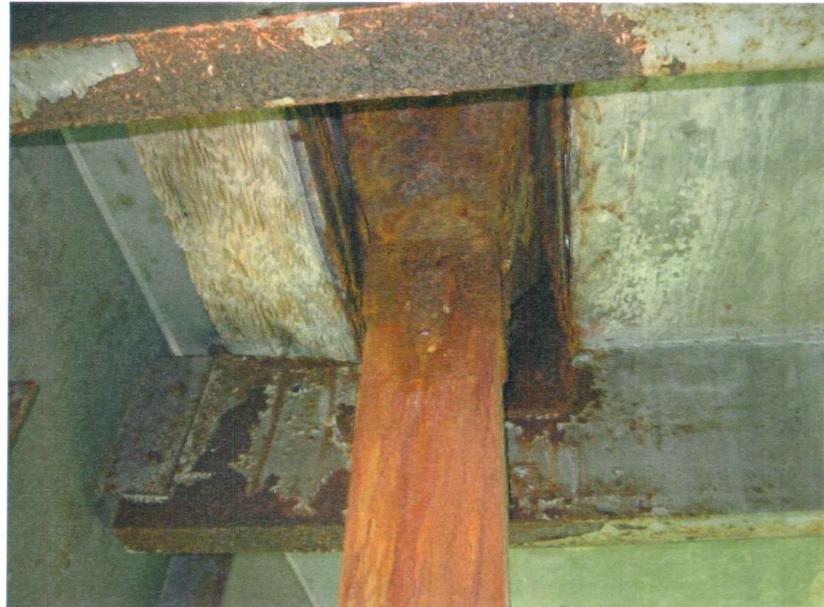
Photo # 14: Underside of deck in Bay 3 between the 1st and 2nd cross frames from Pier 6 in Span 7. Note the rust on the scupper.

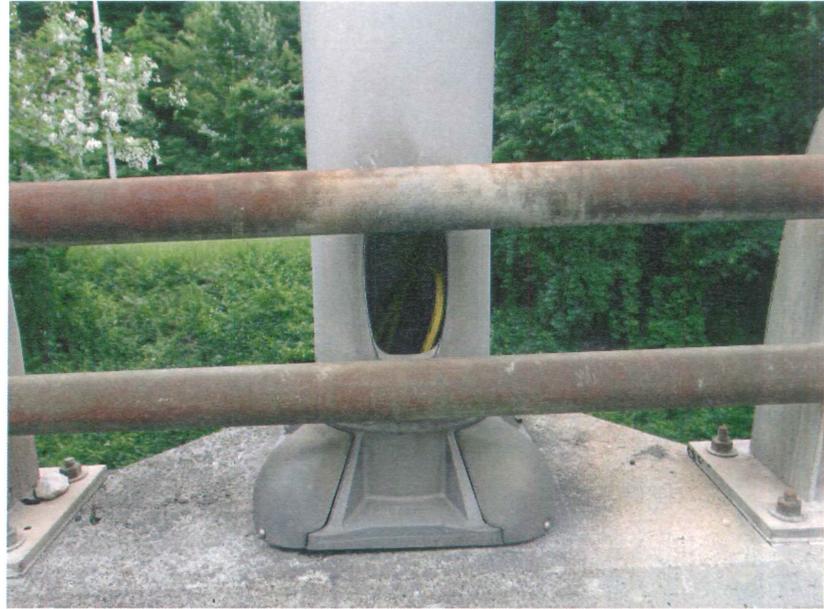
LIGHTING STANDARD:	5	There are light standards on top of west parapet in Spans 1, 3, 6 and 8. The light standard on the west parapet in Span 1 exhibits a missing handhole cover plate with exposed wires. In Span 1 along the west parapet, there is a junction box cover with 10 out of 12 screws missing (but secure) and a junction box with temporary cover. See Field Notes Sheet 8 and Photo No. 16.
UTILITIES TYPE/SIZE:	N	-
CONSTR JOINTS:	N	-
EXPANSION JOINTS:	4	There are new asphaltic plug joints at both abutments and all piers since the last inspection. The asphaltic plug joints exhibit areas of light raveling, adhesion separation cracks and cohesion cracks up to 18' long x 1/8" wide. See Field Notes Sheets 8 through 12 and Photo Nos. 17 and 18.

Photo # 16: Light standard on the west parapet in Span 1. Note the missing handhole cover with exposed wires.

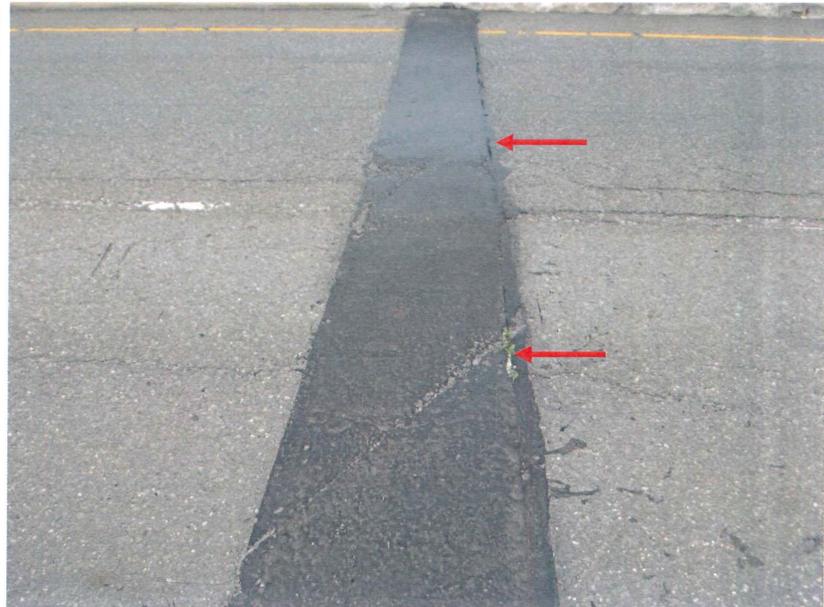
5. The asphaltic plug joints exhibit adhesion separation cracks and cohesion cracks up to 18' long x 1/8" wide. There is a new BMM to address these conditions.

Photo # 18: Asphaltic plug joint at Pier 5. Note the adhesion separation cracks.

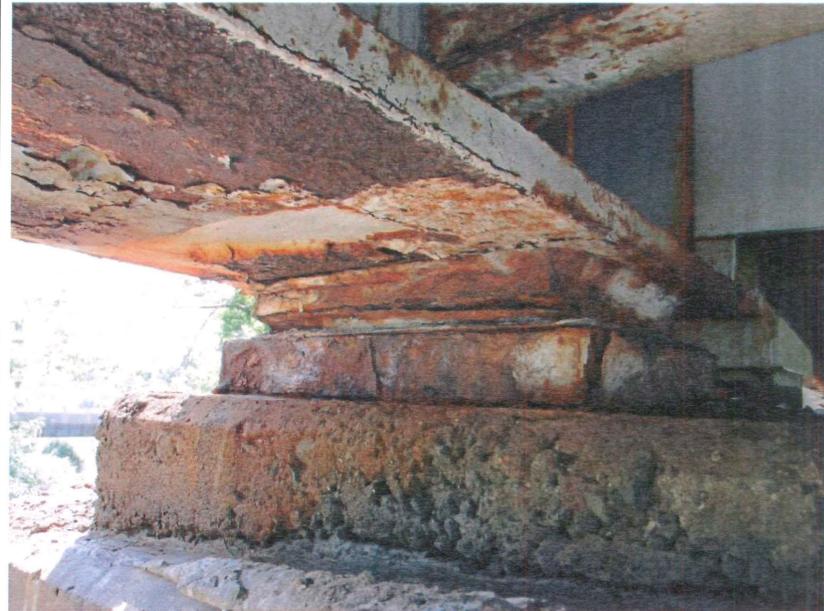
1. The fixed bearings for girders exhibit areas of moderate to heavy rust with up to 1/2" thick pack rust between the bearing plates. Some anchor bolt nuts exhibit up to 80% section loss. These conditions have been previously submitted for repair under Item No. 6 of BMM No. 06-085 and have not been addressed.

Photo # 20: Fixed bearing for Girder G4 at Pier 5 in Span 6. Note the areas of rust in the bearing.

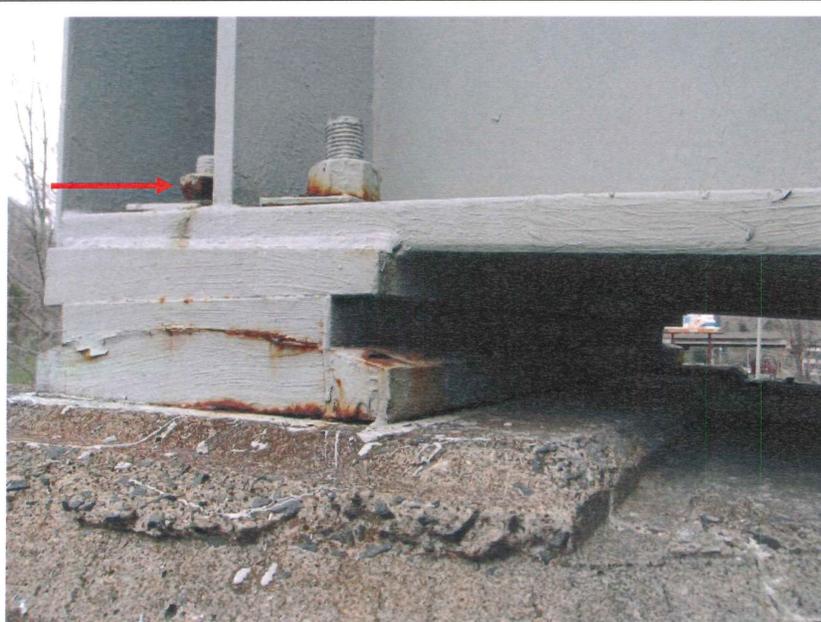
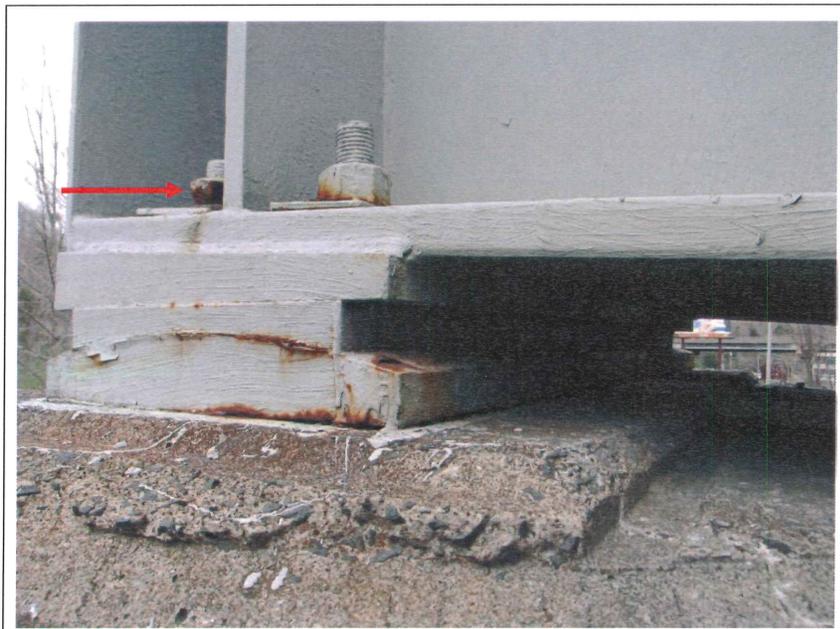
2. The fixed hinges at Pier 1 exhibit up to 9/16" impacted rust between hinge plate and girder web and random pin nuts for hinge assemblies have up to 9/16" gaps under the nut (as-built condition). The sliding expansion bearing for the cap girder at Pier 1 appears to be frozen based on the comparison with previous measurements.

Photo # 21: Expansion bearing for the cap girder at the west column of Pier 1. Note the gap under the masonry plate and section loss in the anchor bolt nut.

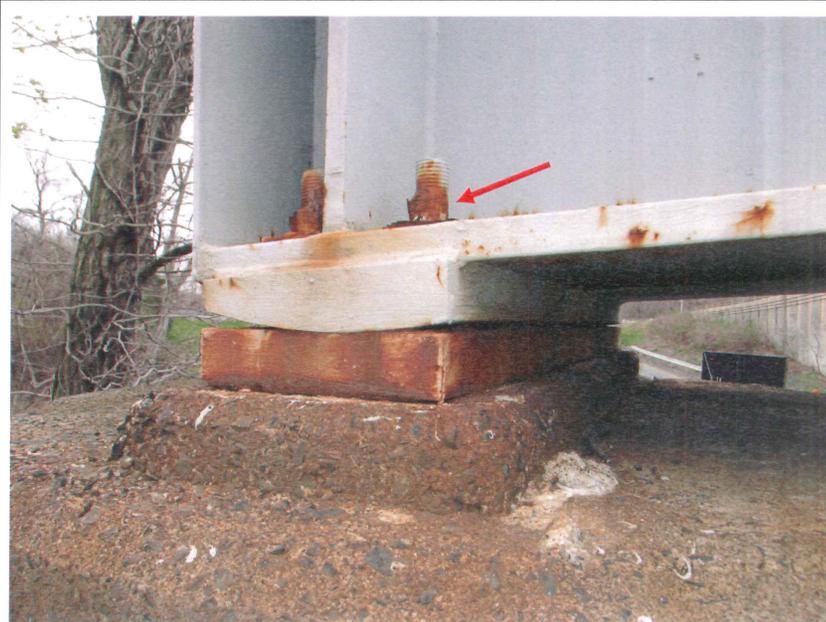
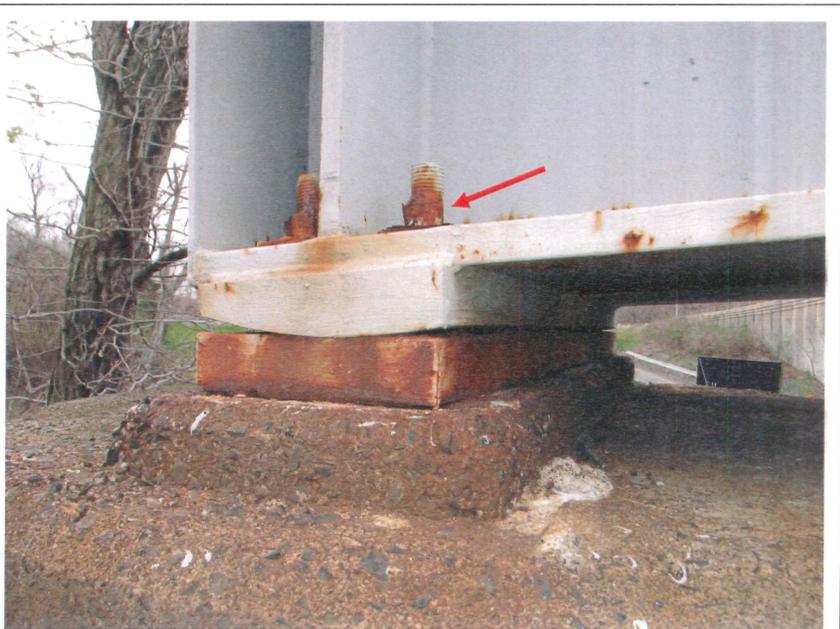
Photo # 22: Fixed bearing for the cap girder at the east column of Pier 1. Note the missing anchor bolt nut.

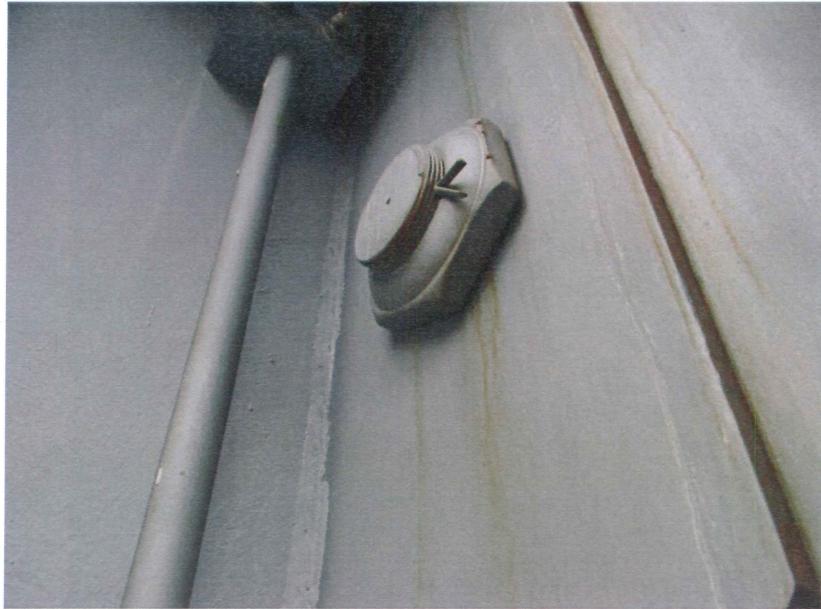
Photo # 23: West side of Girder G1 at Pier 1 in Span 1. Note the gap under the nut.

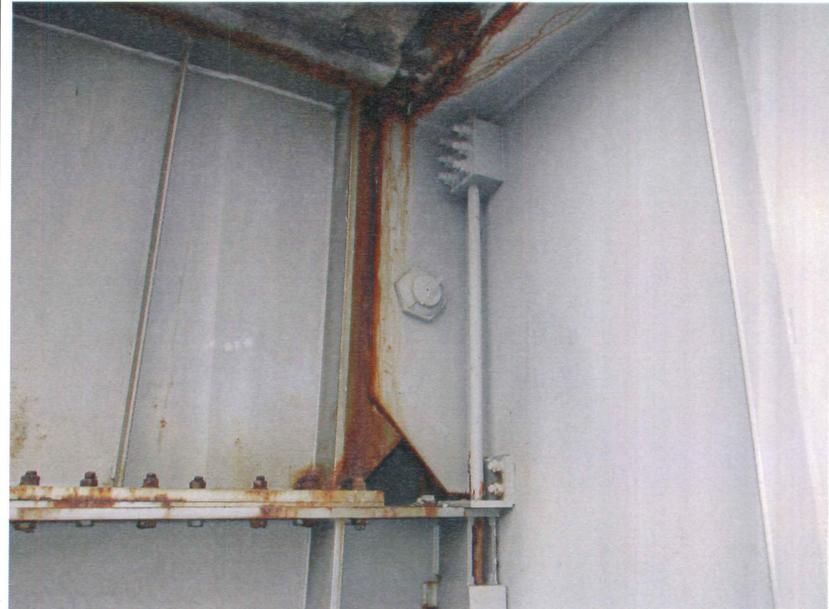
Photo # 24: East side of Girder G4 at Pier 1 in Span 1. Note the bleeding rust and impacted rust between hinge plate and web.

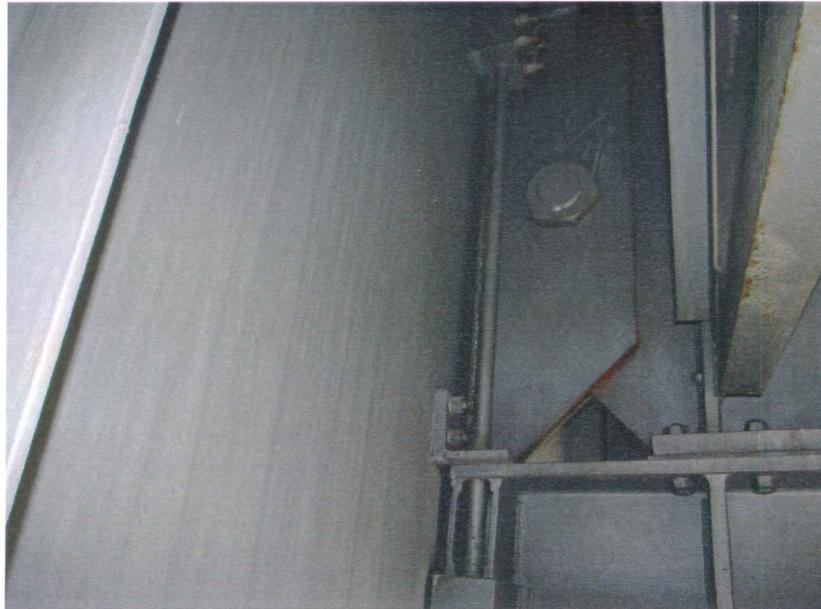
Photo # 25: East side of Girder G3 at Pier 1 in Span 2. Note that the cotter pin is missing.

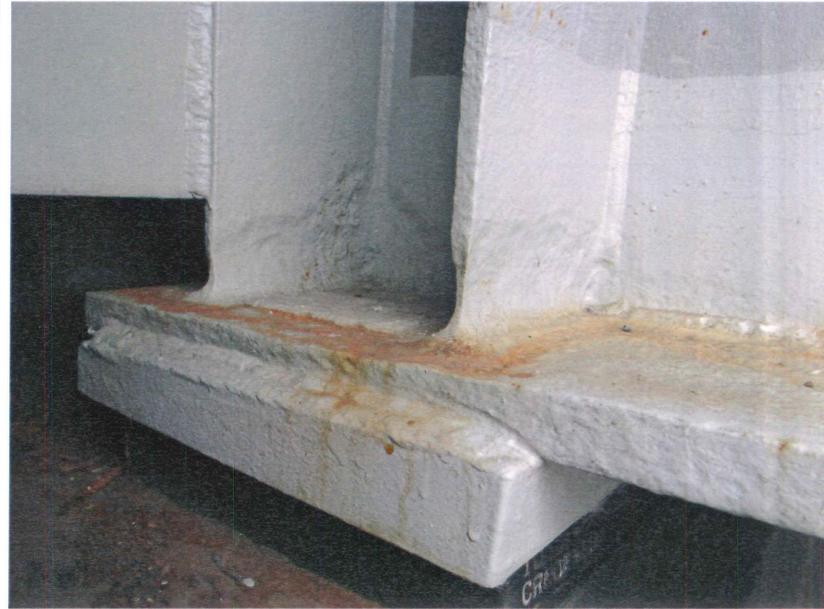
3. The girder ends exhibit section loss in the web and bearing stiffeners resulting in up to 5% loss in web for shear and up to 31% loss in web bearing area (buckling). Girder G4 bottom flanges have section losses up to 3/8" deep x 7" wide at several locations in critical areas resulting in up to 13%. These conditions have been previously submitted for repair under Item No. 5 of BMM No. 10-621 and have not been addressed.

Photo # 26: East side of Girder G4 at the South Abutment. Note the section loss along the bottom of bearing stiffeners and the bottom of web between bearing stiffeners (painted over).

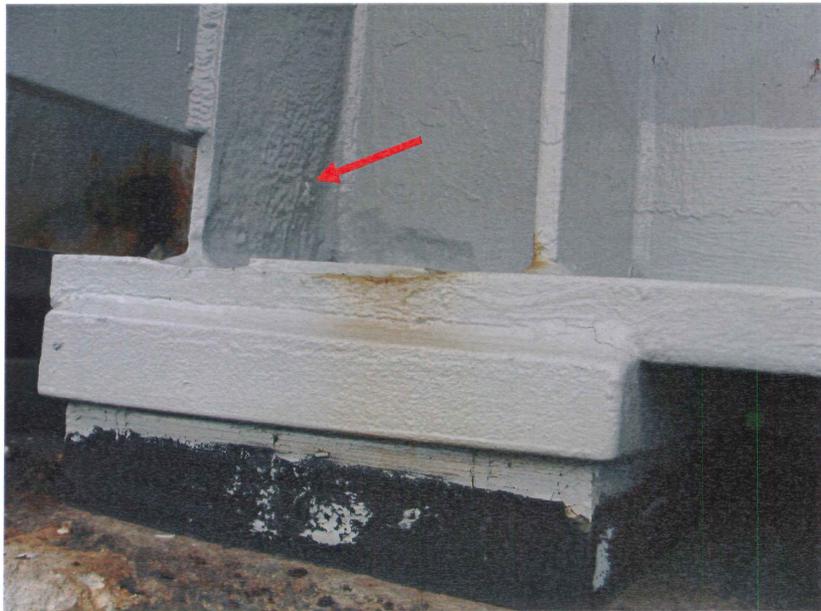
Photo # 27: West side of Girder G1 at Pier 5 in Span 5. Note the section loss along the bottom of web and the bearing stiffener with a rust hole (painted over).

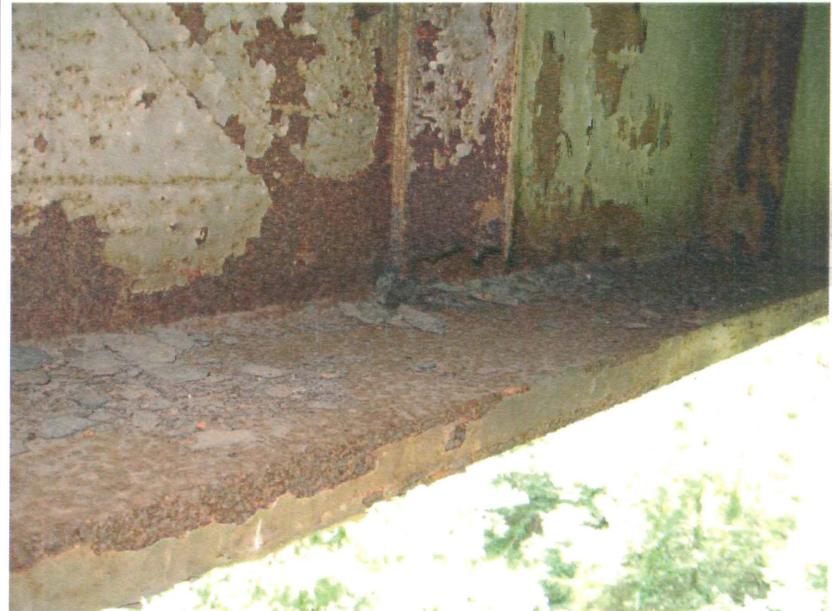
Photo # 28: West side of Girder G4 between the 1st and 2nd cross frames from Pier 6 in Span 7. Note the section in the bottom flange and web and the rust hole in the web stiffener.

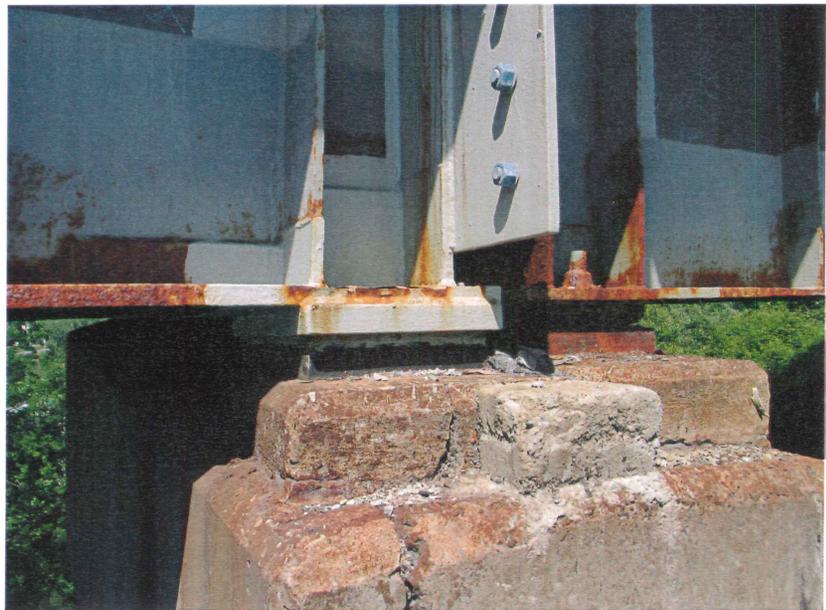
Photo # 29: East side of Girder G4 near Pier 8 in Spans 8 and 9. Note the areas of repair at the bottom of the web and bearing stiffeners. Also note the crack in the pier cap and pedestal.

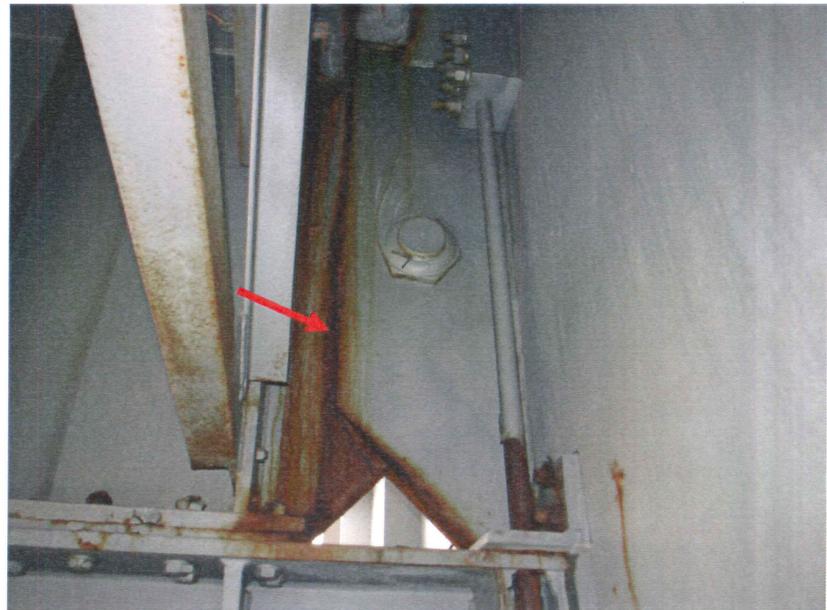
Photo # 30: West side of Girder G4 at Pier 1 in Span 2. Note the section loss in the web.

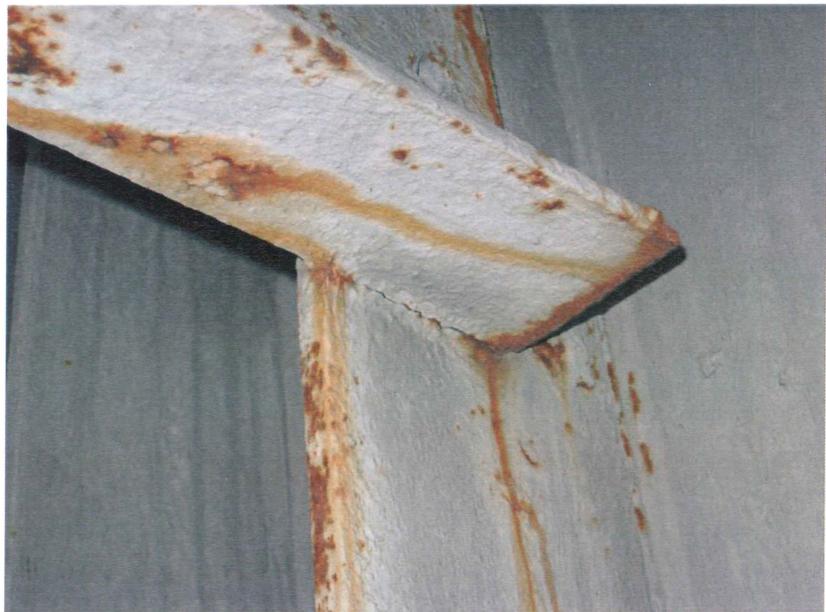
4. There is a missing and broken horizontal welds at the end cross frame connection to Girder G2

Pier 7 in Span 7 and a 4" long cracked lower horizontal weld at the end cross frame connection to Girder G3 at Pier 7 in Span 7. There is a new BMM to address these conditions.

Photo # 31: West side of Girder G2 at Pier 7 in Span 7. Note the cracked weld.

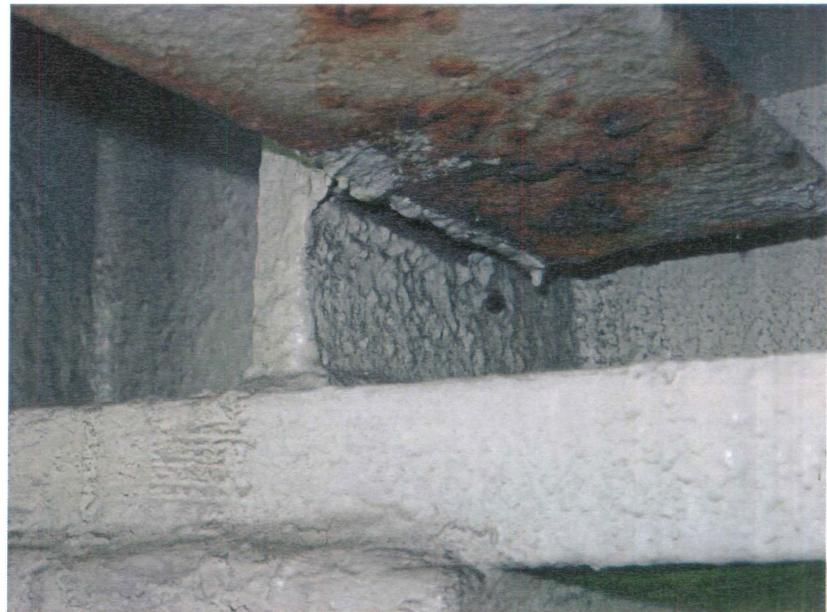
Photo # 32: West side of Girder G3 at Pier 7 in Span 7. Note the cracked weld.

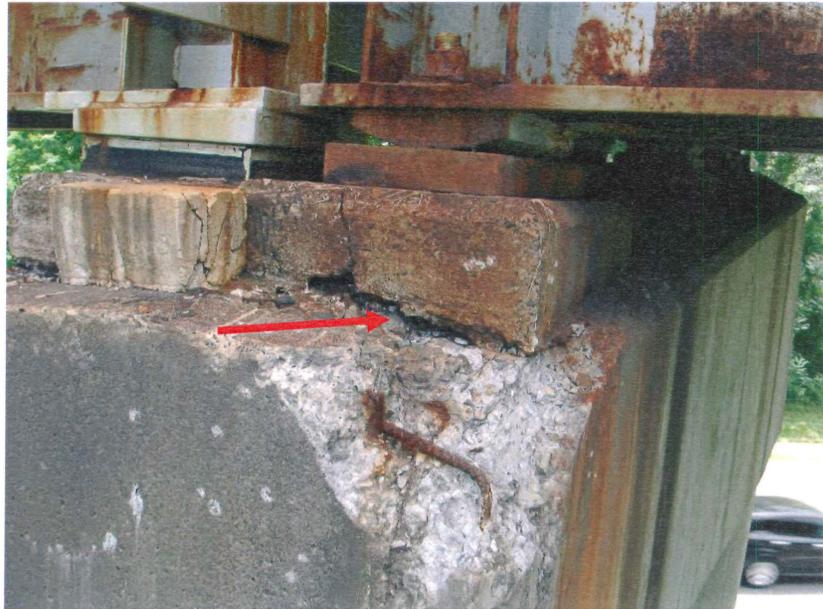
1. There are cracks up to 1/8" wide, hollow areas up to 2' x 2' and spalls/scaling up to 1' x 16" x 4" deep at the end of pier caps. The concrete pedestals spalls up to 10" x 1.5" x 1.5" deep, hollow areas up to 2' x full width and cracks up to 1/4" wide with some cracks extending through anchor bolt line. The pedestal for Girder G4 on Pier 2 is undermined 1' long x 2" high x 2" deep due to a 1' long x 3" high x 2" deep void. An 8" x 8" x 3" deep spall on the south face of the Pier 7 cap under Girder G4 undermines the pedestal for up to 7" x 7" x 3" deep. These conditions have been previously submitted for repair under Item No. 6 of BMM No. 10-621 and have not been addressed.

Photo # 37: East end of Pier 2 in Span 3. Note the spall with exposed rebar in the pier cap and the vertical crack in the pedestal. Also, note that the pedestal is slightly undermined due to a void.

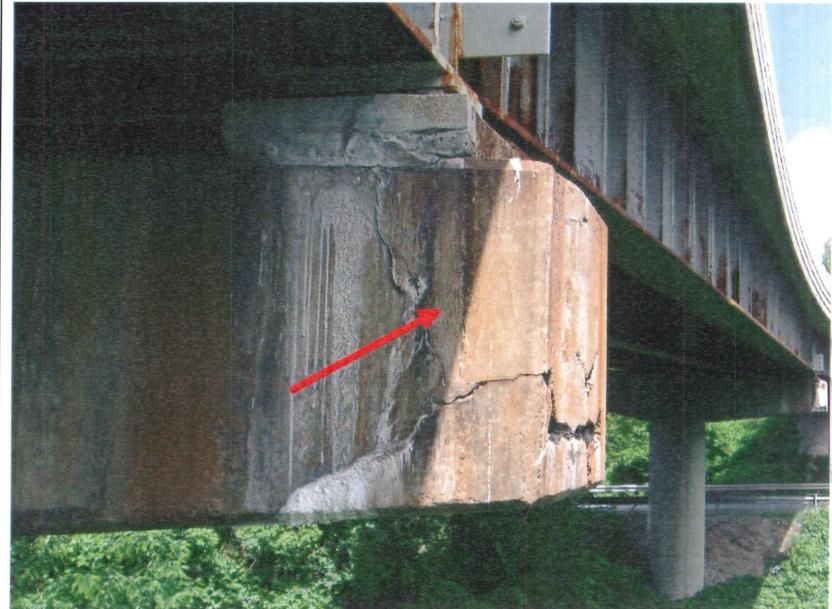
Photo # 38: South face of Pier 6 at the east end. Note the hollow area, cracks and spall.

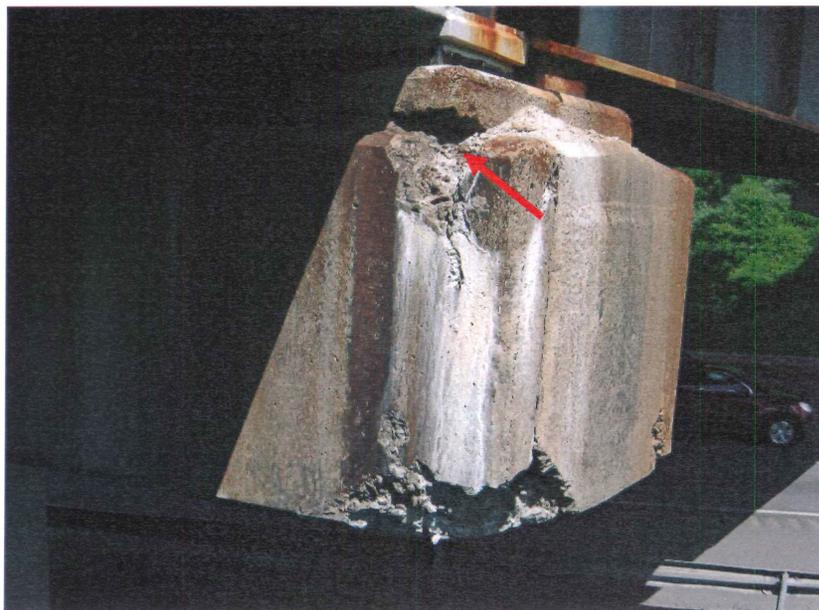
Photo # 39: South face of Pier 7 at the east end. Note the spalls and undermining of the pedestal.

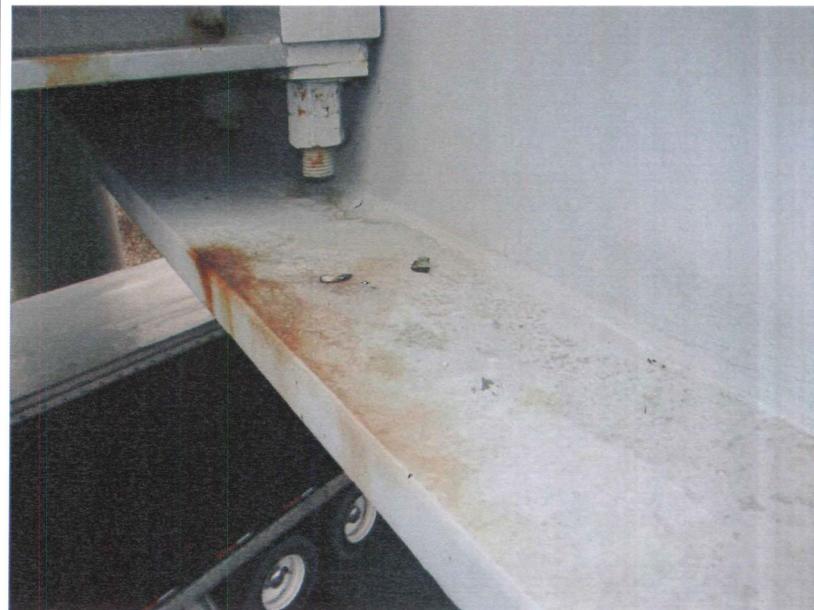
Photo # 40: South side of Pier 1 cap girder near Girder G4 in Span 1. Note the area of pitting in the bottom flange.

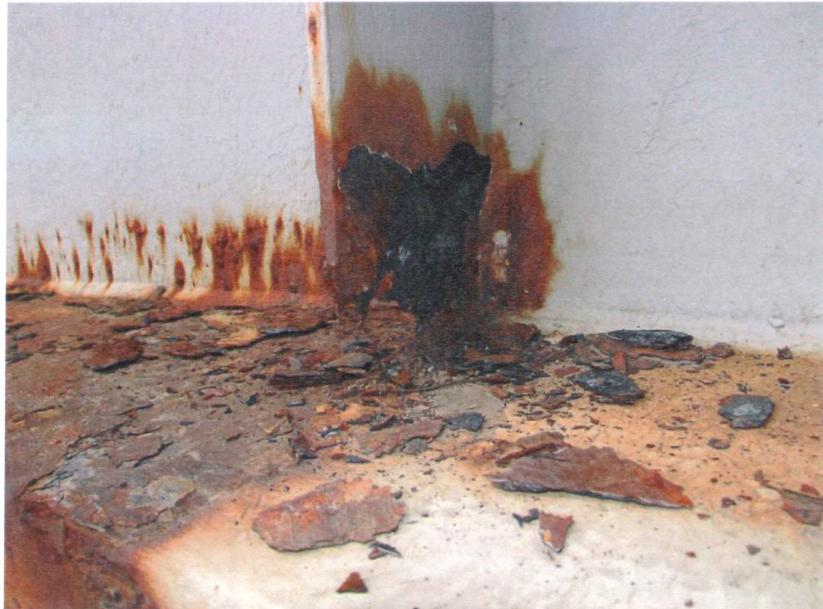
Photo # 41: North side of Pier 1 cap girder near Girder G4. Note the rust hole at the bottom of the web stiffener.
