BRIDGE NO. 03322

50440 - NEW BRITAIN
I-84 RAMPS 181&184
over
I-84 and I-84 Ramp 181

Special and Routine Inspection

05/13/2015

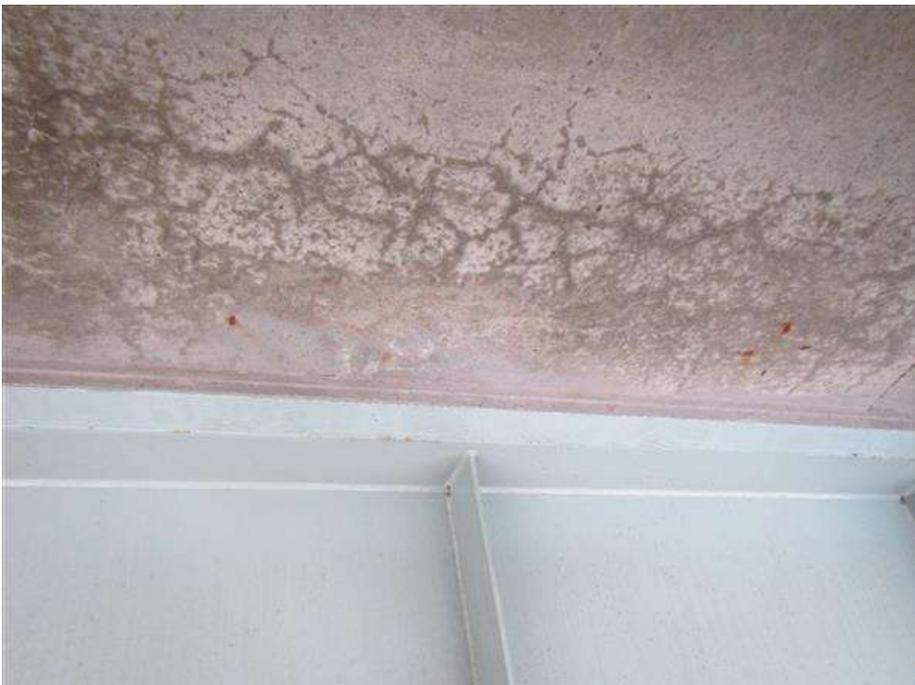
Photo Number: 10

Span 2 in bay 5 underside of deck with 1' diameter hollow area. BMM #13-539 Item # 2 has not been completed.

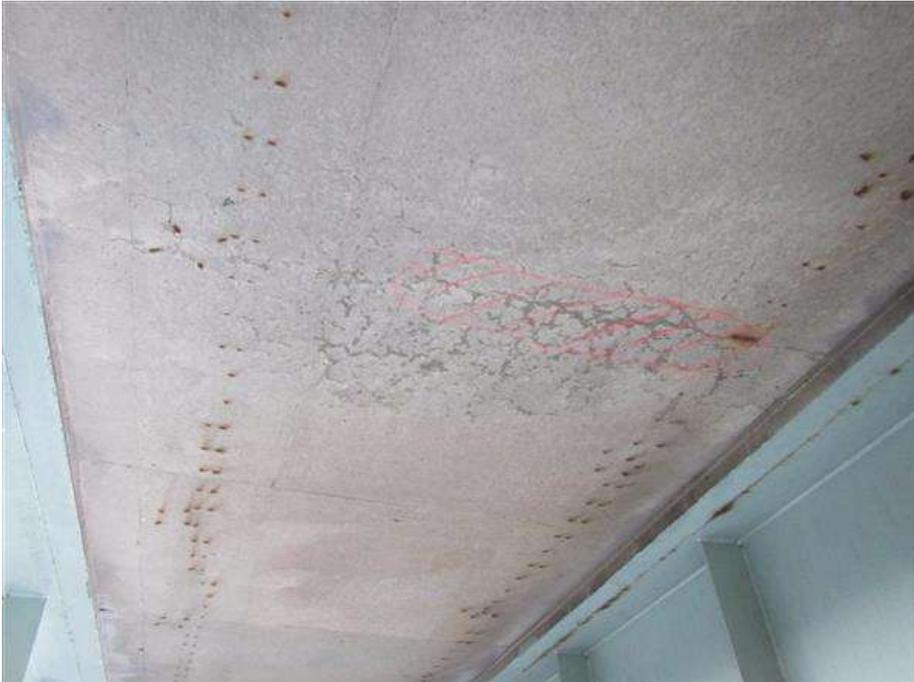
Photo Number: 11

Span 5 in bay 2, panel 3 there is a 3' wide x 6" long hollow area over the I-84 EB right lane. A new BMM has been issued for this condition.

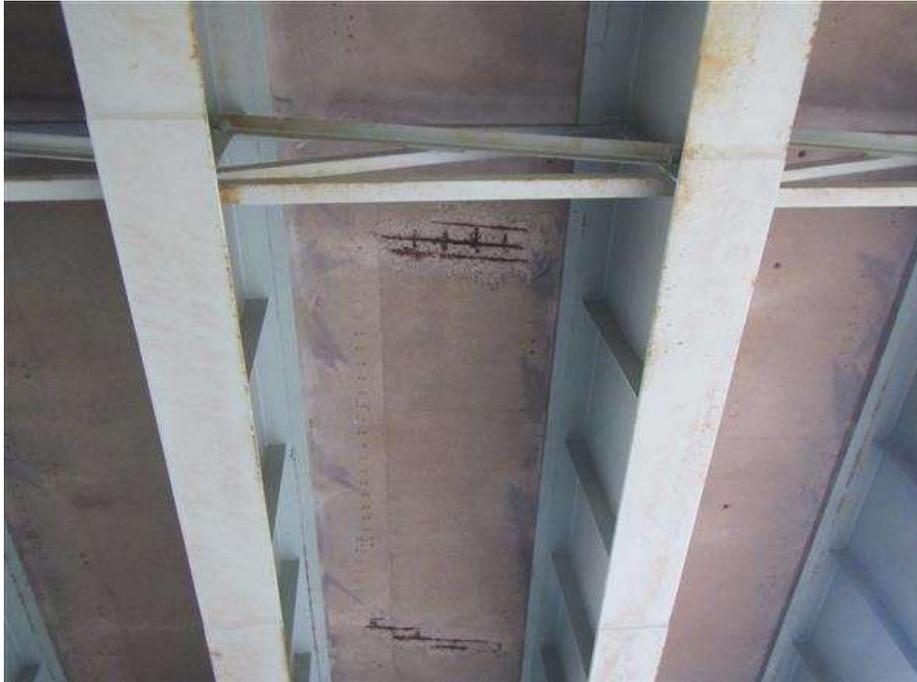
Photo Number: 13

Span 2 in bay 2 near pier 2 has a 5' x 3' x 1-1/2" deep spall with adjacent hollow areas.

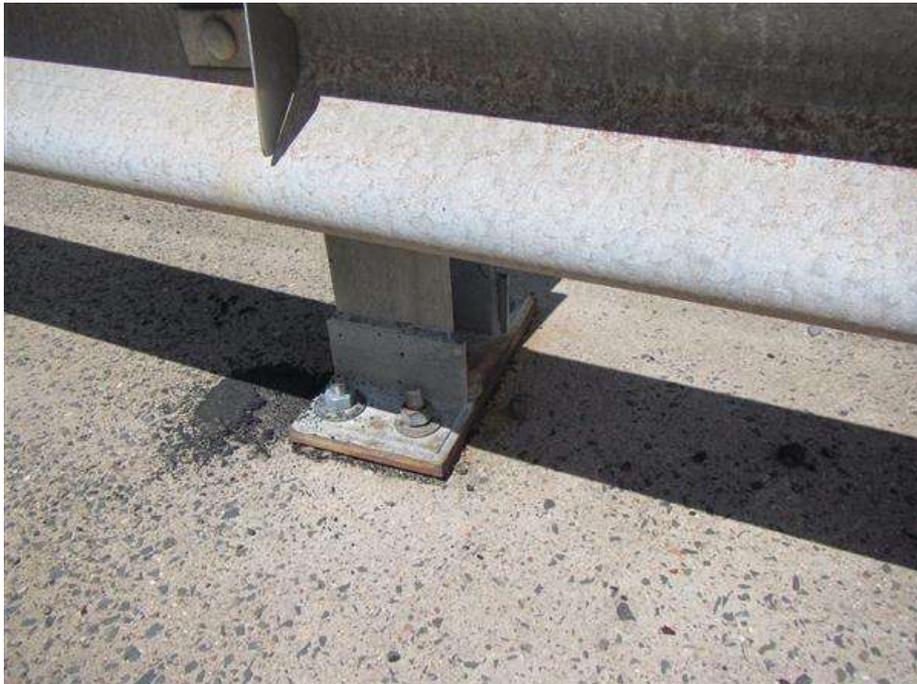
Photo Number: 15

Missing anchor bolt nuts at the median railing has been installed. BMM # 13-539 Item # 1 has been completed.

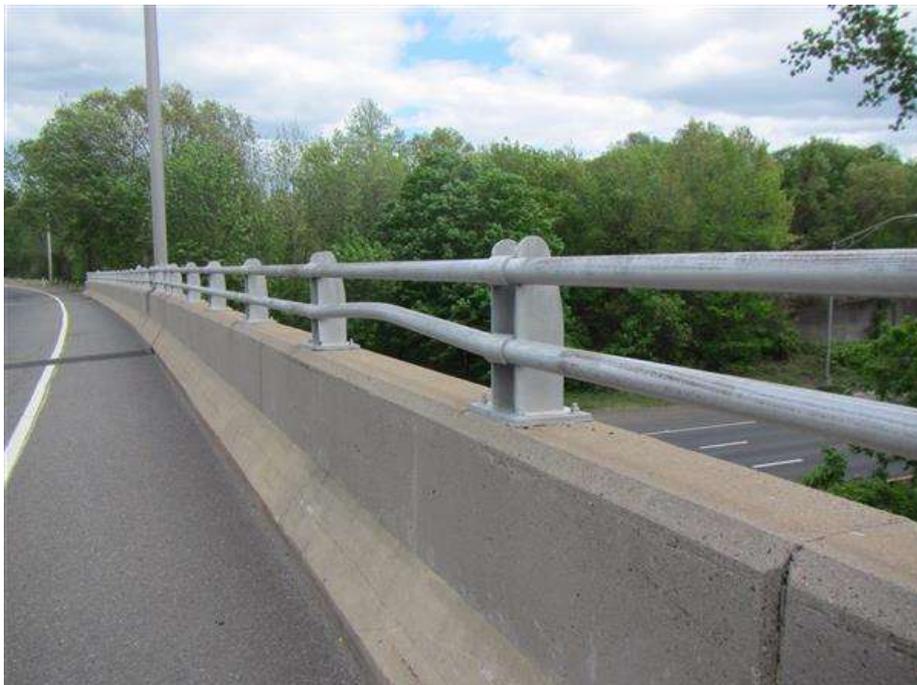
Photo Number: 16

Railing: 6 See field sheets 8-11 and photo 16.
 Two pipe railing have areas of exposed primer and light rust. There are four posts with impact damage at the southwest corner of the bridge. One lower rail is bent in the south side of span 4.
 See field sheets 8 & 9 and photo 16.

South parapet and rail in span 4 with impact damage to the rail.

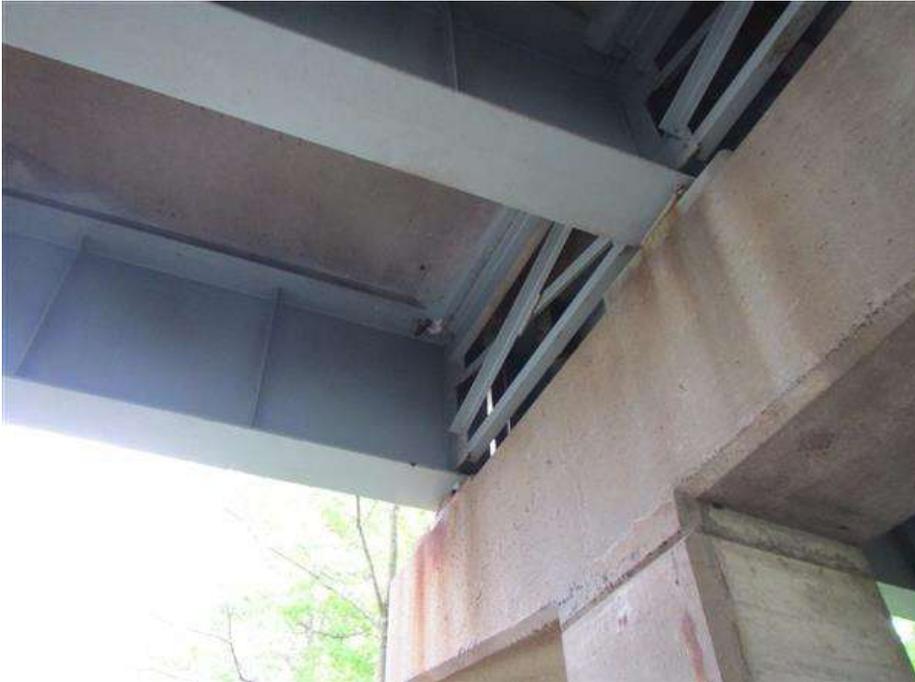
Photo Number: 19

- NOT DONE → 4. A total of four wrought iron weep pipes are short in spans 1, 2 and 4 that is directly above and may drain onto structural steel elements during times of high wind. This condition was noted in previous BMM No. 03-497 as stated below.

Short steel weep pipe in bay 1 of span 2 at pier 2. BMM # 11-493 Item # 4 has not been completed.

- 1. Clean all clogged drainage systems. [2 EA].
- 2. Repair the deck joints. [Approximately 130 LF].
- 3. Remove all loose concrete of the hollow haunch. [Approximately 1/4 CY].
- 4. Extend the weep pipes to below the bottom flange of the Girders. [4 EA].

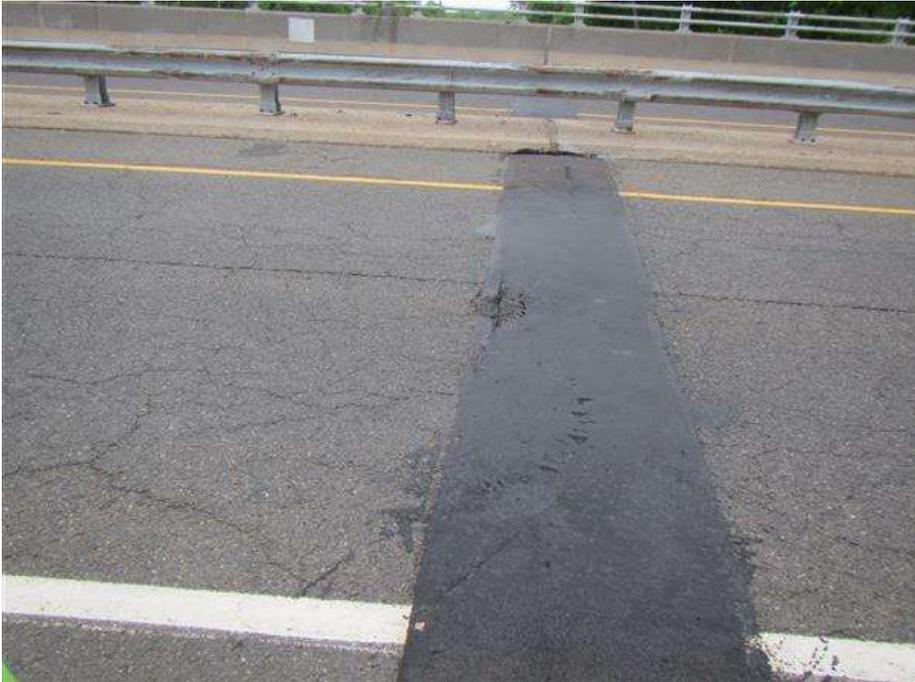
Photo Number: 21

Expansion Joint: 6 Asphaltic plug joints at pier 1 and 4 have adhesion cracks up to 6' long x 1/8" wide. The west abutment joint is heaved up to 1" in the north shoulder. Evidence of past leakage through the deck joints at all locations. BMM No. 11-493 Item No. 2, adhesion cracks and heaving in the plug joints, has been completed. BMM No. 13-539, Item No. 3, adhesion cracks in the plug joints, has not been completed.

Pier 4 deck joint, looking south. BMM # 13-539 Item # 3 has not been completed.

1. Install missing anchor bolt nut (1 EA).
2. Remove the delaminated concrete (LS).
3. Seal the adhesion cracks (± 5 LF).

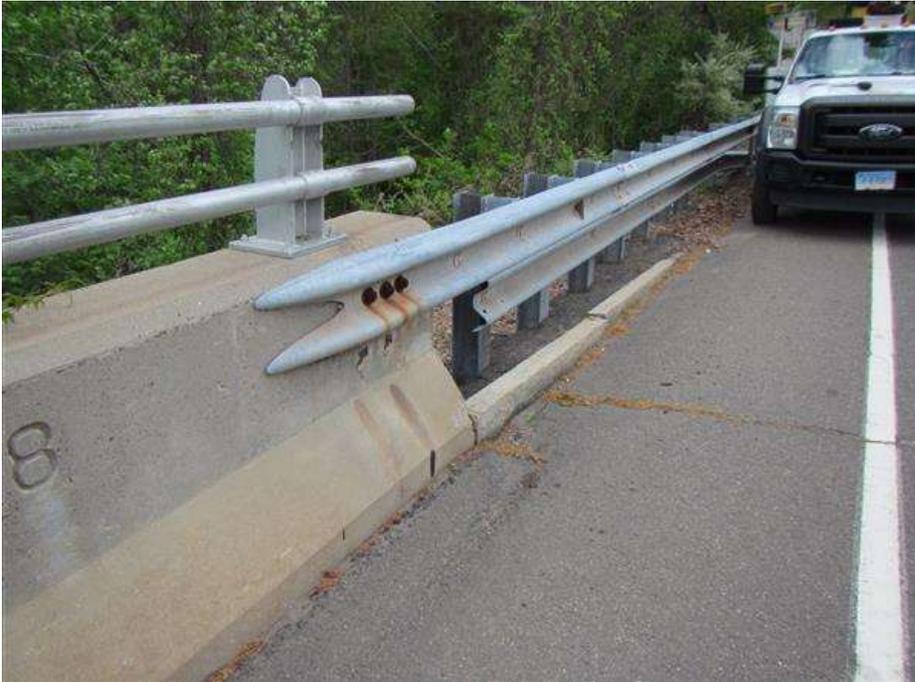
Photo Number: 23

Northeast approach rail.

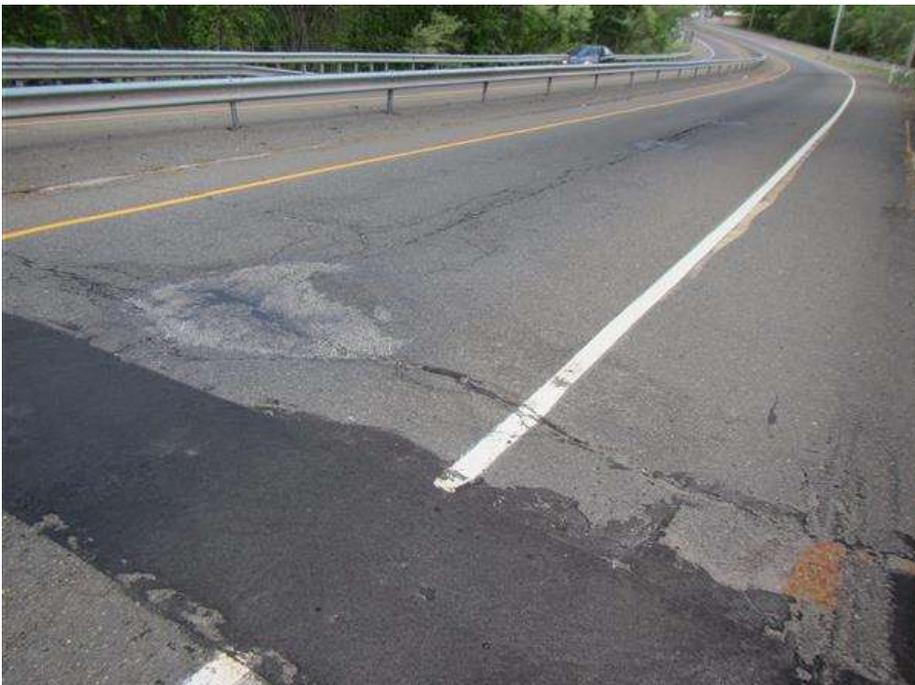
Photo Number: 24

East approach pavement.

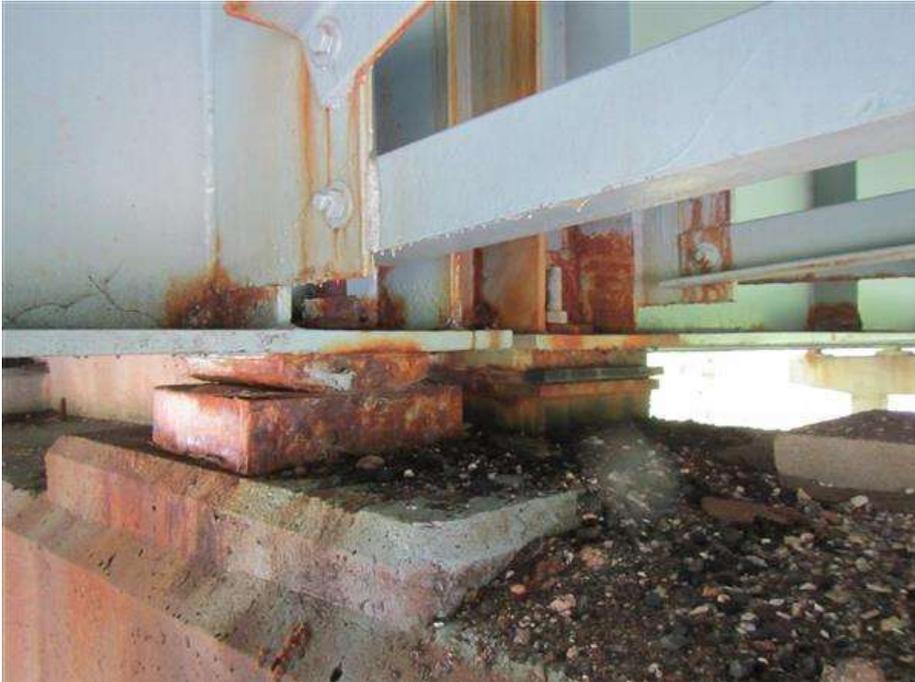
Photo Number: 25

Girder 5 fixed bearing in span 2 at pier 2.

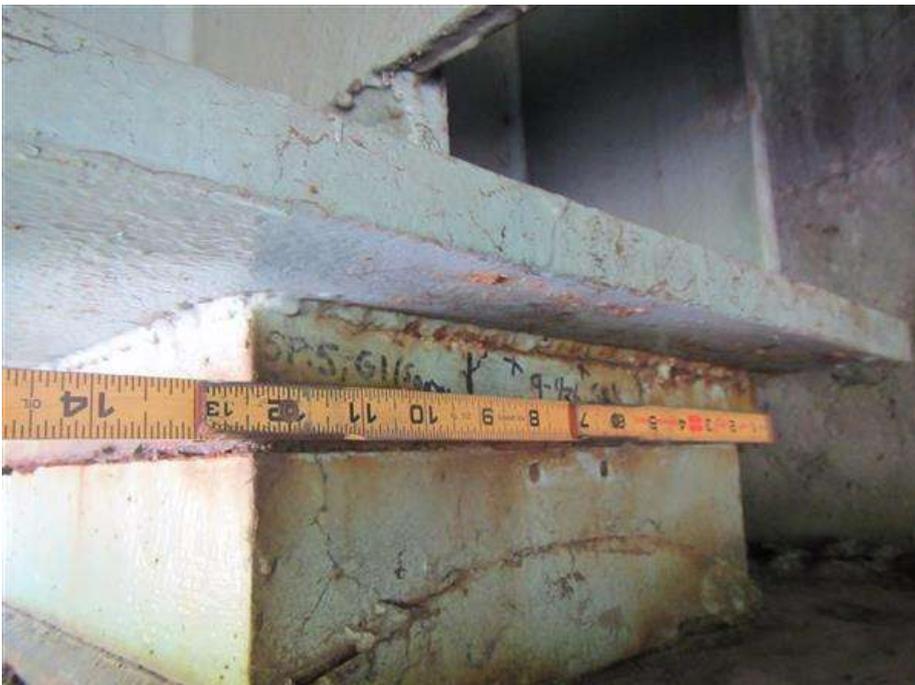
Photo Number: 26

Girder 1 and girder 8 at the east abutment have cracked welds between the bottom flange and bearing sole plate. See item 'WELDS-CRACKS' below.

9-1/2" long crack in sole plate at girder 1 bearing at the east abutment

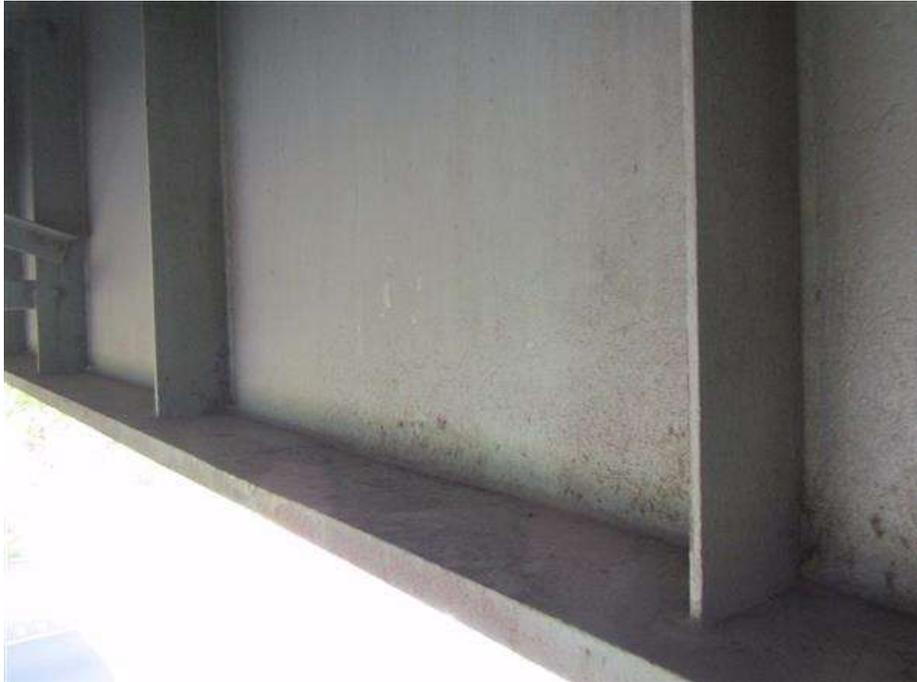
Photo Number: 27

South elevation of girder 1 in span 5 with 2' long x 8 1/4" wide x 1 5/16" remaining section loss in bottom flange.

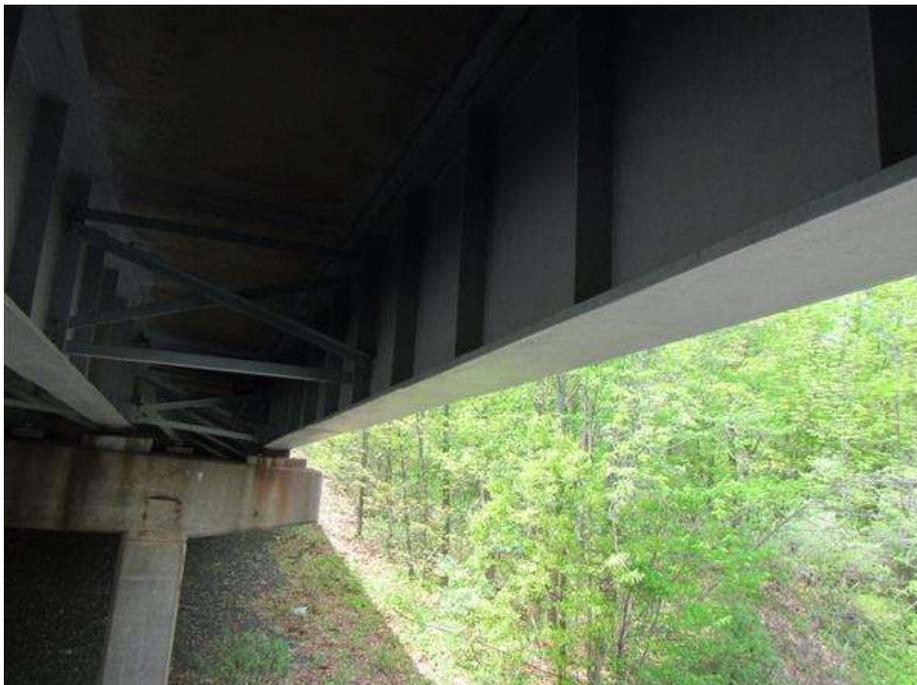
Photo Number: 28

Girder 1 section loss in span 2 with 1 1/4" remaining in the bottom flange.

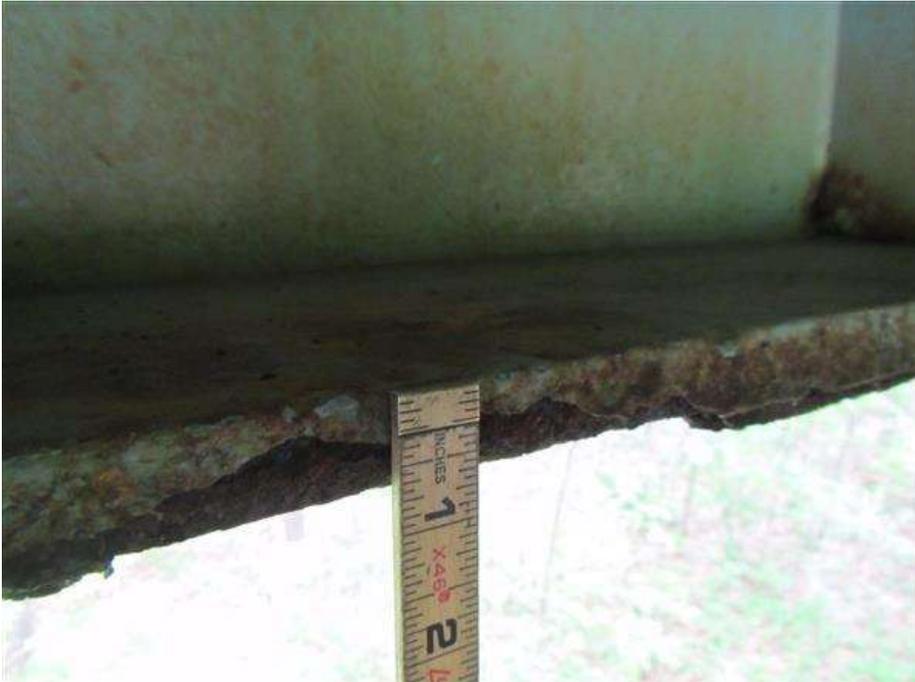
Photo Number: 29

Girder 1 bottom flange in span 3 near pier 3 with 1/8" deep section loss.

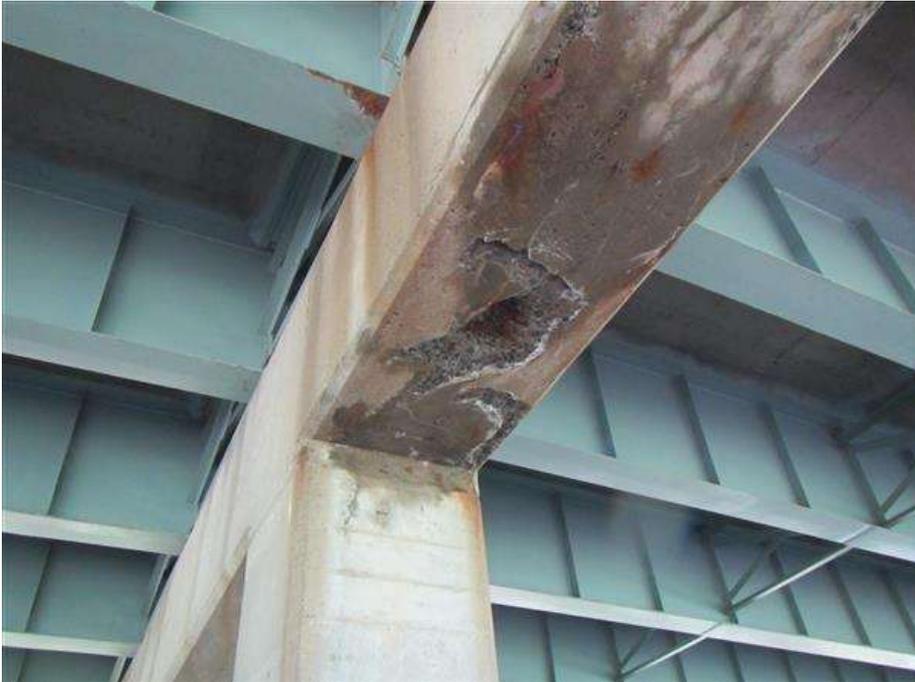
Photo Number: 33

3. Piers 2 and 3 caps have hollow areas up to 13' x full width of the cap typical at the underside and isolated spalls up to 6' x 4" x 4" corner spall with exposed rebar. (Priority E).

Pier 3 underside of cap between columns 2 and 3 with a 3' x 2' x 2" deep spall and adjacent hollow areas. BMM # 07-241 Item # 4 was not completed.

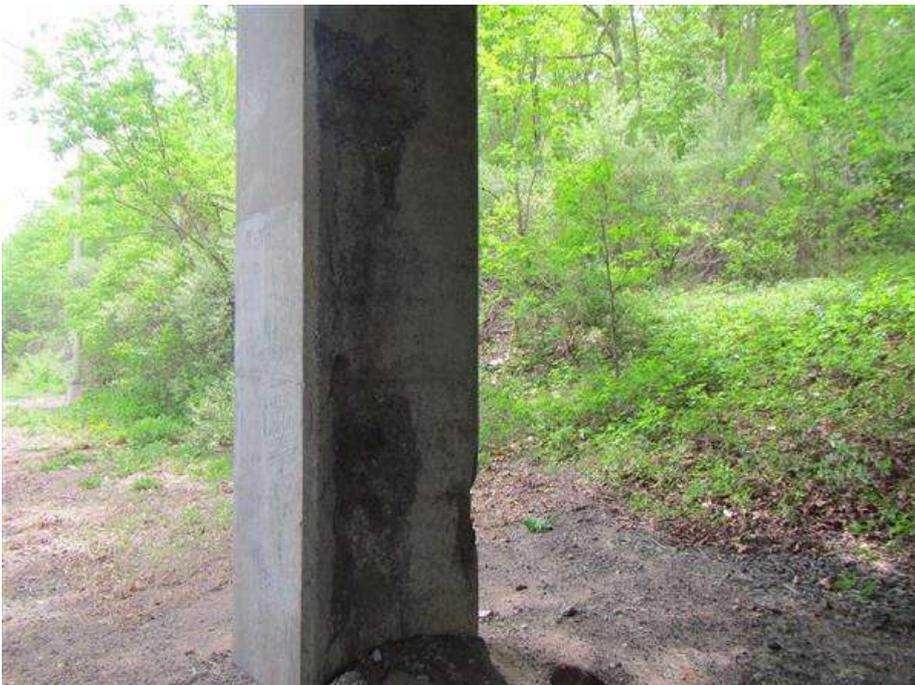
Photo Number: 34

4. Pier 1, column 3 has three spalls up to 2' x 2.5' x 2" deep with exposed rebar and a 2' x 1' hollow area. (Priority E).

Pier 1, column 3, large spalls up to 1' x 2' x 3" deep. BMM # 07-241 Item # 4 was not completed.
