# **NEPA ENVIRONMENTAL REVIEW REPORT**

**Community Development Block Grant – Disaster Recovery  
Owner Occupied Rehabilitation and Rebuilding Program**

**Site ID No. 2097  
3 Weed Circle  
Stamford, Connecticut**

**July 2014**

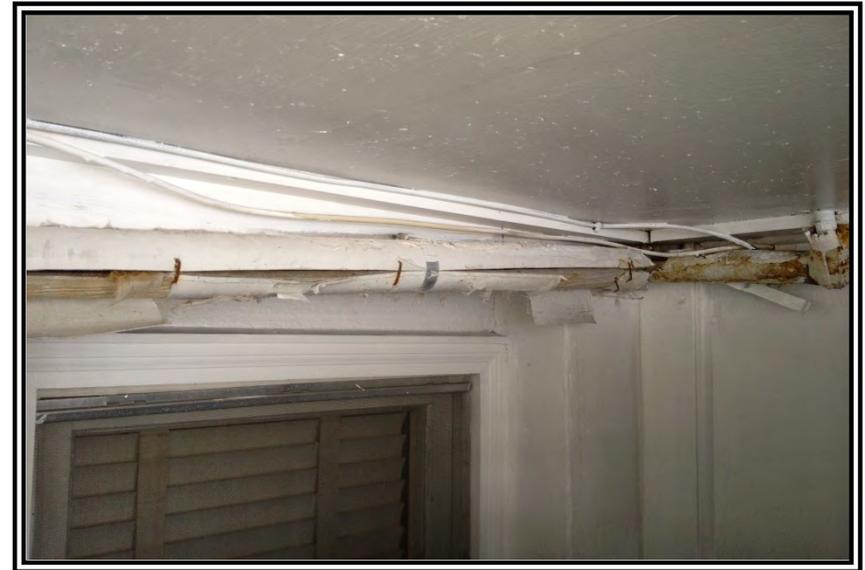
Material	Location	Approx. Quantity	Condition	% Chrysotile
Pipe wrap	Basement and garage	25 LF	Good	60%

3. Asbestos Containing Materials (ACM) - Based on the results of the asbestos survey and testing, the pipe wrap in the garage and basement was identified as an ACM containing asbestos greater than 1%. If this material will be disturbed, it appears that the asbestos containing pipe wrap will have to be removed by a qualified contractor. Additional suspect ACM may be encountered during renovations in spaces that were inaccessible or not apparent during the inspection such as within walls, beneath other layers of flooring, etc. As such, Triton recommends that a competent person be present during the renovation work who is capable of identifying additional suspect materials. Any such suspect materials encountered during the demolition must be sampled, tested, and if necessary, abated.

**Photograph 2**  
**Asbestos containing pipe wrap**

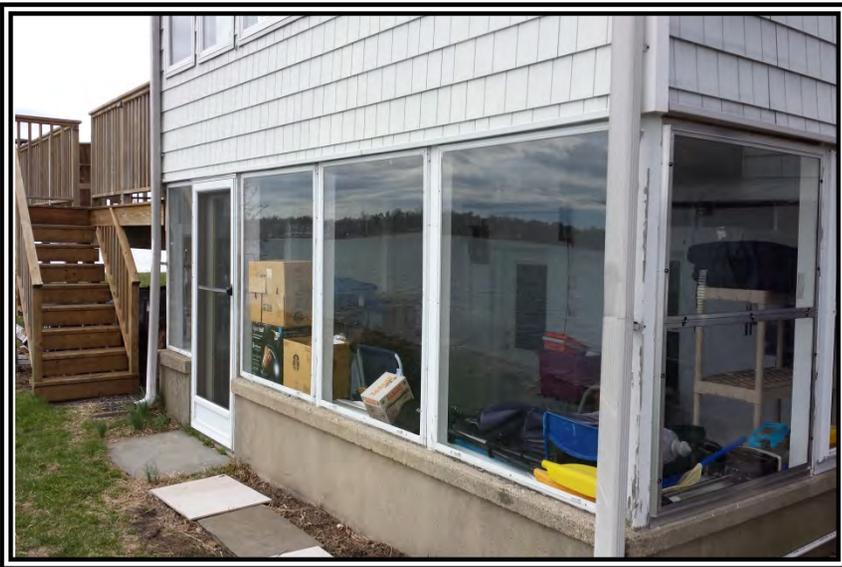
The results of the field XRF sampling are summarized on Form 5.3 “Field Sampling Form for Deteriorating Paint” provided in Appendix C. As indicated on Form 5.3, the following deteriorated paint surfaces were determined to contain lead paint above the HUD action level of 1 mg/cm<sup>2</sup>: porch windows, and the garage window.

- Hazard A - lead levels exceeding 1 mg/cm<sup>2</sup> in deteriorated paint on exterior of the enclosed porch windows (exterior trim) on the C side, and the C-side garage window (trim, sash, and sill).

**Photograph 3**  
**Lead containing paint on enclosed porch**

Although permanent abatement of the exterior paint associated with Hazard A could be completed (paint removal, building component removal, or permanent enclosure) the regulations allow for interim control options which include paint film stabilization.

Interim controls are allowed for exterior components only if the components are not disturbed by the rehabilitation. Therefore, if lead paint on the exterior garage and porch windows is disturbed or deteriorated, full abatement will be needed (paint removal or building component removal). Lead containing materials should be abated in accordance with local, state, and federal regulations including, but not limited to, *Housing and Urban Development – Lead Based Paint Poisoning Prevention in Certain Residential Structures – Rehabilitation Regulations (24 CFR 35(J))* as well as the EPA's Renovation, Repair, and Painting Rule (RRP) of 40 CFR Part 745.

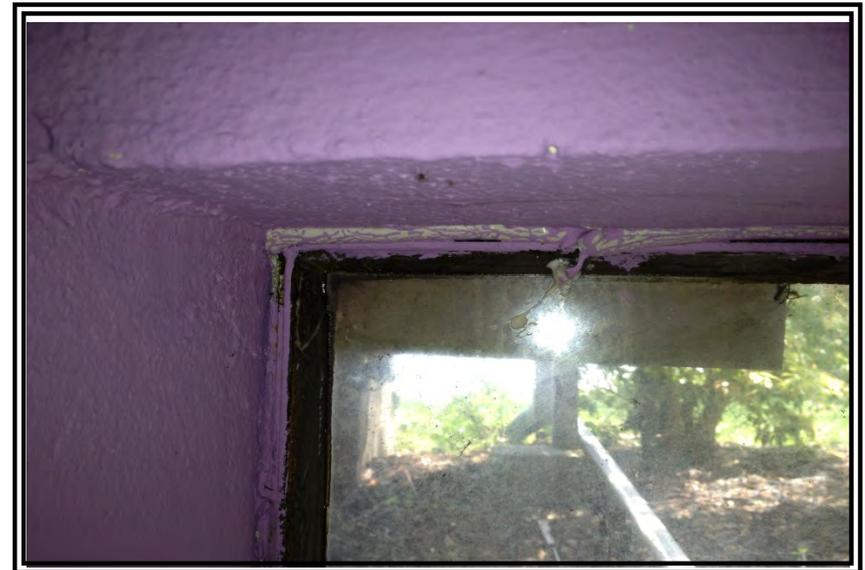
**Photograph 4**  
**PCB containing window caulk**

PCB containing caulk/sealants should be performed in a manner that prevents releases (to air, soil, or other media) and to mitigate health and safety concerns. Given the presence of PCBs in excess of the DEEP residential standard of 1.0 mg/kg, sampling of soil around the structure is recommended.

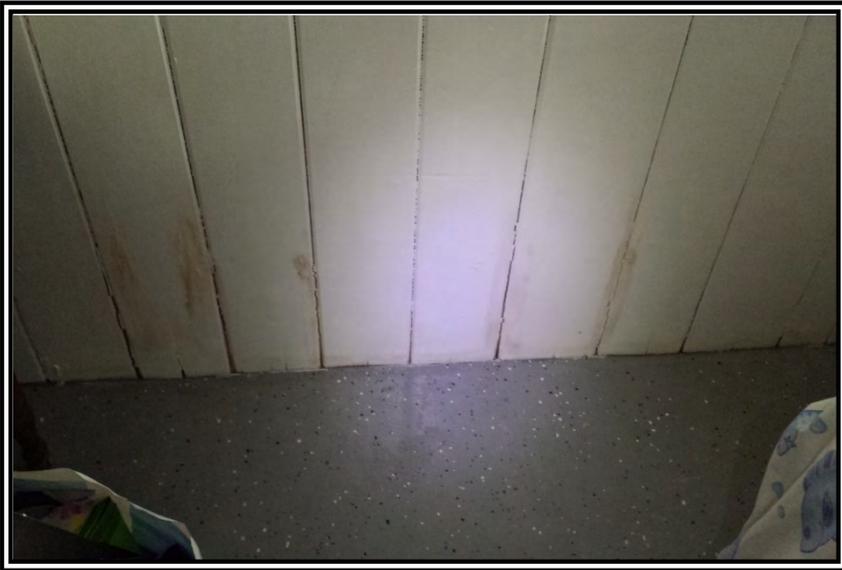
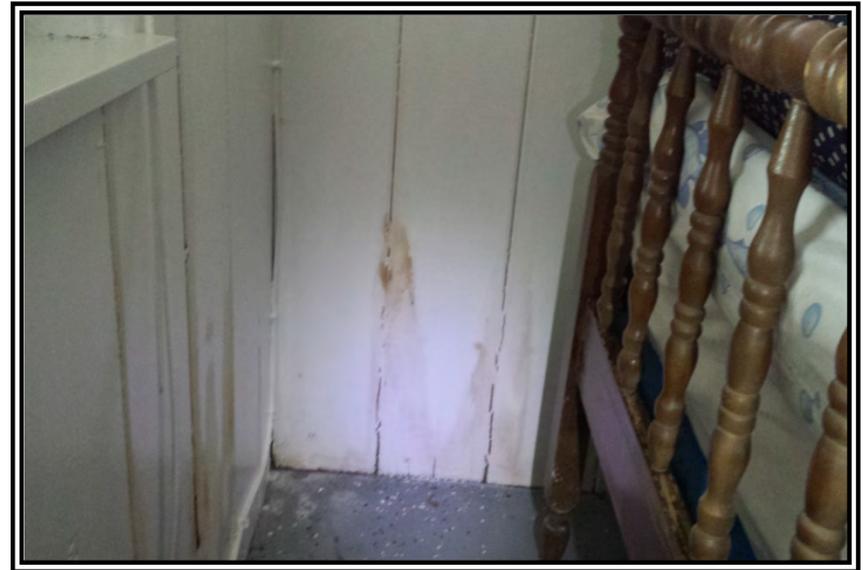
Triton completed a visual mold inspection of the work area on May 21, 2014. Mold was observed on wood paneling walls through the basement and above the drop ceiling panels on the wooden rafters in the basement. Although not directly observed, it is likely that mold is present on both wooden surfaces and insulation behind walls in the basement. Photographs of the apparent mold are provided in Appendix B.

**Photograph 5**  
**Mold on wood paneling in basement**

**Photograph 6**  
**Mold on wood paneling in basement**

5. Mold – Mold was observed on wood paneled walls and on the ceiling rafters above the drop ceiling in the basement and may be present in areas that could not be observed during the inspection (i.e. behind walls). Additional mold impacted surfaces may be encountered during renovation in spaces that were inaccessible or not apparent during the inspection. To protect occupant and worker health, the mold on the ceiling rafters must be abated by a qualified contractor. Pre-abatement air testing will be completed by Triton to establish a baseline. Triton recommends that a competent person be present during the renovation work who is capable of identifying potential additional suspect materials. General precautions should be taken during the renovation process to avoid the potential spread of mold spores and to mitigate health and safety concerns. Clearance testing will be completed (and compared against the baseline) to evaluate the efficacy of the abatement.

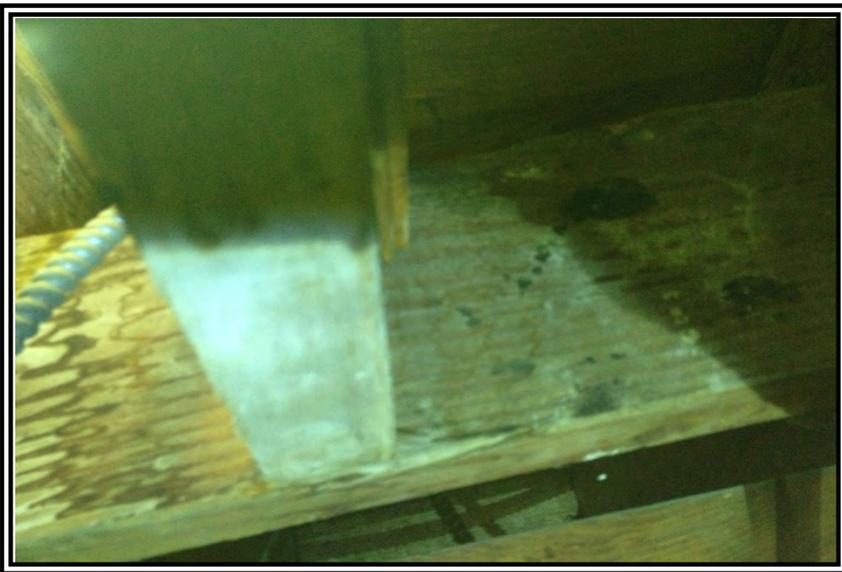
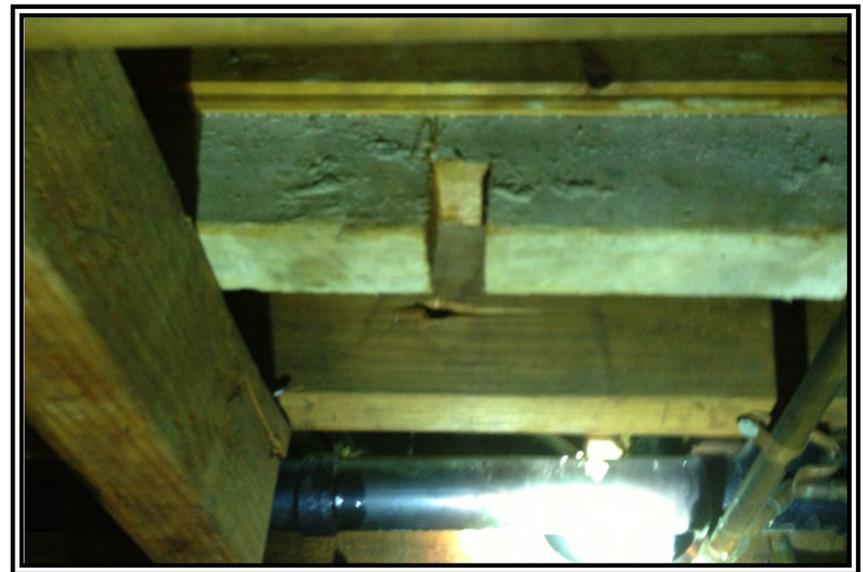
Mold was observed within the work zone on wood paneled walls and on the wooden rafters above the drop ceiling panels in the basement, which was flooded. Mold may be present in other interior areas that could not be observed during the inspection (i.e. behind walls). Due to the intended demolition of the basement, abatement of the mold on (and possibly within) the walls will not be required. However, mold on the ceiling rafters that will remain following raising will require abatement to protect occupant health. Any porous materials containing visible mold that are encountered during the renovation should be removed in accordance with local, state, and federal regulations including, but not limited to, the guidelines put forward in the most recent version of the *Institute for Inspection, Cleaning, and Restoration Certificate (IICRC) Standard and Reference Guide for Mold Remediation* as well as the *Connecticut Guidelines for Mold Abatement Contractors*. The abatement contractor must provide credentials/adequate qualification documentation and a work plan for abatement work with its bid for review by Merritt and Triton. Pre-abatement and clearance air testing will be completed by Triton to evaluate pre and post-abatement conditions.

**Photograph 7**  
**Mold on basement ceiling rafters**

**Photograph 8**  
**Mold on basement ceiling rafters**
