RE: Project 1278 – 1 Burwell Street, Norwalk, CT

This letter is to provide a summary description of the Statutory Checklist for CDBG-DR Applicant – 1278 – 1 Burwell Street.

**Hazardous Materials
Inspection Report**

1 BURWELL STREET
NORWALK, CONNECTICUT

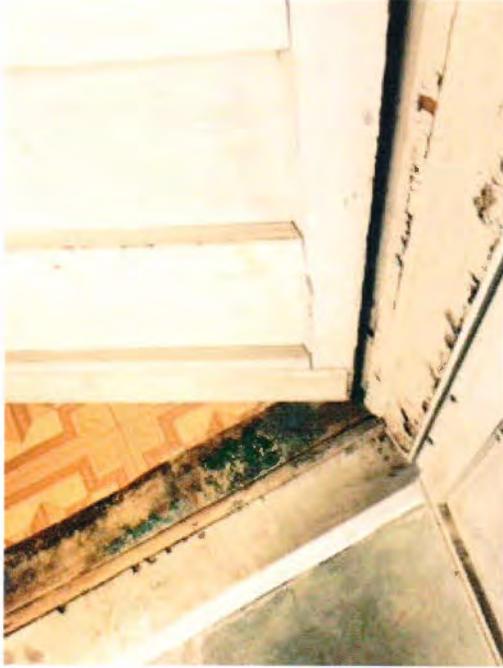
* no sills				
28	4	Dining Rm	3	Door Casing	Intact	Wood	2.8	Positive
29	4	Dining Rm	2	Door Casing	Intact	Wood	-0.1	Negative
				* rubber basebd				
30	5	Rear Porch	1	Door	Intact	Wood	-0.1	Negative
31	5	Rear Porch	1	Door Jamb	Defective	Wood	9	Positive

Rear Door, door jamb, threshold

Lead - Following the HUD Lead-Safe Housing Guidelines, the non-intact areas should undergo interim measures to abate the hazard. The following areas were non-intact as well as testing positive:

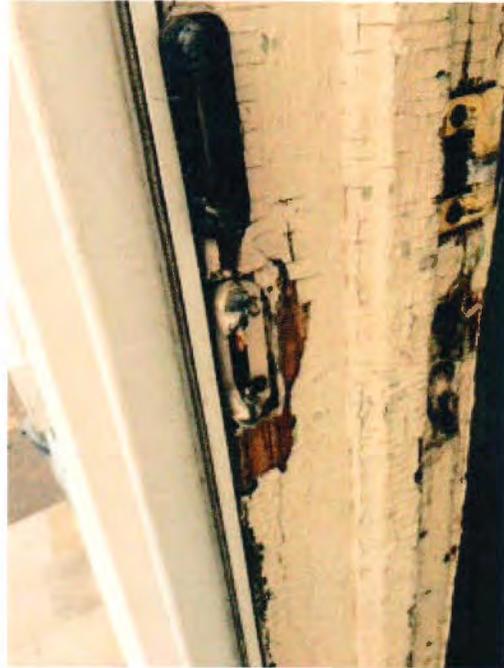
Rear Door Jamb

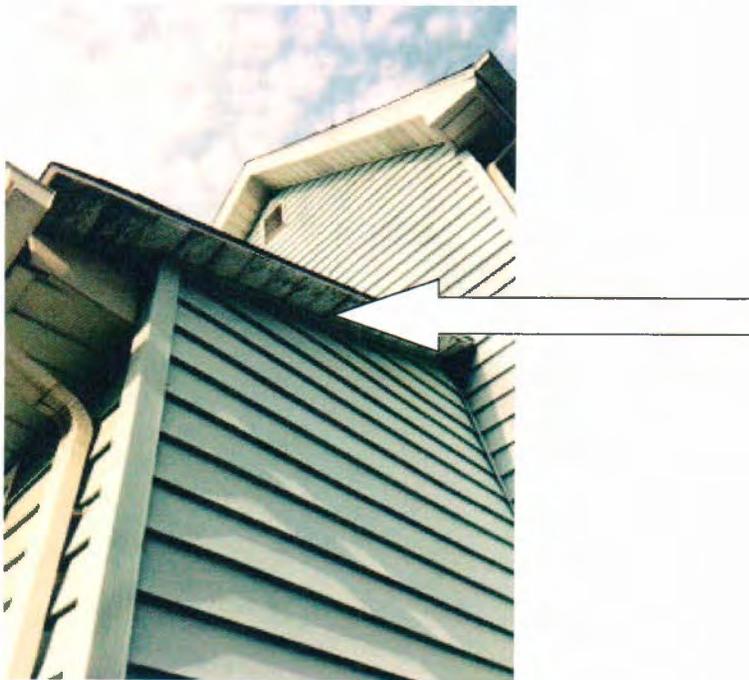
101	14	Exterior	4	Window reveal	Defective	Wood	9.9	Positive
102	14	Exterior	4	Basemnt wnd	Intact	Wood	3.5	Positive
103	14	Exterior	3	Door from Rm #5	Defective	Wood	3.6	Positive
104	14	Exterior	3	Door Jamb	Defective	Wood	9.9	Positive
105	14	Exterior	3	Threshold	Defective	Wood	9.9	Positive
106	14	Exterior	3	Overhang	Defective	Wood	6.5	Positive

Rear Soffitt
