STRUCTURE NO. 03093

INTERSTATE 91
over
N FRONT ST & QUINN RIVER
New HAVEN

Routine Inspection
on
6/16/2014

**BRIDGE NO. 03093
INTERSTATE 91**

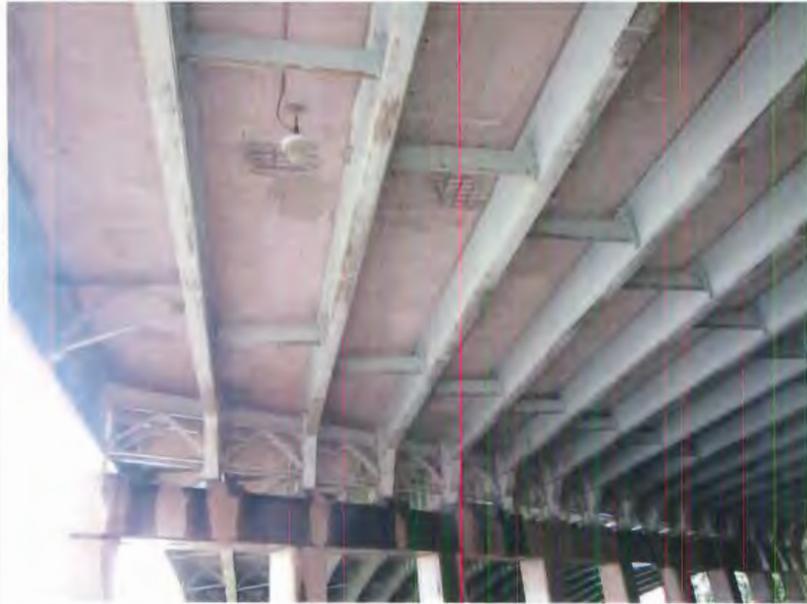
Photo #5 :
 Typical underside, span 1, looking north. Note the active leakage at the pier 1 joint and the large spalls with exposed rebar in the deck underside. Under-bridge lights were not on during the daytime inspection.

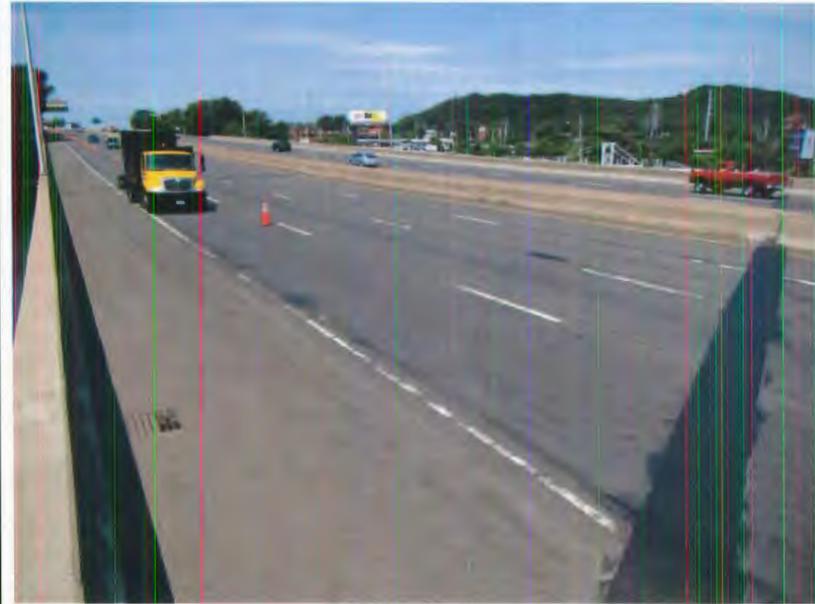
Photo #6 :
 Typical top of deck, northbound, looking southwest from span 3.

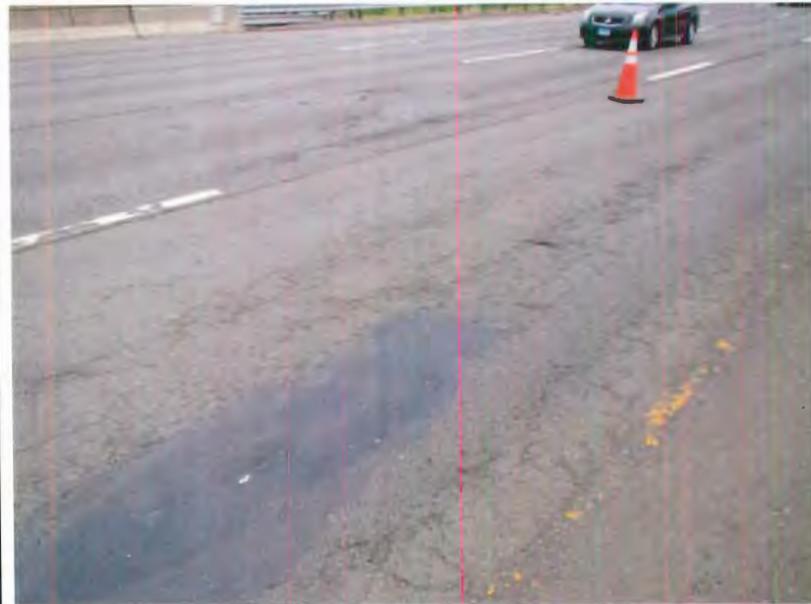
OVERLAY:	5	<p>The bituminous overlay has map cracking throughout, heavy at some locations with random areas of breaking up bituminous/potholes, worst in the southbound left lane of span 3 where there is approximately 200 square feet of breaking up bituminous with potholes up to 6" diameter x 1" deep. The paving seams have cracks up to 1/2" wide and are raveled up 6" wide x 1.5" deep (span 4, southbound). Along the joints, the bituminous is raveled up to 1" wide (south hanger line, span 3) and breaking up with random potholes up to 3' x 6" wide x 2" deep (north hanger line, span 3). In the left two lanes of span 4 southbound, there are random bituminous patches with potholes up to 1.5" deep. The bituminous adjacent the scuppers is dull sounding and has potholes up to 3' x 1' x 1" deep (span 3 southbound). There are random gouges in the shoulders from previous snooper outrigger wheels. See sheets 24-26 and photos 6-8 & 26.</p>

Photo #7 :
Span 4, southbound: Heavy map cracking, raveling, bituminous patches and potholes in the bridge overlay.

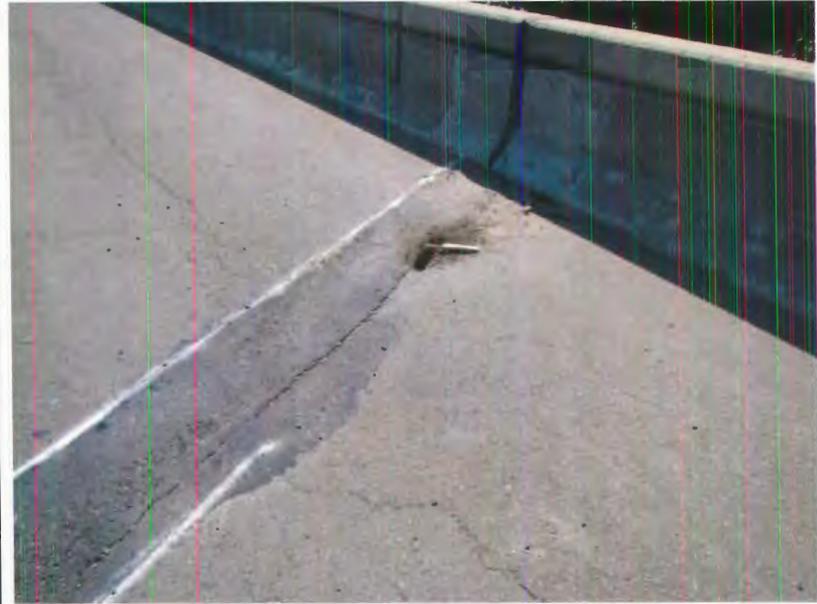
Photo #8 :
Span 1, northbound right shoulder: Pothole in the bridge overlay adjacent to the pier 1 joint. Note the adhesion crack along the asphaltic plug joint.

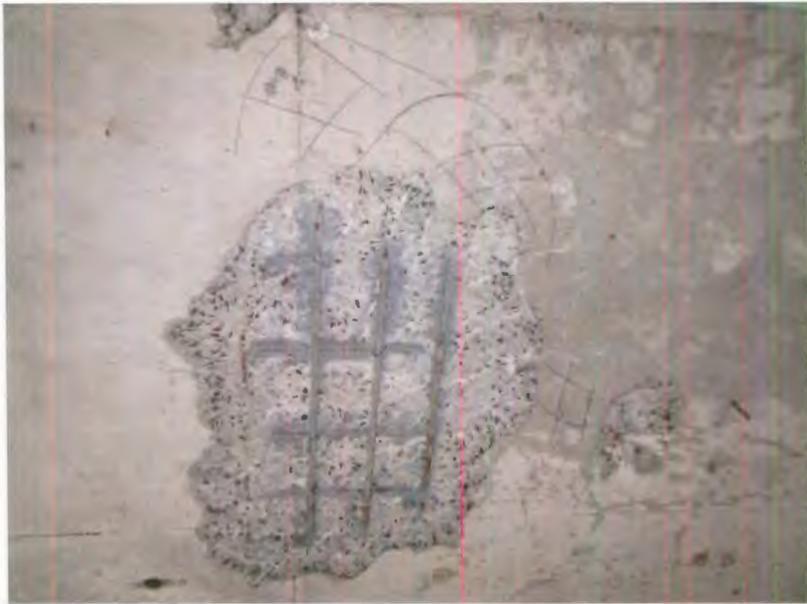
Photo #9 :
Span 1, bay 2, panel 2: Large spall with exposed (coated) rebar. Note the hollow concrete adjacent to the spall over North Front Street travel lanes.

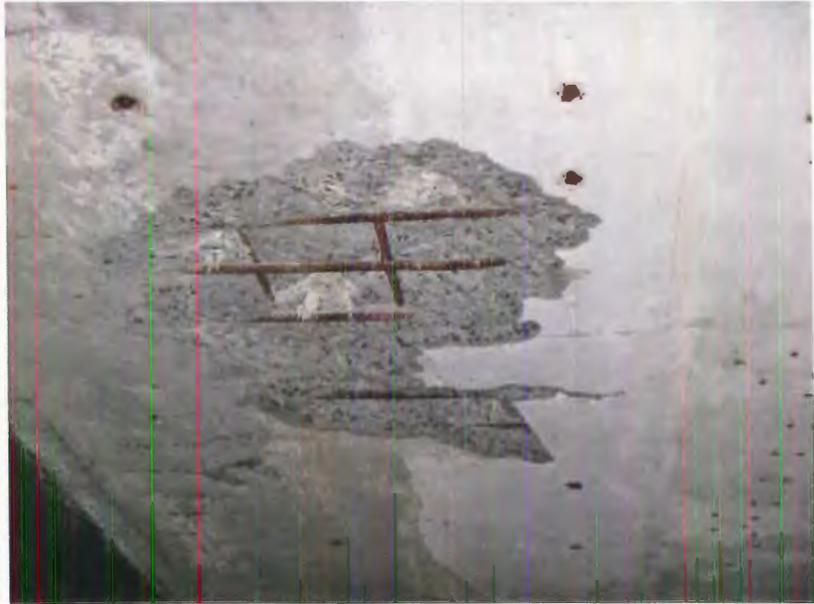
Photo #10 :
Span 2, bay 8, panel 3: Large spall with exposed rebar, up to 3.5" deep.

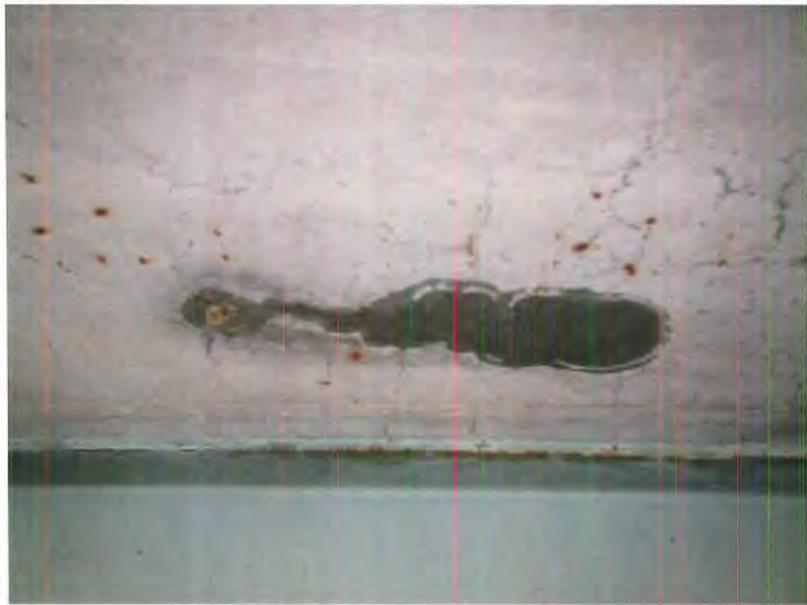
Photo #11 :
Span 1, bay 10, panel 2: Active leakage through the deck at a map cracked area.

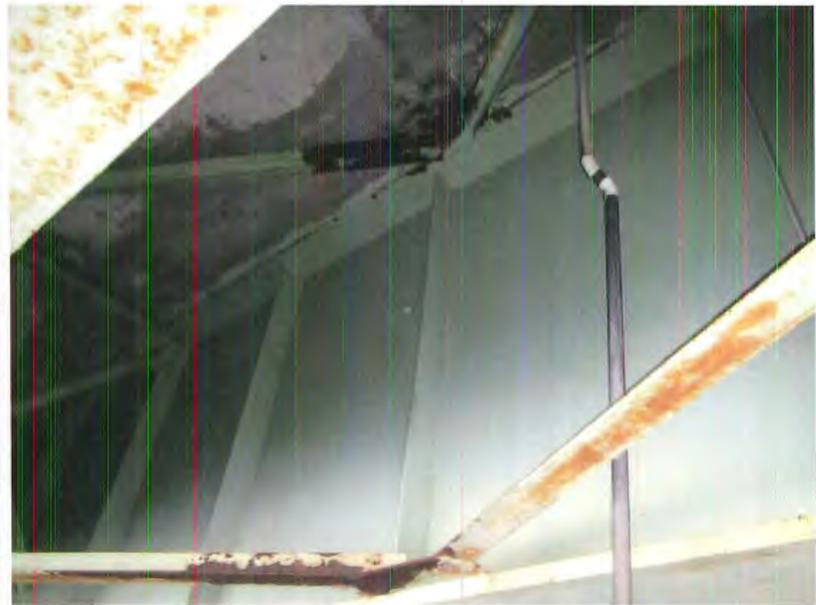
Photo #12 :
Span 3 near midspan, bay 8: Upper and lower lateral bracing with laminated rust and section loss below a spalled area in the deck underside (dry at time of inspection).

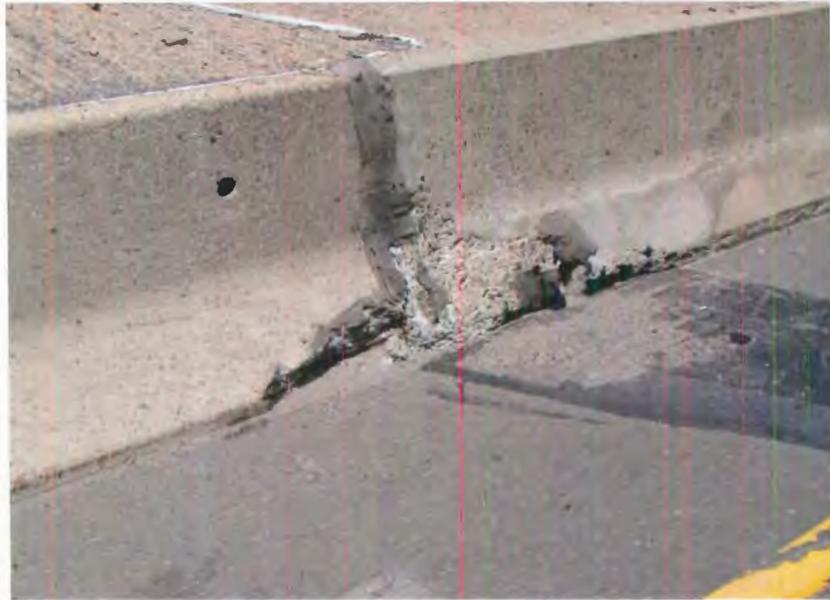
Photo #13 :
 Northbound median at the south abutment joint: Spalled and scaled concrete at the bridge and approach median, mostly in the curb area. Note the exposed rebar at the approach median curb (left side of photo).

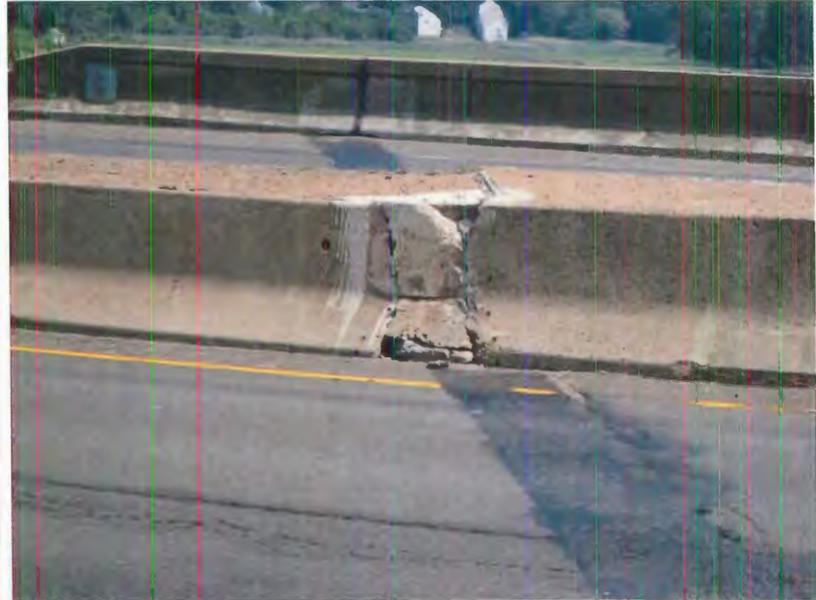
Photo #14 :
 Southbound median parapet at the north abutment joint: Large, full height spalled and hollow area in the approach median. Bridge median/curb with adjacent spalling.

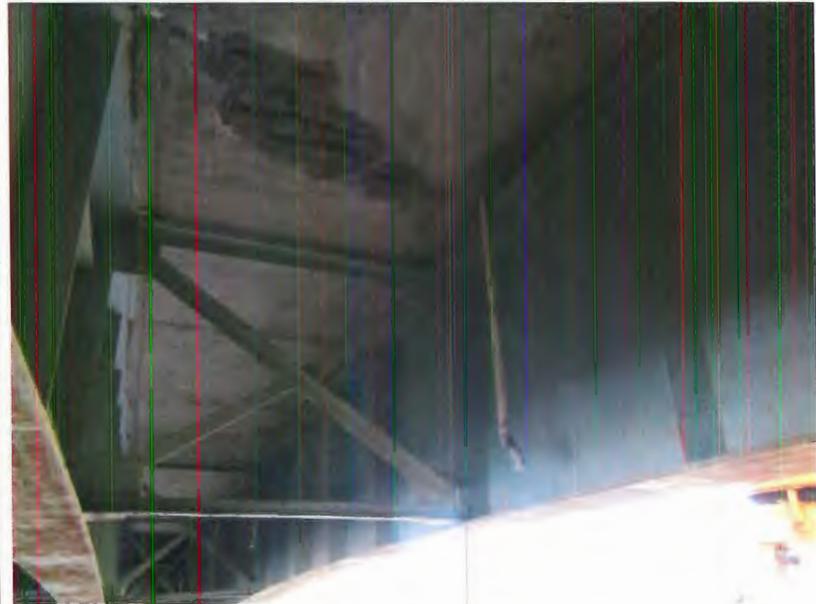
Photo #16 :
Span 4, bay 1, panel 4: Short weep may drain onto the girder bottom flange. Also note the large spall with exposed rebar and efflorescence along the construction joint.

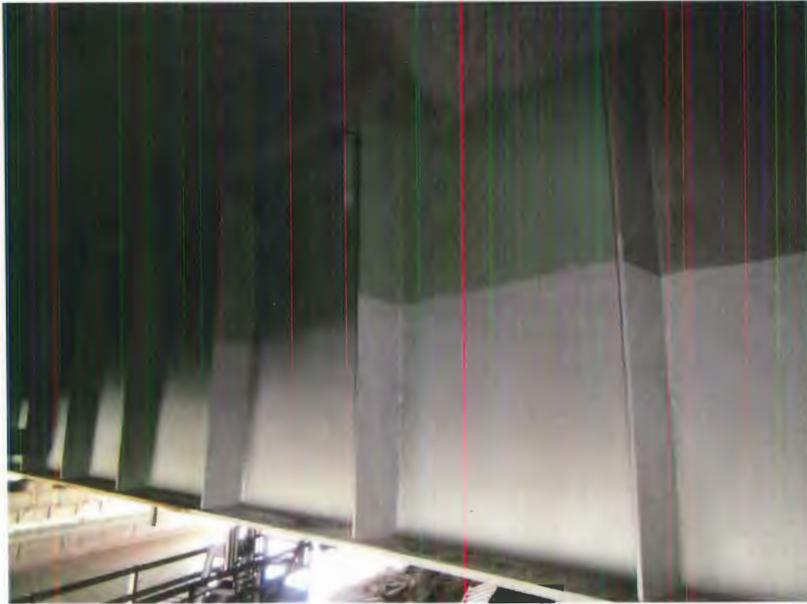
Photo #17 :
Span 4, girder 9, east elevation: Weep has a missing extension and drains onto the girder bottom flange. Note the painted over section losses along the girder bottom flange.

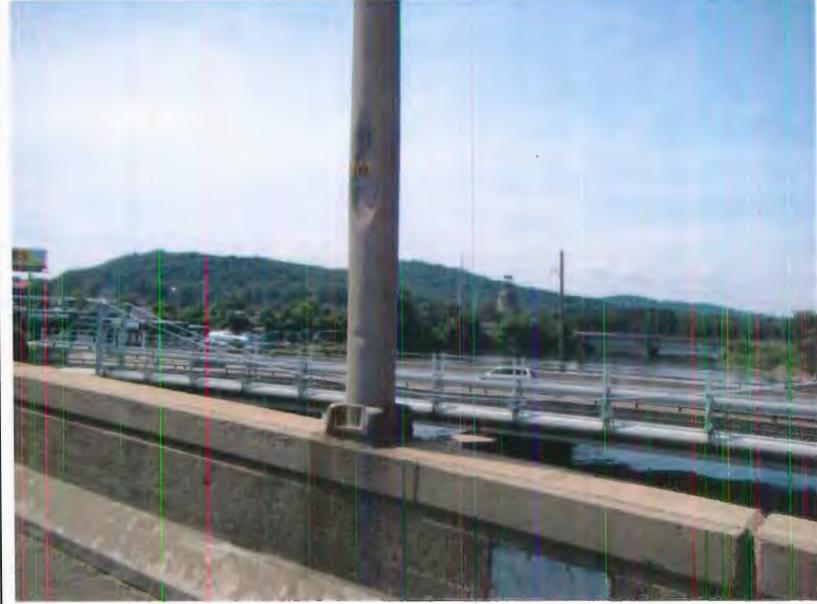
Photo #18 :
Span 3, southbound, west parapet: Light standard with impact damage.

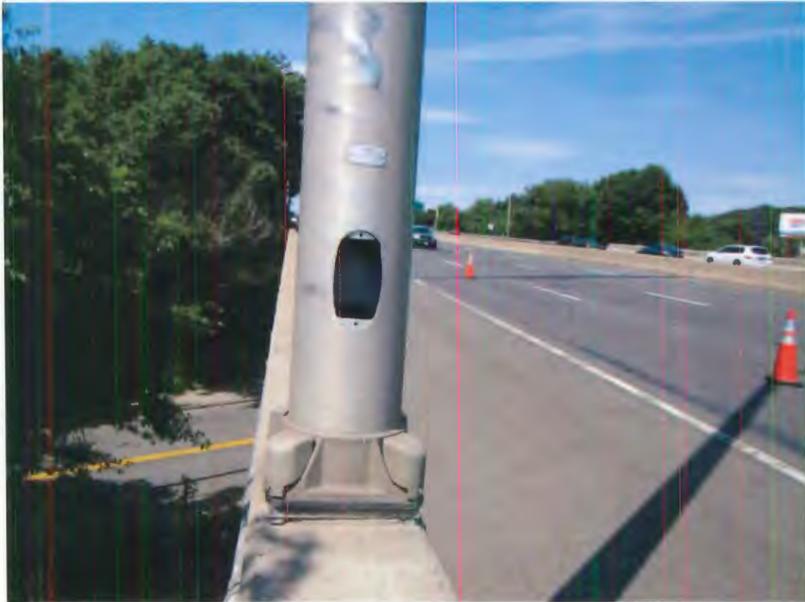
Photo #19 :
Span 2, northbound, east parapet: Missing hand hole cover at the light standard base.

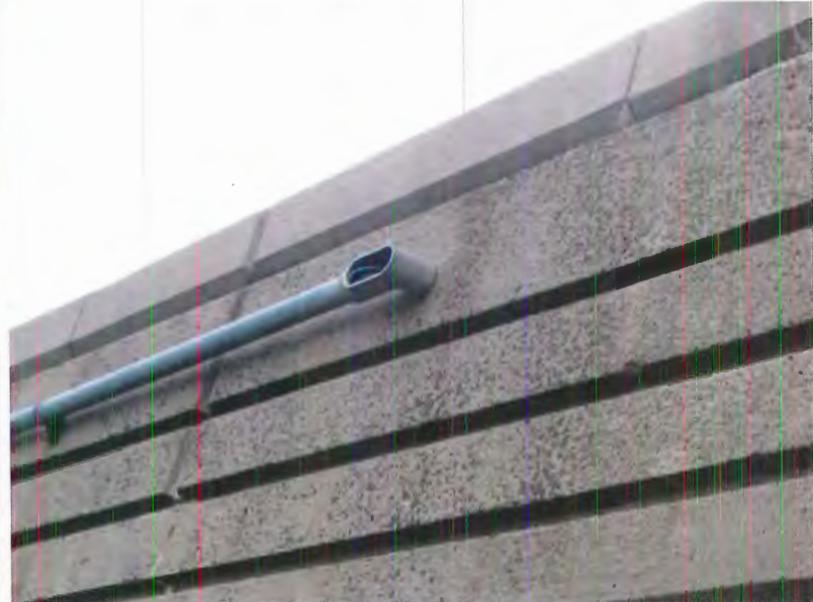
Photo #20 :
Span 3, west parapet, outside face: Conduit elbow with missing access cover.

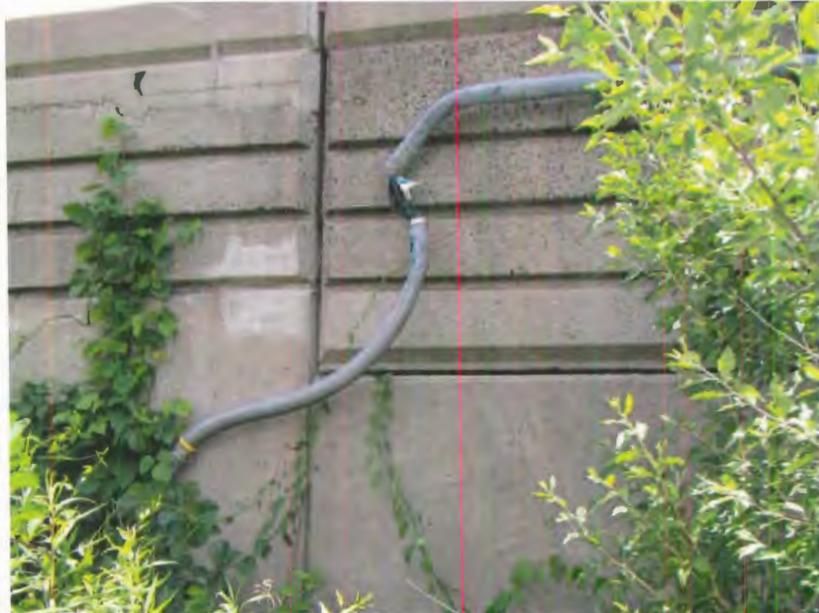
Photo #21 :
Northwest wingwall: Conduit for light standards is separated, exposing wires.

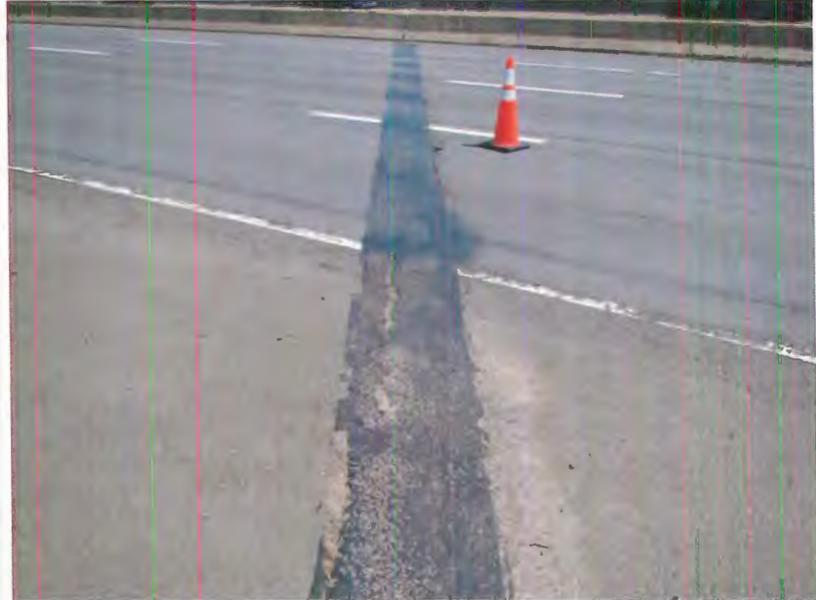
Photo #22 :
Asphaltic plug joint at pier 1, southbound: Cohesion and adhesion cracks along the joint.

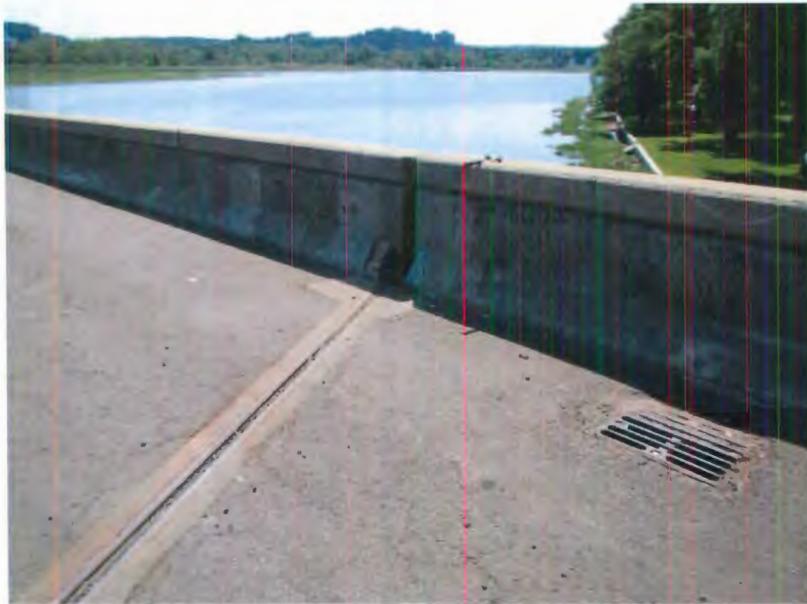
Photo #25 :
 Strip seal joint at the span 3, south hanger line, northbound:
 Missing curb plate at the east parapet.

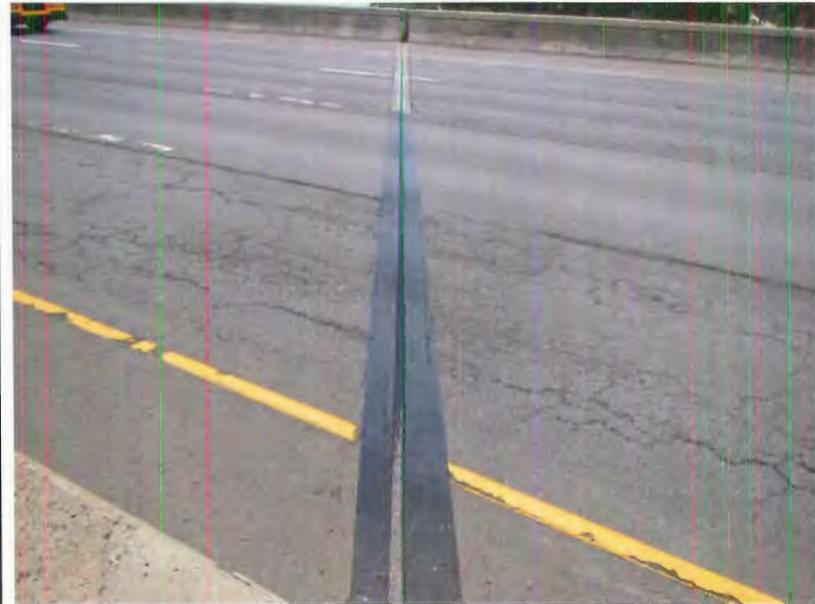
Photo #26 :
 Strip seal joint at the span 3, south hanger line, southbound:
 Repairs to the headers in the left and left-center lanes. Note
 the cracking in the bridge overlay.

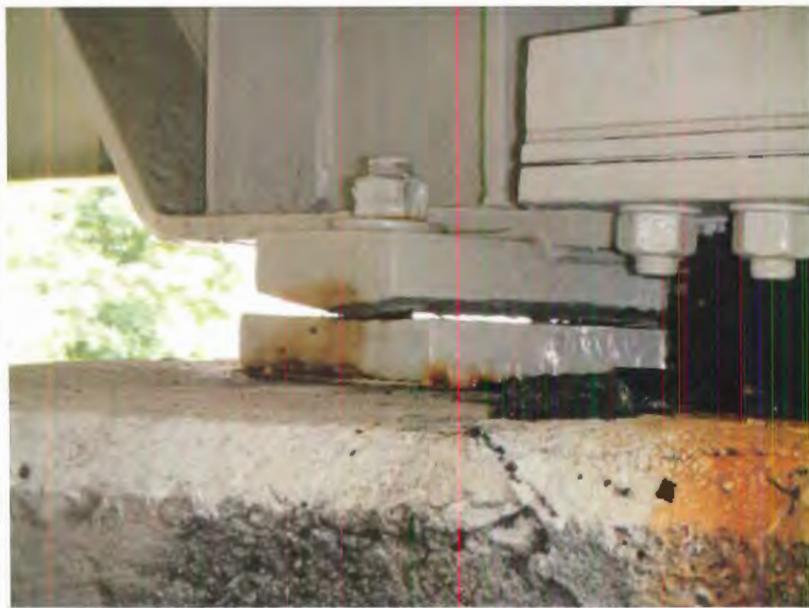
Photo #27 :
Span 1, girder 1 fixed bearing at pier 1: Painted-over impacted rust and gaps between the sole and masonry plates.

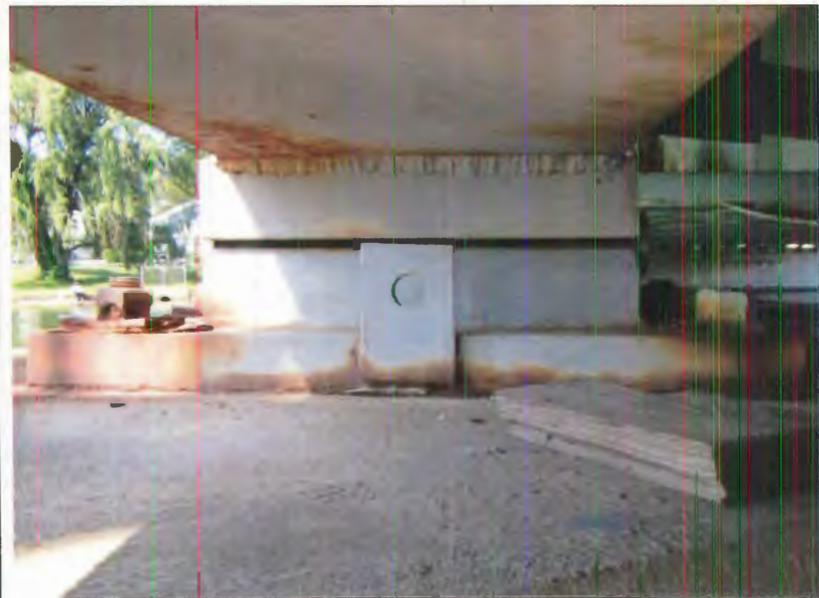
Photo #28 :
Girder 18 bearing at pier 3: Impacted rust under the washers, section loss to the anchor bolt nuts, and surface rust along bearing components.

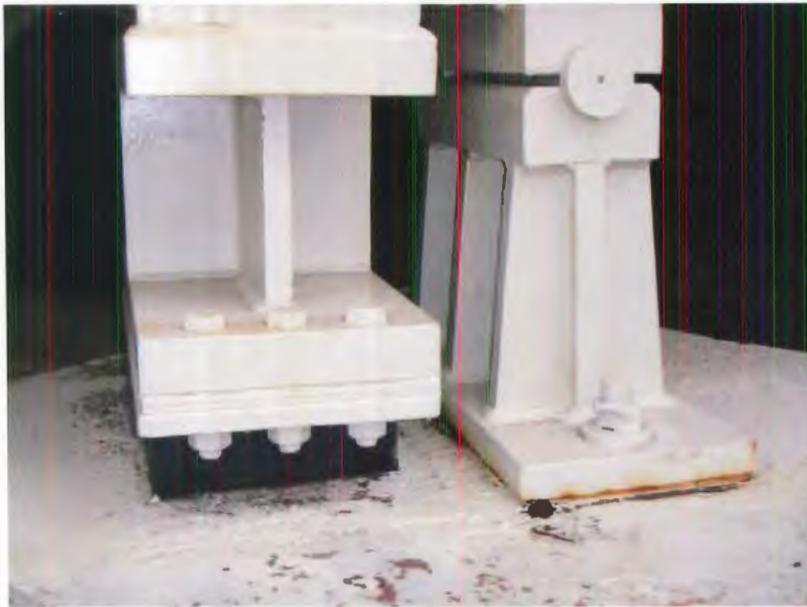
Photo #29 :
Girder 1 bearings at pier 1. Note that the previous span 2 rockers have been replaced with elastomeric bearings.

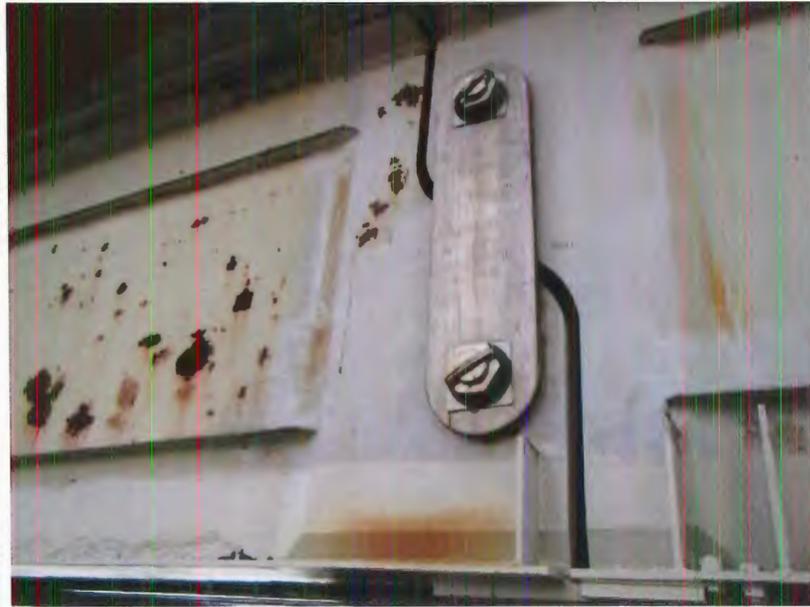
Photo #30 :
Span 3, girder 1 pin and hanger (south line) west elevation, typical. Note the painted over section loss and rusted through hole in the girder web base, just to the left of the thickened portion of the web at the left side of the photo.

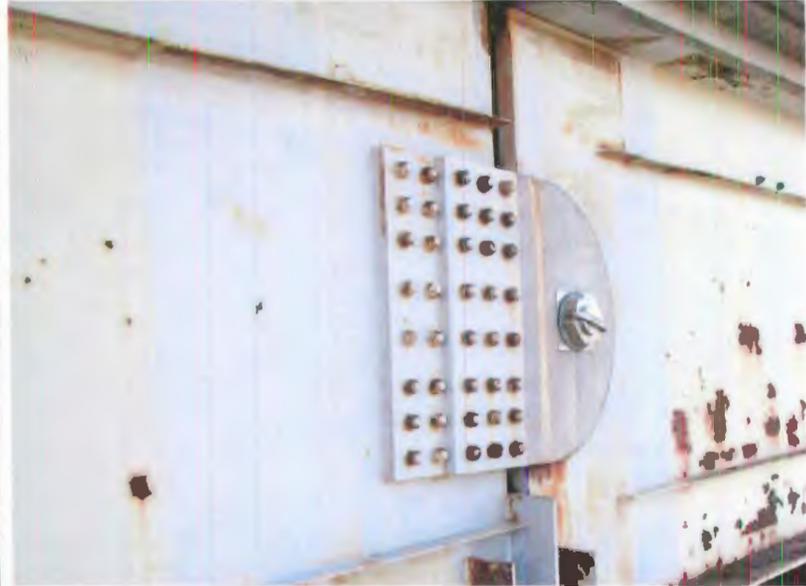
Photo #32 :
Span 3, girder 1 fixed hinge (north line), typical. Note the rust along the hinge nuts.

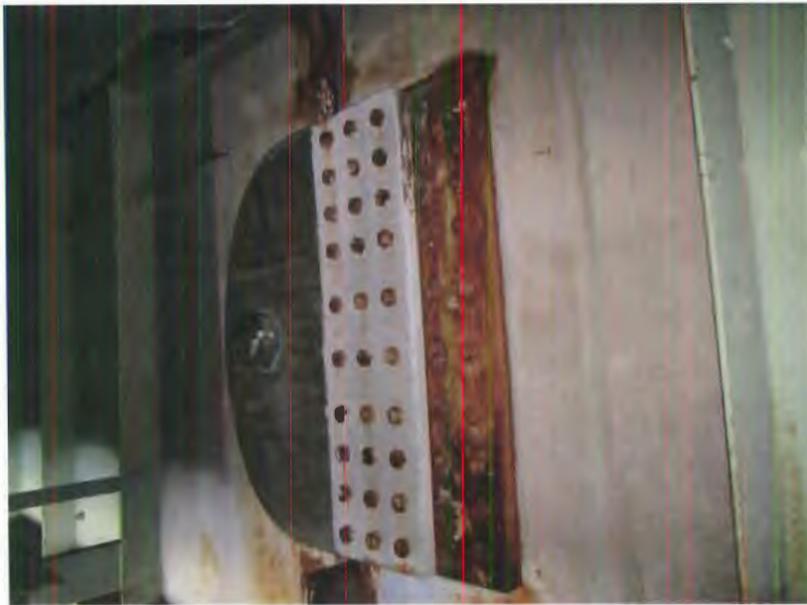
Photo #33 :
Span 3, girder 9 fixed hinge, east elevation: Heavy surface rust on the spacer plate. Also note the rust along the bolt heads.

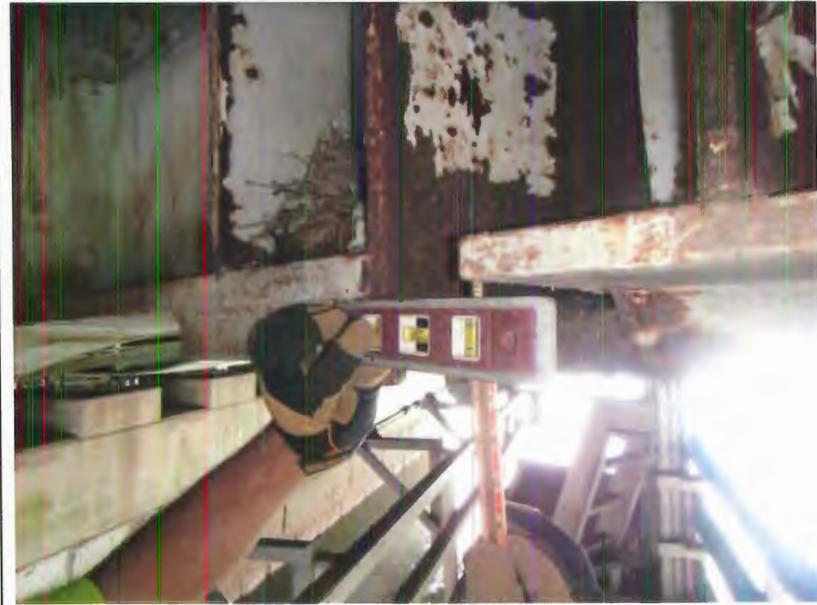
Photo #34 :
Span 3, girder 10 "V" fixed hinge measurement. 3/16" difference in measurement versus last inspection, indicating a rise in the hung span this inspection.

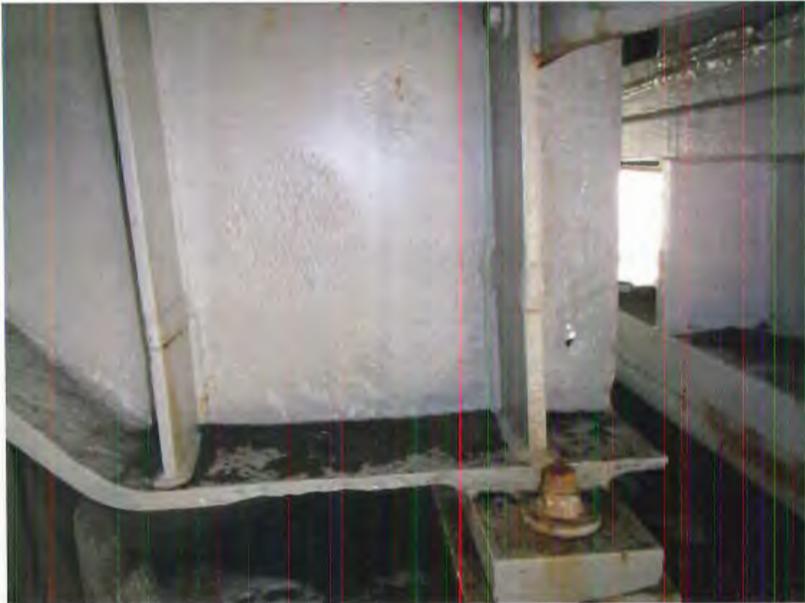
Photo #35 :
Span 1, girder 10, east elevation at pier 1: Bolster bearing stiffener and adjacent stiffener have been repaired. Note the painted-over section losses along the bolster web, including the rusted through hole in the web behind the bearing stiffener.

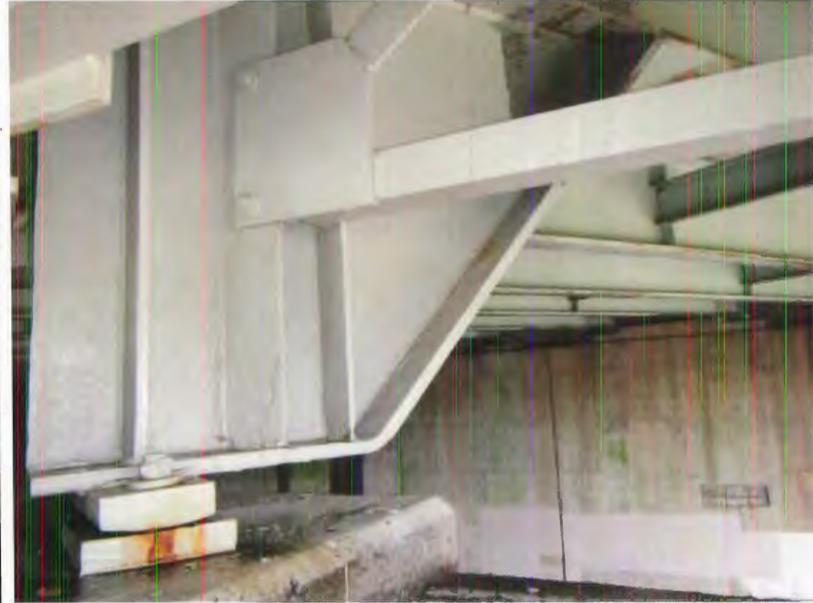
Photo #36 :
Span 1, girder 1, west elevation at pier 1: Painted-over section losses along the bolster web and stiffener bases.

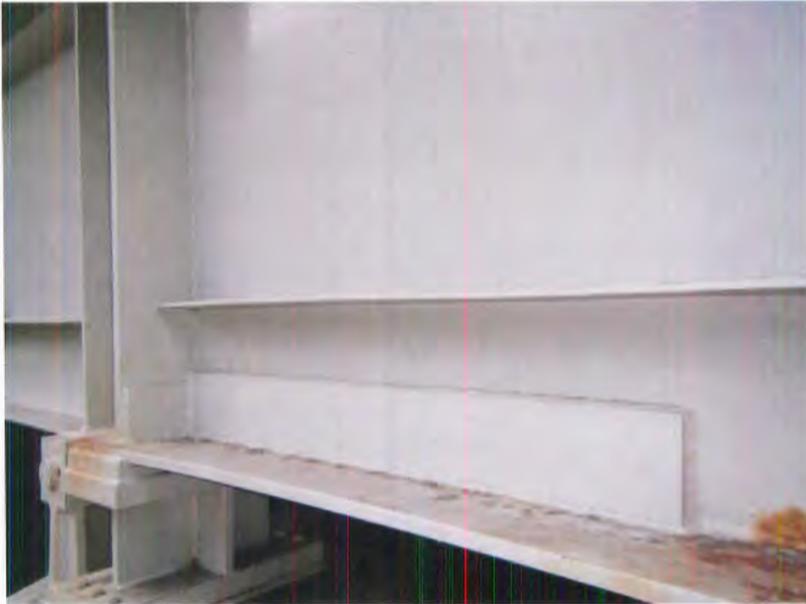
Photo #37 :
Span 2, girder 1, east elevation at pier 1: Repair plates at the girder web base and bearing stiffeners.

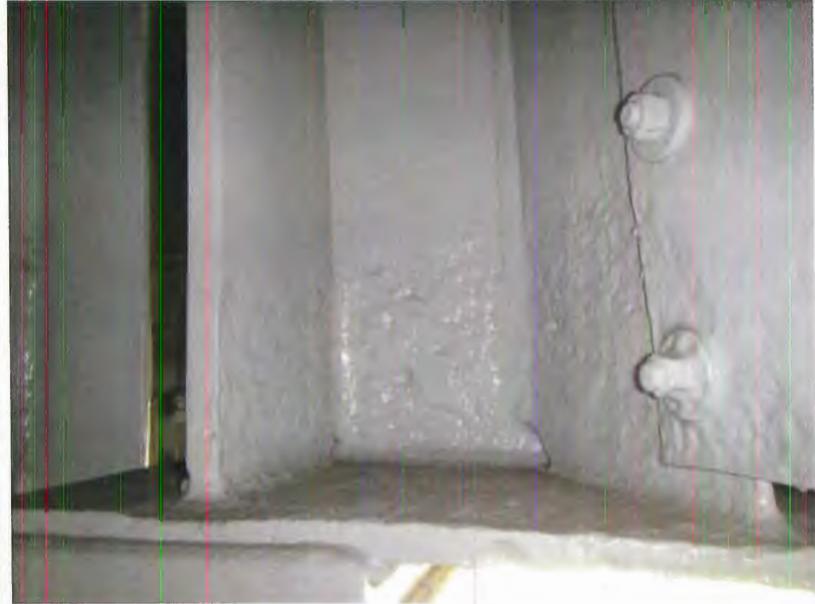
Photo #38 :
Span 2, girder 7, east elevation at pier 1: Web base and bearing stiffener with painted over section loss. Web has an isolated pin hole.

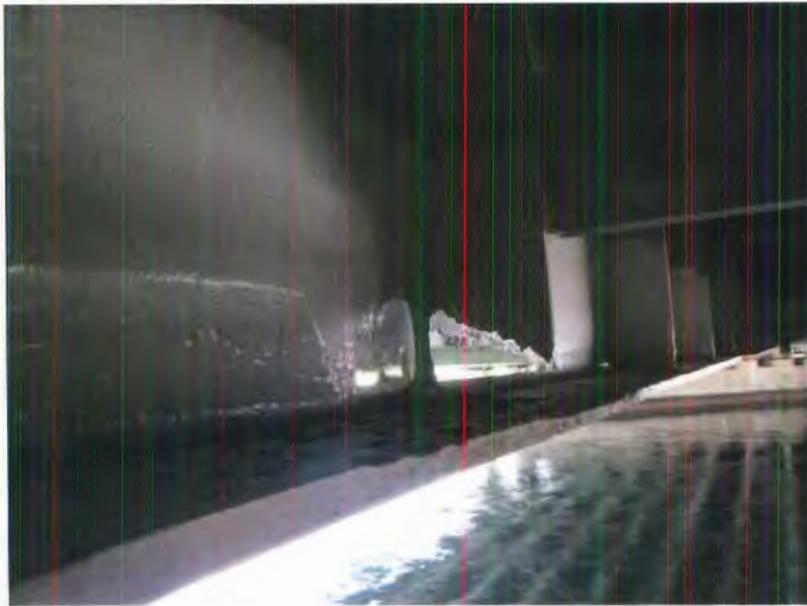
Photo #39 :
Span 3, girder 9 hung span near pin & hanger (south line):
Web and stiffeners with rusted through holes and section loss. Note the section loss to the girder bottom flange.

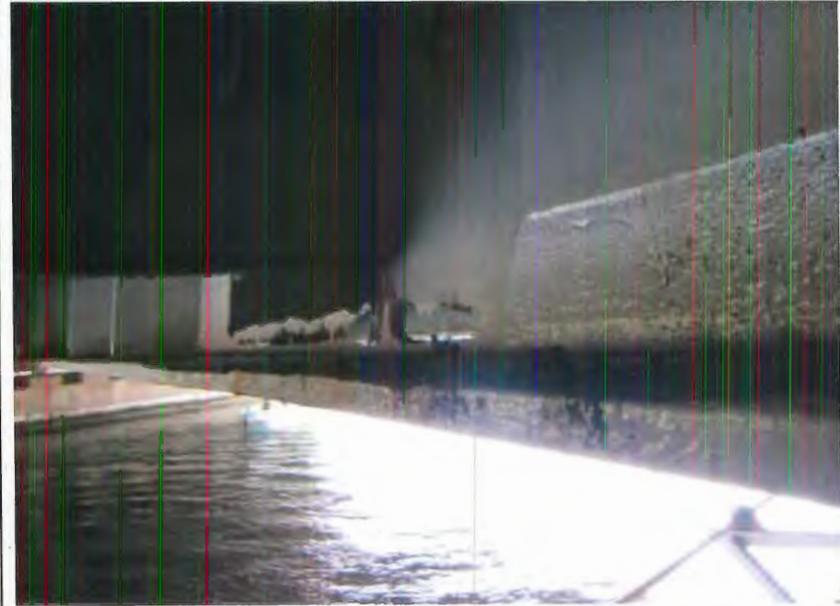
Photo #40 :
Span 3, girder 10 hung span near pin & hanger (south line):
Web base and stiffener with section loss and rusted through holes. Note the section loss to the girder bottom flange.

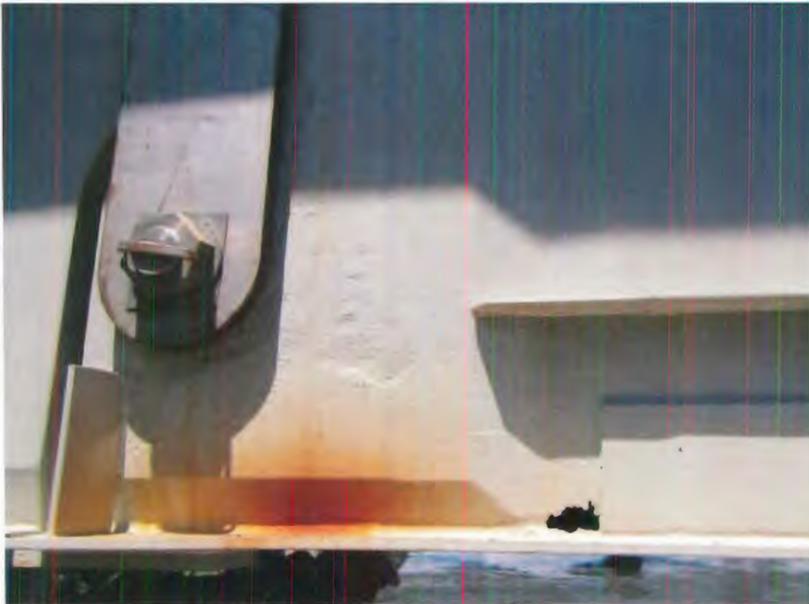
Photo #41 :
Span 3, girder 18 at the pin & hanger (south line, east elevation): Hung section of girder with repair plate and rusted through hole at the base of the web. Also note the typical pitting in the thickened portion of the web around the pin and hanger assemblies.

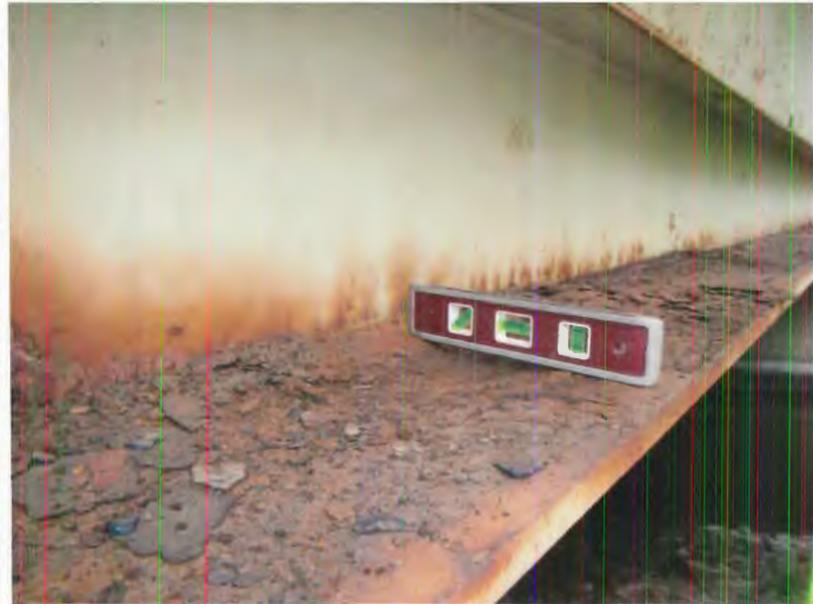
Photo #42 :
Span 2, girder 18: Up to 9/16" deep section loss to the outside leg of the girder bottom flange.

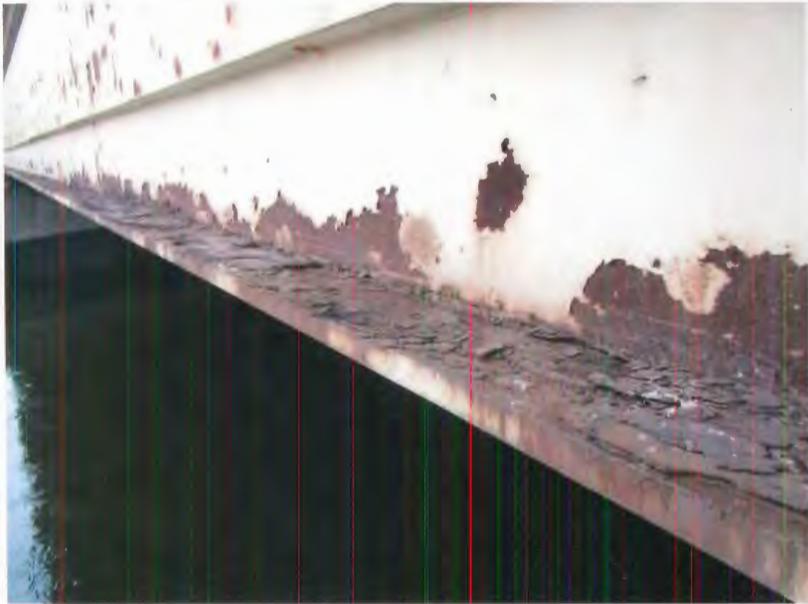
Photo #43 :
Span 3, girder 1 hung span: Laminated rust with section loss along the outside leg of the girder bottom flange near midspan.

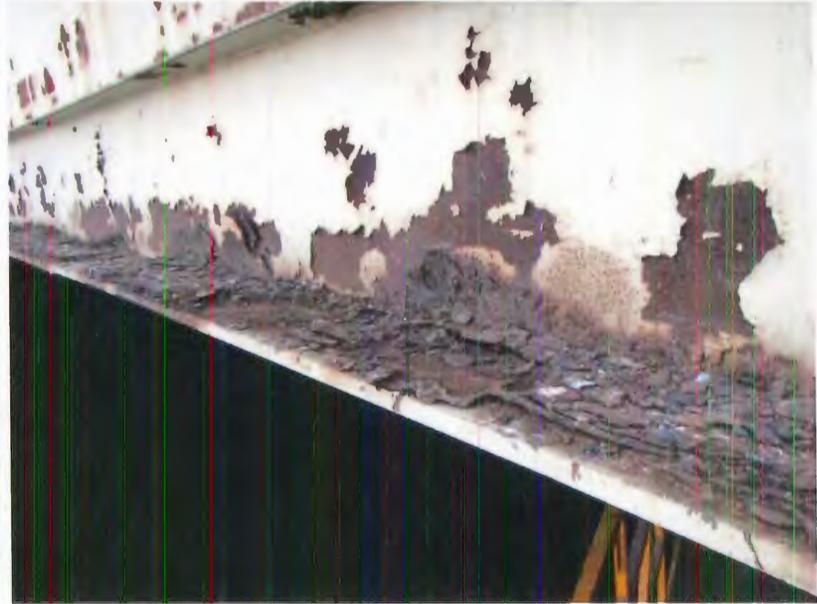
Photo #44 :
Span 3, girder 1 hung span: Laminated with section loss along the outside leg of the girder 1 bottom flange between the pin and hanger (south line) and the first transition.

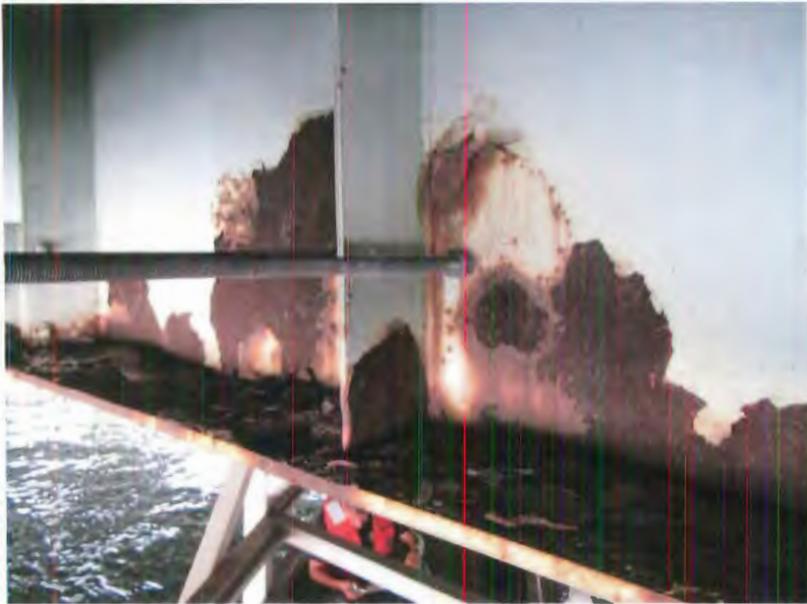
Photo #45 :
Span 3, girder 10 hung span: Laminated rust and section loss to the base of the web and bottom flange between the fixed hinge (north line) and first transition at the east elevation of the girder.

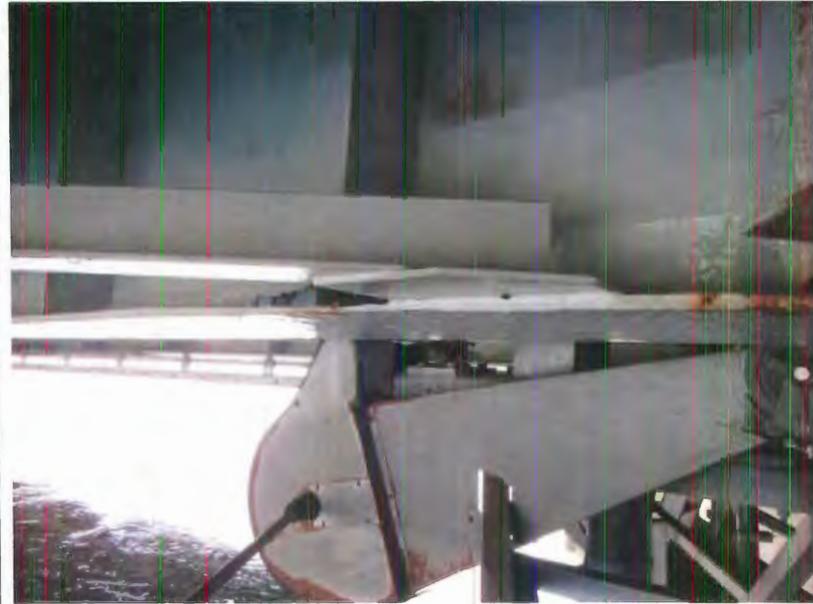
Photo #46 :
Span 3, bay 8, south end of hung span: New lateral bracing member has been installed since the last inspection.

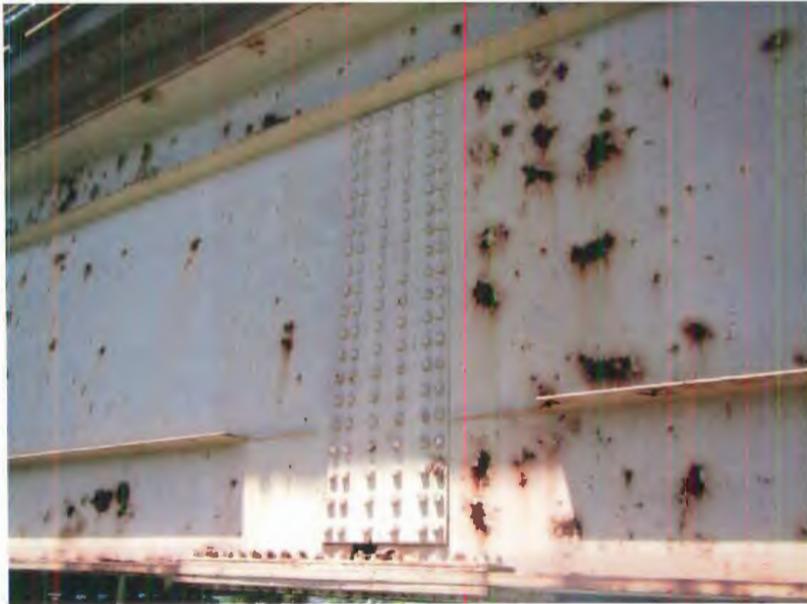
Photo #49 :
Span 3, girder 18, east elevation: Partial height bolted splice/repair along the web and bottom flange.

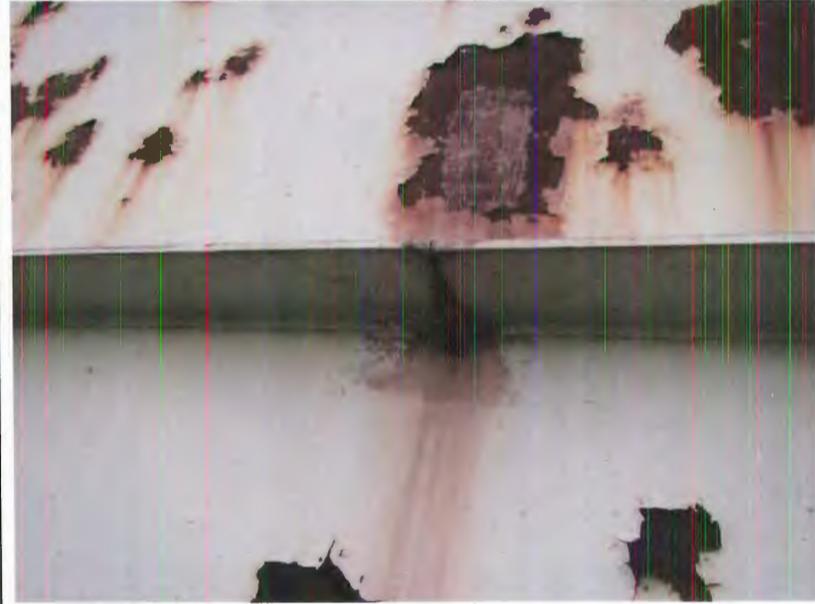
Photo #50 :
Span 3, girder 1 near mid-span: Cracked longitudinal stiffener butt weld. Note the stop hole drilled in the girder web, just below the stiffener butt weld.

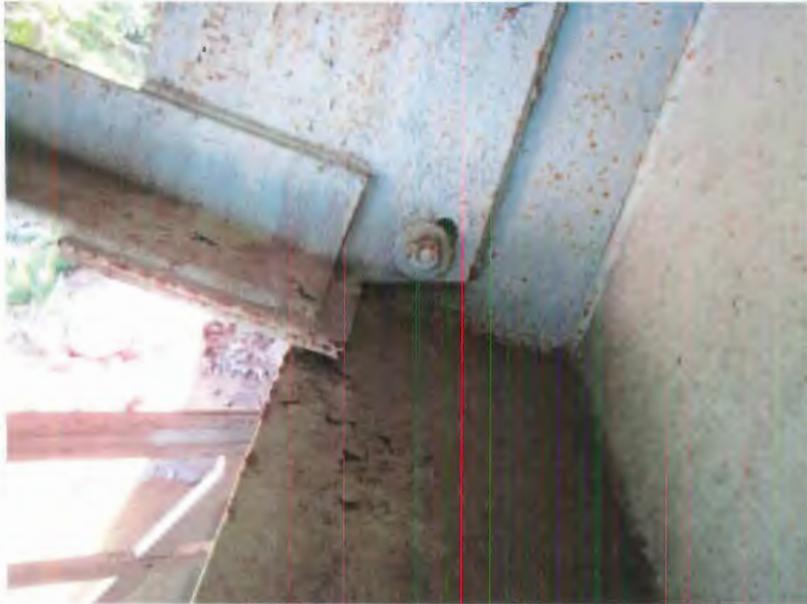
Photo #51 :
Span 2, girder 16, east elevation near pier 2: Missing weld between the girder bottom flange and the diaphragm lower horizontal gusset plate.

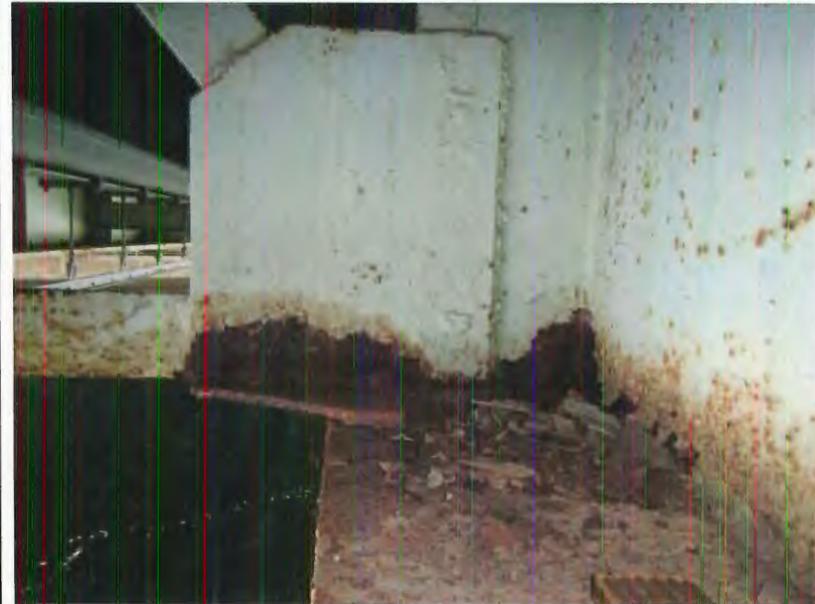
Photo #52 :
Span 3, girder 13, west elevation: Cracked return weld between the girder bottom flange and the edge of the diaphragm horizontal gusset plate at the first intermediate diaphragm north of the south hanger line. Also note the plug welded bolt holes in the vertical connection plate.
