STRUCTURE NO. 03093

INTERSTATE 91
over
N FRONT ST & QUINN RIVER
New HAVEN

Routine Inspection
on
6/16/2014

**BRIDGE NO. 03093
INTERSTATE 91**

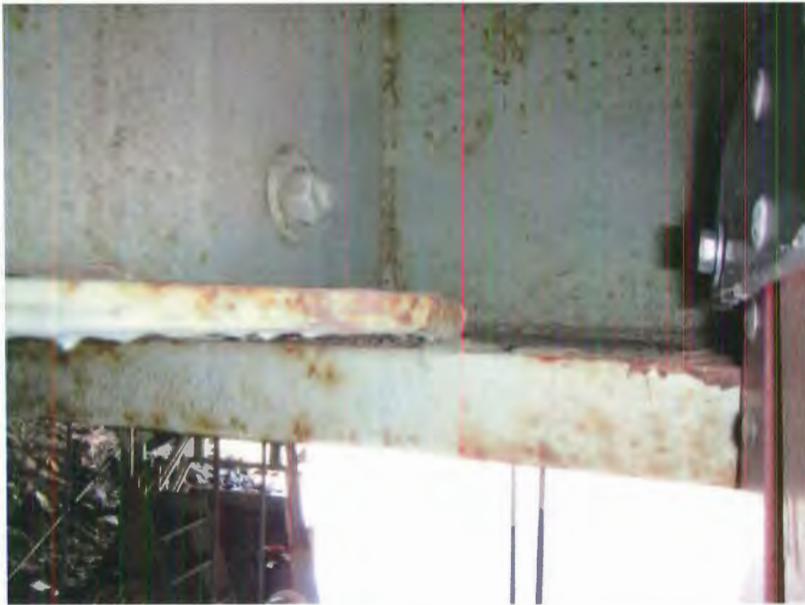
Photo #53 :
Span 4, girder 9, west elevation: Impacted rust/gap between the girder bottom flange and the horizontal gusset plate at second intermediate diaphragm from the north abutment. Note that the return weld between the plate and flange is not fused/broken.

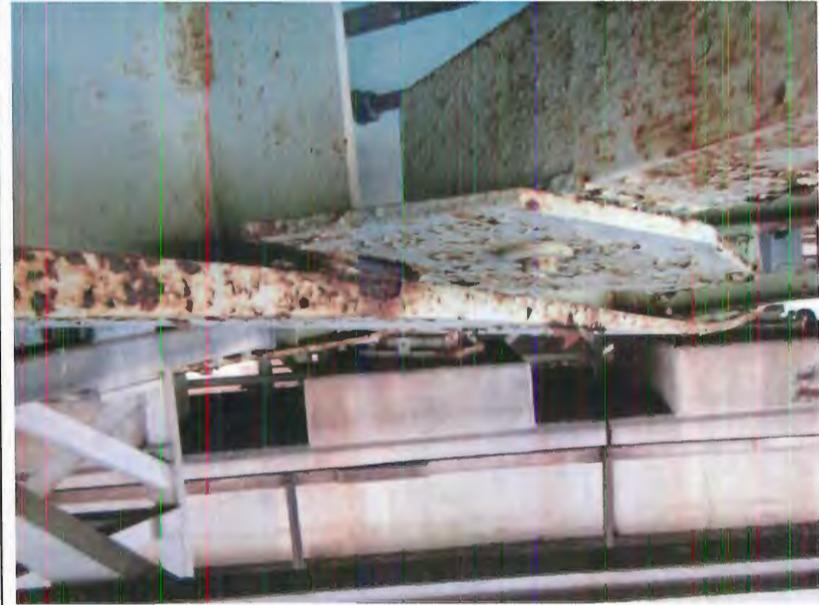
Photo #54 :
Span 3, girder 9, west elevation: Missing weld and up to 7/8" impacted rust between the girder bottom flange and the lateral bracing horizontal gusset plate at the second lateral bracing connection from pier 2.

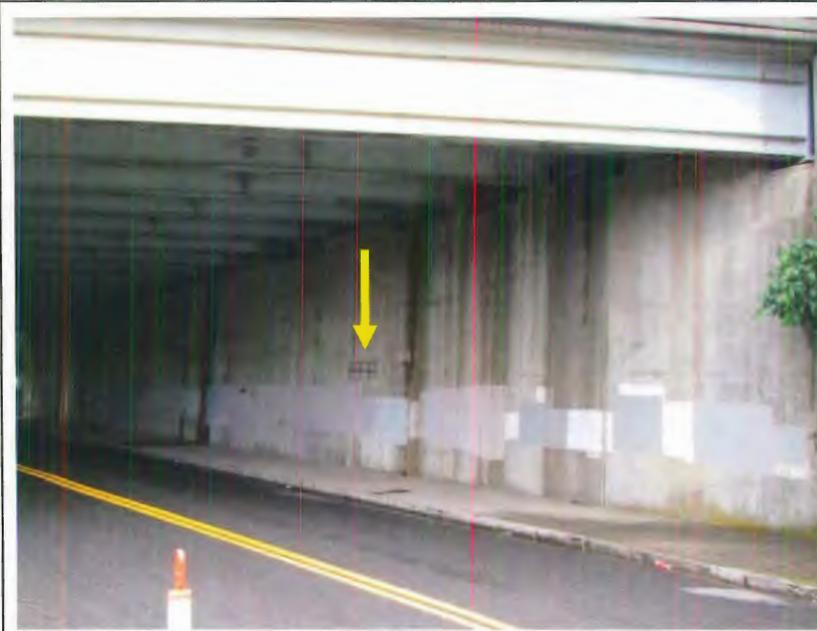
Photo #59 :
 South abutment, typical. Note the area with the exposed rebar that was prepared for repair, but repair not completed. Also note the active joint leakage.

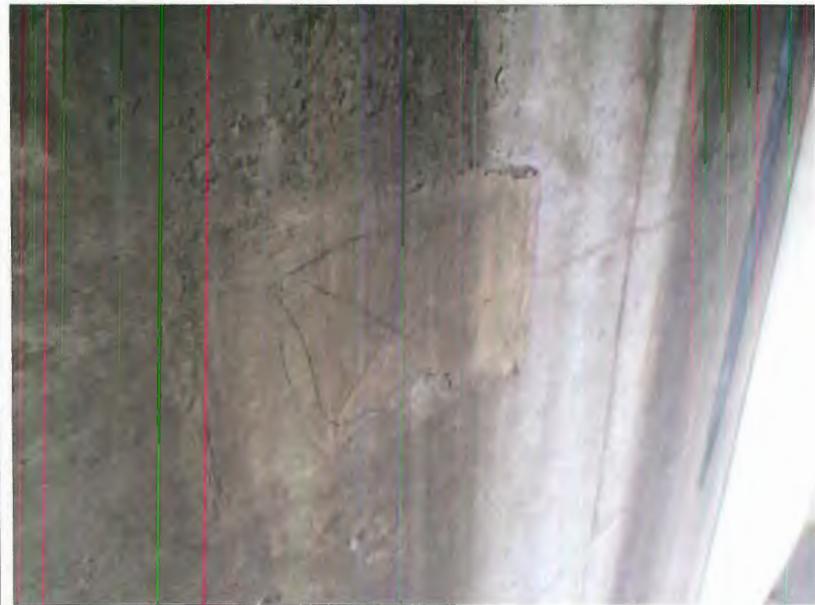
Photo #60 :
 South abutment stem, bay 3: Hollow area in the stem adjacent to a sidewalk.

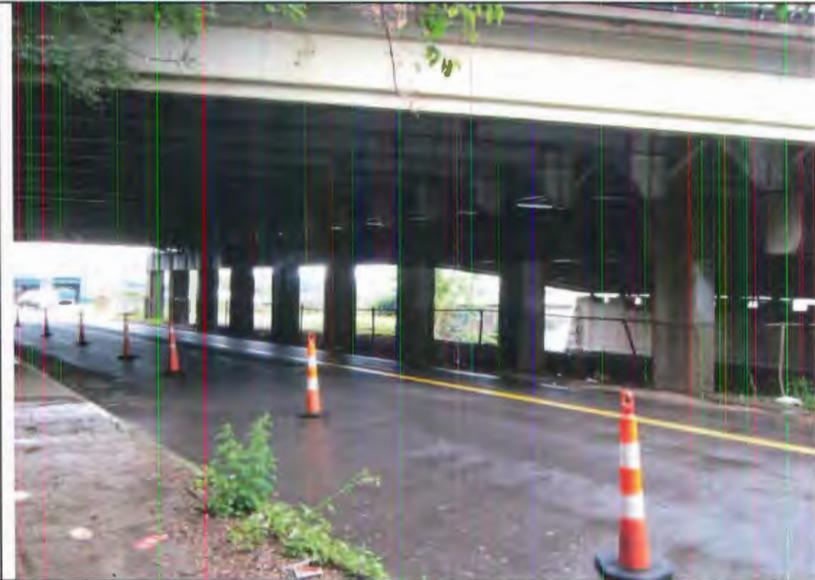
Photo #64 :
Pier 1, south elevation, typical. Note the active joint leakage.

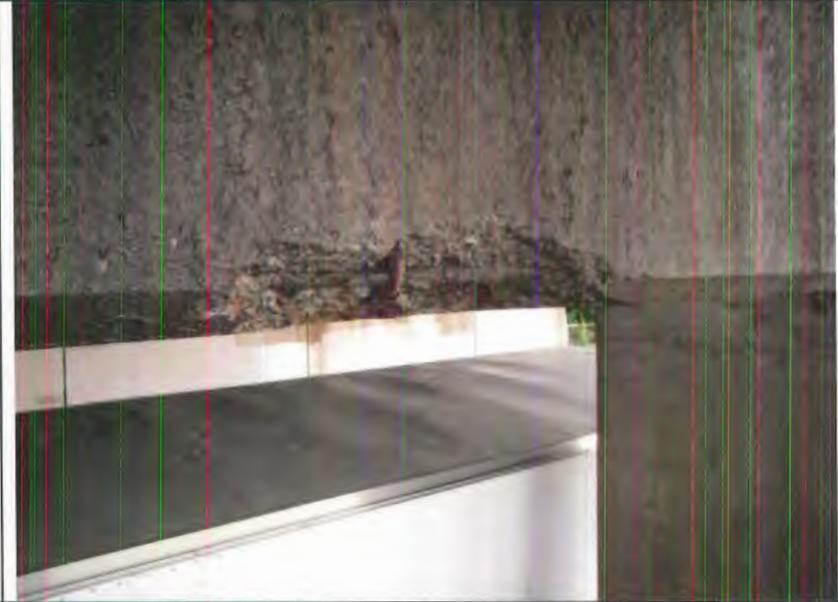
Photo #66 :
 Pier 1, north elevation: Spall with exposed rusted rebar in the pier cap between girders 3 & 4.

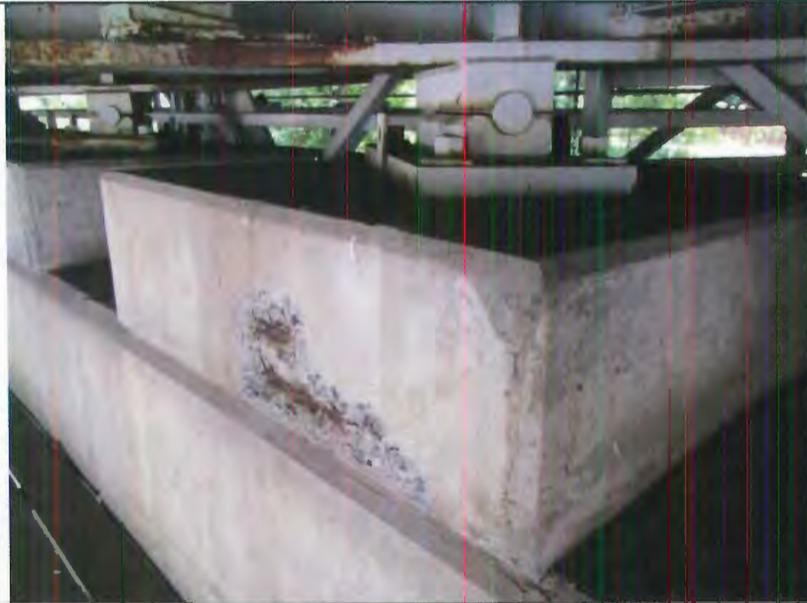
Photo #67 :
Pier 2, north elevation: Spall with exposed rebar in the girder 9 pedestal.

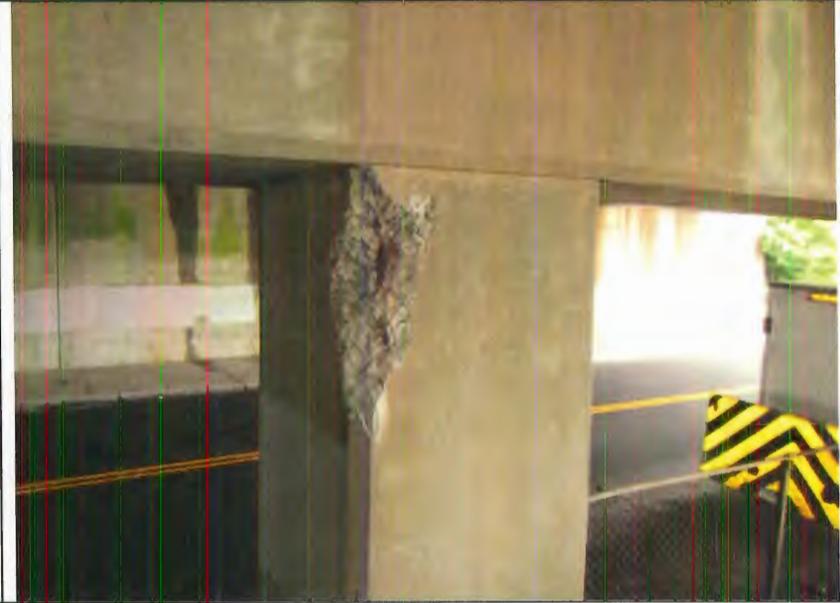
Photo #68 :
Pier 1, column 4, north elevation: Large spall with exposed rebar.

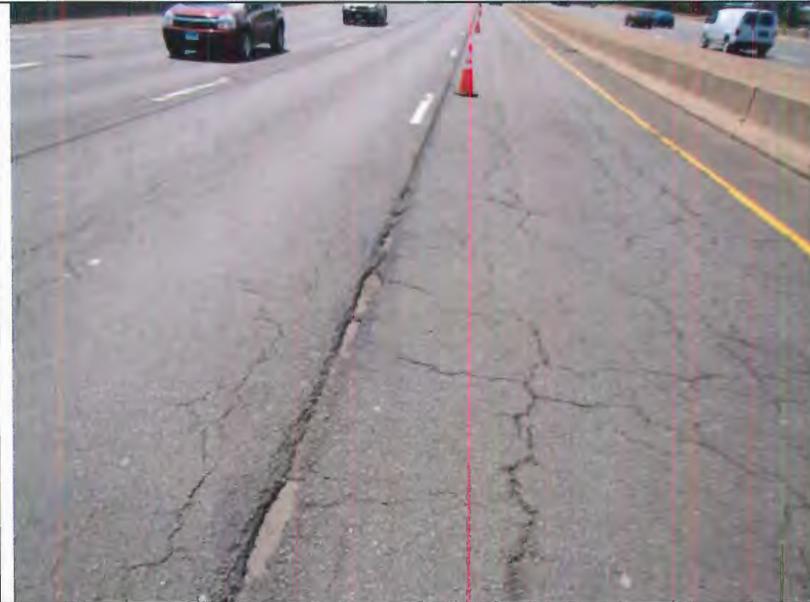
Photo #73 :
North approach pavement, northbound: Heavy map cracking throughout and raveling along the paving seams.

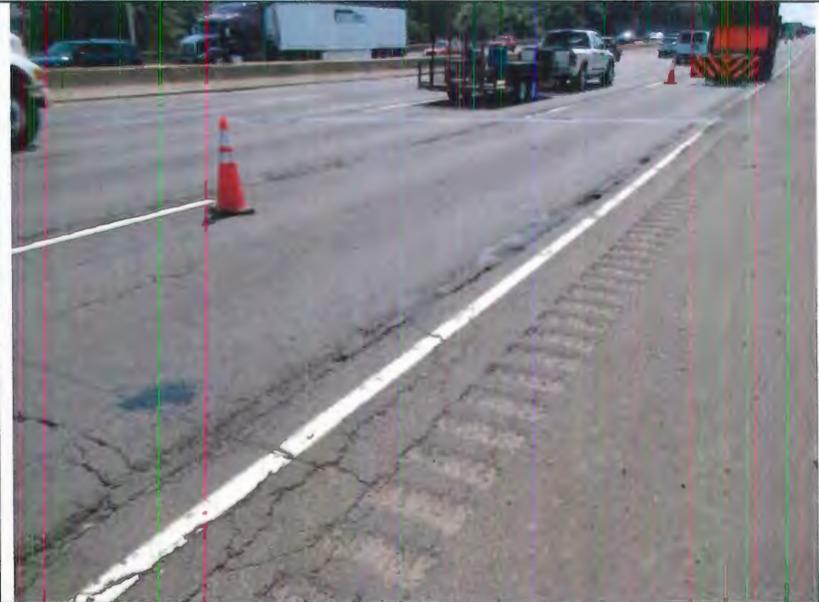
Photo #74 :
North approach pavement, southbound: Map cracking throughout and raveling, potholes, and settled patches along the paving seams.

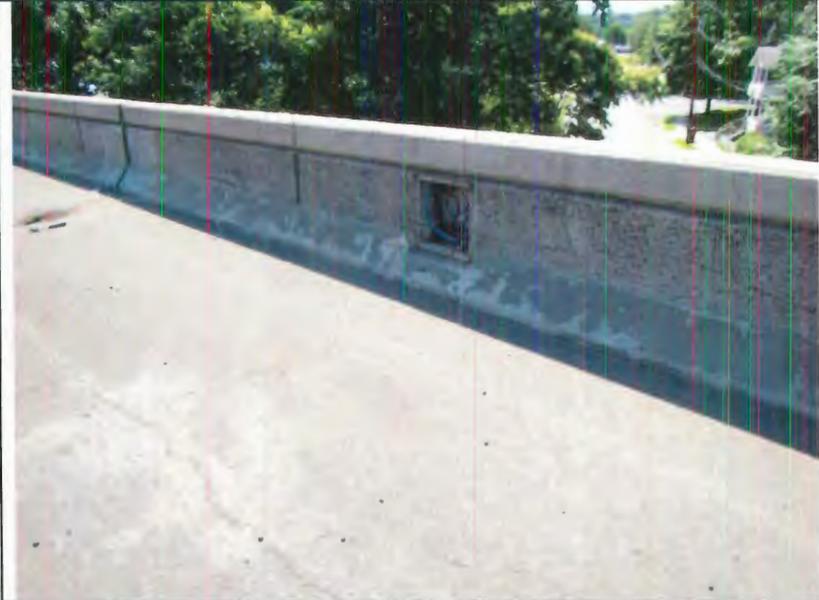
Photo #76 :
 Span 1, east parapet, northbound: Missing junction box cover with exposed wires.
