Cherry Brook Primary School

Roof Evaluation and Replacement Recommendations

4 Barbourtown Road,
Canton, Connecticut 06019

November 5, 2015

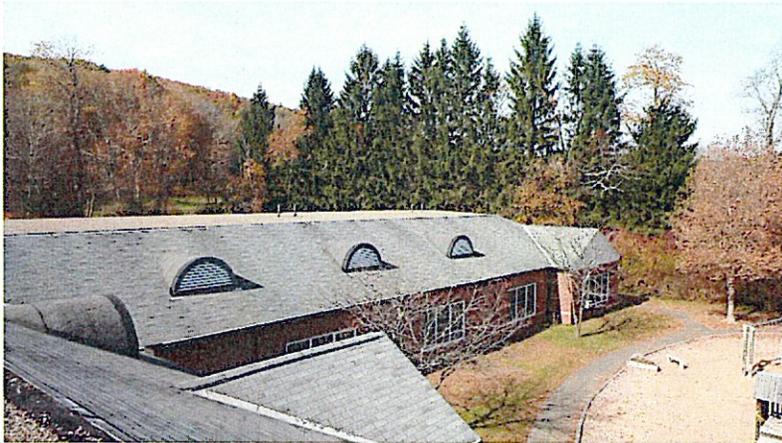
The Asphalt Shingle Roofs at the Cherry Brook School are generally in poor condition and showing signs of accelerated wear, while the shingle roof areas appear to be vented properly, with soffit vents located at the eave of the roofs & with a continuous ridge vent located at the top of the roofs. The existing three tab shingles appear to be reaching the end of their useful life & will need to be replaced soon. This is evident by the shingles discoloration in areas that have received the most sun exposure as well as have become brittle indicating that the asphalt shingle roofs have reached the end of their useful life. There are a few areas, where patching has occurred in order to prevent water penetration into the building. These are signs that the ability of the Asphalt Shingle Roofing system to consistently stop water infiltration into the building's interior has been compromised.

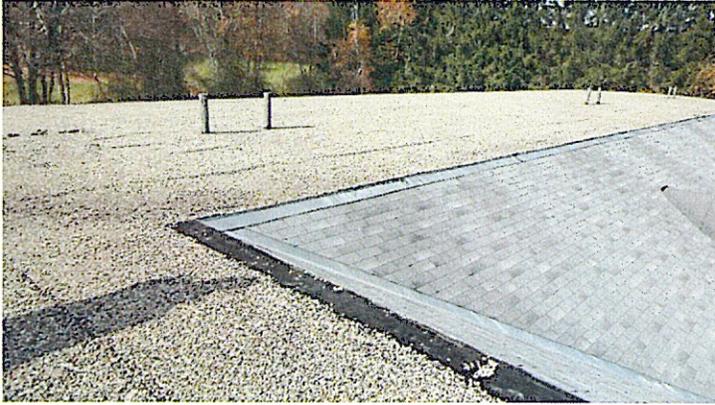
The ballasted (BUR) roof areas are of similar condition, these areas appear to be of similar if not worse condition than the shingled roof areas. We have observed within the flat areas that the asphalt based roofing material has begun to blister. This reaction is a result of prolonged exposure from the elements, the age of the roof, the constant expansion and contraction that happens naturally with the change of the seasons. The BUR roof will continue to deteriorate rapidly in direct sunlight and in the presence of standing water. There does not appear to be areas of direct failure which would be indicated by a noticeable repair work, however we feel that the flat areas have also reached the end of their useful life and are in need of replacement.

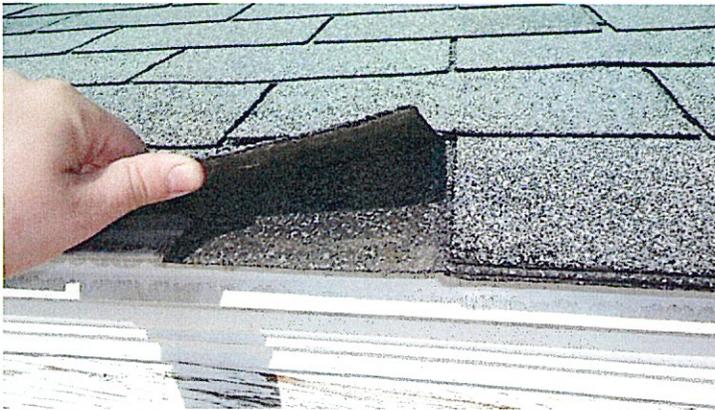
The Cherry Brook School was originally constructed in 1941, with a renovation and addition project completed in 1994. The one-story facility's construction consists of wood and metal super structures and of wood metal roof decking. The wood roof decks were observed at random locations from below and did not show any signs of significant staining that would indicate prolonged exposure to water. Without extensive demolition, it would not be possible to perform a full inspection of the existing decks, but due to the age of the roof, it is possible that small sections of the wood roof decking may need to be replaced at the time of the roof replacement. The most conservative and recommended approach would be to provide an allowance for a percentage of wood decking replacement as part of the overall roof replacement project.

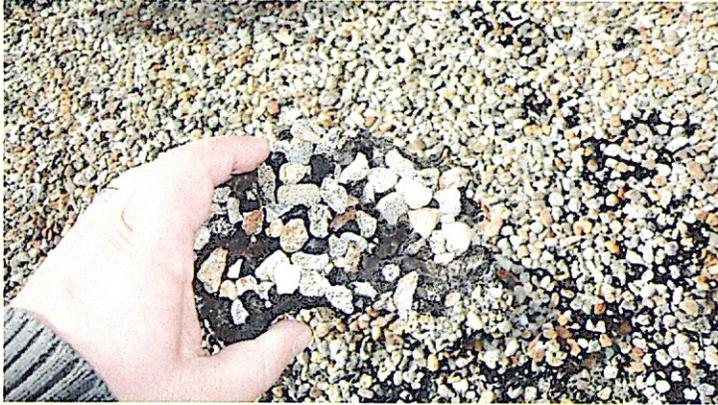
The existing sloped asphalt shingle roof areas do not contain any rooftop mechanical equipment or exhaust fans, and the existing ballasted roofs also do not contain any rooftop mechanical equipment or exhaust fans, however there are multiple vent stack locations throughout the roof area. The roofs at the Cherry Brook School consist of one large sloped asphalt shingle roof area totaling 22,753 SF., and one large area of BUR roof area totaling 11,587 SF., The existing drainage system consists of two variations of drainage, all of the flat roof area has been constructed with an existing slope within the structure that empty's on to the sloped roof areas. The sloped asphalt shingle roofs have had a metal gutter system installed that also has been piped to an external underground drainage system.
