Subject: On-Call Asbestos, Lead, Air Quality & Demolition Compliance  
Agreement No. 04.27-01(15)  
HazMat Inspection - Bridge No. 01766, I-84 WB over Amtrak & Local Roads, Hartford,  
CT  
ConnDOT Assignment No. 514-5229  
ConnDOT Project No. 63-701  
TRC Project No. 222165.5229.0710

TRC performed a limited survey for hazardous building materials associated with the rehabilitation of Bridge No. 01766 in Hartford, Connecticut. Results of the survey identified lead paint to be present on the structural steel/metal bridge components (0.1 mg/cm<sup>2</sup> and 0.13% by weight) of Bridge No. 01766. Results obtained from TCLP waste stream sampling and analysis for leachable lead from the paint on the structural steel/metal bridge components (12 mg/L) characterized the paint waste stream at Bridge No. 01766 as EPA RCRA/CTDEEP hazardous waste. Dark gray caulking on the abutment wall and black railing support pad were sampled and found to contain no asbestos. No bird/pigeon guano accumulations were observed around in accessible areas of the bridge. Homeless activity was observed at Bridge No. 01766, including but not limited to bedding and trash with potential for sharps which could conta

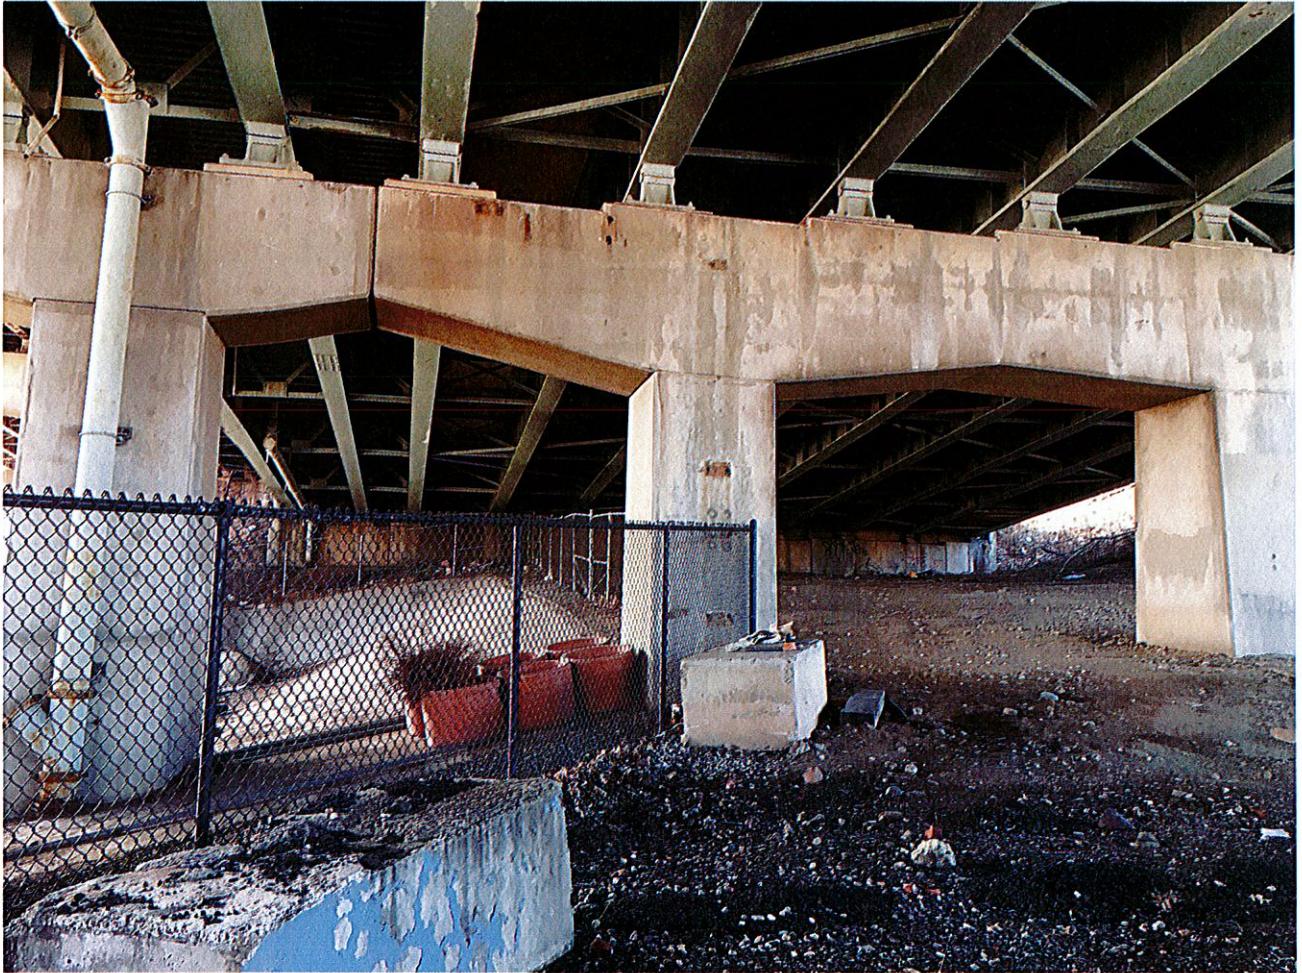
**PHOTO 1**  
Bridge #01766 Underside View
