PRE-RENOVATION INVESTIGATIVE SURVEY FOR HAZARDOUS BUILDING MATERIALS

**SOUTHINGTON MAINTENANCE FACILITY
476 MULBERRY STREET
SOUTHINGTON, CONNECTICUT
Project No. 131-205**

**State of Connecticut
Department of Transportation**
Newington, Connecticut

Issued
March 2016

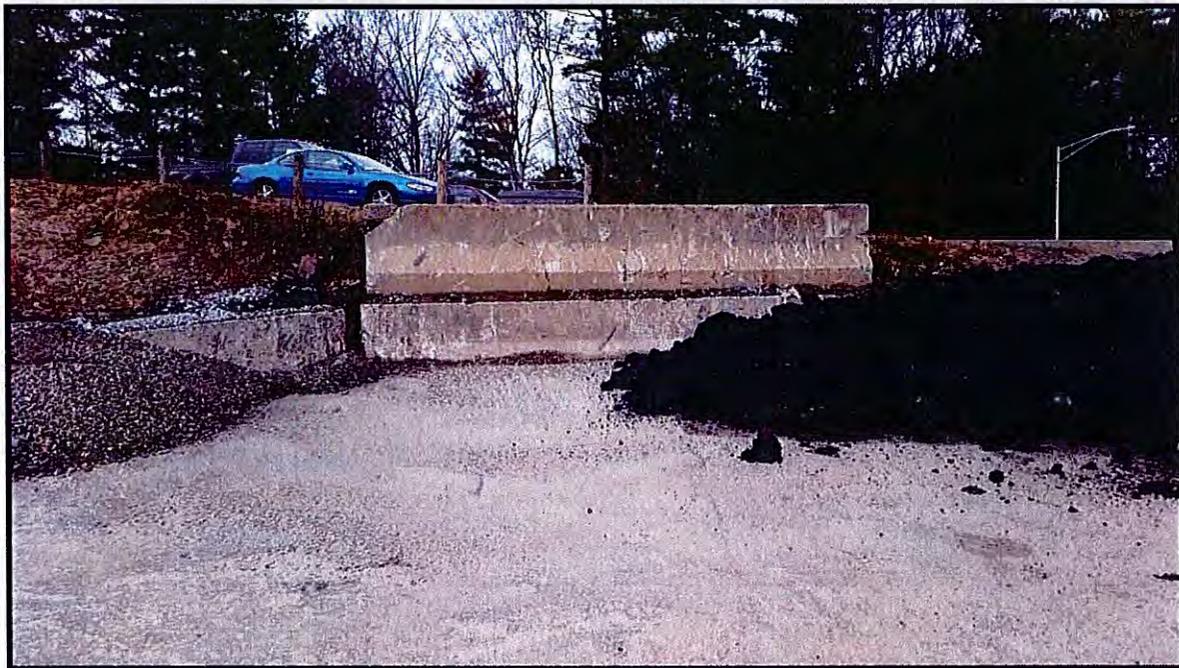
PHOTO 46. Retaining Wall To Be Removed.

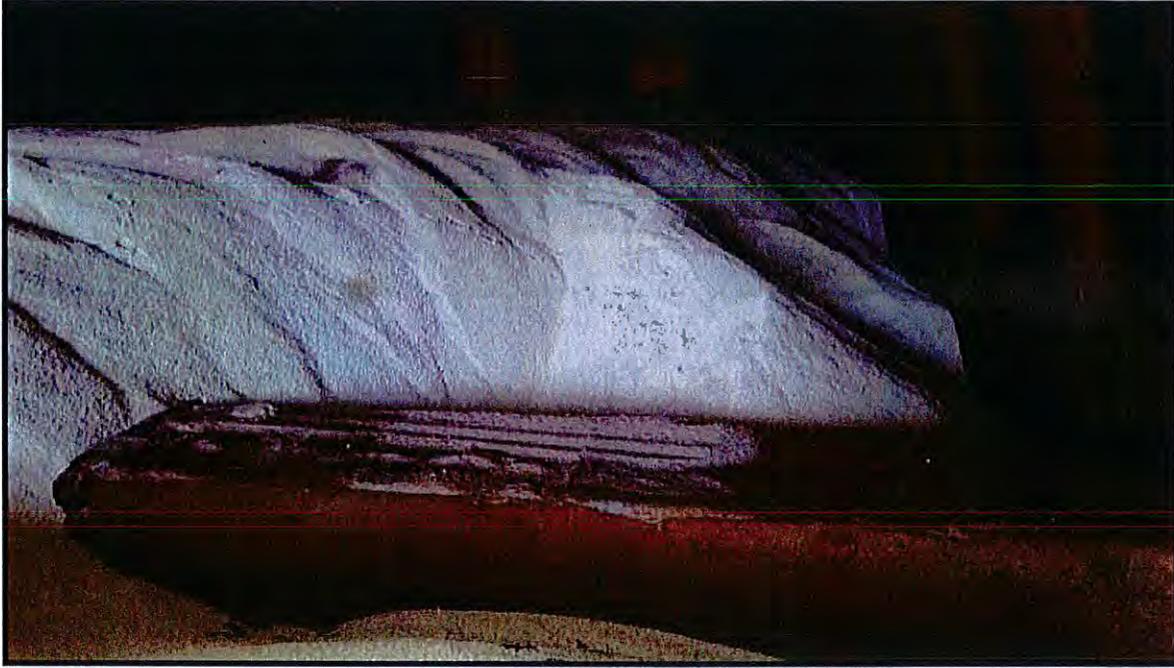
PHOTO 47. Salt Shed Wall to be Removed.

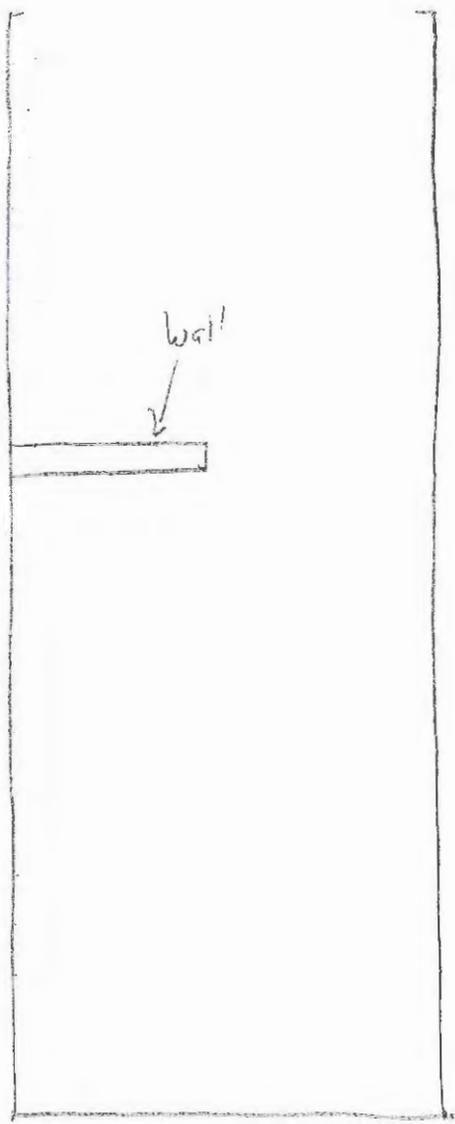
Salt Shed

Wall - only top foot of wall exposed at time of inspection - Rest buried in salt.

Wall wrapped in timber with ply wood cap - under cap was loose stone fill and solid concrete. No seen between timbers at wall of the actual walls of Salt Shed.
