NEPA ENVIRONMENTAL REVIEW REPORT

**Community Development Block Grant – Disaster Recovery
Owner Occupied Rehabilitation and Rebuilding Program**

**Site ID No. 5096
253 Adams Street
Bridgeport, Connecticut**

March 2016

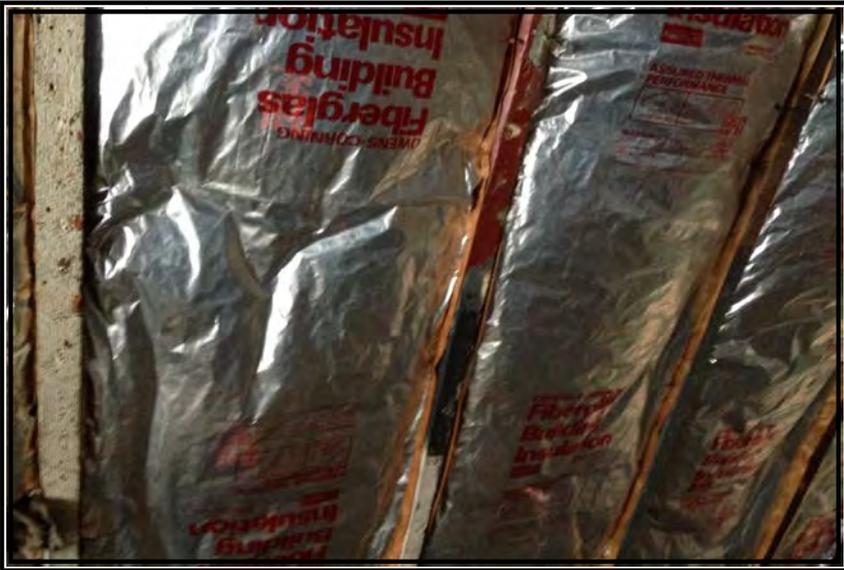
Initial XRF testing completed for the work zone identified lead-based paint on the exterior soffits surrounding the roofs and on the rafters in the attic. In addition, a lead risk assessment was performed in accordance with 24 CFR Part 35.1320. During the completion of the proposed work activities, if the lead-based paint is disturbed or deteriorated, lead-containing materials should be abated in accordance with local, state, and federal regulations including, but not limited to, *Housing and Urban Development – Lead-Based Paint Poisoning Prevention in Certain Residential Structures – Rehabilitation Regulations (24 CFR 35(J))* as well as the EPA's Renovation, Repair, and Painting Rule (RRP) of 40 CFR Part 745.

Photograph 1
Lead-containing red paint on attic rafters

3. Lead-Based Paint - Based on the work zone lead inspection, lead paint was identified within the work zone (soffits and attic rafters). Given the presence of lead, renovation work that disturbs these surfaces should be completed in accordance with the EPA Renovation, Repair, and Painting (RRP) rule. The contractor should be familiar with where the lead paint is present such that they can take appropriate worker protection under OSHA regulations in 29 CFR. The lead hazard risk assessment also identified a lead hazard associated with exterior trim, porch floors, interior ceilings and walls, floorings, window troughs and sills, dripline soils, front garden soils near porch, exterior doors, and porch floors. Upon review of the hazard control options listed in Section 3.1.2.5, a site-specific lead hazard control plan should be developed and implemented. Notification of these lead hazards should be made to the homeowner and occupants within 15 days. Clearance testing will be performed by Triton following the work. If any of the lead-containing deteriorated painted surfaces or soils are to be disturbed during the rehabilitation work, abatement of the lead hazard should occur (versus interim controls). All debris generated during the implementation of the interim controls/abatement must be properly characterized via TCLP testing and disposed of at appropriately permitted facilities.

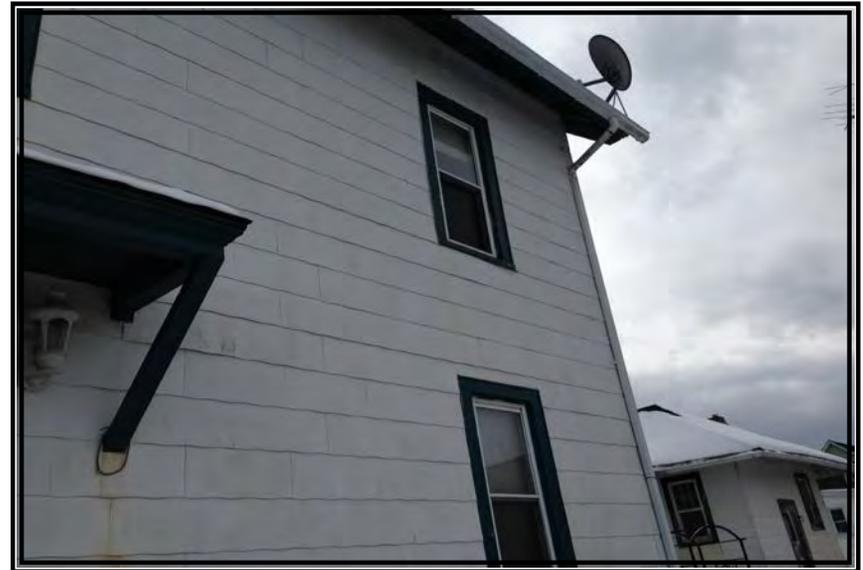
Photograph 2
Lead-containing green paint on roof soffit

Interim controls are allowed for exterior components only if the components are not disturbed by the rehabilitation. Therefore, if lead paint on the roof soffits are disturbed or deteriorated, full abatement will be needed. Lead-containing materials should be abated in accordance with local, state, and federal regulations including, but not limited to, *Housing and Urban Development – Lead-Based Paint Poisoning Prevention in Certain Residential Structures – Rehabilitation Regulations (24 CFR 35(J))*.

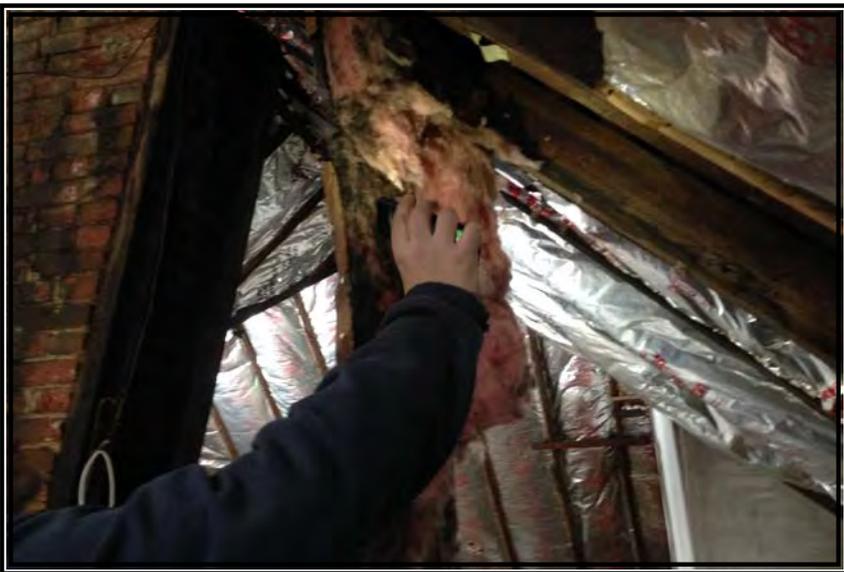
Triton completed a visual mold inspection of the work area on February 10, 2016. Mold was observed on wood components and within the insulation of the attic. It is anticipated that these materials will be disturbed during the replacement of the roof. Photographs of the apparent mold are provided in Appendix B.

Mold was observed within the work zone on the wooden rafters of the attic and on insulation in the attic. Mold may be present in other interior areas that could not be observed

Photograph 3
Mold on insulation in attic

5. Mold - Mold was observed on wood components and within the insulation of the attic, and may be present in areas that could not be observed during the inspection (i.e. behind walls). Additional mold impacted surfaces may be encountered during renovation in spaces that were inaccessible or not apparent during the inspection. To protect occupant and worker health, the mold on the roof rafters must be abated by a qualified contractor and the affected insulation should be replaced. Pre-abatement air testing will be completed by Triton to establish a baseline. Triton recommends that a competent person be present during the renovation work who is capable of identifying potential additional suspect materials. General precautions should be taken during the renovation process to avoid the potential spread of mold spores and to mitigate health and safety concerns. Clearance testing will be completed (and compared against the baseline) to evaluate the efficacy of the abatement.

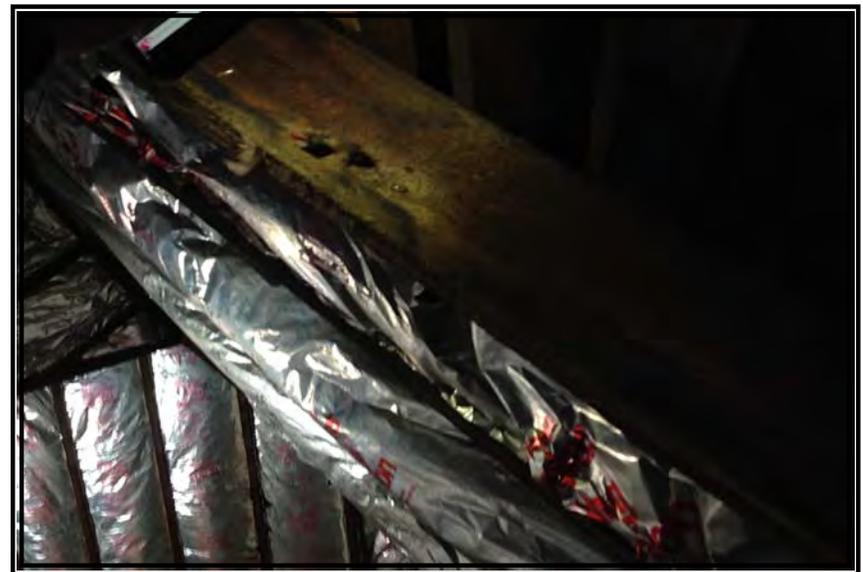
Photograph 4
Mold on rafter in attic
