Subject: On-Call Asbestos, Lead, Air Quality & Demolition Compliance
Agreement No. 04.27-01(15)
HazMat Inspection – Sign Supports at Nine (9) Sites, I-84, Southington, Plainville,
Farmington, & New Britain, CT **(REVISED)**
ConnDOT Assignment No. 514-5214
ConnDOT Project No. 173-304
TRC Project No. 222165.5214.00710

TRC performed a limited survey for hazardous building materials associated with sign support removals at 9 Sites on I-84 in Southington, Plainville, Farmington and New Britain, Connecticut. Results of the survey identified the following on the sign support surfaces at the following Sites:

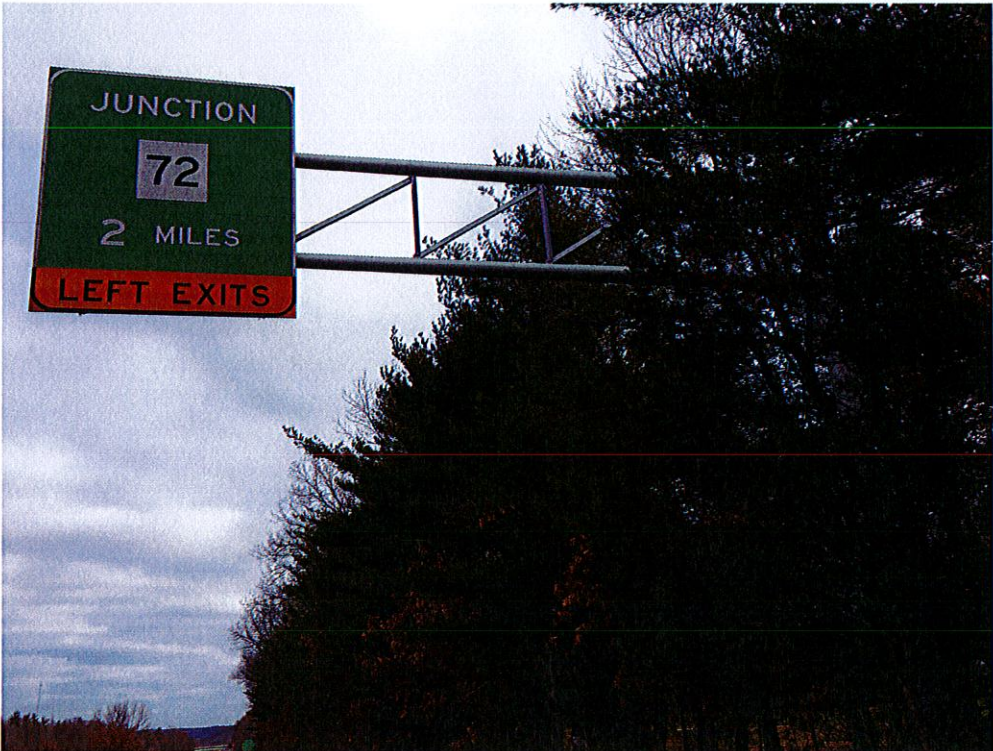
PHOTO 1
Site No. 1 – Sign Support No. 25555

- Detectable amounts of lead in paint were confirmed present at Sign Support Nos. 21555 (Site No. 1), 21563 (Site No. 2), 21572 (Site No. 3), 21696 (Site No. 6), 21699 (Site No. 7), 21700 (Site No. 8) & 21701 (Site No. 9).

- Projected paint waste debris was characterized as non-hazardous, non-RCRA waste at Sign Support Nos. 21555 (Site No. 1), 21563 (Site No. 2), 21572 (Site No. 3), 21692 (Site No. 4), 21696 (Site No. 6), 21699 (Site No. 7), 21700 (Site No. 8) & 21701 (Site No. 9).

- Black tar at the base of the sign support poles at Sign Support Nos. 21699 (Site No. 7), 21700 (Site No. 8) were found to contain asbestos.
- **ACM tan caulking beneath baseplates was identified during the inspections of additional sign support poles/baseplates. Sign Support Nos. 21555 (Site No. 1), 21563 (Site No. 2), 21572 (Site No. 3), 21692 (Site No. 4), 21696 (Site No. 6), 21699 (Site No. 7), 21700 (Site No. 8) & 21701 (Site No. 9) were considered homogeneous to the additional poles inspected and are therefore presumed to have the same ACM tan caulking beneath the baseplates as well.**

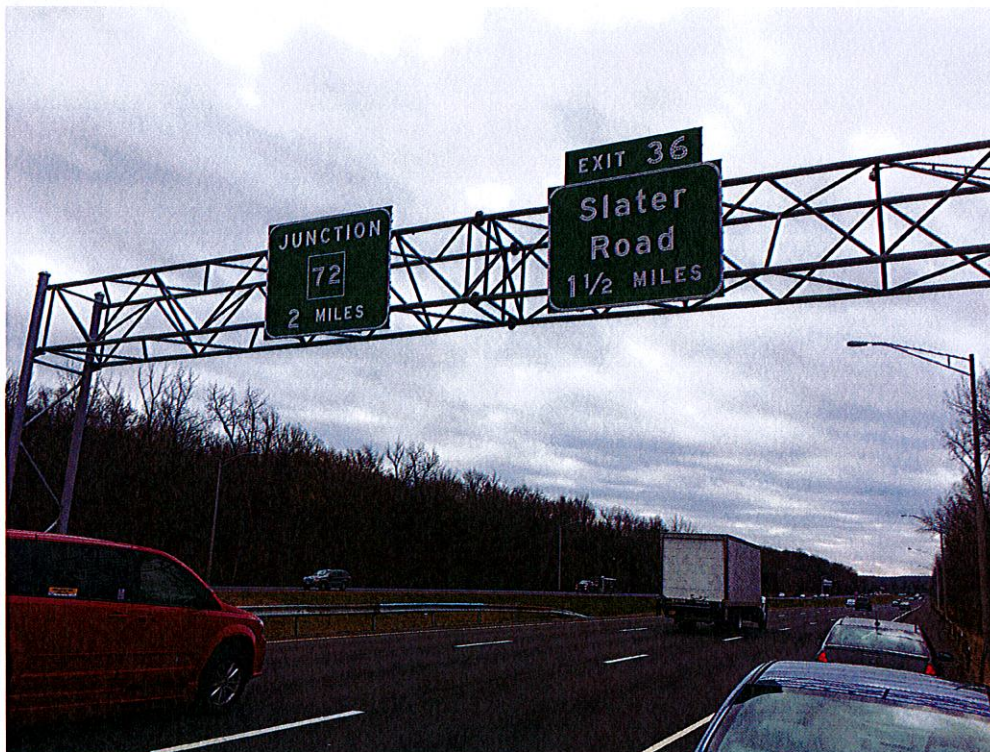
PHOTO 4
Site No. 4 – Sign Support No. 21692

- No detectable amounts of lead were identified at Sign Support No. 21692 (Site No. 4).
- Any paint on the sign support at Sign Support No. 21570B (Site No. 5) is presumed as lead paint (inaccessible).

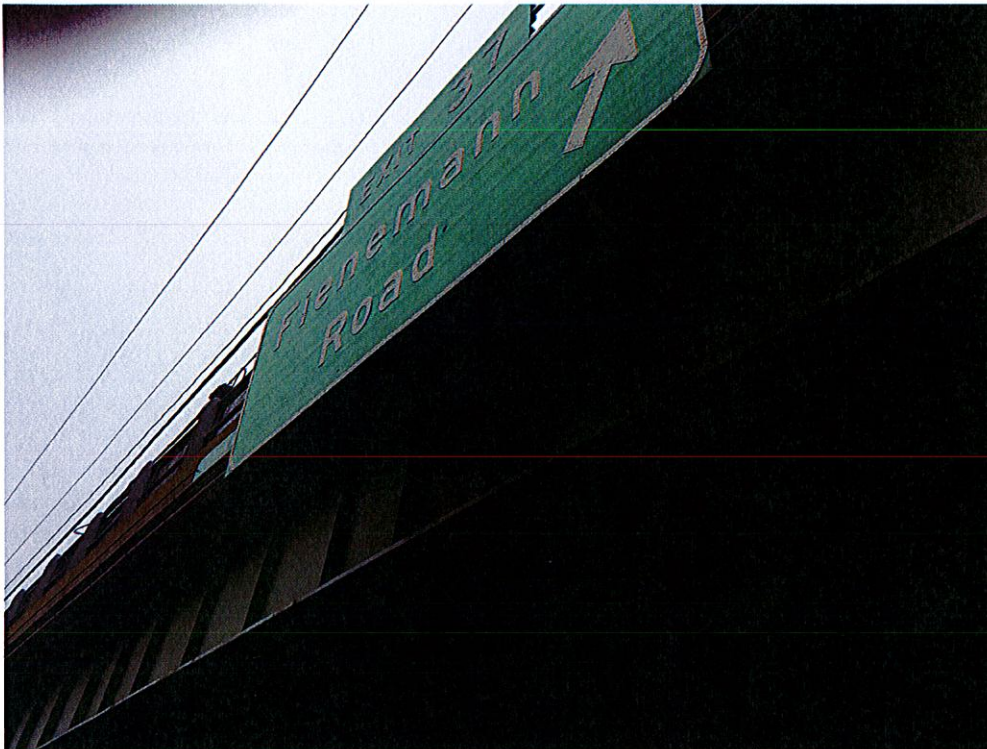
PHOTO 5
Site No. 5 – Sign Support No. 21570B

- Any paint waste debris to be generated at Sign Support No. 21570B (Site No. 5) is presently presumed as EPA RCRA/CTDEEP hazardous waste pending actual characterization testing when accessible.
