Subject: On-Call Asbestos, Lead, Air Quality & Demolition Compliance  
Agreement No. 04.27-01(15)  
HazMat Inspection - Bridge Nos. 03330/03331, Route 349 NB/SB over Amtrak, Groton, CT  
ConnDOT Assignment No. 514-5275  
ConnDOT Project No. 58-332  
TRC Project No. 222165.5275.0710

TRC performed a limited survey for hazardous building materials associated with the rehabilitation of Bridge Nos. 03330/03331 in Groton, Connecticut. The concrete decking/support beams and metal railing (galvanized) of the two bridges were unpainted therefore no lead paint was identified. No detectable amounts of lead paint ( $0.0 \text{ mg/cm}^2/\text{ND} < 0.10\%$  by weight) were identified on the painted concrete abutments/piers of both bridges, therefore any paint waste stream from the concrete abutments/piers would be characterized as non-hazardous non-RCRA waste. Suspect asbestos containing material in the form of gray seam caulking around foot posts of the railings was sampled and found to contain asbestos. Suspect asbestos containing material in the form of black expansion joint coating found along road seams and black tar coating on abutments and embankments were sampled and found to contain n

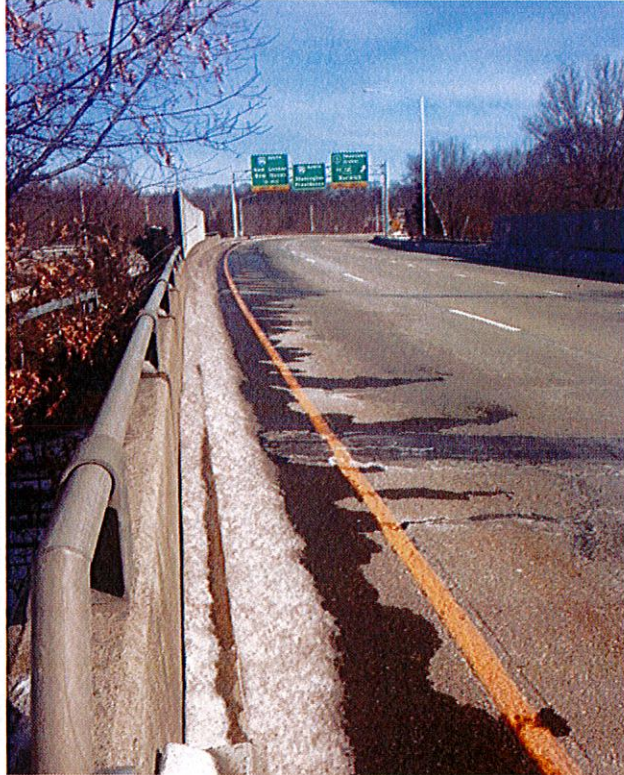
**PHOTO 1**  
Bridge 03331 - Roadside

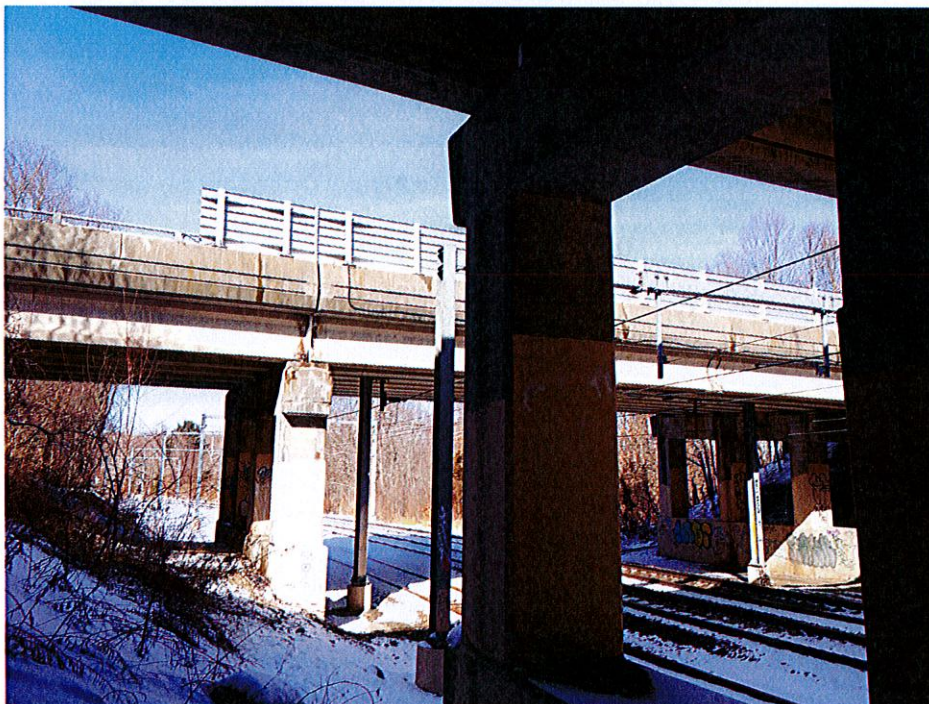
**PHOTO 2**  
Bridge 03330/03331 - Sideview

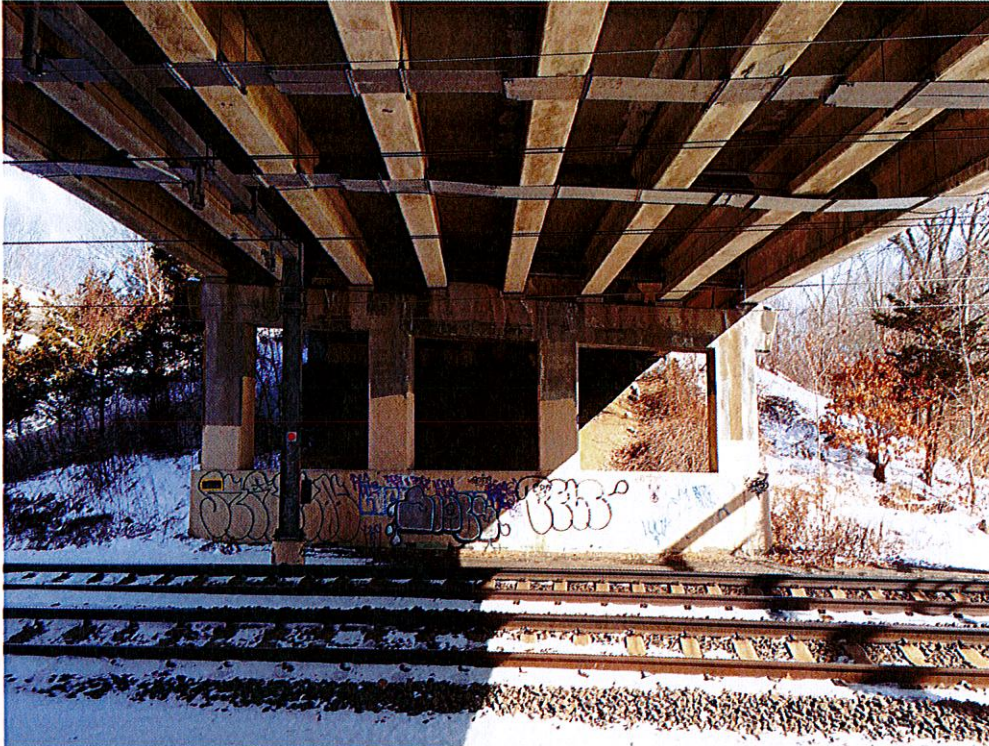
**PHOTO 3**  
Bridge 03331 – Underside (presumed transite panels)

- Concrete decking with concrete support beams
- Possible transite (or metal) plank attached to concrete decking directly above tracks.
  - ↳ \* No safe way to inspect \*
- PVC drainage pipe from road surface (RT 39A)
- Concrete beams sit on rubber pads at bridge abutments

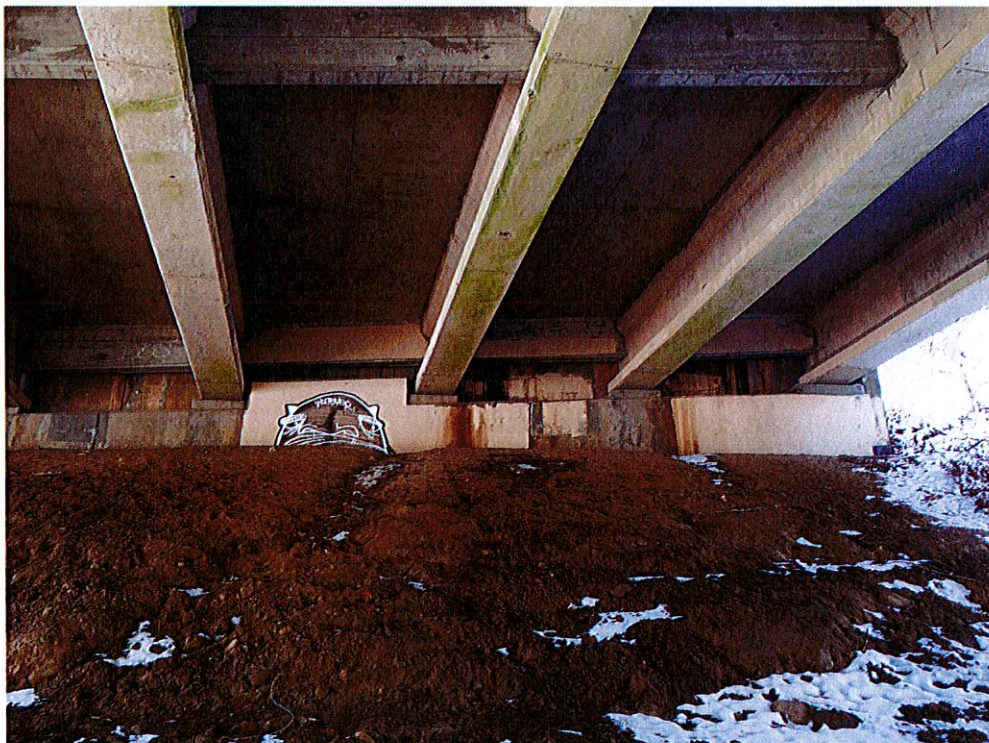
**PHOTO 4**  
Bridge 03331 – Underside (abutment)
