## Regional School District 13 - Facility Utilization Study

## 2.4 Summary of the MEP Analysis Report

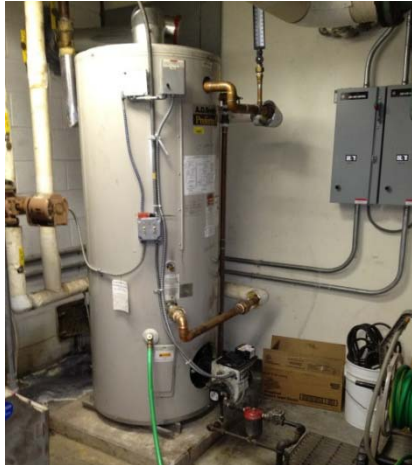
Brewster School's mechanical, electrical, and plumbing systems have served the community well. Many systems are roughly 15-25 years old, with a few more recent

replacements (e.g., the water heater and some site lighting). However, some systems are nearing or past their useful life expectancy: for example, the boilers, heating hot water pumps, administrative air handling system, kitchen hood exhaust system (as well as other exhaust fans), and an inadequate fire protection system; the boilers in particular constitute a code violation. Air flow problems in classrooms create a noise issue, and there is also a need to renovate the problematic roof vent piping near the kitchen, and related systems -- including the air handling units, chiller, ventilators, boiler, and exhaust fans -- will also eventually need

planned replacement. A full-coverage sprinkler system and an emergency generator are needed, and efficiency improvements to some plumbing and electrical systems could result in a reduced carbon footprint and cost savings.

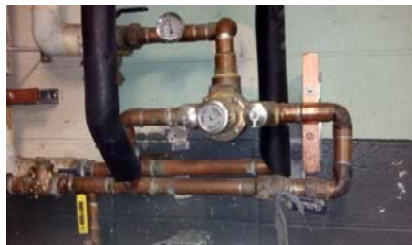
A slightly newer building, Korn School has MEP systems which are mostly about 10-15 years old and generally in good condition. However, some systems are nearing or

past their useful life expectancy: for example, the administrative air handling system and the kitchen hood exhaust system. Other systems are showing wear -- e.g., leaks are developing in the plumbing hydro-tank -- and parts issues also require attention (the need for kitchen grease interceptors, certain plumbing valves, etc.). Related systems including

the air handling units, chiller, ventilators, boiler, and exhaust fans, will also eventually need planned replacement. A full-coverage sprinkler system and an emergency generator are needed, and efficiency improvements to some plumbing and electrical systems could result in a reduced carbon footprint and cost savings.
