## BRIDGE NO.06840

15910 - COLCHESTER  
ROUTE 2  
over  
BROOK

Special Inspection

8/05/2019

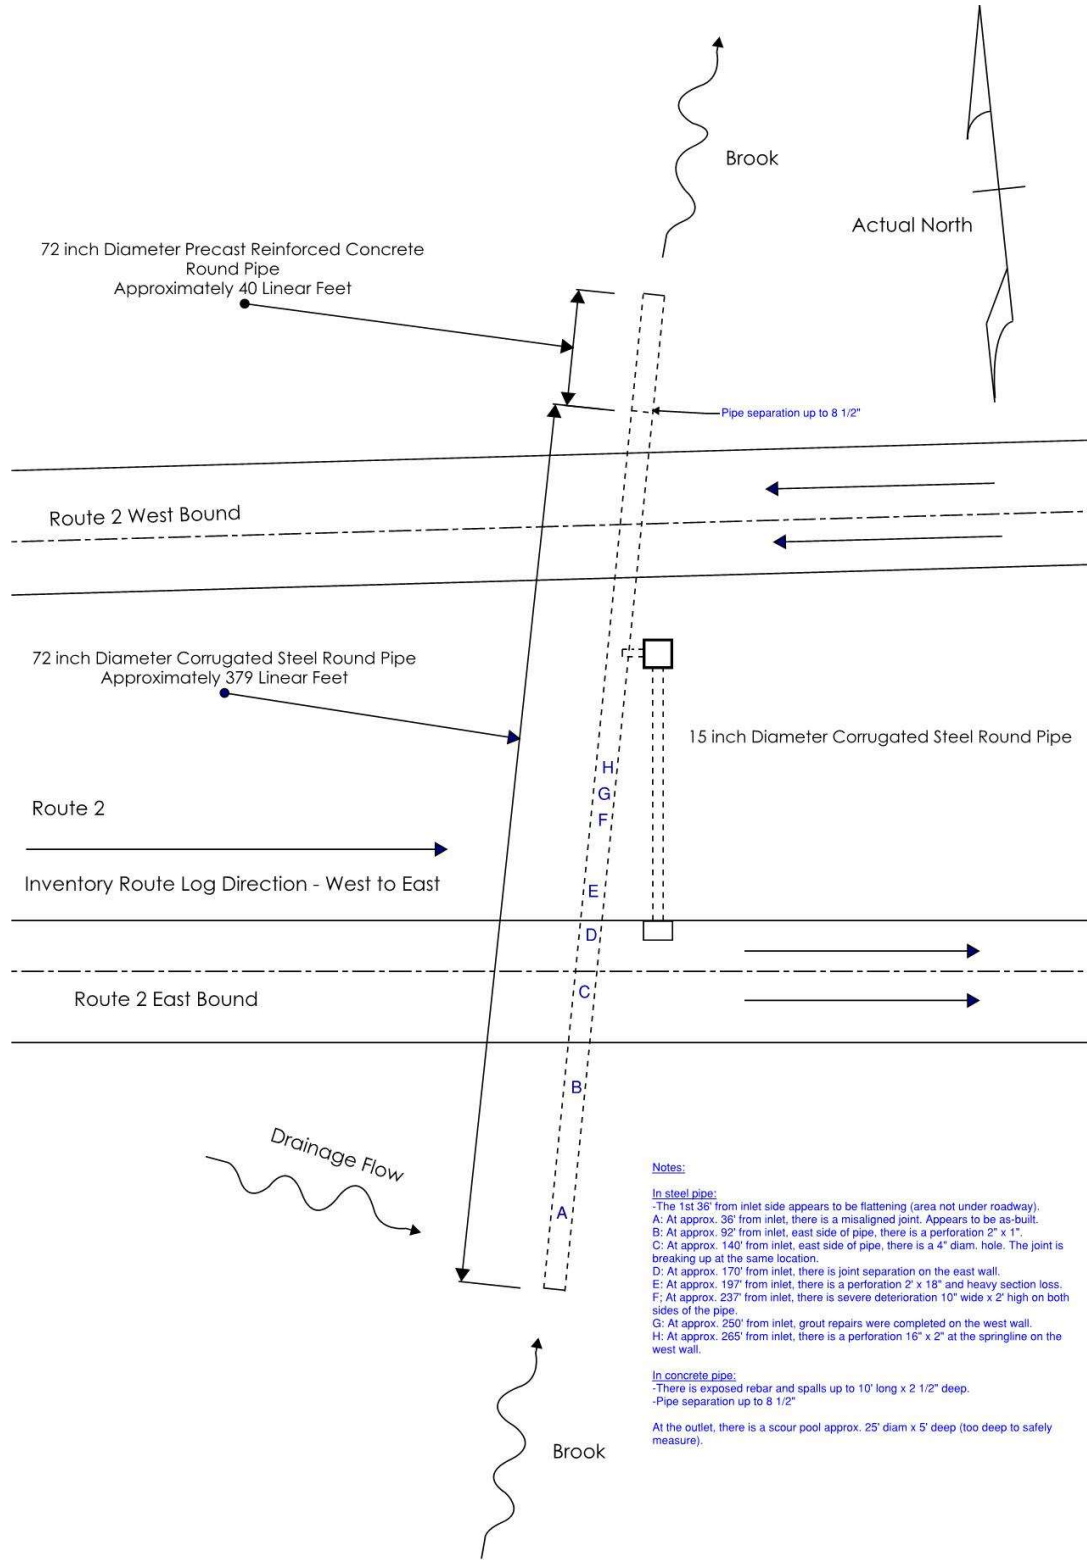
**Sketches**

- The 1st 36' from inlet side appears to be flattening (area not under roadway).
- A: At approx. 36' from inlet, there is a misaligned joint. Appears to be as-built.
- B: At approx. 92' from inlet, east side of pipe, there is a perforation 2" x 1".
- C: At approx. 140' from inlet, east side of pipe, there is a 4" diam. hole. The joint is breaking up at the same location.
- D: At approx. 170' from inlet, there is joint separation on the east wall.
- E: At approx. 197' from inlet, there is a perforation 2' x 18" and heavy section loss.
- F: At approx. 237' from inlet, there is severe deterioration 10" wide x 2' high on both sides of the pipe.
- G: At approx. 250' from inlet, grout repairs were completed on the west wall.
- H: At approx. 265' from inlet, there is a perforation 16" x 2" at the springline on the west wall.

- There is exposed rebar and spalls up to 10' long x 2 1/2" deep.
- Pipe separation up to 8 1/2"

At the outlet, there is a scour pool approx. 25' diam x 5' deep (too deep to safety measure).

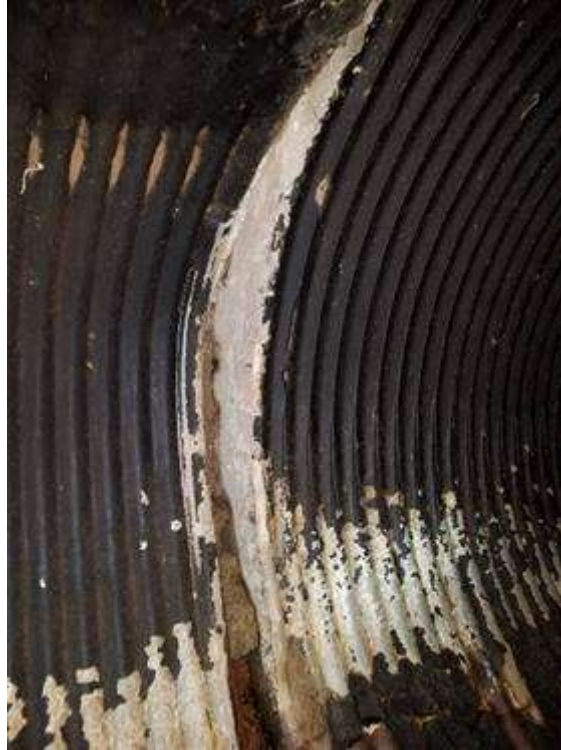
Photo Number: 7

Misaligned joint approximately 36' from inlet. Appears to be as-built.

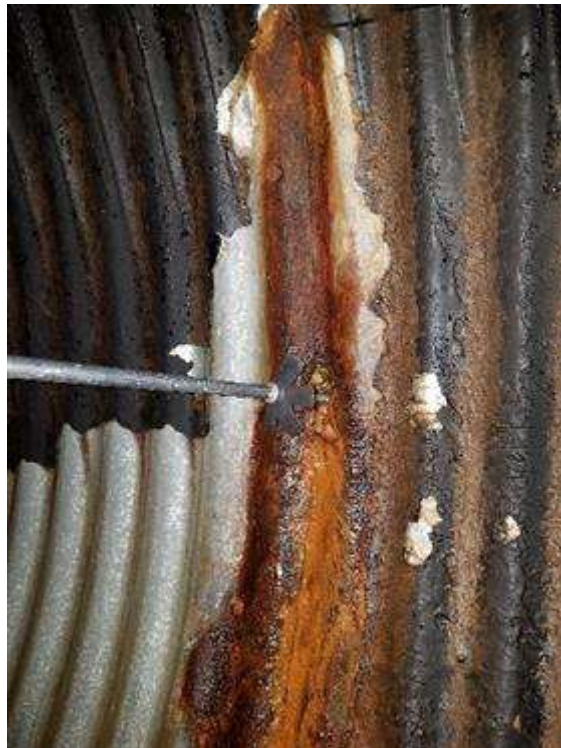
Photo Number: 8

Perforation 2" x 1" on east wall approximately 92 feet from inlet

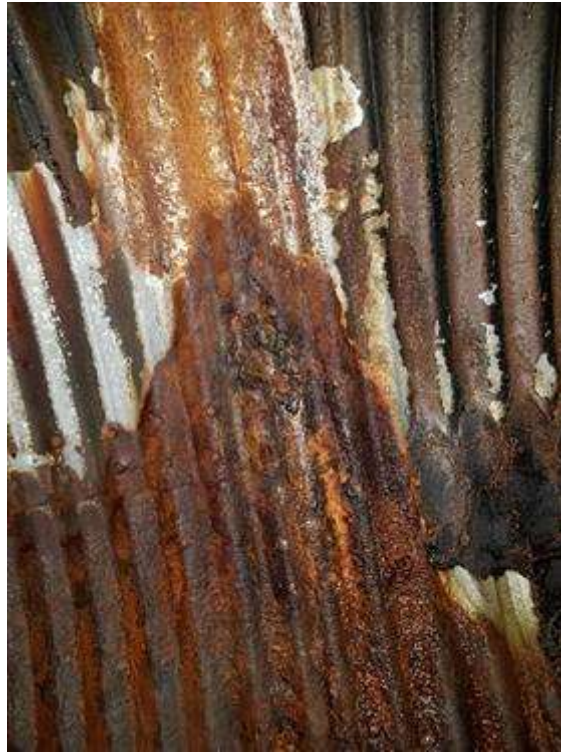
Photo Number: 9

4" diameter hole on the east wall approximately 140 feet from inlet (joint breaking up at same location).

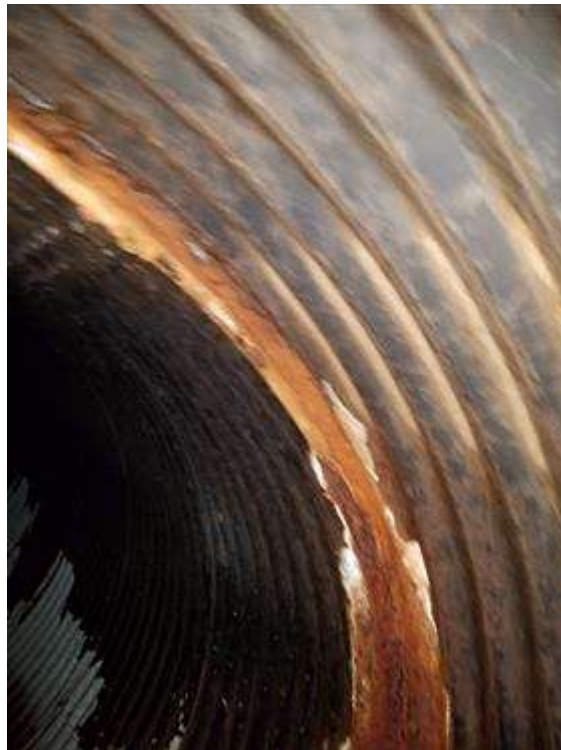
Photo Number: 10

Joint separation on east wall approximately 170 feet from inlet

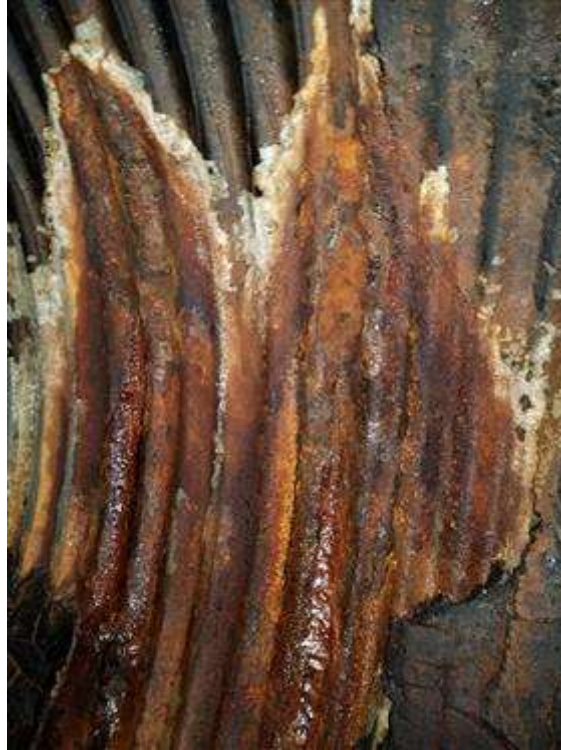
Photo Number: 11

**Feature Inspected:** Culvert interior  
**Inspection Results:** Up to 2' x 18" perforations (at 197 feet from inlet) and heavy section loss in steel pipe. See sketch for details.  
**Action To Be Taken:** 12 month inspection frequency until culvert replacement under Project 0028-0202, advertise date 11/2019

Perforation 2' x 18" and heavy section loss on west wall approximately 197 feet from inlet.

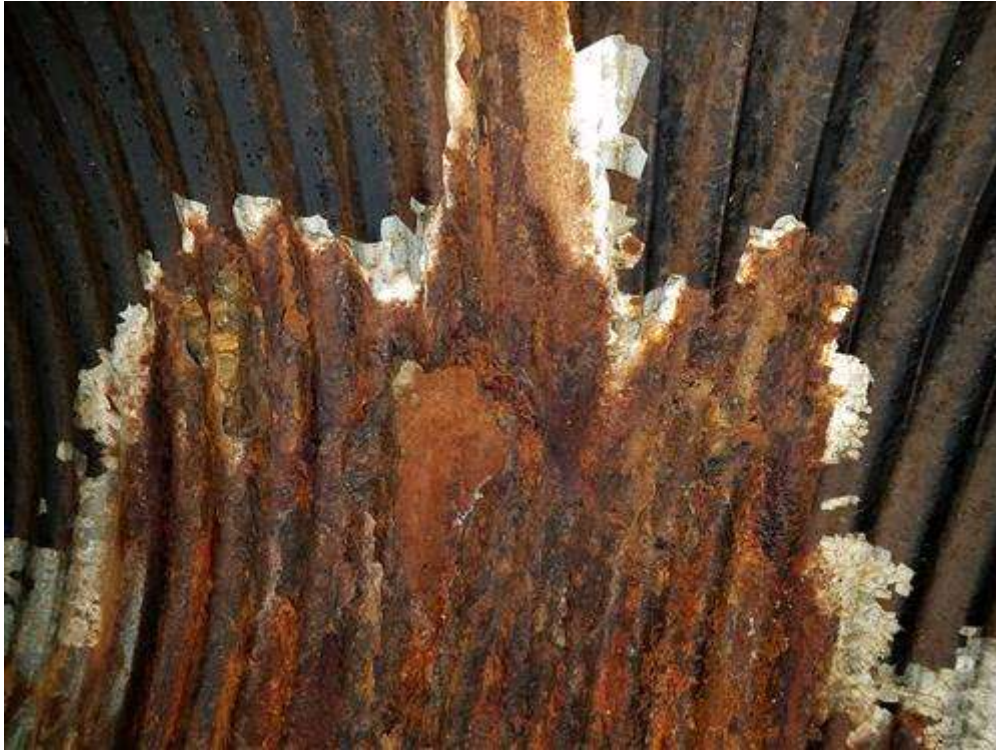
Photo Number: 13

Severe deterioration 10" wide x 2' high approximately 237 feet from inlet on east wall

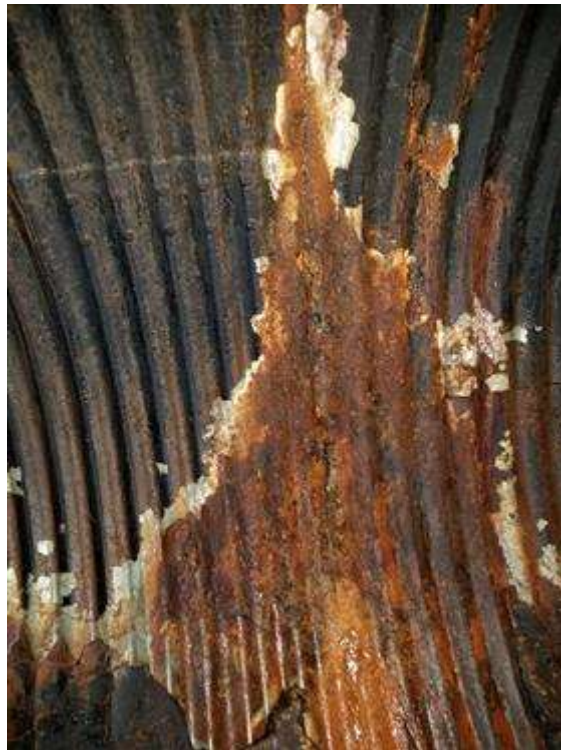
Photo Number: 14

Severe deterioration 10" wide x 2' high approximately 237 feet from inlet on west wall

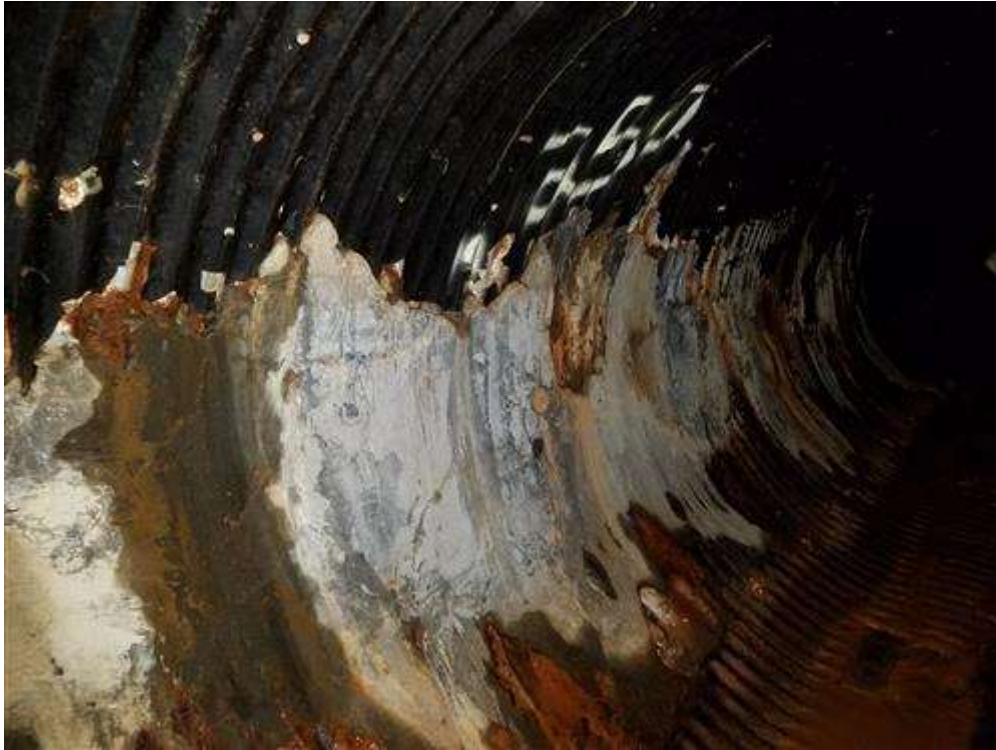
Photo Number: 15

Grout repairs on west wall at 250 feet from inlet

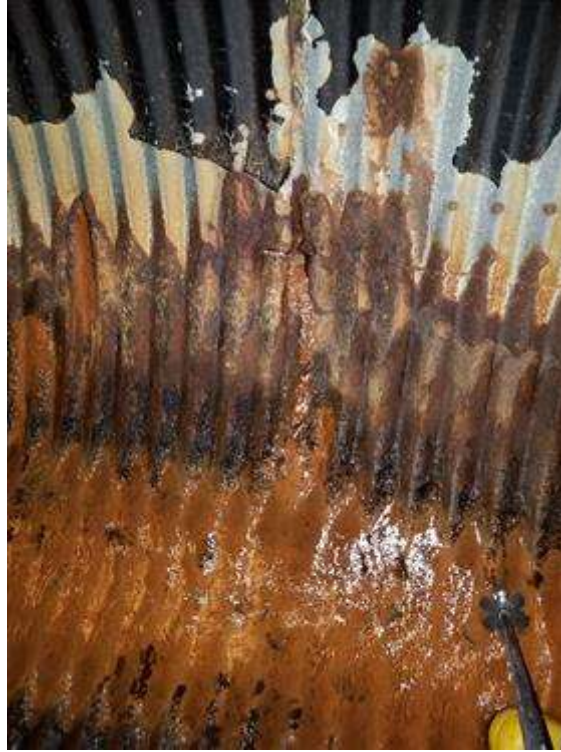
Photo Number: 17

Perforation 16" x 2" wide on west wall at springline at approximately 265 feet from inlet

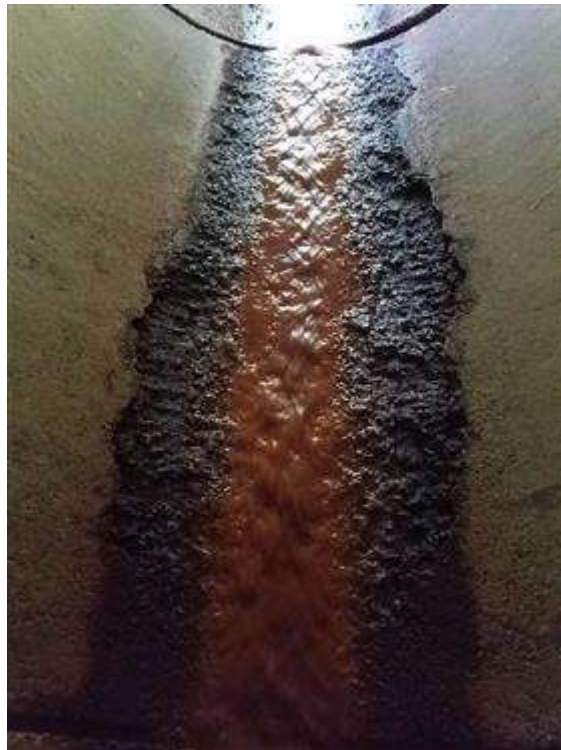
Photo Number: 20

Invert of concrete pipe. Exposed rebar and spalls up to 2 1/2" deep x up to 10' long.

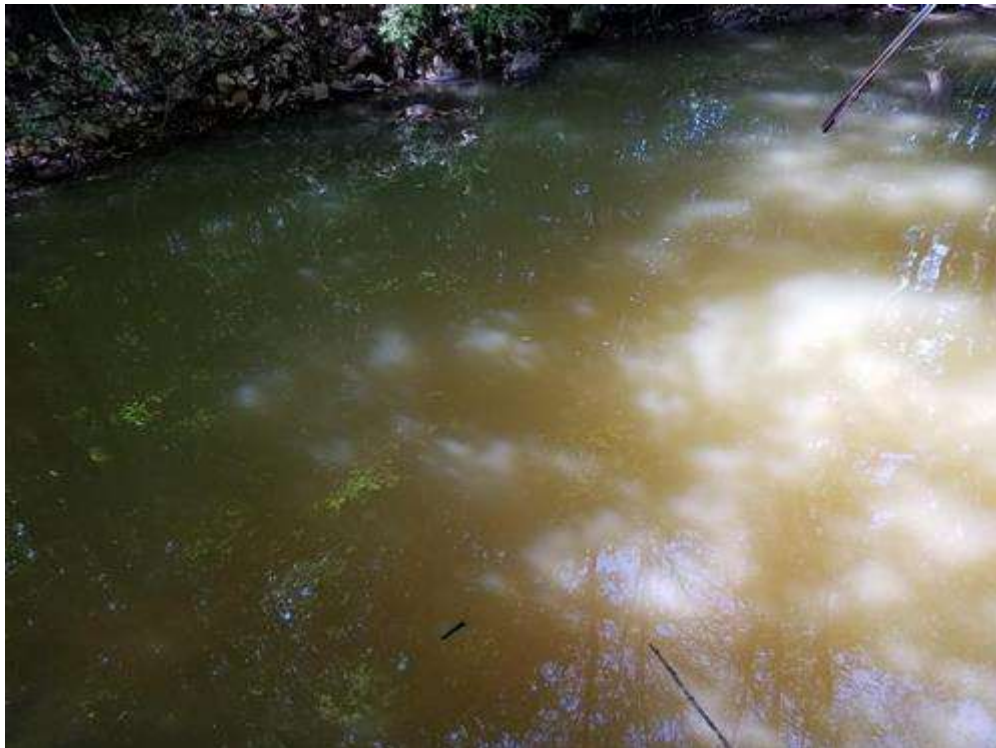
Photo Number: 24

Scour pool approximately 25' diameter x 5' deep (too deep to safely measure) at outlet

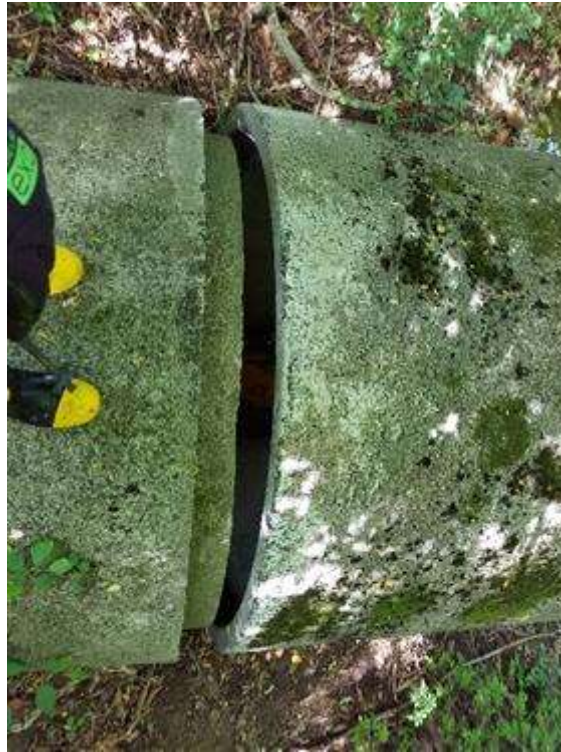
Photo Number: 25

Concrete pipe separation 8-1/2" wide on outlet side
