BRIDGE NO.06841

15910 - COLCHESTER
ROUTE 2
over
BROOK

Routine and Special Inspection

2/06/2019

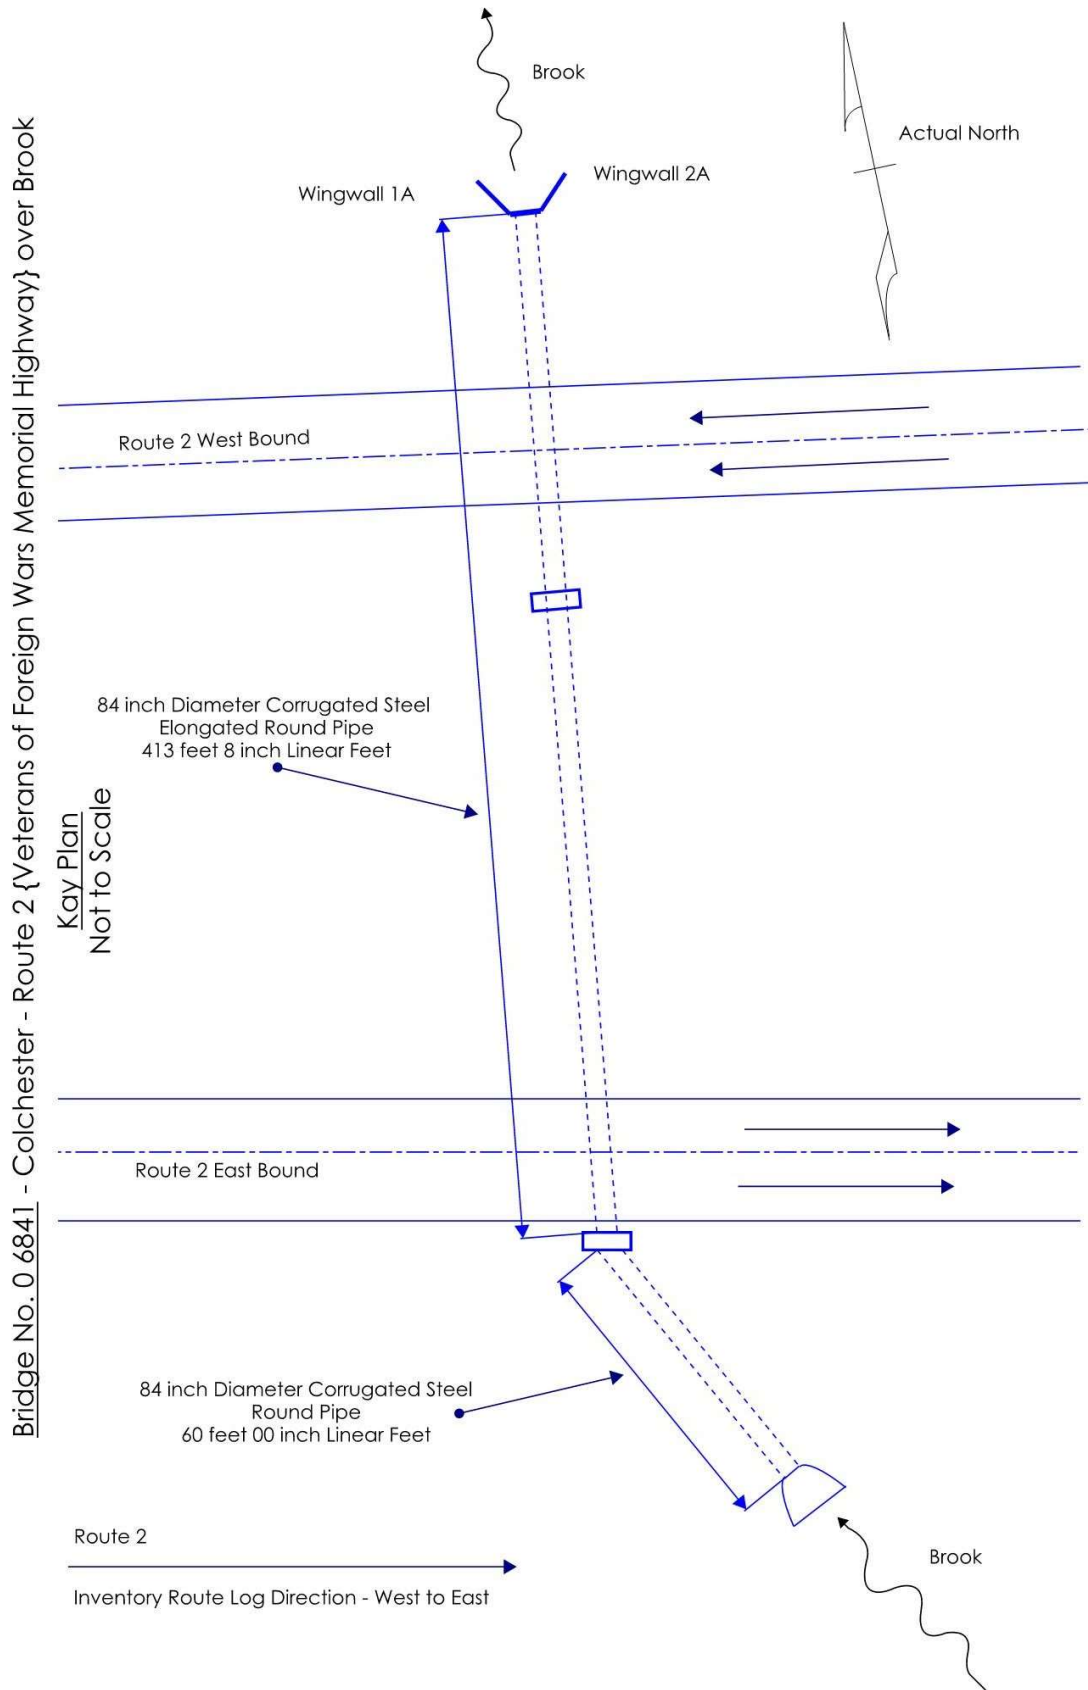
Note: Corrugated Steel Round Pipe {Inlet Section} exhibits a Distortion {Bulge}, Approximately 18 inch Bulge, Located in the Top Plates {Crown} of the Corrugated Pipe The Effected Area is Approximately 6 feet wide by 25 feet Long Located Approximately 50 feet from Inlet.

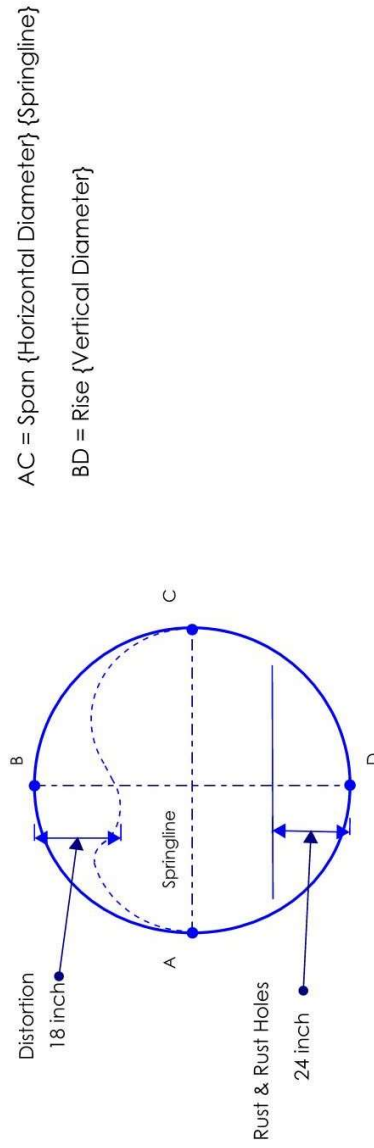
Corrugated Steel Pipe
Cross-Section
Not to Scale
March 6, 2018

Note: Corrugated Steel Round Pipe & Round Elongated Pipe exhibits an Area of Light to Extensive Heavy Rust with Deep pitting, Scattered Rust Holes & Pronounced Thinning

Some Deflection or Penetration When Struck with Hammer.

Numerous Random Rust Holes Ranging in Size Approximately 1/2 inch diameter to Approximately 10 inch by 12 inch

These Conditions for the Full Length of the Corrugated Steel Round Pipe & Round Elongated Pipe and Located on the Bottom Plates {Invert} Approximately 24 inch High Area

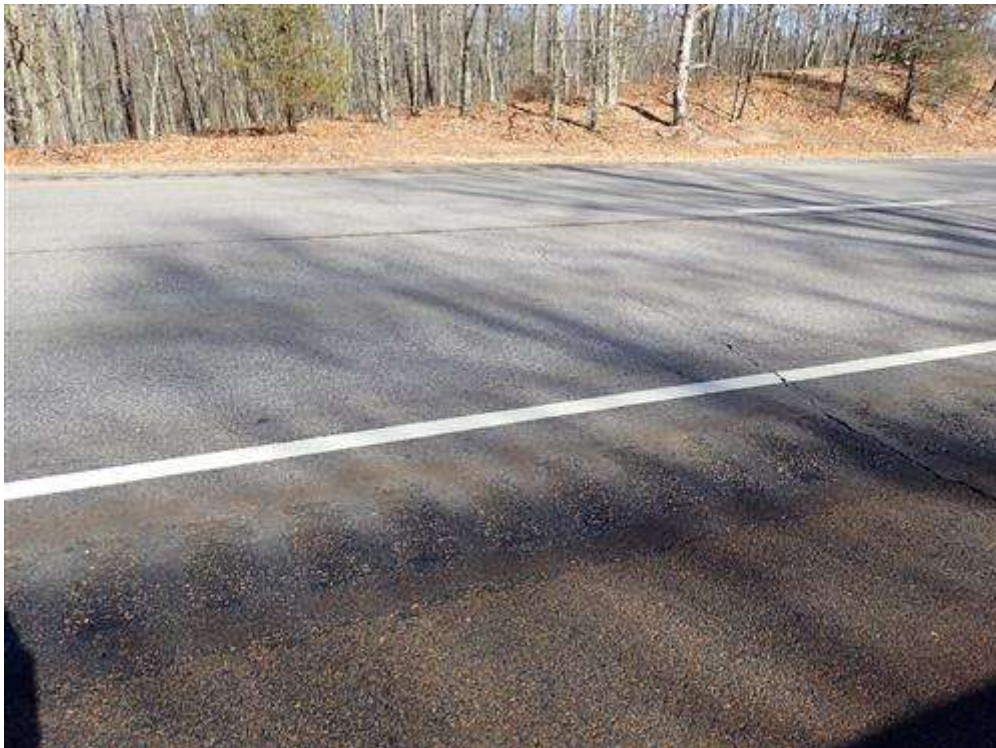
Photo Number: 2

Overlay: 7 Bituminous Concrete Pavement exhibits:
 Up to 3/4" open transverse cracks with light raveling, mostly in shoulders.

Eastbound overlay.

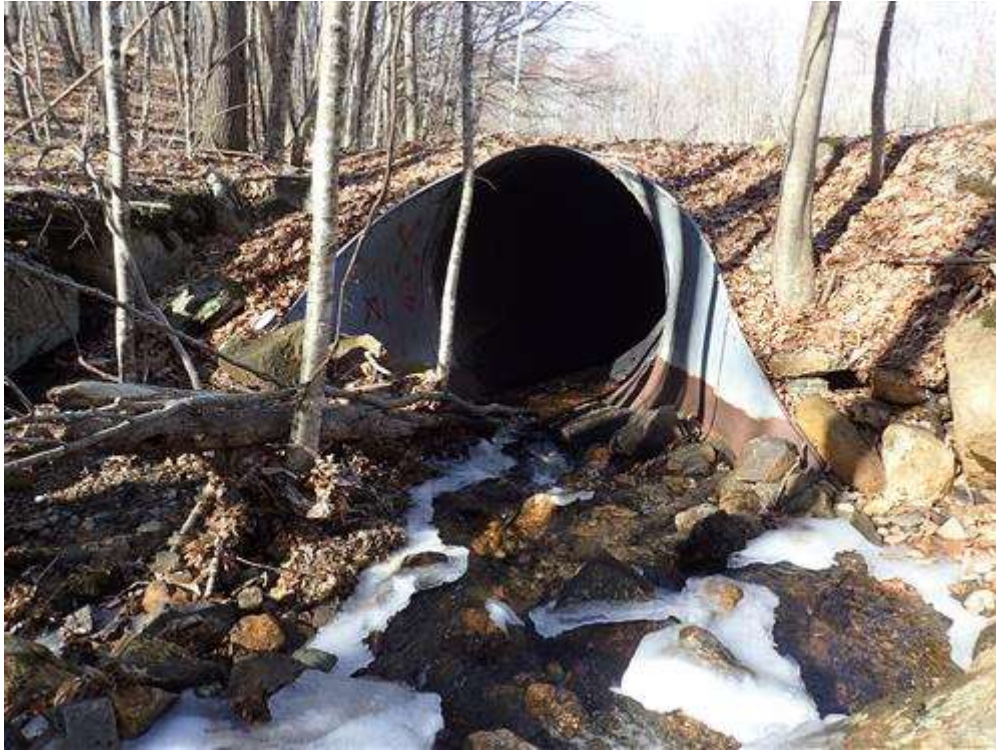
Photo Number: 3

South elevation. (inlet)

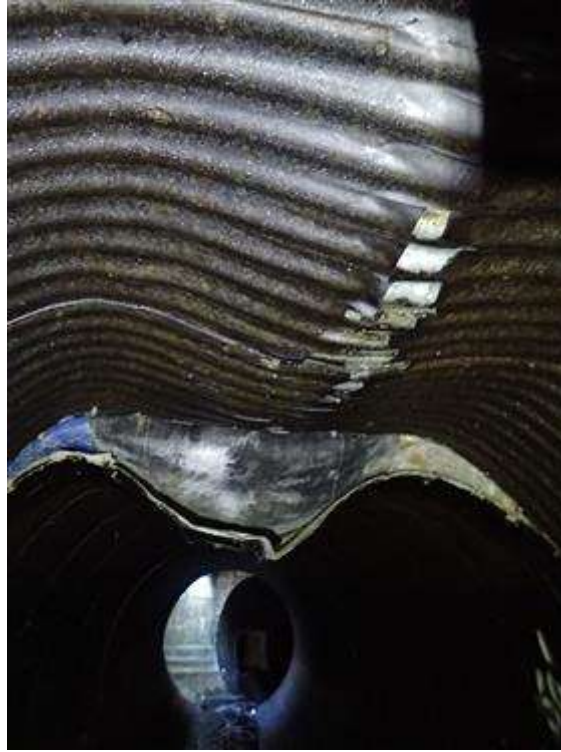
Photo Number: 5

Past noted damage to upper section of pipe.

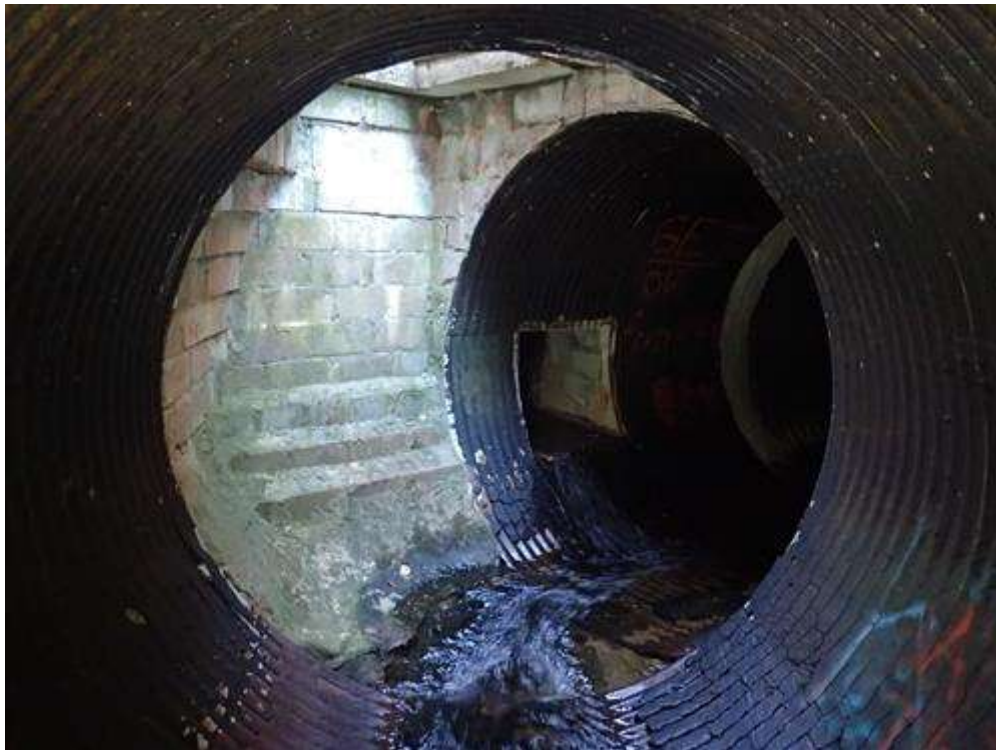
Photo Number: 6

Catch basin junction.

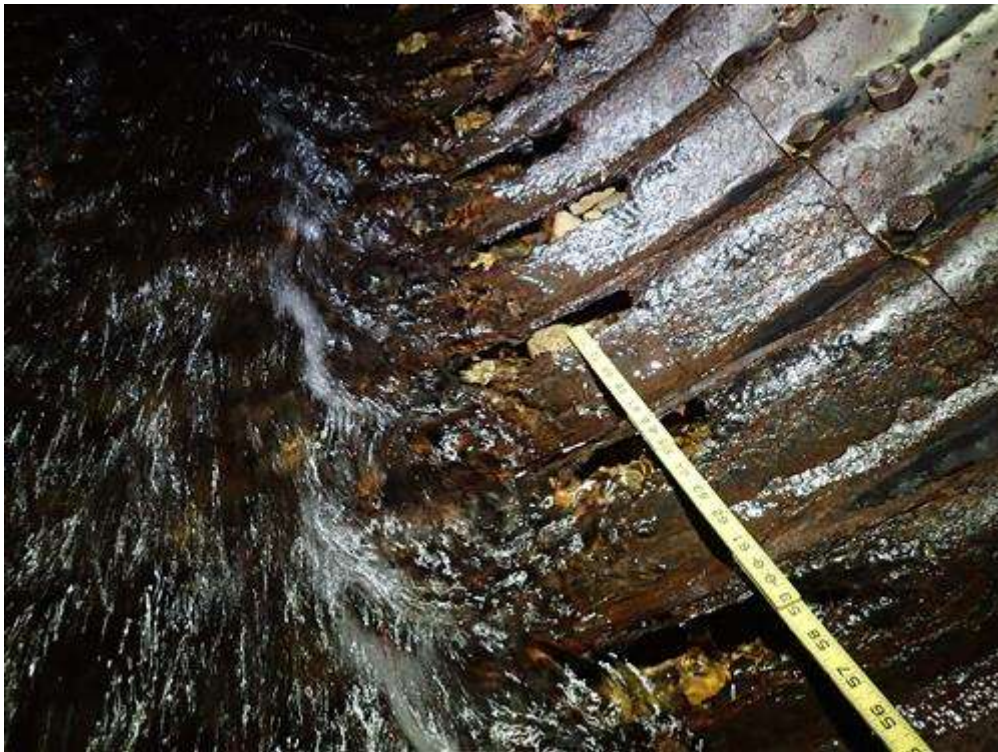
Photo Number: 8

7 ft. Round a.c.c.m.p. - inlet (north), flared steel end treatment with heavy laminar rust and minor
 Loss of asphalt coating at and below waterline throughout with varying degrees of section loss.
 50 ft. north of inlet, top dented in up to 18 in. Area is approximately 25 ft. Long. Note, this appears to
 be a construction defect and is not under the roadway.
 From 80 ft. To 125 ft. north of inlet, perforations in edges of bottom plate up to 12 in. X 2 in.
 From 125 ft. To 300 ft. north of inlet, heavy laminar rust with scattered perforations up to 4 in. X 3 in.
 From 240' north of inlet, 3 missing bolts at seam along bottom.
 264 ft. north of inlet, perforations in west side and bottom plates. Area is 6 ft. long with the largest hole
 being 12 in. X 10 in. Can probe behind pipe 14 in. This condition is typical at 291 ft. north of inlet.
 From 300 ft. To 360 ft. north of inlet, heavy laminar rust on bottom plate with minor section loss.

Section loss to invert near inlet.

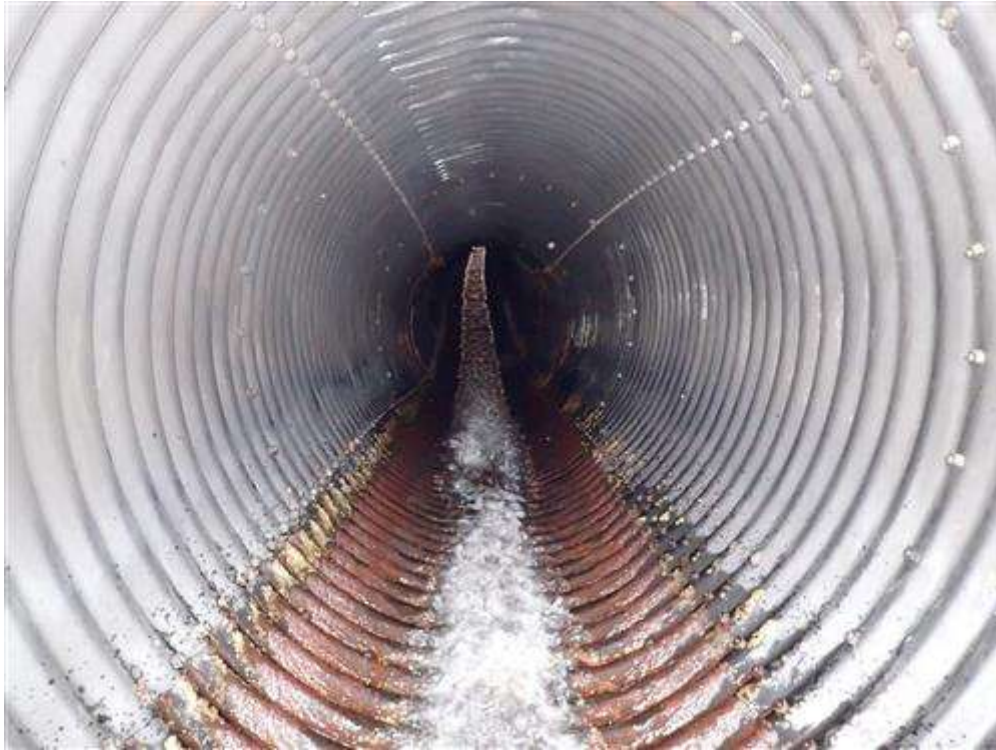
Photo Number: 9

Looking through pipe. Noted pipe is angled downward towards outlet.

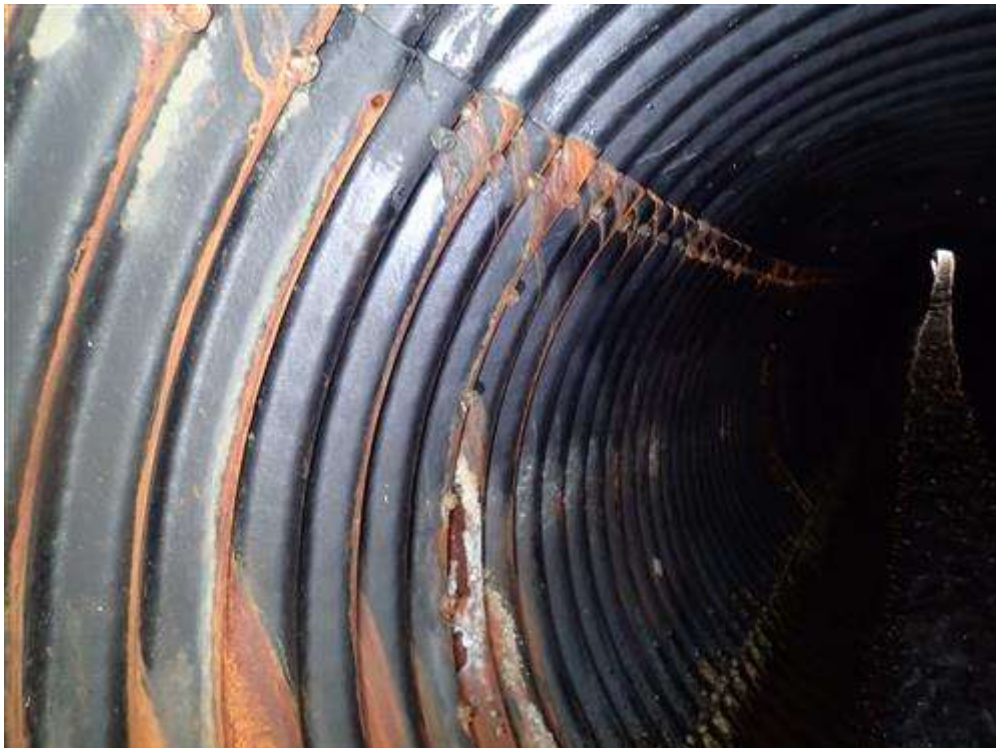
Photo Number: 10

Rust along upper bolt line.

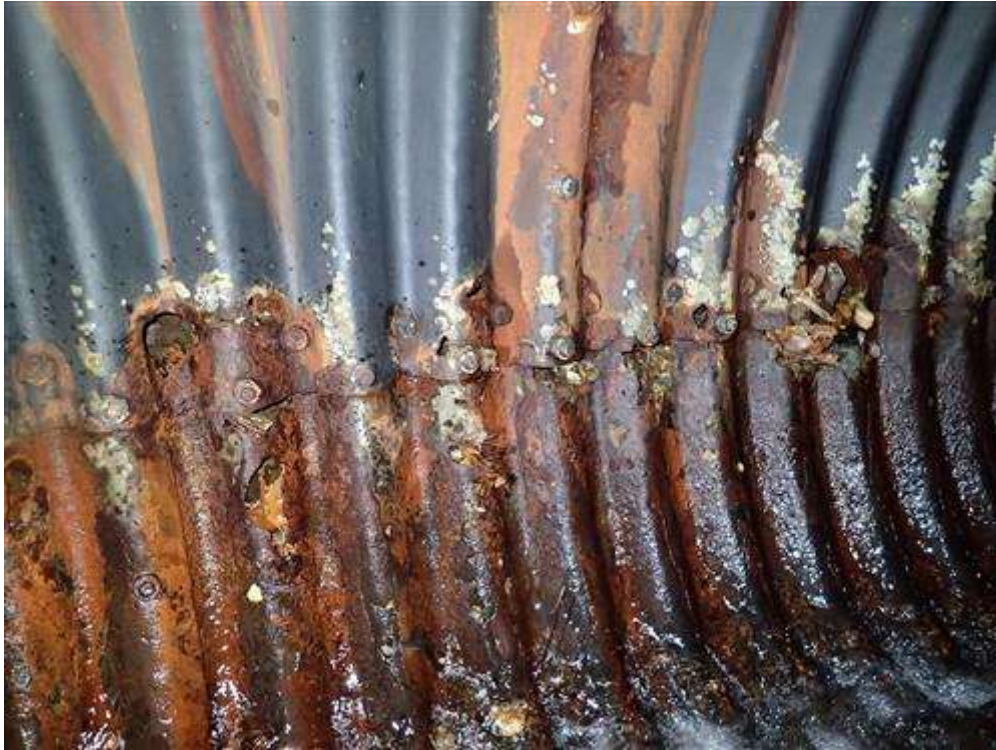
Photo Number: 11

360 ft. North of inlet, (4) holes torn through top plate (from construction) some sealed.
 370 ft. North of inlet, (2) perforations in west side plate 4 in. X 3 in. Each.
 405 ft. north of inlet, perforation in east side and bottom plate 6 in. X 2 in.

Section loss pipe random areas through out.

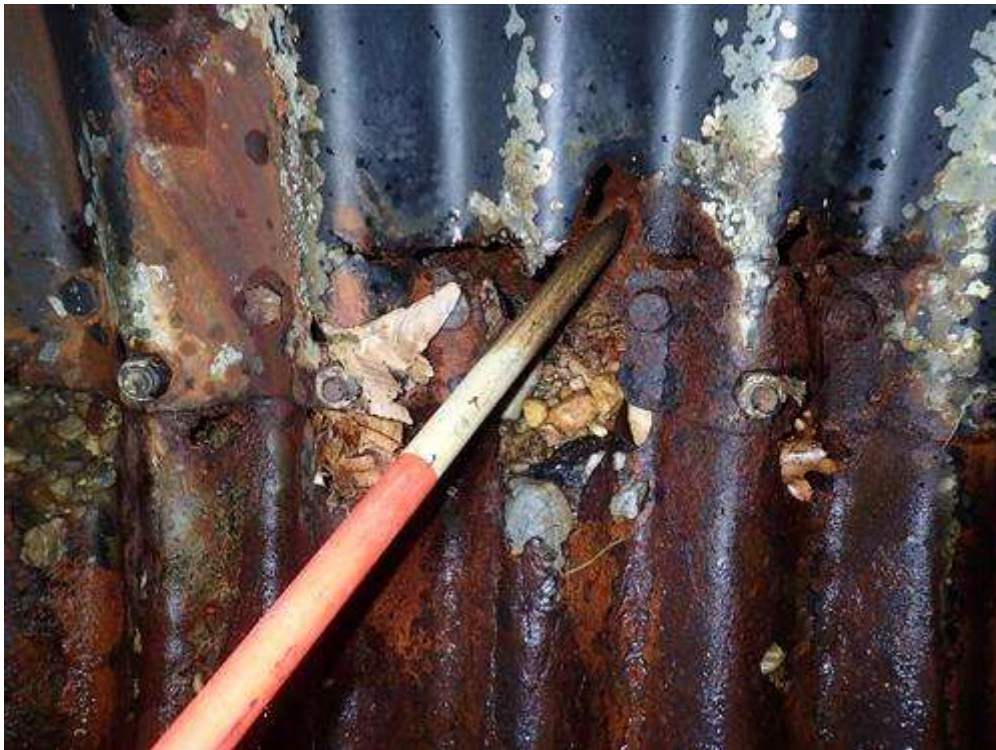
Photo Number: 12

More section loss to pipe sections some penetrations up to two feet deep.

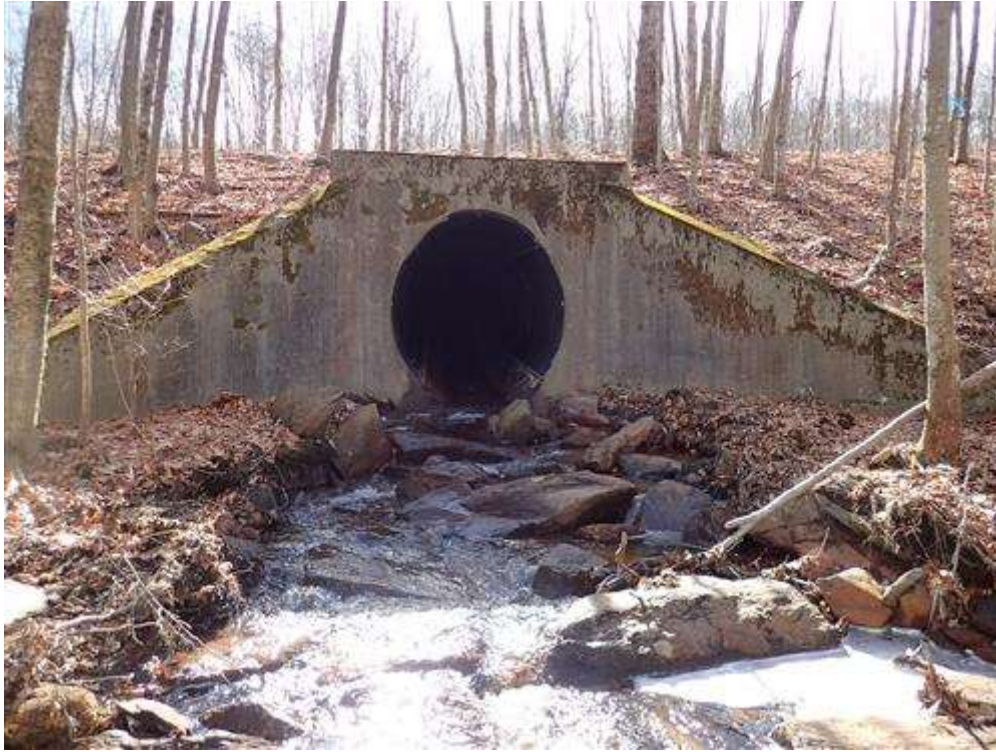
Photo Number: 13

Outlet (north) only - concrete.
 - light scale at and below waterline.

Outlet- cut off wall exposed up to 10" high x full width.

North elevation. (outlet)

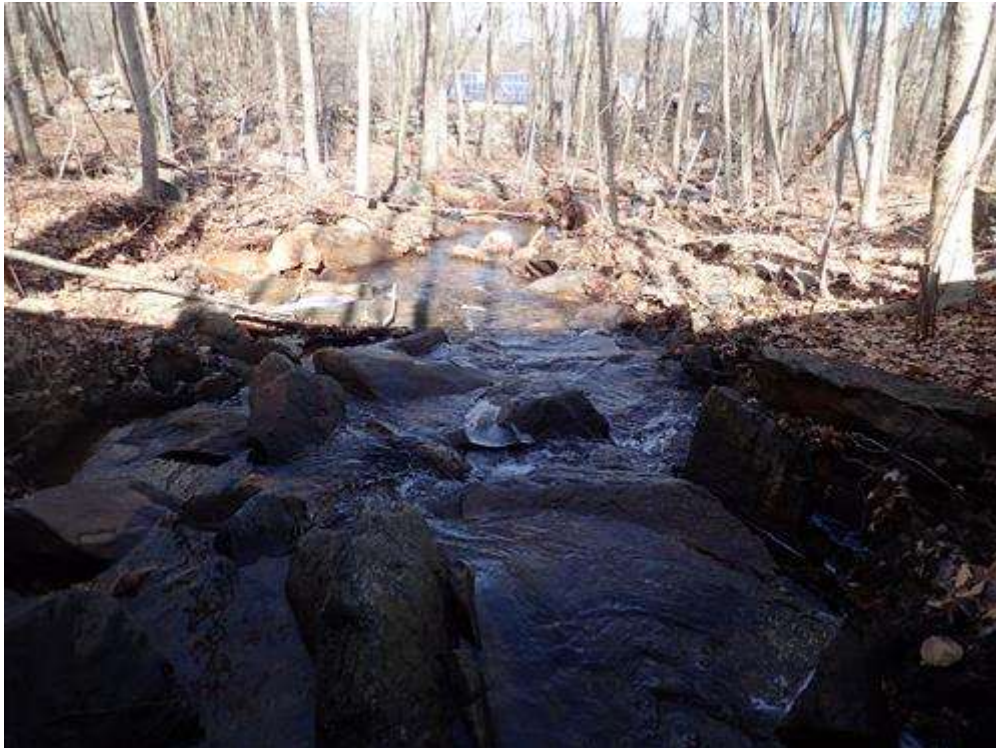
Photo Number: 14

Looking downstream.

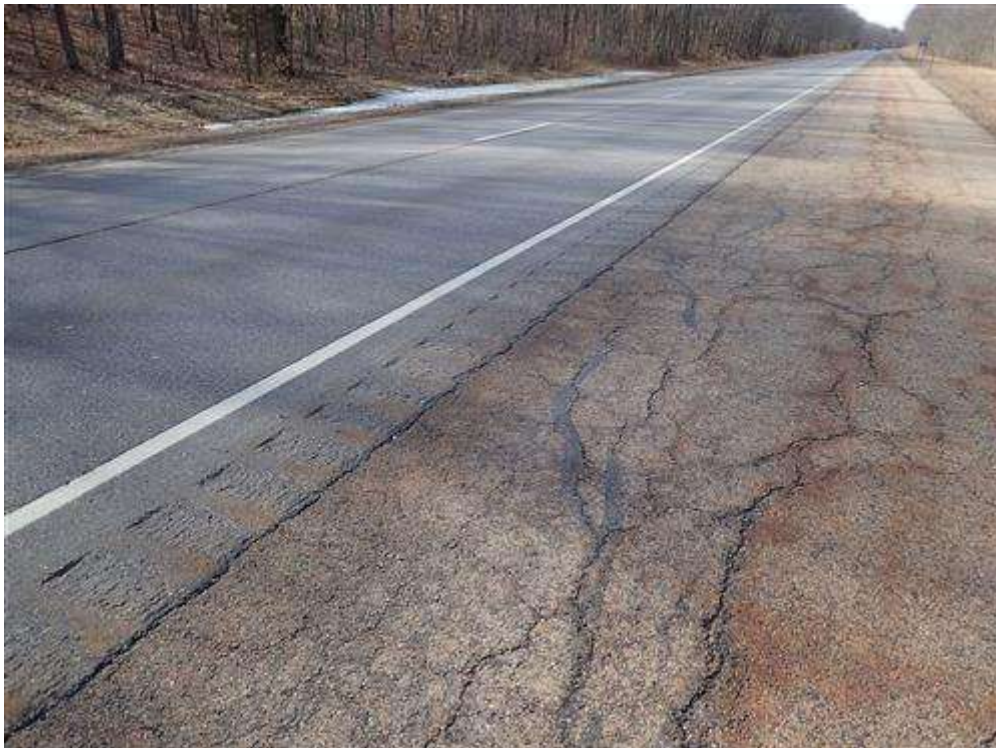
Photo Number: 16

Approach Slab:	N	
Relief Joints:	N	
Approach Guide Rail:	N	
Approach Pavement:	7	Bituminous Concrete Approach Pavement exhibits: Up to 3/4" open transverse cracks with light raveling, mostly in shoulders. Westbound- up to 1/2" open map cracking thru out shoulder.
Approach Embankment:	8

View of westbound overlay.
