BRIDGE NO.06842

15910 - COLCHESTER
ROUTE 2 E/B
over
BROOK

Routine Inspection

2/06/2019

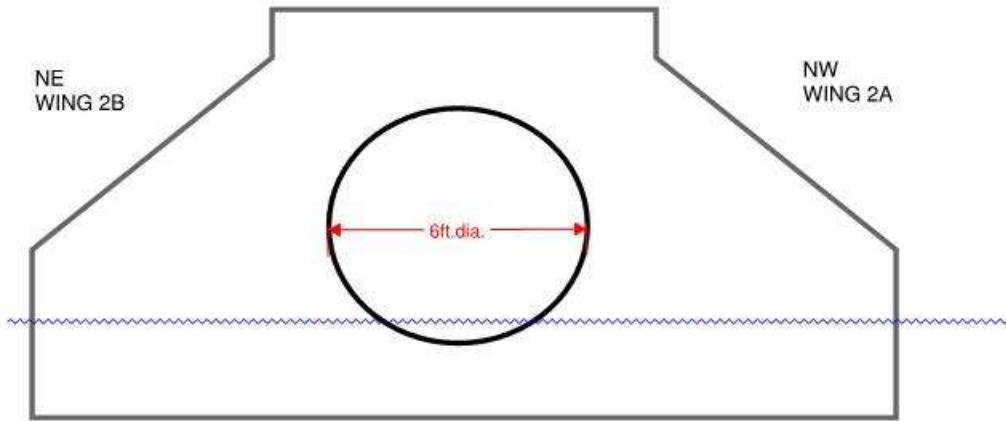
NORTH ELEVATION (outlet)

Channel - Scour:	<input type="text" value="5"/>	<p>Minor scour noted at the outlet:</p> <p>A 4ft. dia. scour pool between the wingwalls at the outlet with water depths up to 48" deep.</p> <p>Scour at the outlet has exposed the cut-off wall full width x up to 28" high.</p> <p>The top of the footing on the northeast wingwall is approx. 3ft. long.</p> <p>Water depths upstream range from 1" to 3".</p> <p>Water depths in the pipe are 1" to 3".</p>
Embankment - Erosion:	<input type="text" value="7"/>	<p>Minor around the inlet and outlet pipe ends.</p> <p>Behind the north headwall there's</p>
Debris:	<input type="text" value="6"/>	Dead branches and some natural debris along the embankments.
Vegetation:	<input type="text" value="8"/>	Embankments are well vegetated.
Channel Change:	<input type="text" value="8"/>	
Fender - System:	N	
Spur Dikes and Jetties:	N	
Rip Rap:	N

Debris:	8	
Retaining Wall System:	6	Reinforced concrete wingwalls: Light map hairline cracks. The top of the footing at the northeast wingwall is exposed 3' long.
Footing:	6	The top of the footing at the northeast wingwall is exposed 3ft. long.

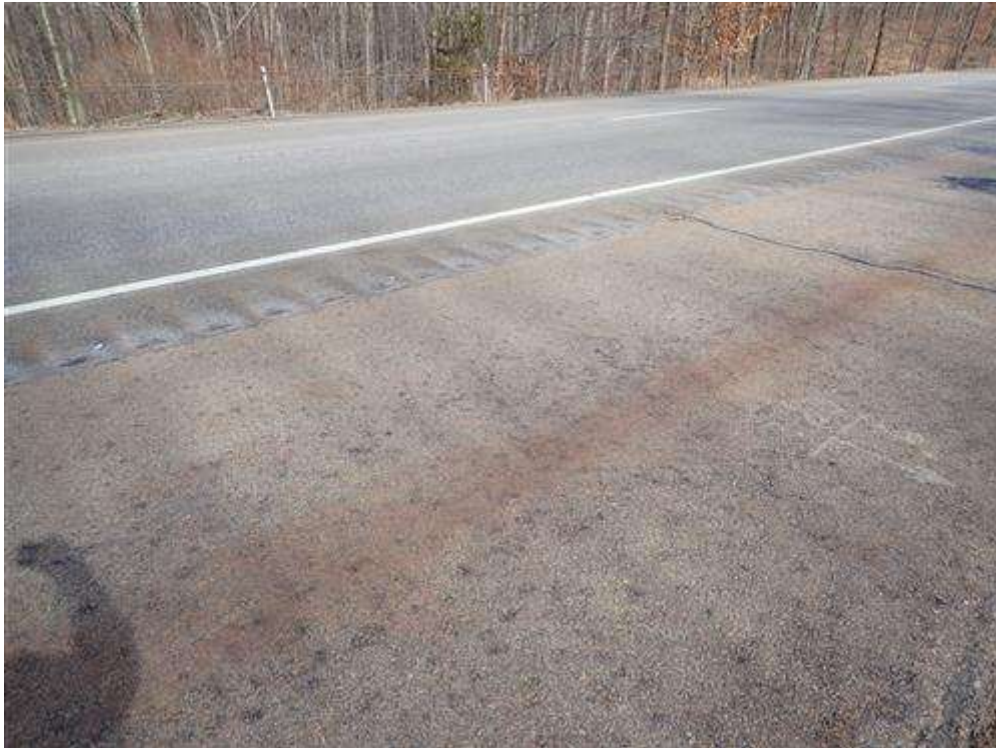
Photo Number: 2

Overlay: Bituminous Concrete Pavement with Approximately 26 feet of Ballast exhibits:
Transverse and longitudinal cracks open up to 1/4" maximum.
Slightly open paving seam down the centerline open up to 1/4".

View of overlay.

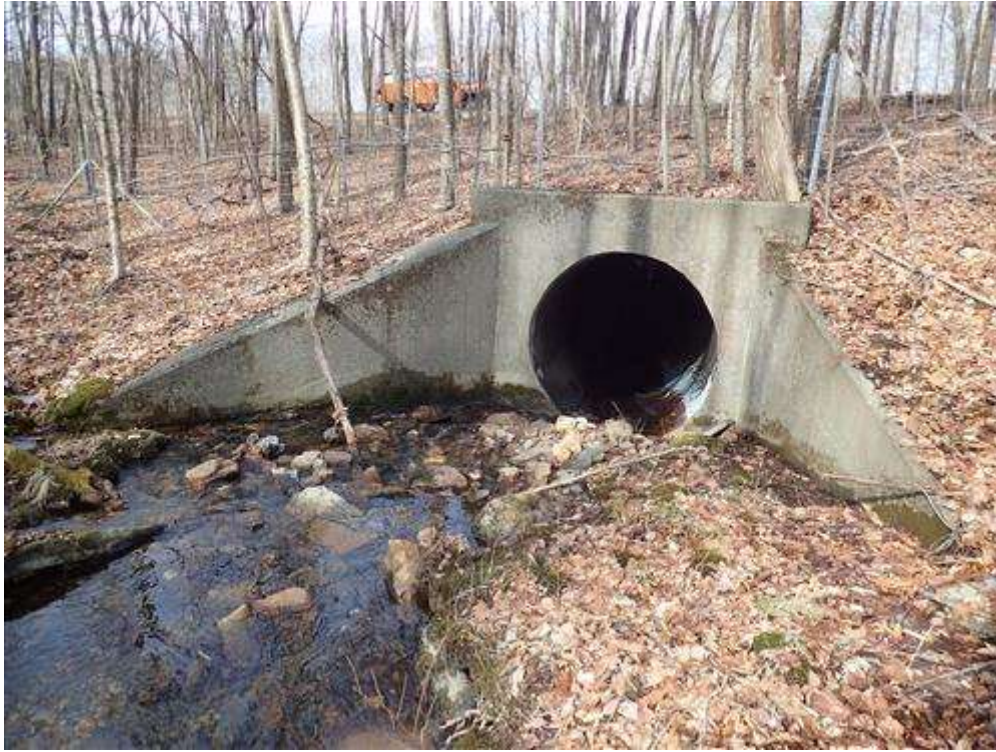
Photo Number: 3

South elevation. (inlet)

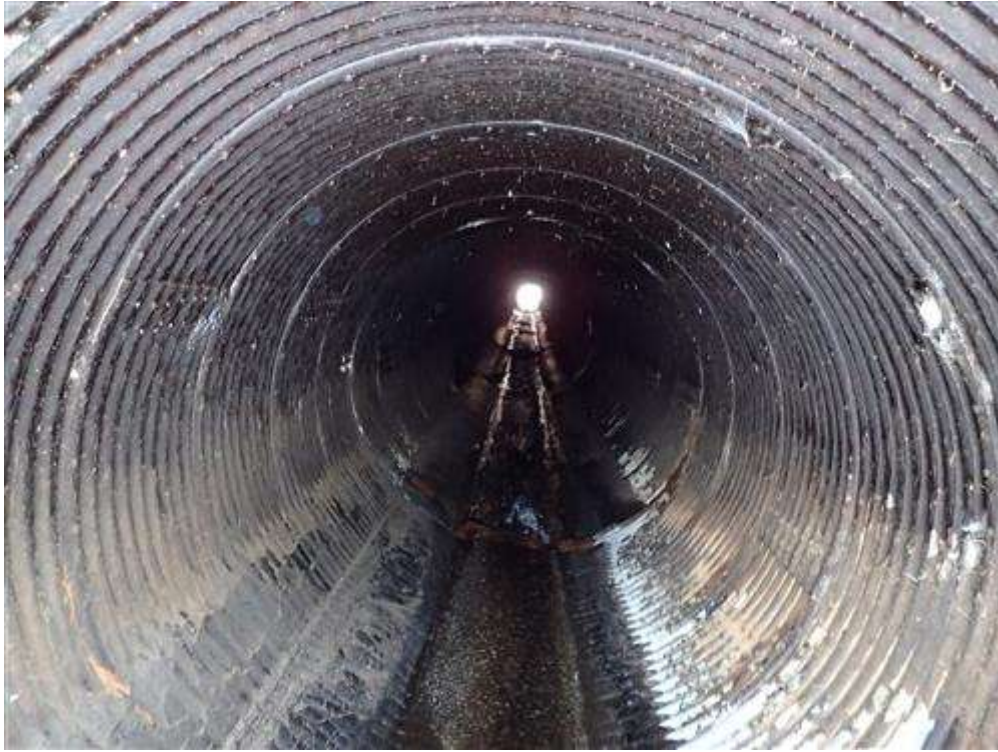
Photo Number: 5

Barrel:	N	
Concrete:	N	
Steel:	3	Corrugated Steel Round Pipe Culvert exhibits: Overall rating based on flattening condition of the crown of pipe {possibly a construction defect}. The worst section of flattening is from 12' mark to the 75' mark {measurements start at the outlet end}. The crown is flattened up to + 12". Random areas of asphalt coating loss on the corner and bottom plates with heavy rust on exposed steel. Between the 50' mark and 90' marks the invert and lower stems exhibit perforations up to 4" in diameter with active water leakage. The joints at the same locations also exhibit water leakage. Small < 1/2" diameter perforations scattered throughout the invert were the steel is exposed.
Timber:	N	
Headwall:	7	Reinforced concrete headwall: Light map hairline cracks. Cable mesh fence over the top of the inlet headwall.
Cutoff Wall:	5	Scour at the outlet has exposed the cut-off wall full width x up to 28" high.

Looking through pipe.

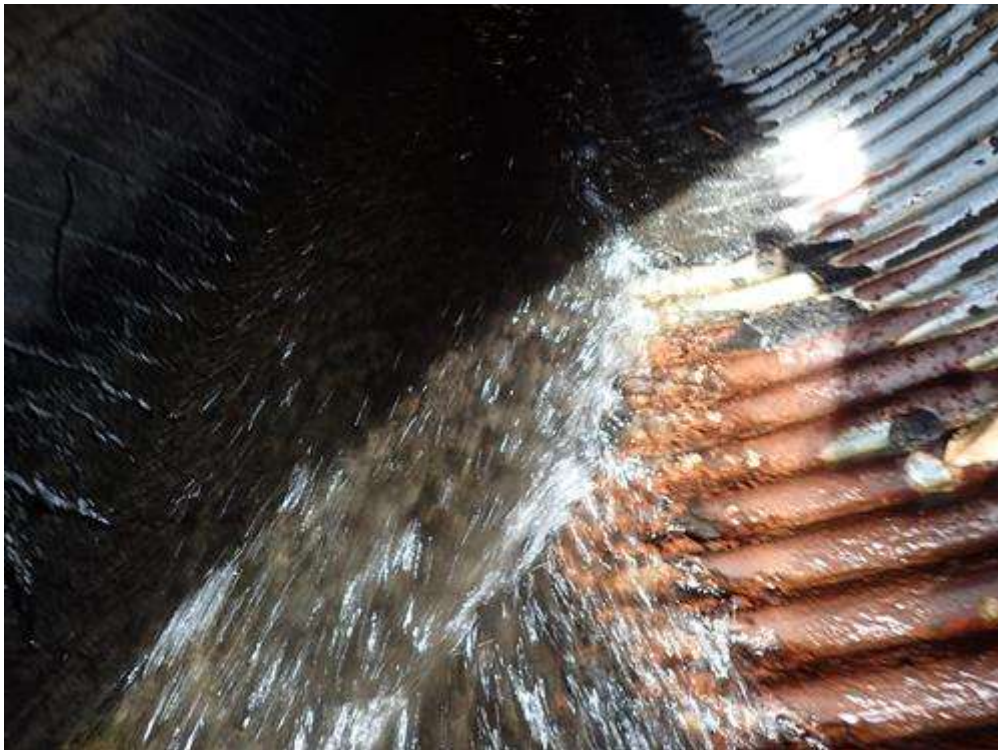
Photo Number: 6

Rust on pipe along water line.

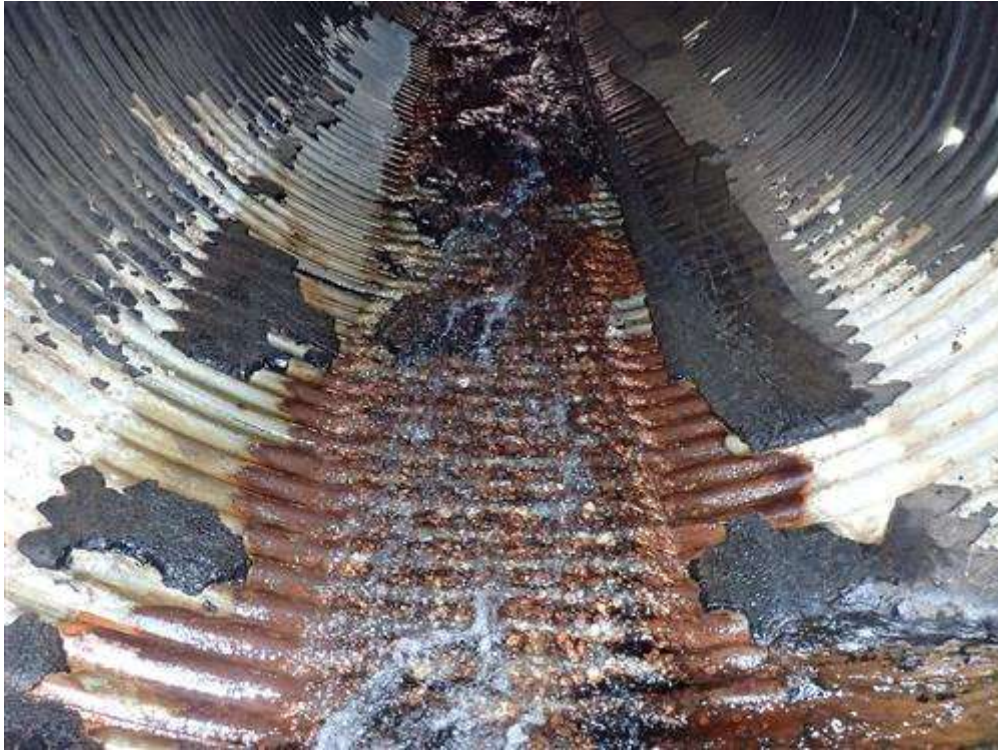
Photo Number: 7

View of invert near outlet.

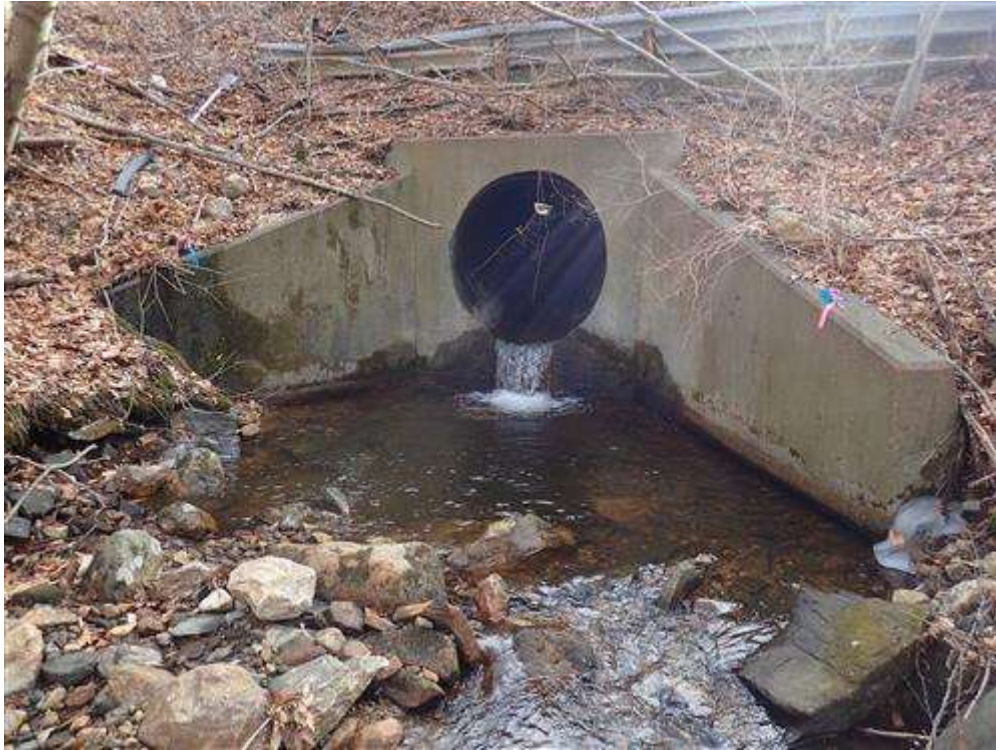
Photo Number: 9

Cutoff Wall Exposed: Yes - Outlet Cutoff Wall Exposed up to Approximately 28 inch high by the Full Length of the Cutoff Wall

North elevation. (outlet)
