July 26, 2018

Subject: On-Call Asbestos, Lead, Air Quality & Demolition Compliance
Agreement No. 04.27-01(15)
HazMat Inspection – Bridge Nos. 06840, 06841 & 06842 (Culverts/ACCMPA),
Under Route 2, Colchester, CT
ConnDOT Assignment No. 514-5740
ConnDOT Project No. 28-202
TRC Project No. 222165.5740.0710

Applicant: State of Connecticut, Department of Transportation
Project No. 28-202 (Constr.), 170-3250 (P.E.)
Rehabilitation of Bridge Nos. 06839, 06840, 06841, 06842
Various location along Route 2 in Colchester

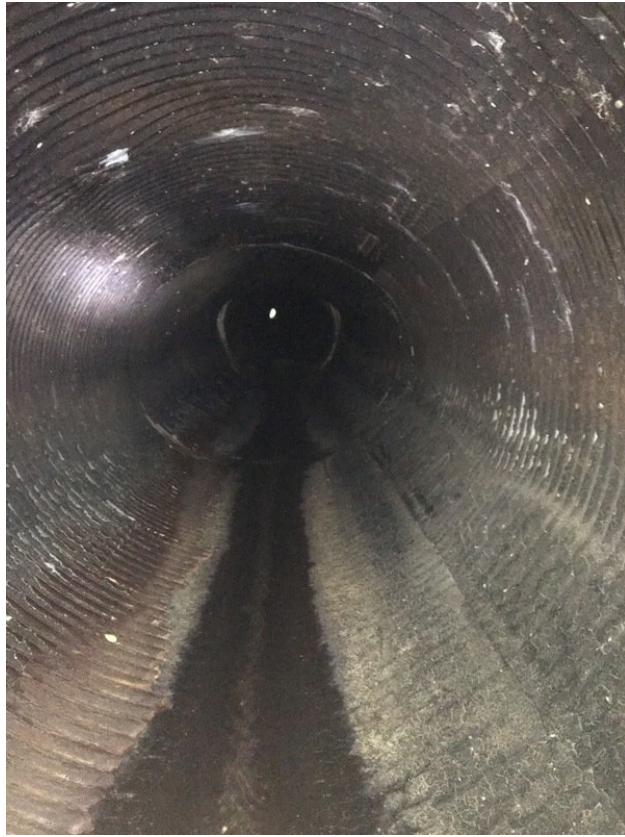
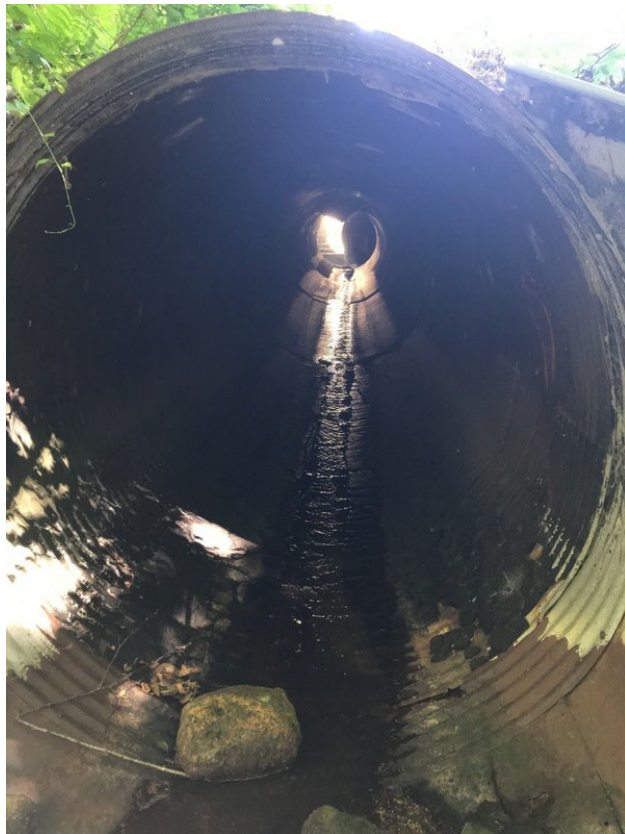
Bridge 06840

Based upon field investigation and engineering analysis of this structure, the existing structure is found to be structurally deficient due to the deteriorated condition of the pipe. The concrete pipe extension at the outlet exhibits light surface scale at the invert, exposed rebar, and severe scale. The corrugated metal pipe exhibits advanced section loss, heavy rust, and an area of perforation that is 17 feet long by 4 feet wide. The first 36 feet of the metal pipe, which is not located under Route 2 is flattened due to construction defects.

The proposed project consists of rehabilitating the culvert by relining the existing structure with centrifugally cast concrete. Approximately 1.5 inches of concrete will be sprayed on the inside walls of the existing pipe providing an opening of 5.75 feet. Before the culvert is relined, the existing pipe will be cleaned of debris and holes will be pressure grouted. The existing 40 ft. of concrete pipe at the outlet will be removed and an intermediate riprap basin and apron will be constructed to reduce the outlet velocity prior to the existing scour hole. Approximately 15 feet of pipe at the inlet will be removed as well, and new concrete end treatments will be constructed at both ends. The culvert will be installed with baffles to help decrease the outlet velocities and promote aquatic habitat.

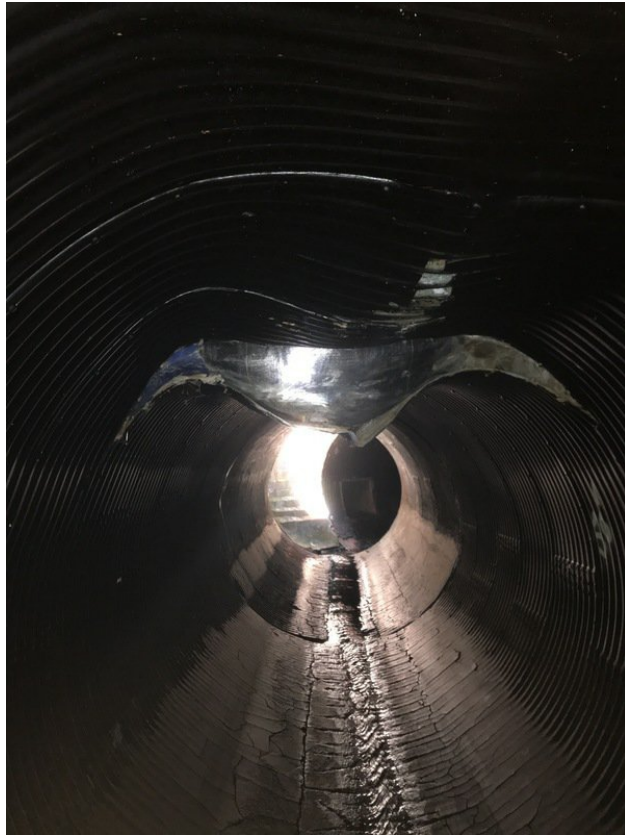
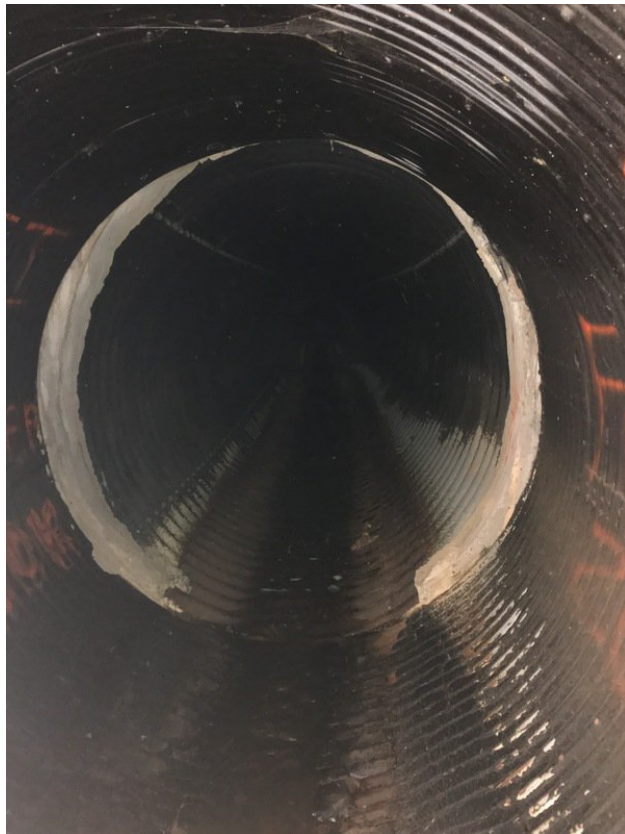
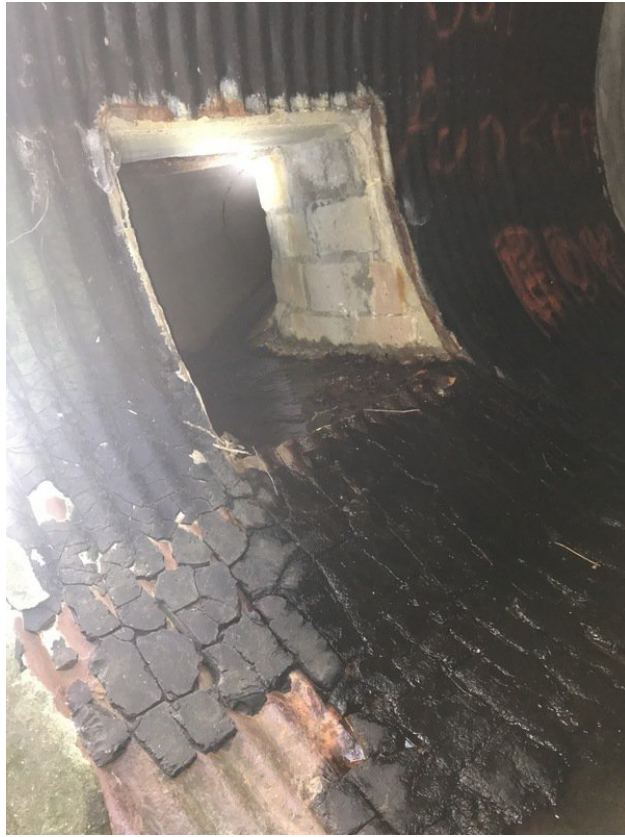
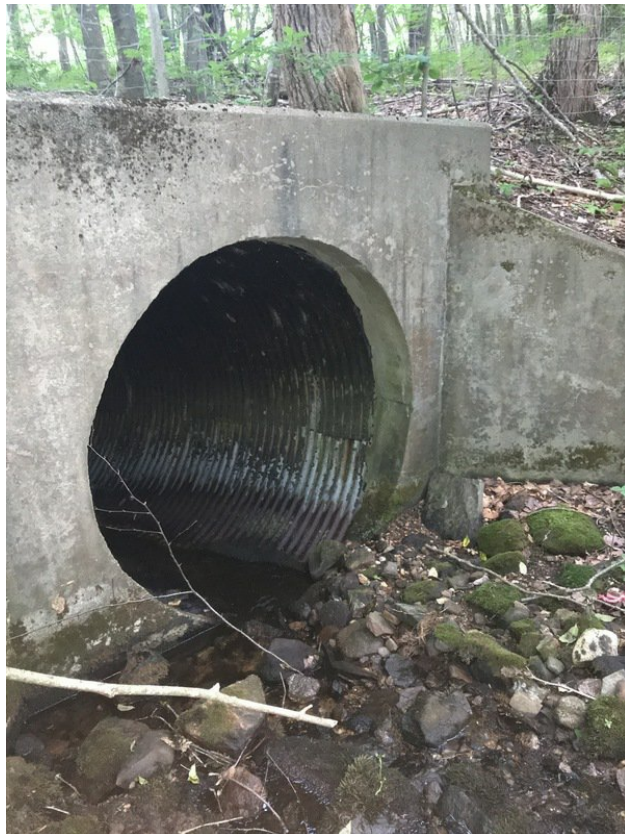
Bridge 06841

- 6' dia; \approx 300+ yds
- galv (no paint)
- tar covered (int only) T4
- * partial collapse mid way *

Based upon field investigation and engineering analysis of this structure, the existing structure is found to be structurally deficient due to the deteriorated condition of the existing metal pipe. The culvert exhibits heavy laminar rust, minor section loss, and perforations where the largest hole can be probed up to 9 inches. The concrete headwall at the outlet has some light scale at and below the waterline. The asphalt coating has section loss at and below the waterline throughout the culvert. Approximately 50 feet from the inlet, the top of the culvert is dented approximately 18 inches, which is likely the result of a construction defect, and is not located under Route 2.

The proposed project consists of rehabilitating the existing structure by lining the interior of the 84" pipe with structural concrete. Before the culvert is relined, the existing pipe will be cleaned of debris and holes will be pressure grouted. Weirs at 9" high will be placed through the culvert to promote fish passage and reduce outlet velocity. The initial 75' of the existing pipe and existing catch basin will be removed. A new headwall will be constructed at the new inlet location and the existing 30" Reinforced Concrete Pipe (RCP) will be realigned and exit through the new headwall.

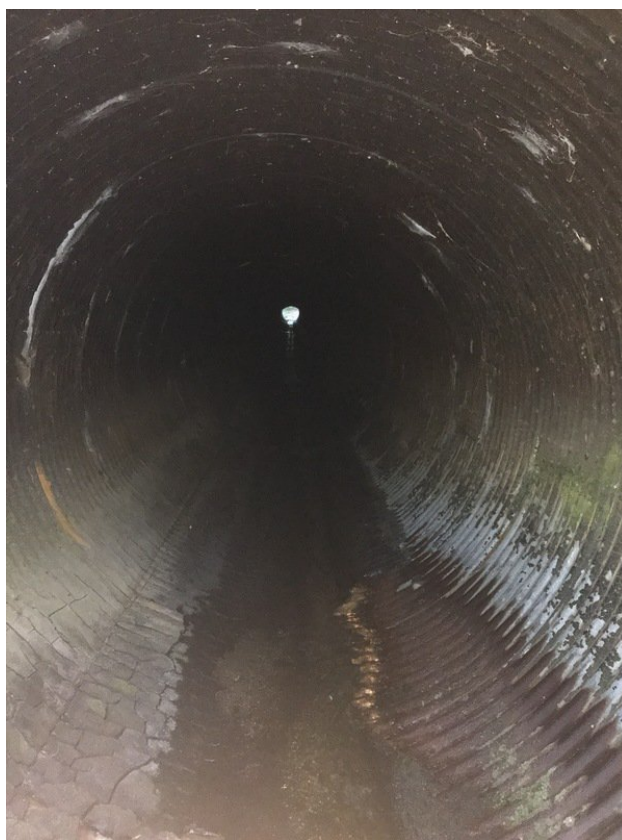
Bridge 06842

Based upon field investigation and engineering analysis of this structure, the existing structure is found to be structurally deficient due to the deteriorated condition and deformed shape of the existing 72-inch pipe. The corrugated metal pipe exhibits flattening of the crown, which is directly under Route 2 Eastbound. There are areas of asphaltic coating loss on the corner and bottom plates with heavy rust on the exposed steel. The pipe also exhibits several perforations with active water leakage. The reinforced concrete headwalls and wing walls have light map cracking and are in good condition overall.

The proposed project consists of rehabilitating the existing structure by relining the existing structure with structural concrete. Before the culvert is relined, the existing pipe will be cleaned of debris and holes will be pressure grouted. Weirs at 9" high will be placed through the culvert to promote fish passage and reduce outlet velocity. The existing end treatments will be repaired as necessary. The culvert will be installed with baffles to help decrease the outlet velocities and promote aquatic habitat. The decreased outlet velocities will also help minimize additional outlet protection needed.
