ENVIRONMENTAL REVIEW REPORT

**Community Development Block Grant – Disaster Recovery
Owner Occupied Rehabilitation and Rebuilding Program**

Applicant # 1846

**3 Marsh Road
Westport, Connecticut**

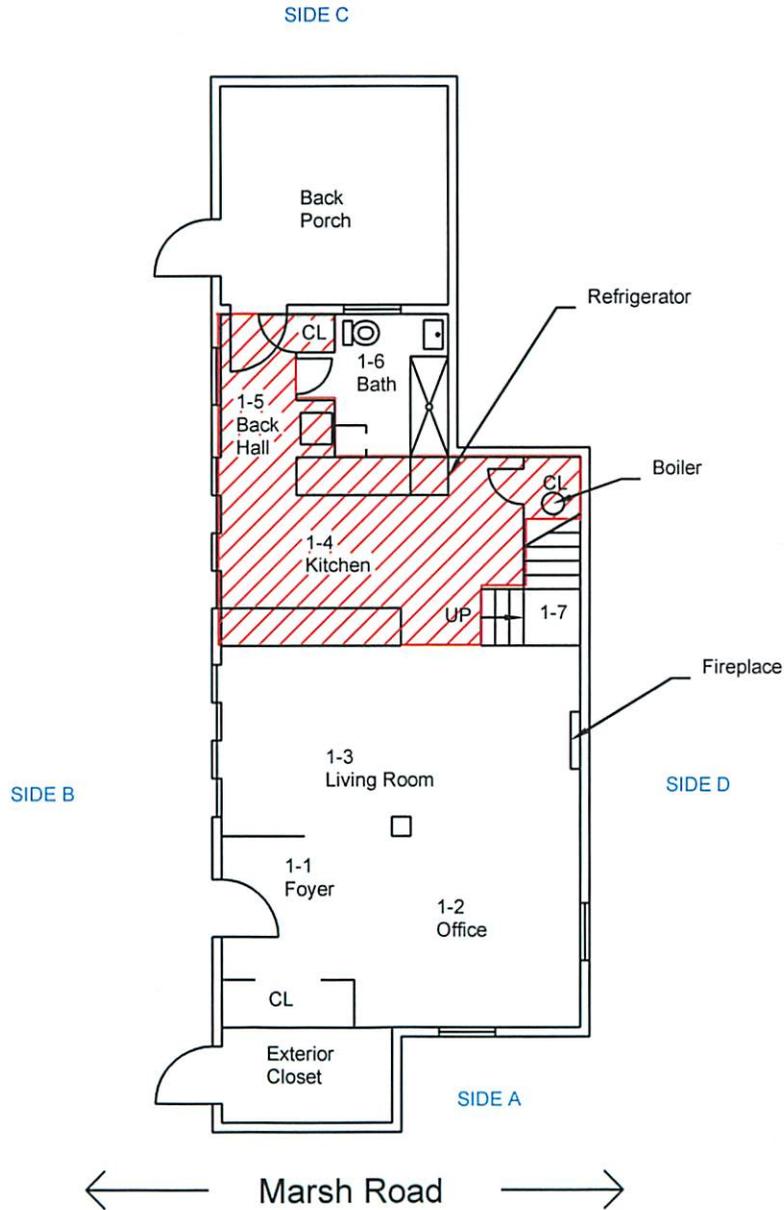
Site 026 - Main Level
 3 Marsh Road, Westport, CT
 CS# 183-481, 7/1/14

Location of ACM flooring in Scope of Inspection

All Asbestos Containing Materials (ACM) detected in the path of the inspection must be removed prior to the disturbance of these materials. Asbestos removal is regulated by federal and state agencies. Abatement work must be done by a licensed asbestos abatement contractor using proper procedures and practices, including containment, decontamination facilities, negative air units and trained and CT DPH licensed workers. Final re-occupancy testing is also required, if the building is going to be reoccupied after the asbestos removal and strongly recommended even if the building is not going to be re-occupied such as in the case of building demolition, for removal of greater than three (3) sq. ft or linear ft of ACM. A CT DPH Licensed Project Monitor is always required for final visual inspections after asbestos removal.

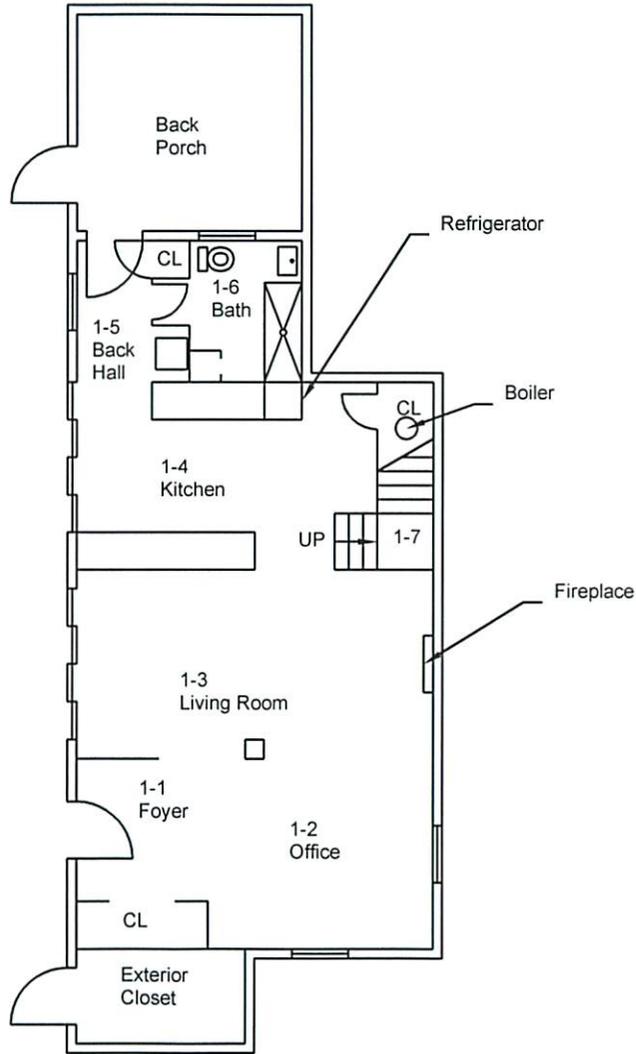
ChemScope Inc.
 Site 026 - Main Level
 3 Marsh Road, Westport, CT
 CS# 183-481, 7/1/14

Room / Material	% Moisture (WME)	Notes
1-2 and 1-3 / carpeting on wood	10-16%	No visible mold
First Floor / Sheetrock walls	10-20%	No visible mold
First Floor / Wood paneling walls	10-20%	No visible mold
First Floor / Sheetrock ceilings areas with stains	9-20%	No visible mold
First Floor / Sheetrock ceilings areas without stains	< 10%	No visible mold
Crawlspace/ Soil Floor	20-75%	No visible mold
Crawlspace/ Fg batt insulation and wooden ceilings	20-75%	Visible Mold

In general, correction of water damage requires first eliminating the source of the water. With the house being raised there should be a great increase in the ventilation below the house, which should address the excess humidity in the crawlspace. Raising the structure and installing a concrete foundation will also address the potential for mold in the soil of the crawlspace.
