September 14, 2016
Project 1403900-36-1000

**Re: National Environmental Policy Act (NEPA) Statutory Checklist for 123 High Street,
Mystic, CT**

**Project Name and Identification/Location: Owner-occupied Rehabilitation and Rebuilding Program
Application #1611 123 High St, Mystic, CT**

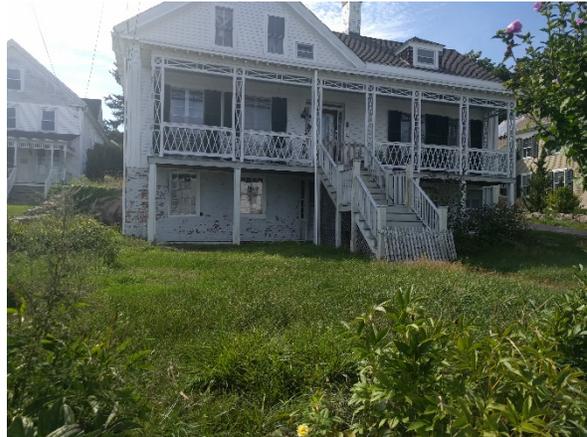
Photo 1: Front of residence; looking W.

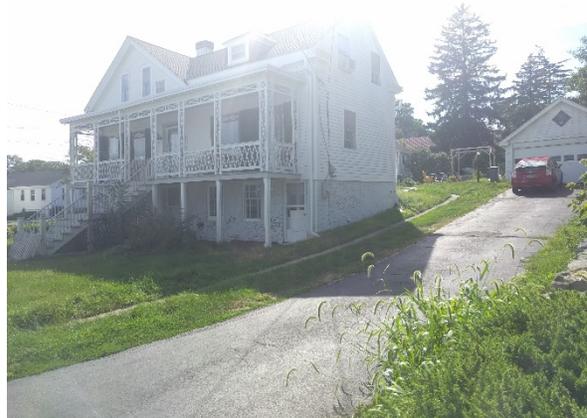
Photo 2: Front of residence; looking SW.

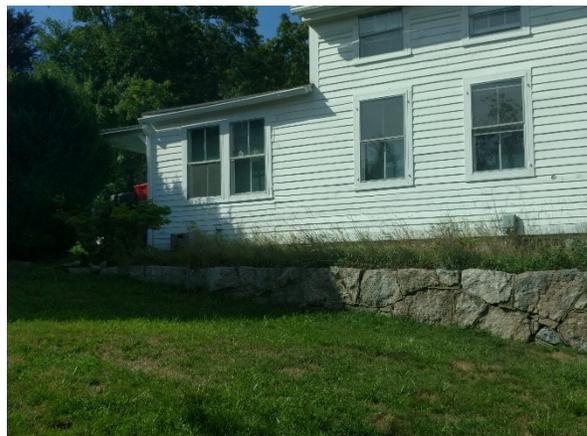
Photo 3: Side of property; looking N.

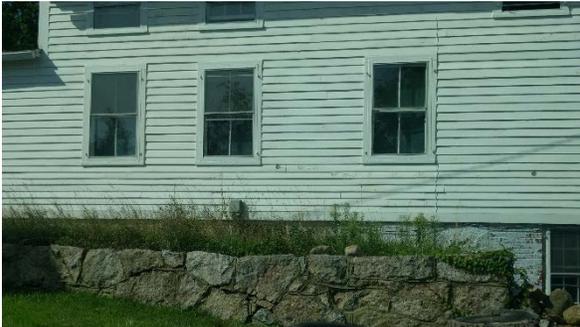
Photo 4: Side of property; Looking E.

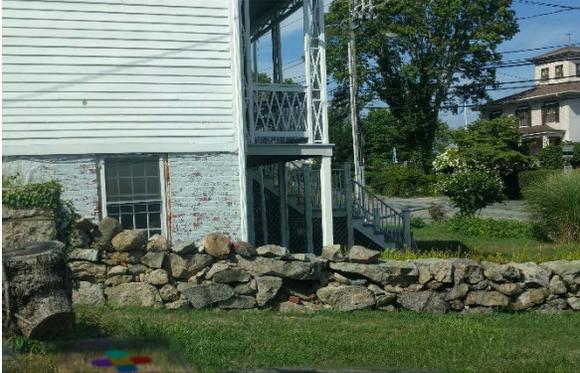
Photo 5: Side of property; Looking E.
