Project: Silver Sands
Location: Milford, CT

- THE PURPOSE OF THIS PROJECT IS TO RESTORE AND IMPROVE THE GREAT CREEK TIDE GATE AND OUTLET STRUCTURE AT SILVER SANDS STATE PARK IN MILFORD, CT. THE PROPOSED WORK INCLUDES REPAIRS AND MAINTENANCE TO THE EXISTING TIDE GATE AND INSTALLATION OF AN IMPROVED OUTLET ON SILVER BEACH.

Review and Recommendations Concerning the Self-Regulating Tidegates

December 20, 2011

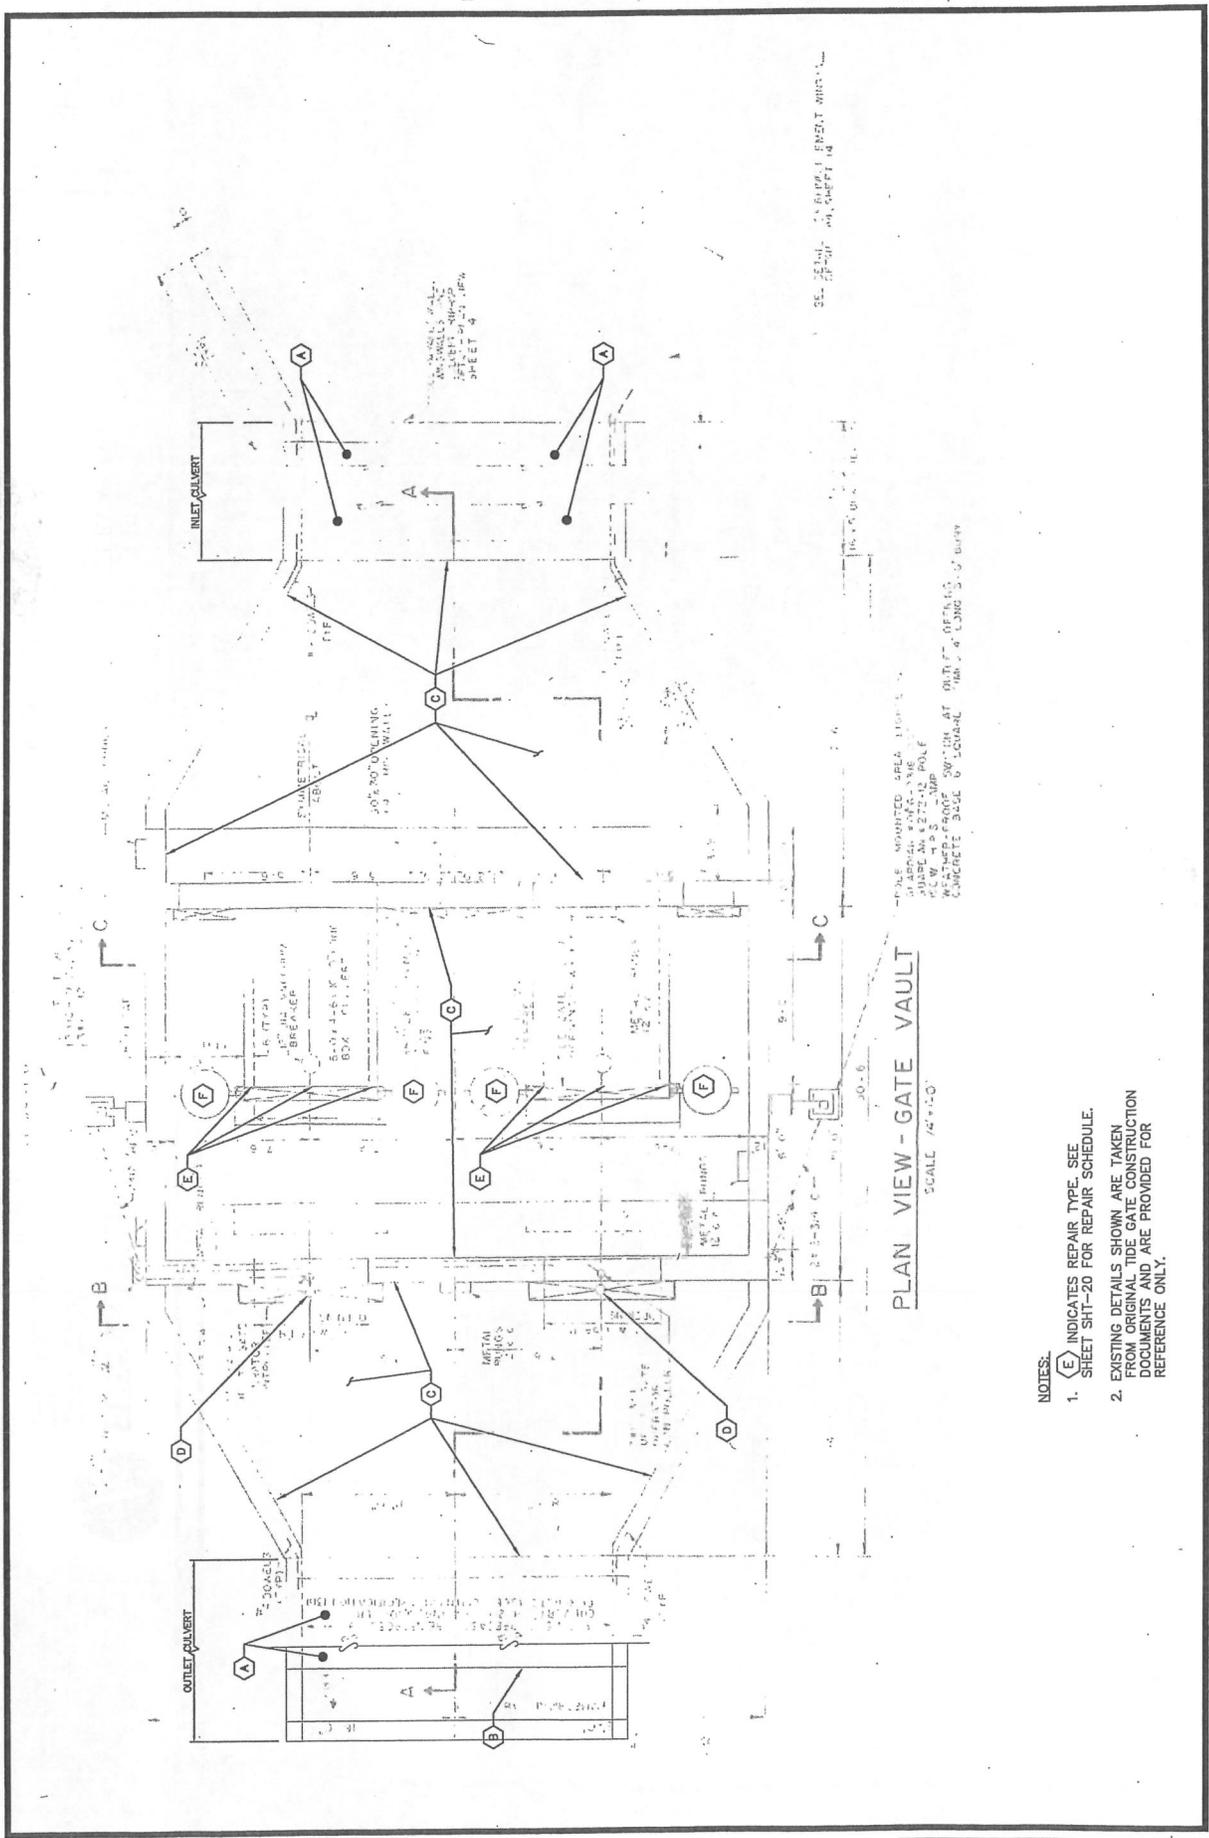
PLAN VIEW - GATE VAULT
 SCALE 1/4" = 1'-0"

- NOTES:
1. (E) INDICATES REPAIR TYPE SEE SHEET SHT-20 FOR REPAIR SCHEDULE.
 2. EXISTING DETAILS SHOWN ARE TAKEN FROM ORIGINAL TIDE GATE CONSTRUCTION DOCUMENTS AND ARE PROVIDED FOR REFERENCE ONLY.

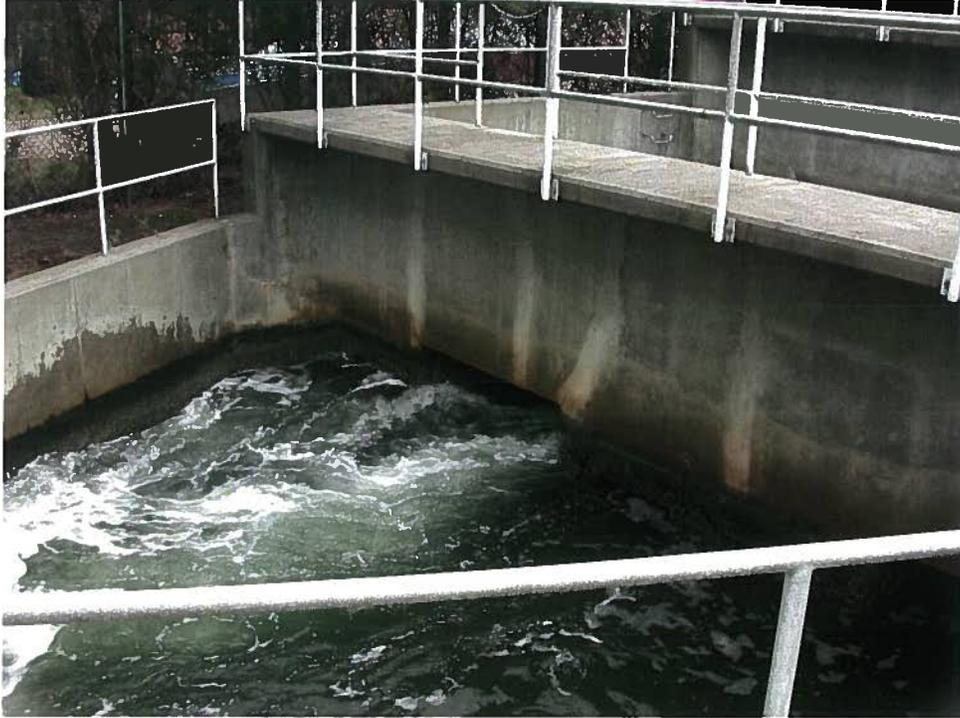
The Neoprene rubber Gasket {Plan Sheet 2, part no. 27/28} and Gasket Backing Plate {29/30} have separated at the adhesive joint on the easterly SRT along the invert's easterly side of the opening of the box culvert where it leaks at high tide (photo 3834, 4226). The stainless steel gasket backing plate is still bolted to the studs in the concrete, while the 3.5-ft. long gasket was recovered on the floor of the chamber at its transition to the creek channel upstream. The two horizontal neoprene

gasket sections, at the crown and invert of the SRT culvert, were originally designed as a single unit 7-ft. long, but the gaskets on the SRT invert and crown are composed of two separate pieces, each 3.5-ft. long, and secured with three studs in the face of the box culvert (photo 4083, 4122). The two-piece gasket is at variance with the SRT plans and I could not find any explanation for this anomalous condition. It is possible that the fabricator (SMF) could not obtain gaskets of the initial 7-ft. design and so provided an alternate that Spiegel and Zamecnik (S&Z) covered in revised shop drawings or the “as-built” provided to the state (S&Z’s representative supervised the installation of all SRTs during construction.)

3834. View of easterly culvert invert gasket leak at high tide with the SRT closed.

Recommendation: Rebond the gasket to the stainless steel backing plate and install on the studs.

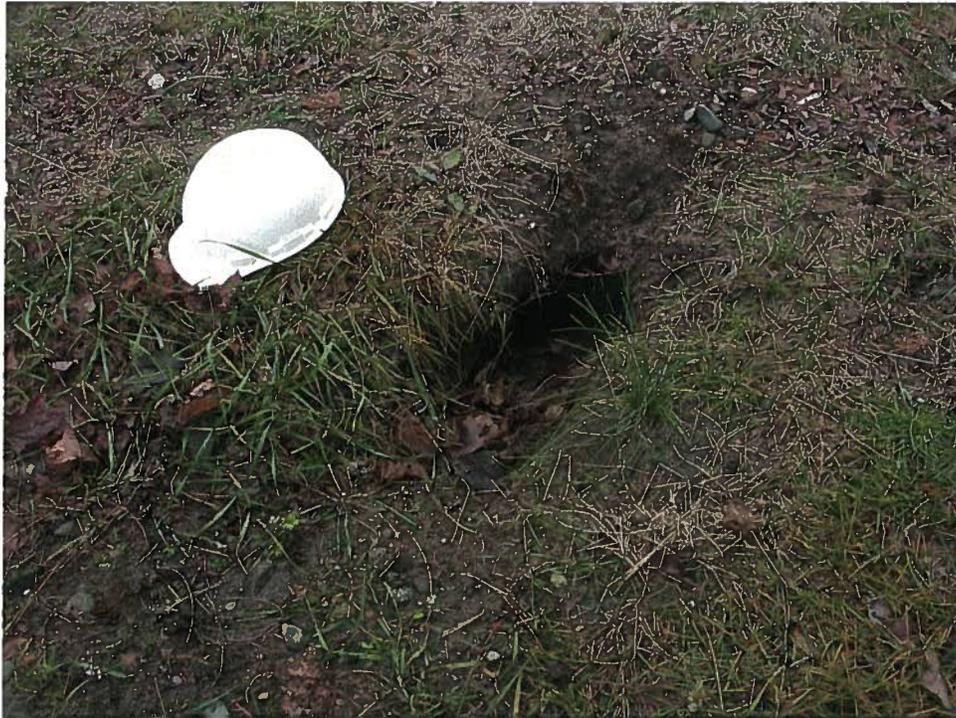
A hole was observed in the ground surface near the northeasterly corner of the chamber installation with sediment patterns in the grass indicating that the hole may have been flowing during the recent Tropical Storm Irene (photo 3877).

3877. View of hole in the soil located outside of the northeasterly corner of the concrete chamber with indications of flowage from recent Tropical Storm Irene.

Recommendation: Investigate the hole and secure as necessary.

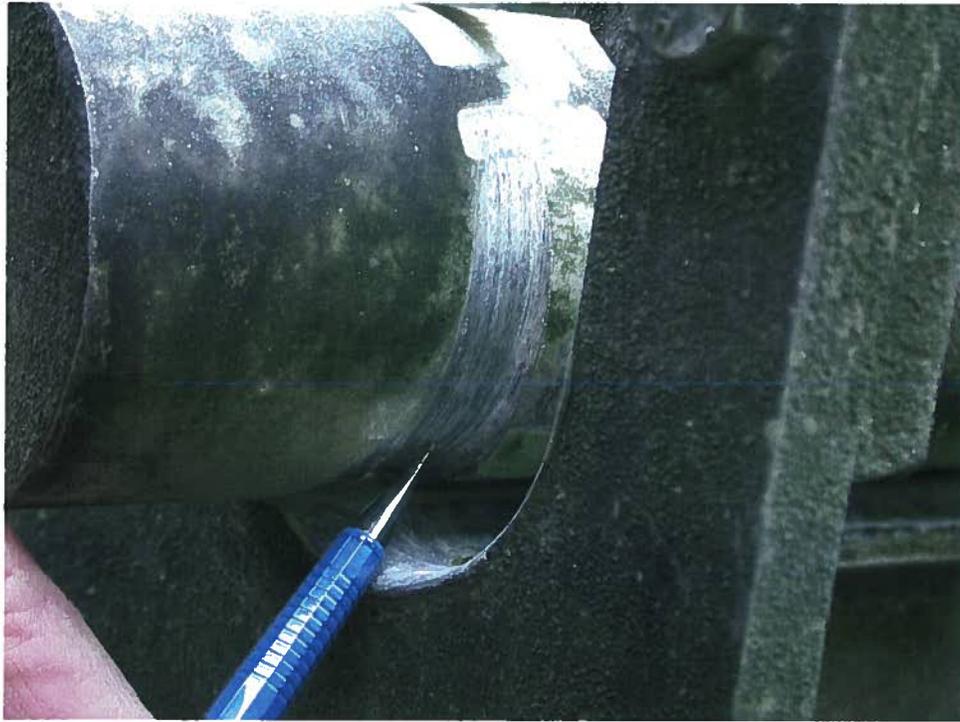
4077. View of scoring of shaft and mushrooming and down-cutting of hinge side plate due to hinge shaft rotating in place, instead of rolling forward, when gate door closes.

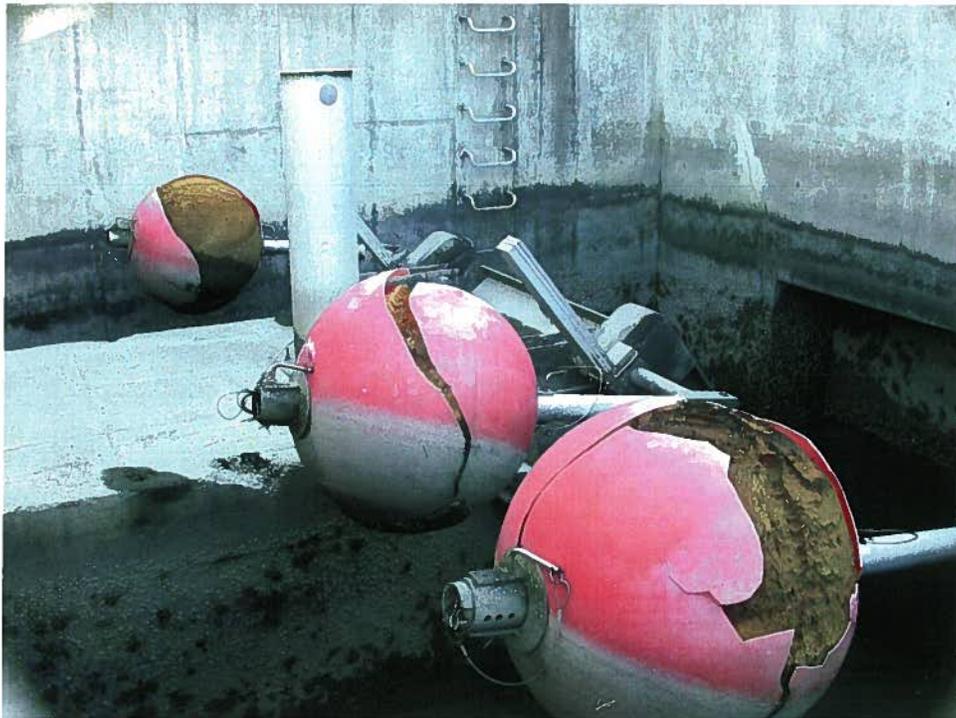
4081. View of deteriorated, but serviceable, foam-injected PVC shell upper floats and the pin-and-plate apparatus for adjusting position of float ball on the float ball arm and sleeve.

Recommendation: Replace the upper floats with all new spheres (foam-injected with internal PVC sleeve tubing as per original design plans).

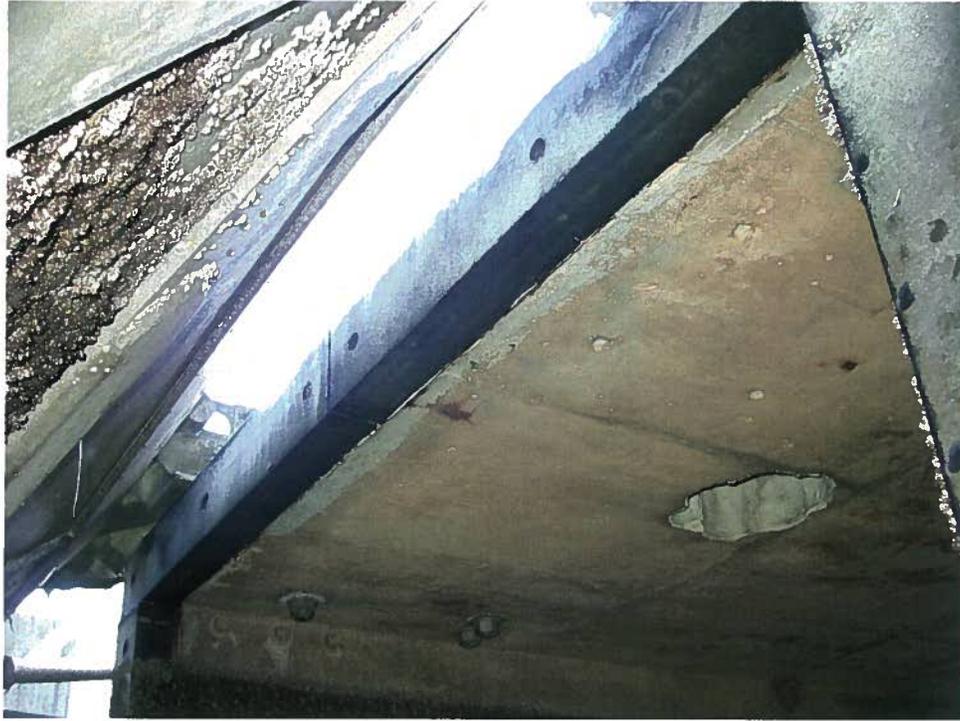
4083. View of intact two-piece (left- and right-side) gasket assembly on crown of easterly SRT for comparison with missing right-hand half gasket at invert immediately below. Vacuum-break hole in ceiling to right.

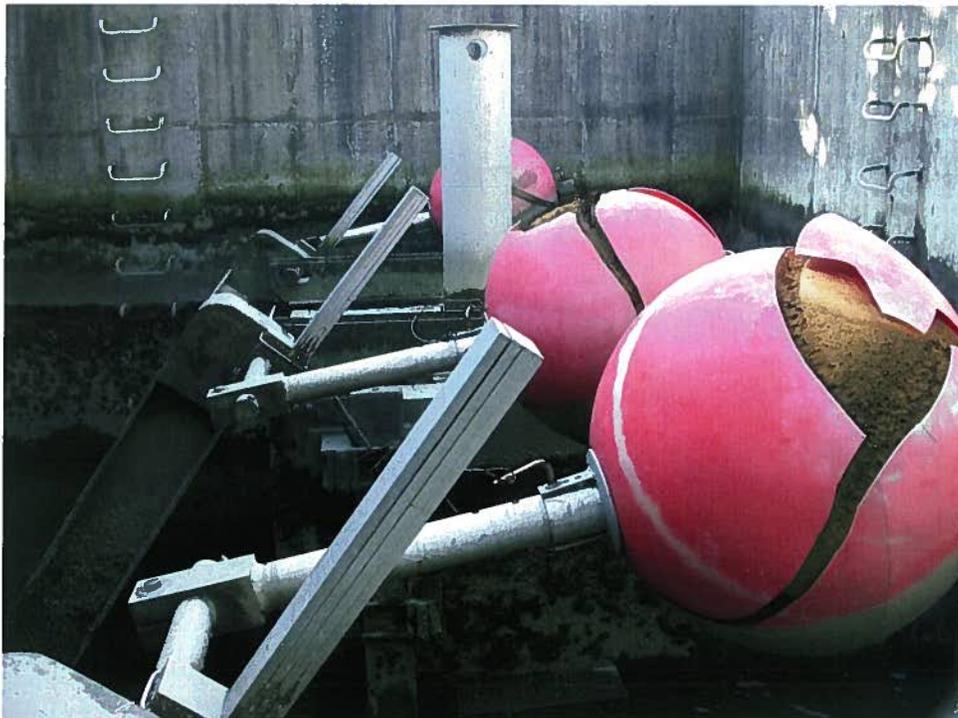
4088. Alternate view of foam-injected molded PVC shell upper floats that are still safe and functional in spite of their cosmetically-deteriorated appearance.

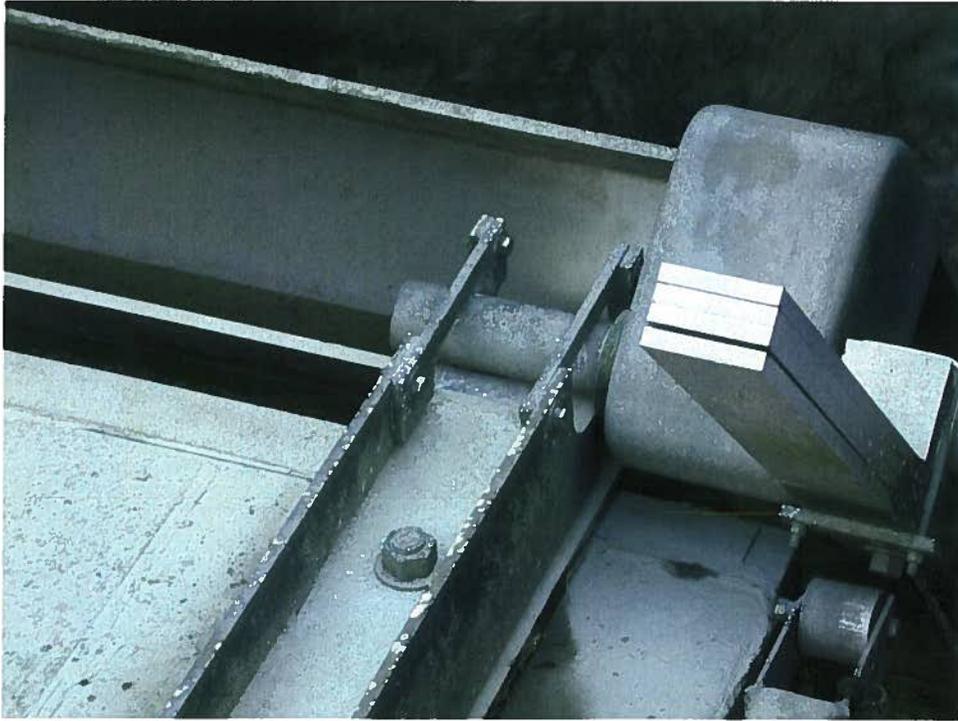
4103. View of SRT hinge shaft in hinge box, with gate door above, and leaf-spring arm, and top of vertical float in lower right. Deformation of hinge shaft and side plate is due to rotation instead of rolling in the slot.

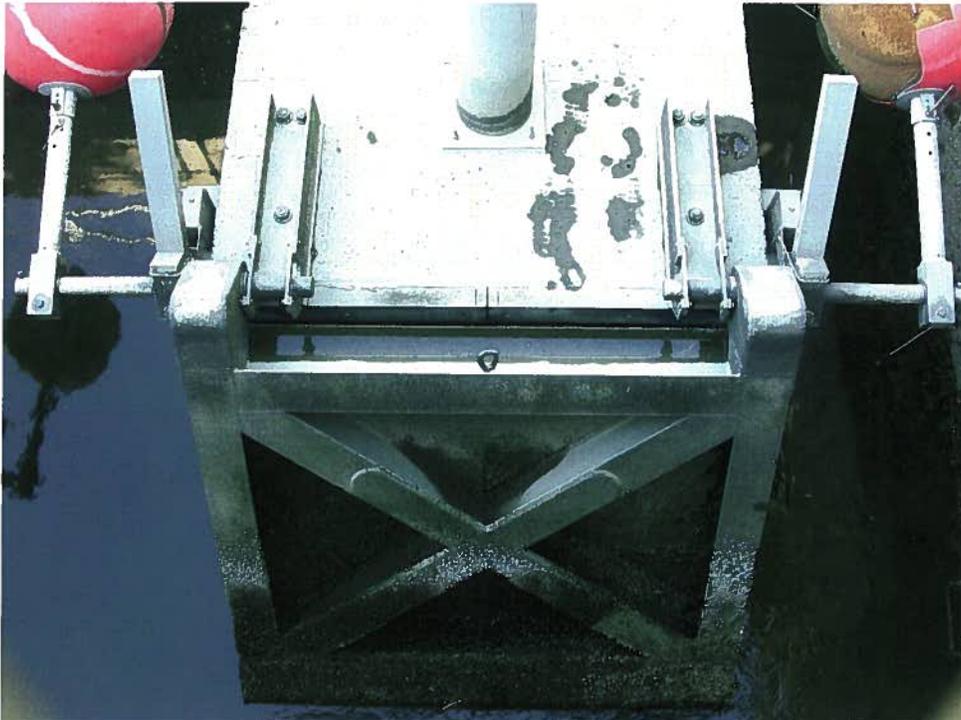
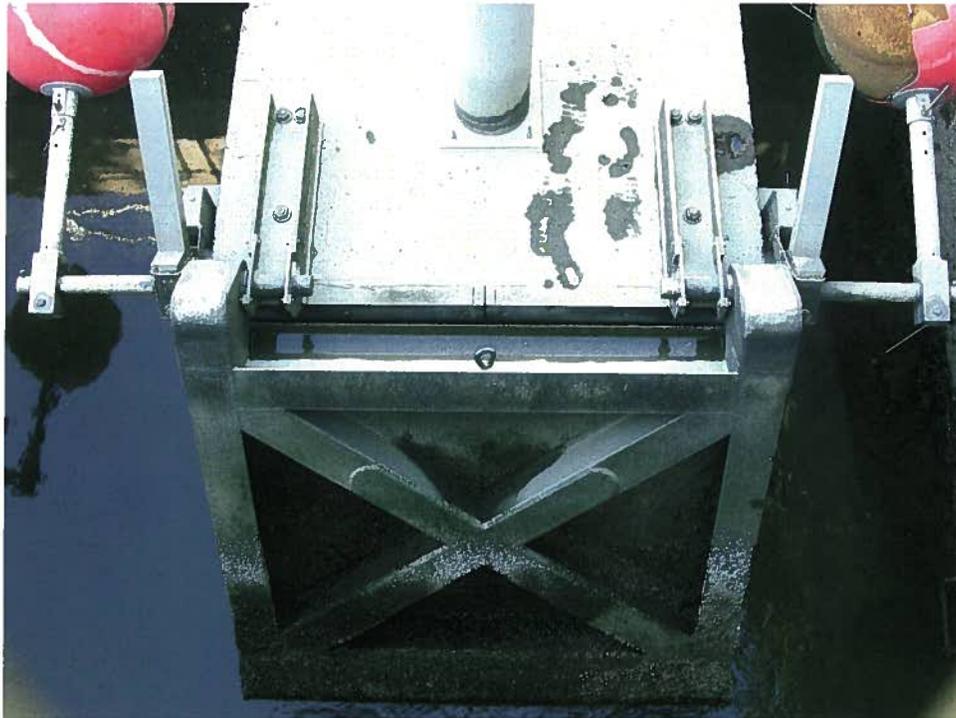
(Photo 4118. View of easterly Self-Regulating Tidegate Assembly)

4118 View of easterly SRT assembly with gate door and bottom float, hinge boxes and hinge shafts supporting leaf-springs (with vertical floats below and behind) and upper float arms and PVC floats.

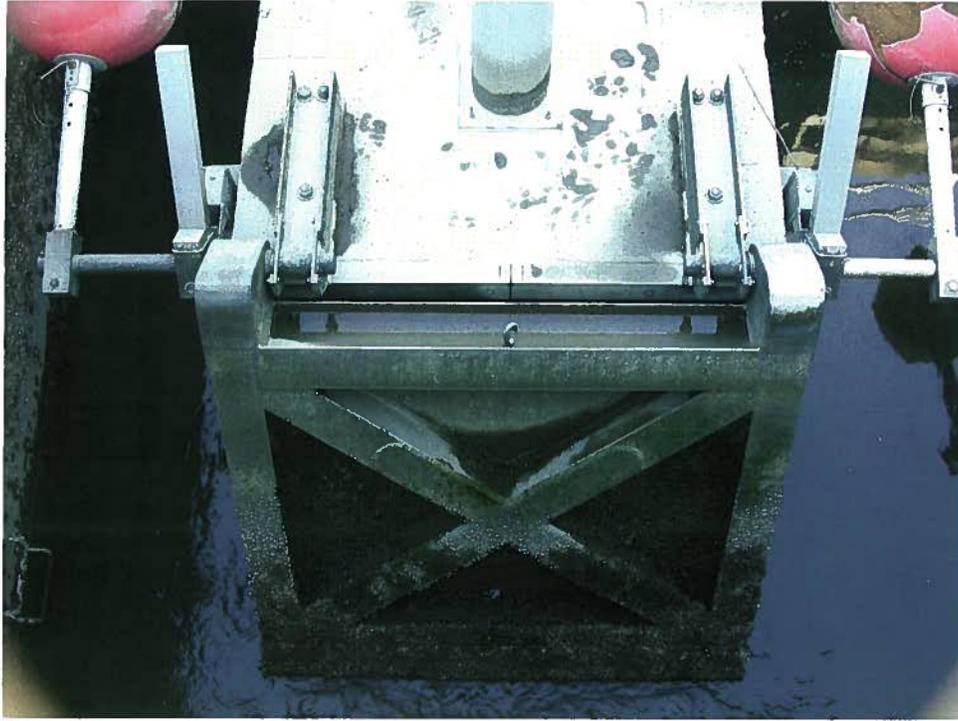
4122. View of westerly SRT at crown of culvert noting the two-piece gasket with center joint which is identical to the gasket at the invert with its right-hand half-section having separated from the mounting plate and studs.

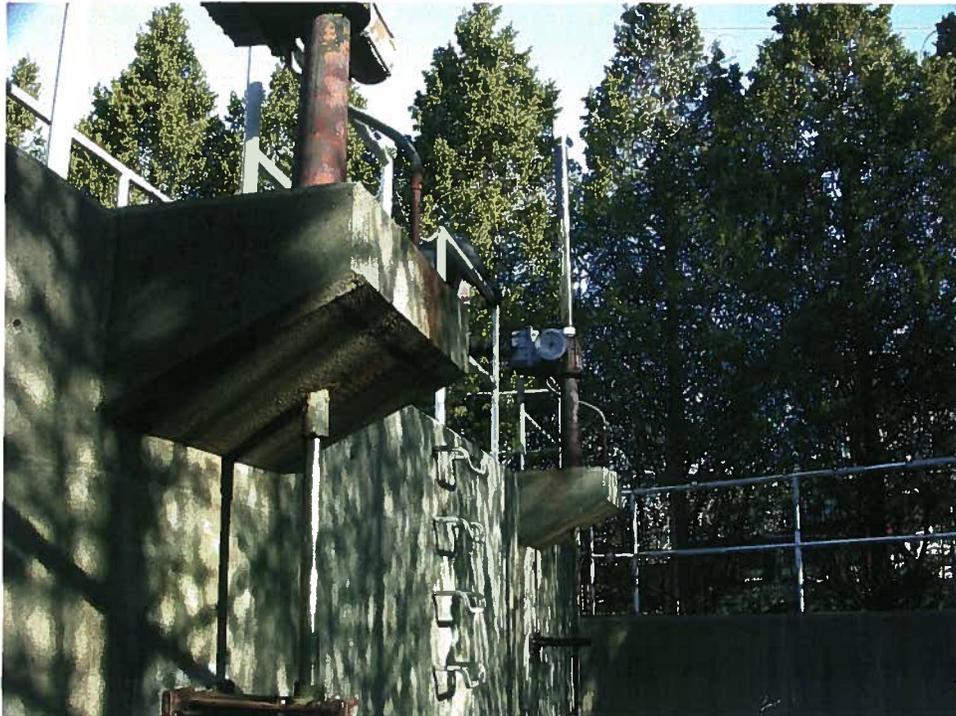
4133. View of Sluice Gate assemblies and the protective plastic sleeves with marker tapes indicating the relative positions of the sluice gate valve stems for proper operation of the SRTs.

Recommendation: The clear plastic protective sleeves over the lift screws should be cleaned or replaced and permanent reciprocal sluice-gate opening reference points clearly marked on the sleeves for systematic adjustment of the sluice-gates; and indirect adjustment of the SRTs.

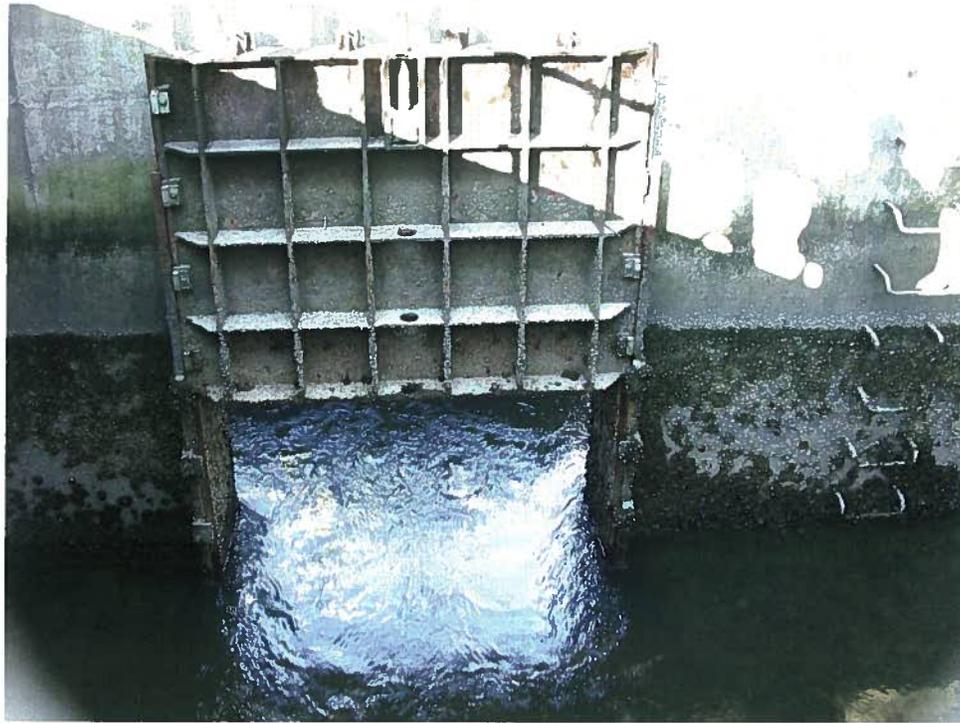
As a corrective measure, the two sluice gates are operated at very different and opposite openings, with reciprocal settings of approximately 100% (primary gate) and 25% (secondary gate) of gate capacity, so as to cause a crossing water current to flow from the fully-opened primary sluice gate, past the rear SRT that closed prematurely, and then approach from the side of the fully opened adjacent SRT (thereby avoiding the turbulent flow impinging on the leading edge of the SRT). These settings allow the SRTs to open at any time that the head inside the SRT is greater than the water level outside the SRT. The sluice gate openings are adjusted manually: 100% for the primary gate opening and 25 – 30% for the secondary sluice gate opening. The sluice gate lift-stem settings are marked at reciprocal points with tapes of different colors on the guide housings and the sluice gate settings are periodically reversed to ensure equal wear and tear on all gate assemblies.

4135. View of the westerly Sluice Gate valve leaf adjusted to the wide-open position (reciprocal position of easterly Sluice Gate is three-quarters closed) for proper operation of the SRTs located immediately behind.

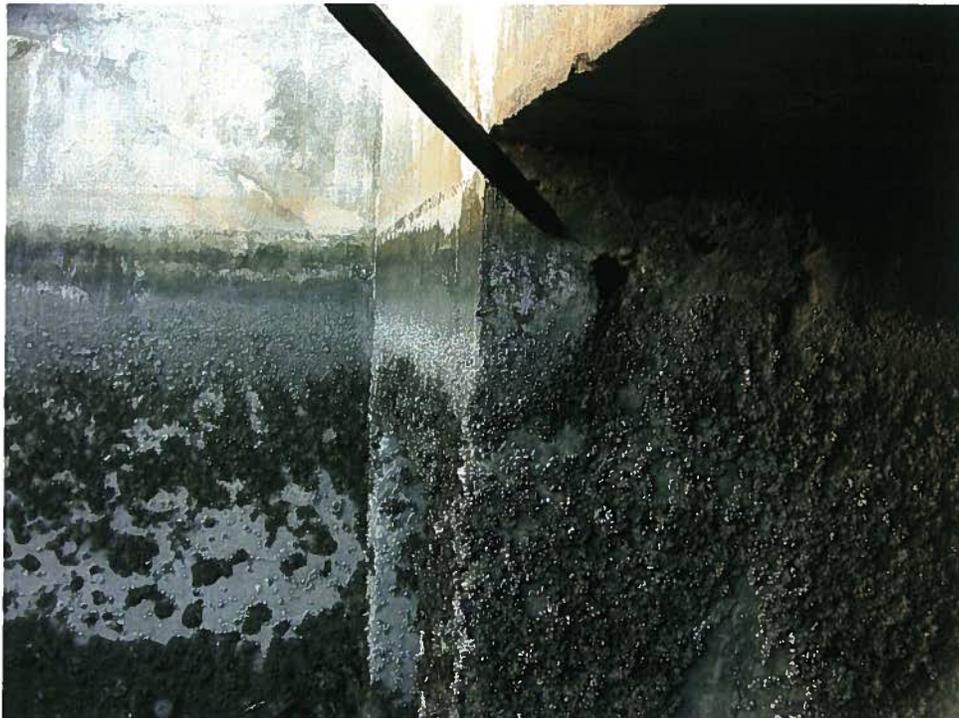
4142. View of upper easterly wall of easterly box culvert noting a hole that flows freely with water at high tide after the SRTs are closed. Steel rebar is visible in the hole.

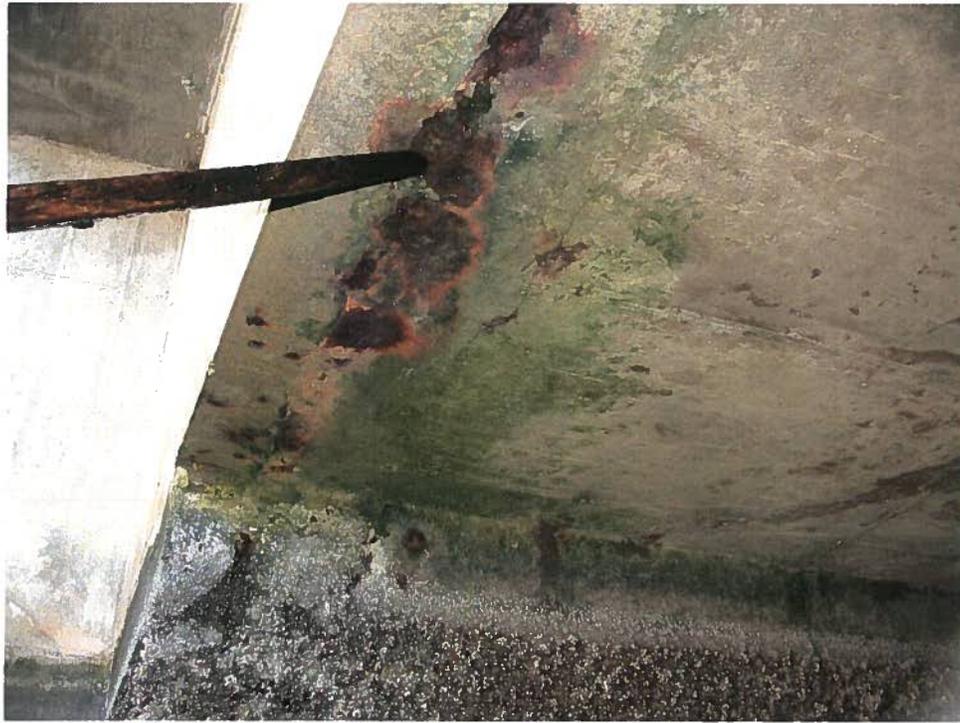
The concrete ceilings of both SRT box culverts are spalled and scaling with exposed rebar (photos 4144, 4147).

4144. View of ceiling of box culvert with rust staining the surface where the reinforcing steel is exposed through the concrete.

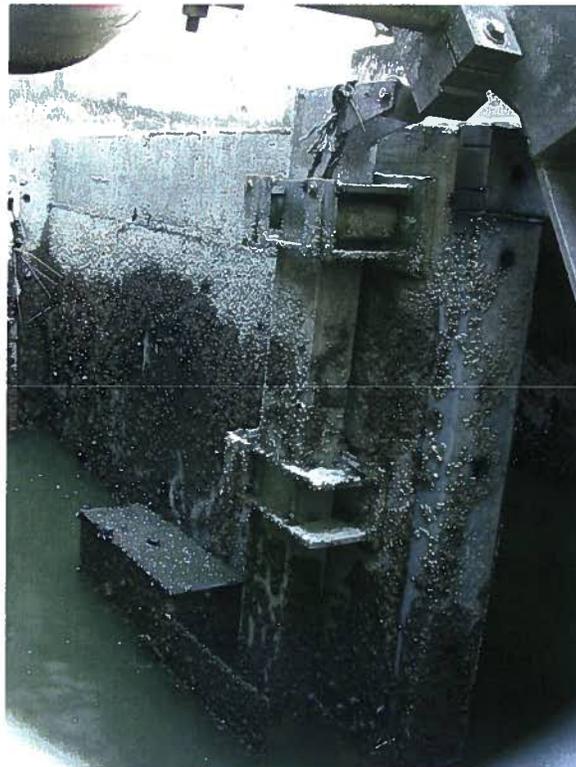
4155. View of SRT complete vertical float assembly secured with a rope in its low tide position.

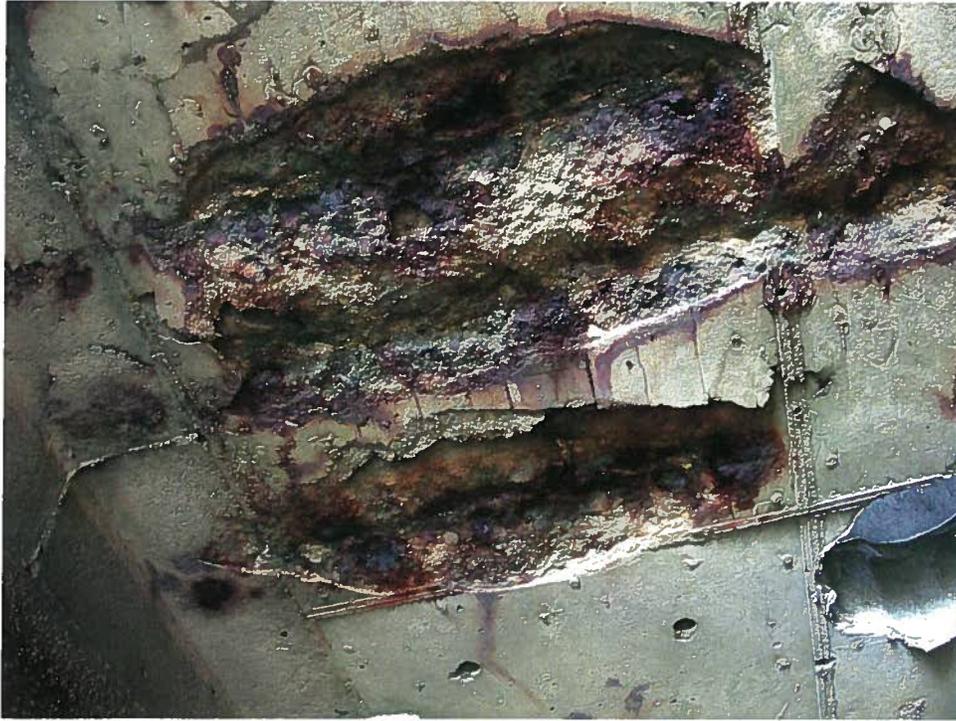
4147. View of ceiling of westerly box culvert with spalling of concrete and rust staining of surface from an earlier repair due to exposure of reinforcing rods to seawater. The hole for the vacuum-break is to lower right.

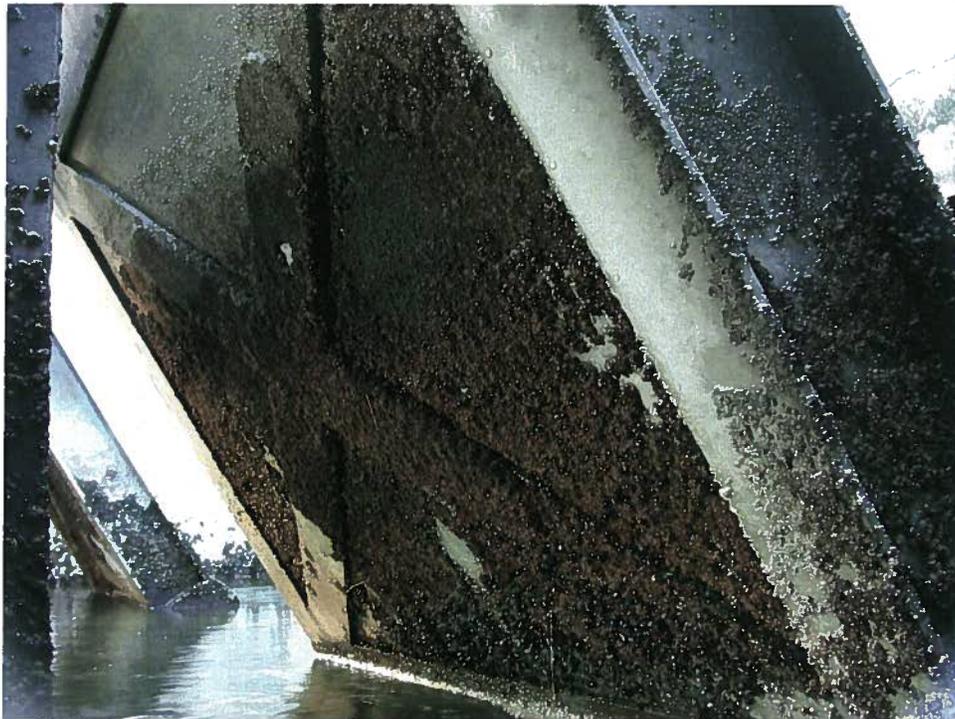
4157. View of westerly SRT gate door filler plates and cross-beams with the marine-fouling community adhering to the gate surface.

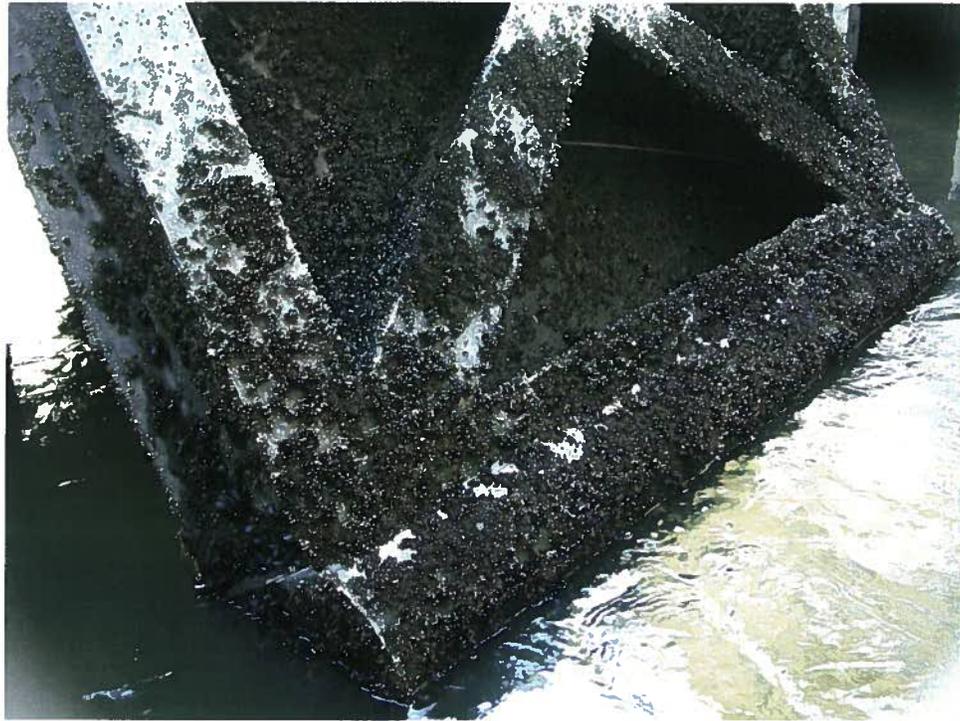
4158. View of westerly SRT gate door and bottom float with bio-fouling primarily composed of acorn barnacles and blue mussels.

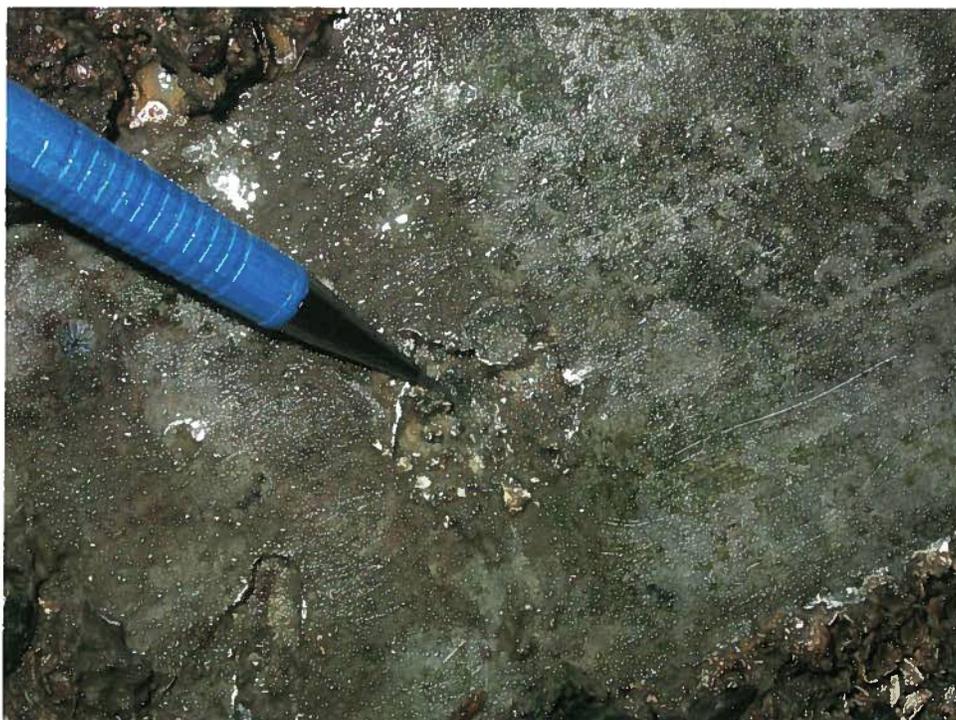
4160. View of SRT gate door cross-beam where the marine-fouling community has been scrapped away disclosing the pit corrosion beneath (center and lower left).

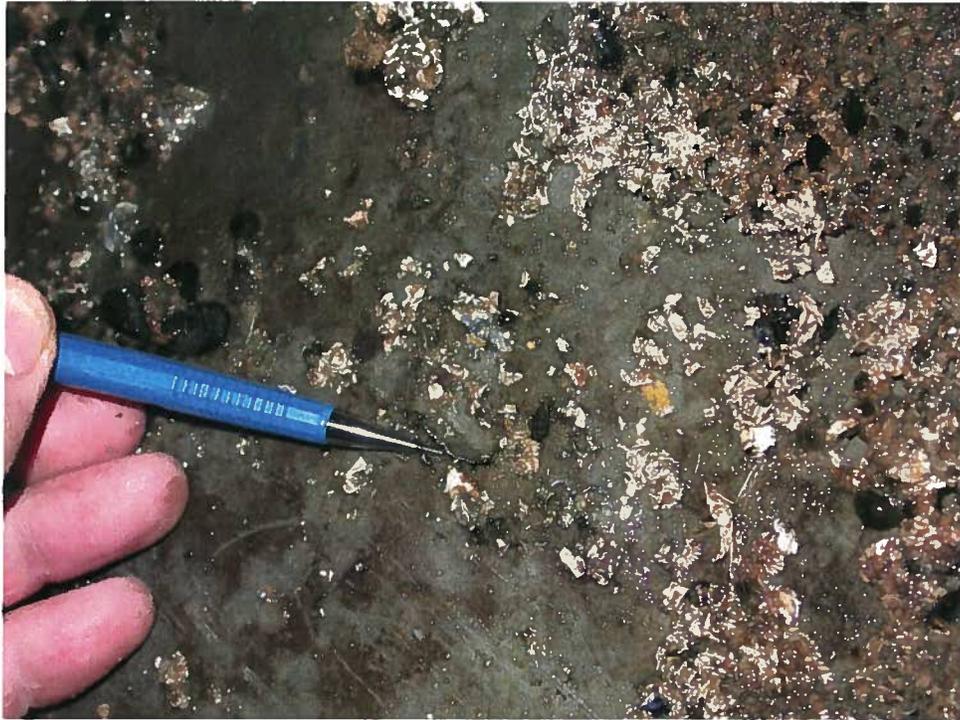
4162. View of SRT gate door triangular filler plate where bio-fouling has been removed exposing pit corrosion and exfoliation of thin aluminum blisters.

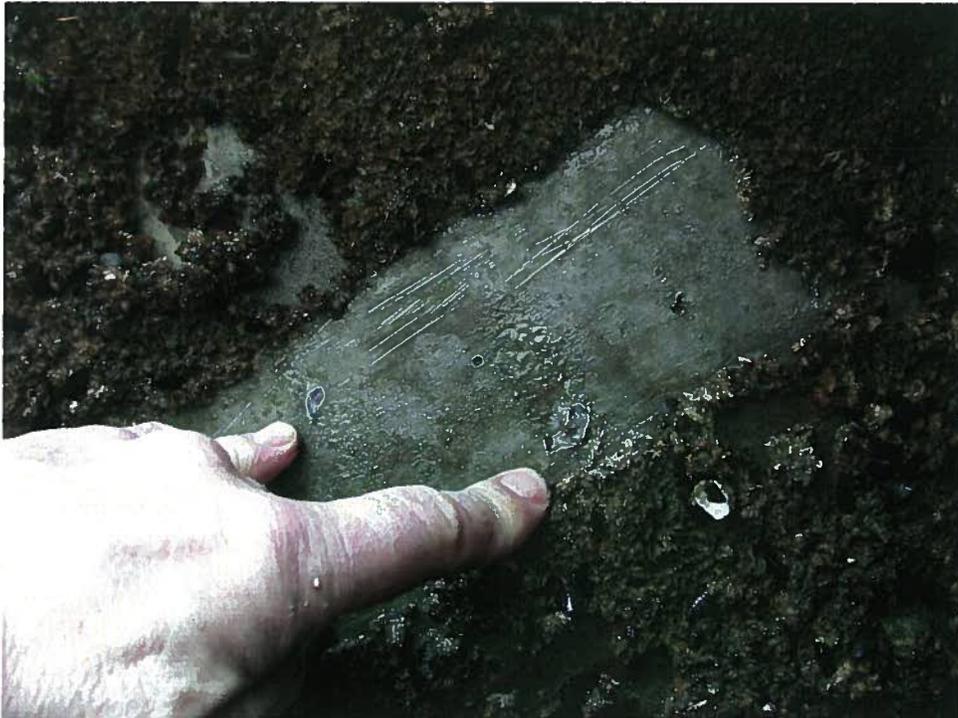
4164. View of SRT gate door filler plate where the marine-fouling community has been scrapped away exposing the scattered blisters and pit corrosion beneath.

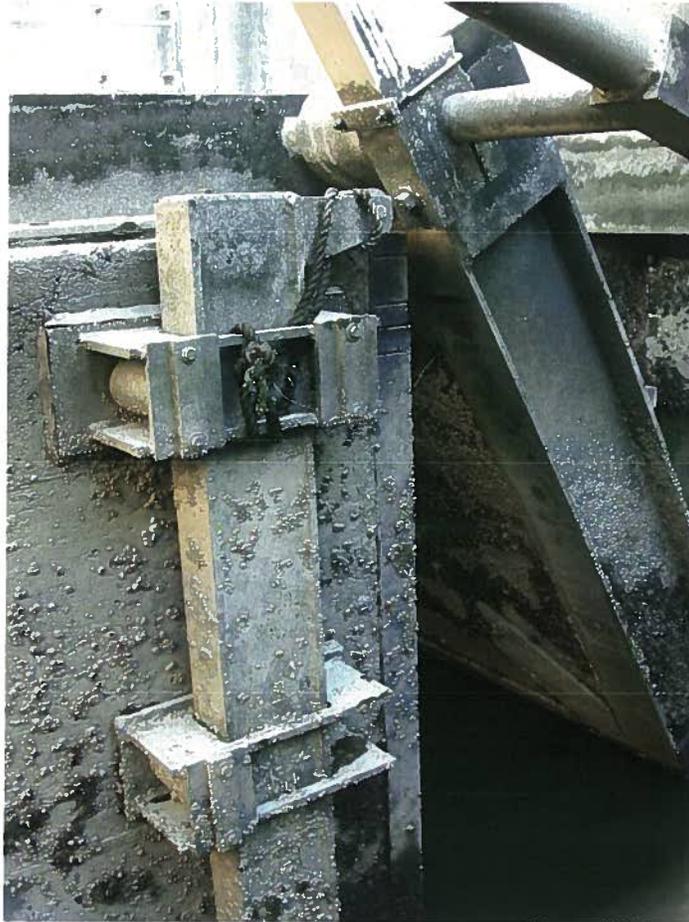
4168. Low tide view of upper portion of vertical float assembly having been deactivated with rope and stone weights because the floats are not needed at the particular upper float settings now used to close the SRTs.

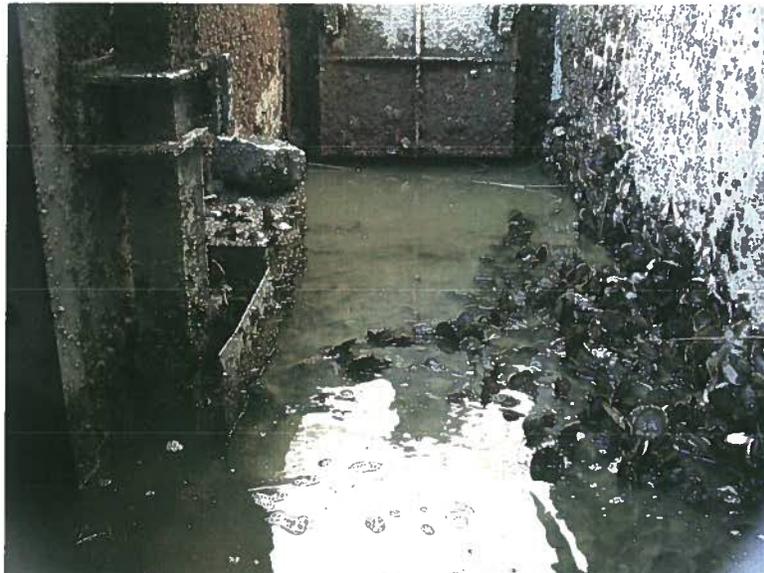
4171. Low tide view of lower portion of easterly SRT vertical float assembly (on left) noting accumulations of debris and oyster bed on wall and floor of chamber.

Recommendation: The chamber floor around the SRTs and the SRT door sumps below the gates contain accumulations of mud, shells, bottles and debris that should be removed with a shovel (photo 4171).

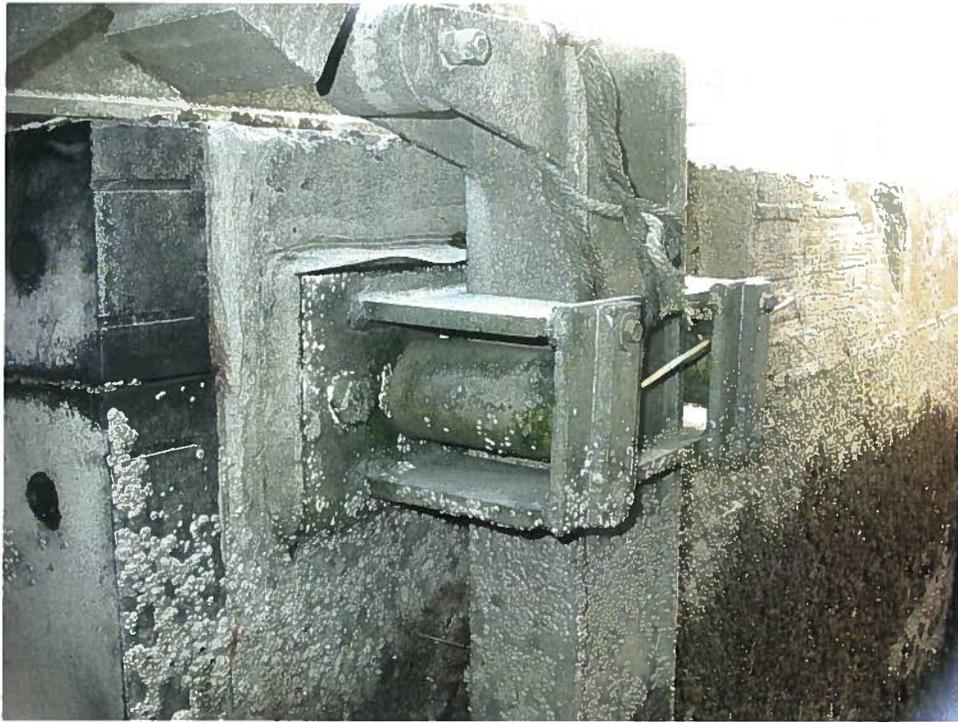
An inspection of the SRTs will show that one of its sub-assemblies has been deactivated, i.e., the vertical floats located on each side of the SRT. The SRTs have a vacuum-break or Air Purge {25} (photo 4074) which is designed for operational conditions on long culverts that allow for the development of dynamic opening forces on the rear (interior) face of the SRT following its closure. These forces are the result of closure of the SRT on an in-coming tide with the submerged culvert flowing full behind it; and developing a velocity head that, upon gate closure, caused the water to evacuate the culvert and then rush back into the culvert and run-up against the interior face of the door with its velocity head differential exceeding the tidal forces acting on the exterior face of the gate and thereby causing the gate door to reopen. This hydraulic flow reversal could be repeated several times in a harmonic sequence to the detriment of the gate assembly. To prevent this repetition or cycling, two buoyant vertical float assemblies are poised for deployment from just below and behind the gate hinge shaft {14} spring arms {8} and they float up behind the spring float arms when the gate door rotates closed. They remain deployed until they drop out of position with the receding tide water. These vertical float sub-assemblies are unnecessary at the Great Creek chamber installation with the present upper float settings for SRT closure because the chamber SRT culverts are in an essentially open system that does not become submerged and produce vacuum forces, nor does it confine discharge water in a long culvert behind it and therefore do not form the cycling forces that tend to reopen the SRT – the SRTs stay closed after closing due to the greater force of the tide water on the outside or exterior face of the SRT door. If the vertical floats deploy under these circumstances, they have no effective role in SRT operation and only serve to temporarily and slightly retard water flow when discharging from the marsh through the SRT and the four adjacent flapper tidegates. To prevent even that temporary and minor flow reduction, the vertical floats have been weighted and/or tied down to prevent their deployment (photo 4174).

4174. View of lateral float and roller assembly depicting rope used to restrain the float from deploying when the gate closes as the float is not needed at the present upper float settings for gate closure.

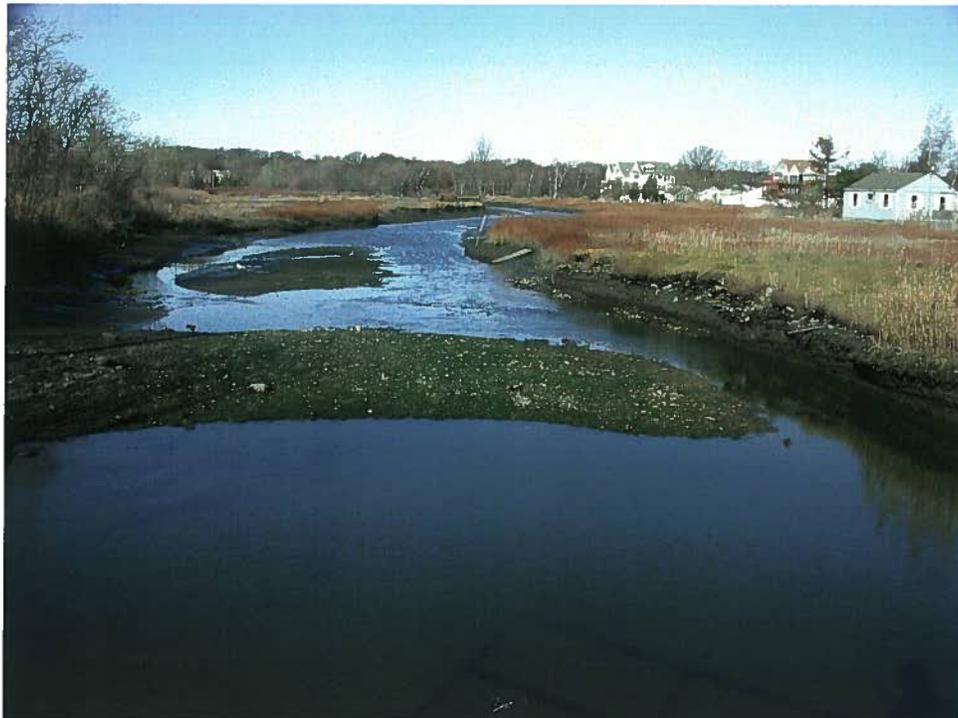
4180. View of flood-tide sandbar on the inland side of the chamber deposited from water currents carrying in beach sand and scouring of the channel bottom. Its removal could incrementally enhance water flow.
