**STATUTORY CHECKLIST [§58.35(a) activities]  
for Categorical Exclusions and Environmental Assessments**

**Project Name and Identification No. DOH #1060 – 7 Caroline Street, Milford**

RE: Hazardous Building Materials Survey for Proposed Renovations  
Location: 7 Caroline St, Milford, CT  
LEA Comm. No. 01MH4.05  
Project Number 1060

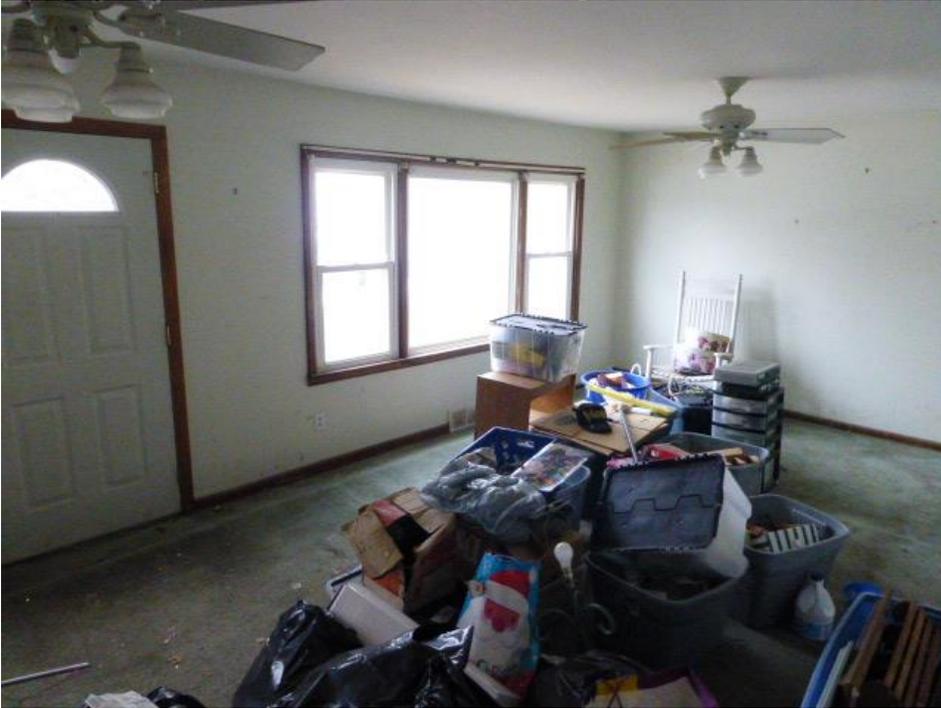
Living Room – Typical State of Sheetrock / Joint Compound

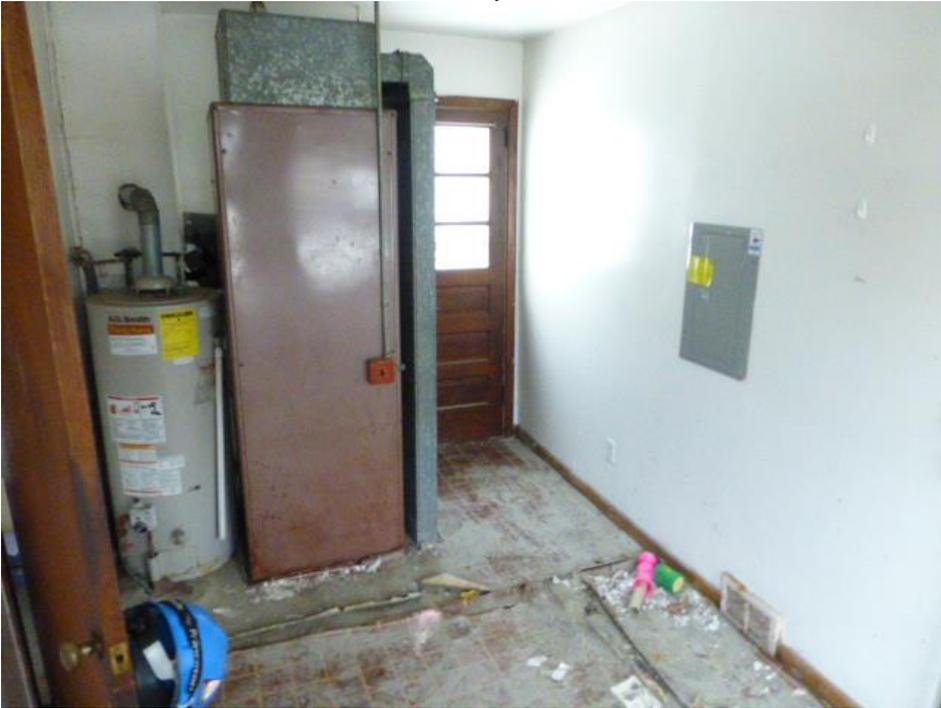
Boiler Room – Floor Tile and Boiler / Chimney Flue

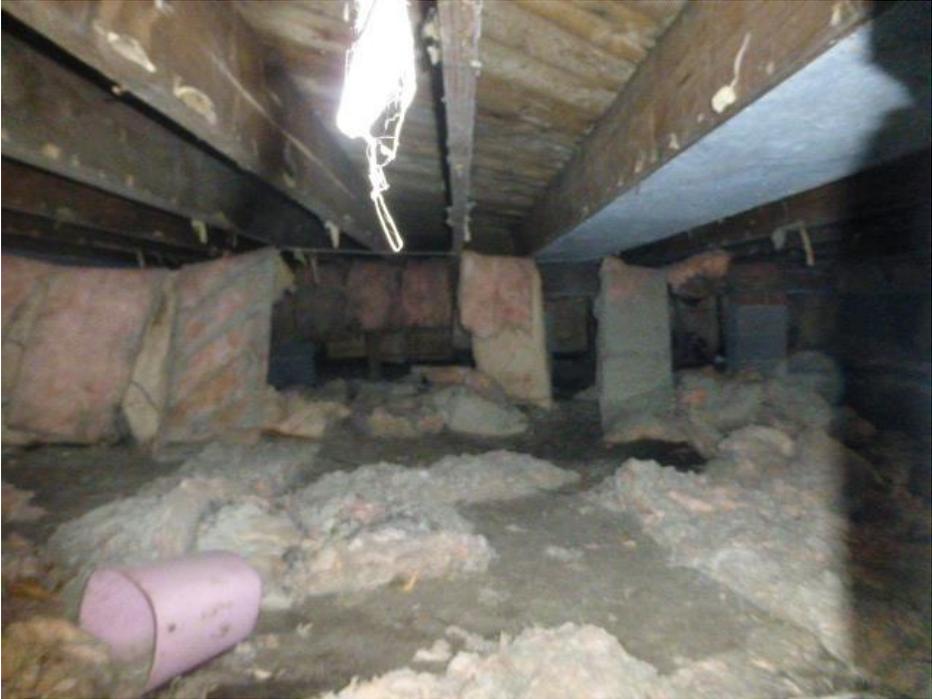
Basement – Mold Growth

LEA observed water damage and mold growths on the sheetrock of the living room and wood members of the crawl space of the dwelling. The visually impacted surfaces were swab sampled and analyzed via direct microscopic examination in order to determine mold type and relative concentration of the mold. The samples were labeled and delivered with a Chain of Custody to EMSL, which is located in Cinnaminson, NJ. The samples were analyzed by direct examination optical microscopy for mold species identification and quantification. EMSL is an AIHA approved Laboratory.

LEA recommends contracting a qualified mold remediation contractor to remove all mold affected surfaces and treatment of structural studs, headers, etc. prior to renovations.
