**ENVIRONMENTAL REVIEW REPORT**

**Community Development Block Grant – Disaster Recovery  
Owner Occupied Rehabilitation and Rebuilding Program**

**Applicant # 1215**

**13 James Street  
Milford, Connecticut**

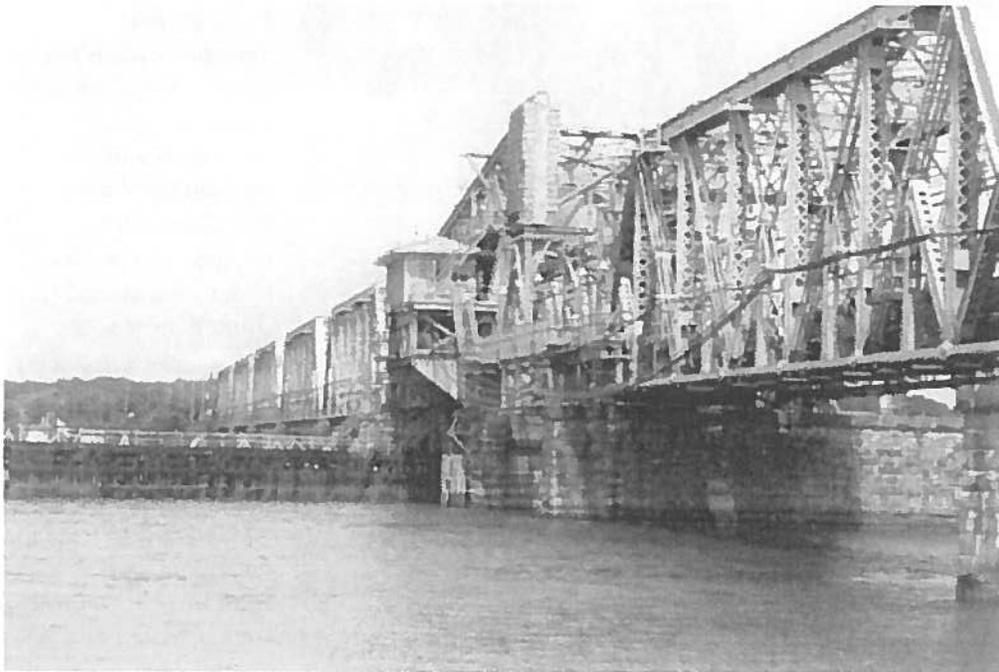
*Connecticut River Railroad Bridge, Old Lyme - Old Saybrook, camera facing northwest (HPI photograph).*

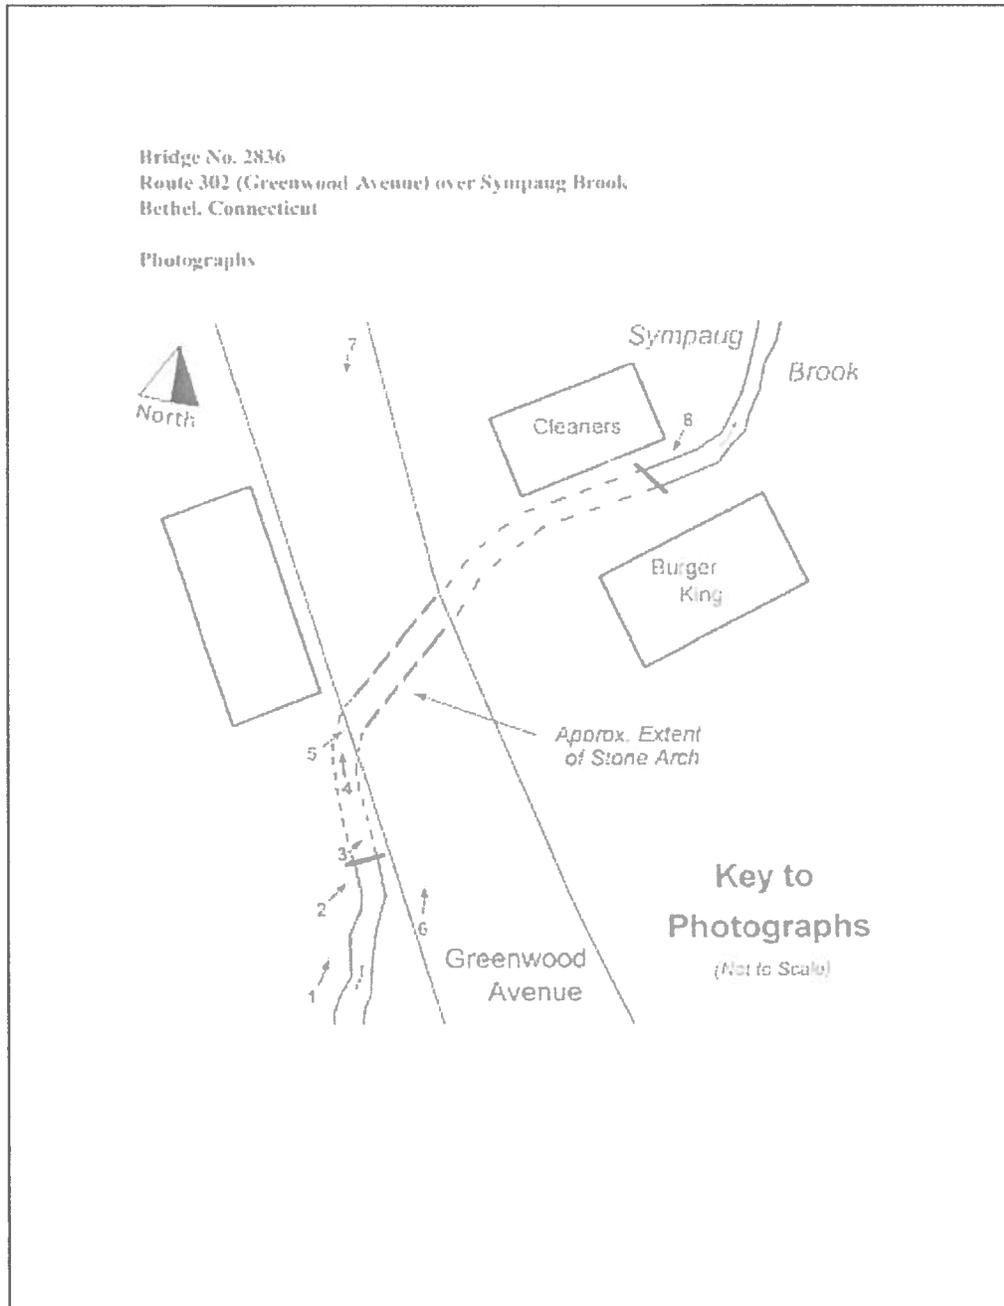
Figure 1: Example of Photographic Site Plan.

Figure 1 provides an acceptable example of a Photographic Site Plan.
