Subject: Department of Housing Superstorm Sandy Reviews
189 Hillside Avenue
Milford, Connecticut

RE: Site Investigation/Wetland Delineation
187-189 Hillside Avenue, Milford, Connecticut

RE: Hazardous Building Materials Survey for Proposed Renovations
Location: 189 Hillside Ave, Milford, CT
LEA Comm. No. 01MH4.17

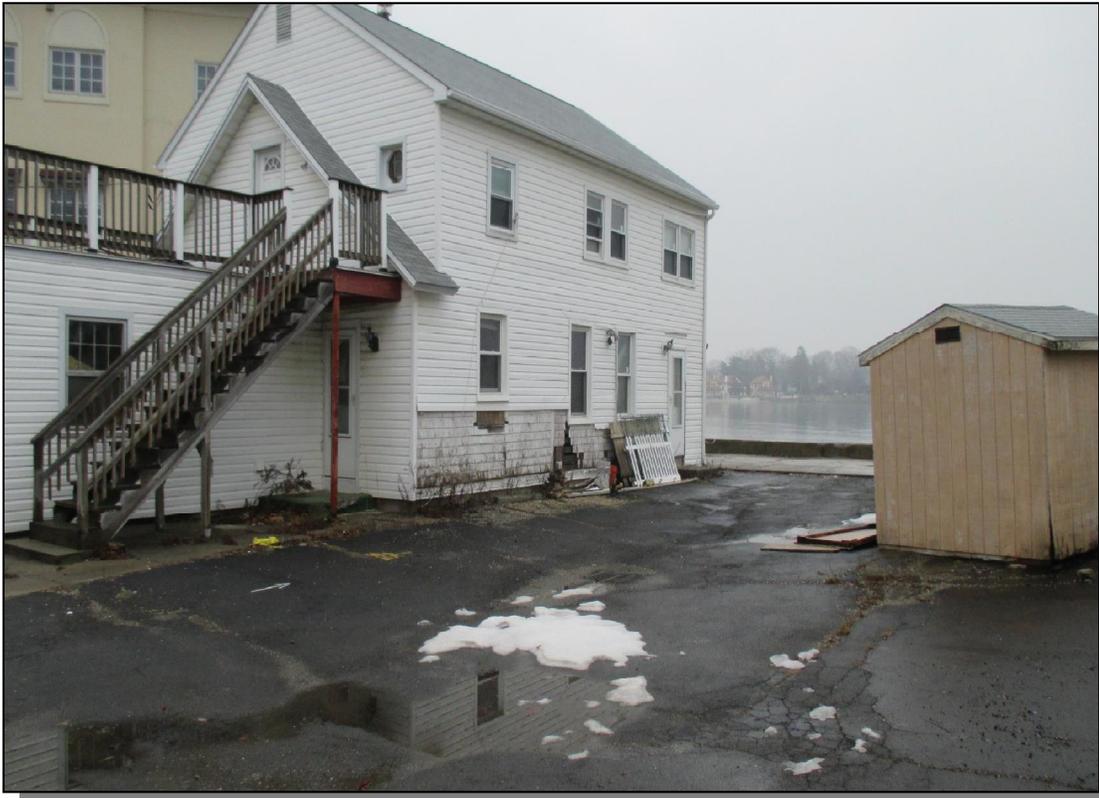
As per your request, Mr. James McManus a soil and wetland scientist with **JMM Wetland Consulting Services, LLC** (JMM) conducted a site visit at the above-referenced site on March 17th, 2015. The purpose of the investigation was to verify the absence or the presence of regulated wetland areas in accordance with the State of Connecticut Statutes (i.e. tidal and inland). The subject site is located east of Hillside Avenue in Milford, CT. The site is currently a developed lot with a single-family residence, an area of unmaintained lawn/landscaping located in the western part of the site, a shed, paved driveway, and concrete pad. A concrete seawall with coastal features to the east of the seawall are located off-site to the east of the site's eastern property line (see photos 1-2, attached).

Photo 1: View of residence (JMM photo taken 3/17/15); facing northeasterly

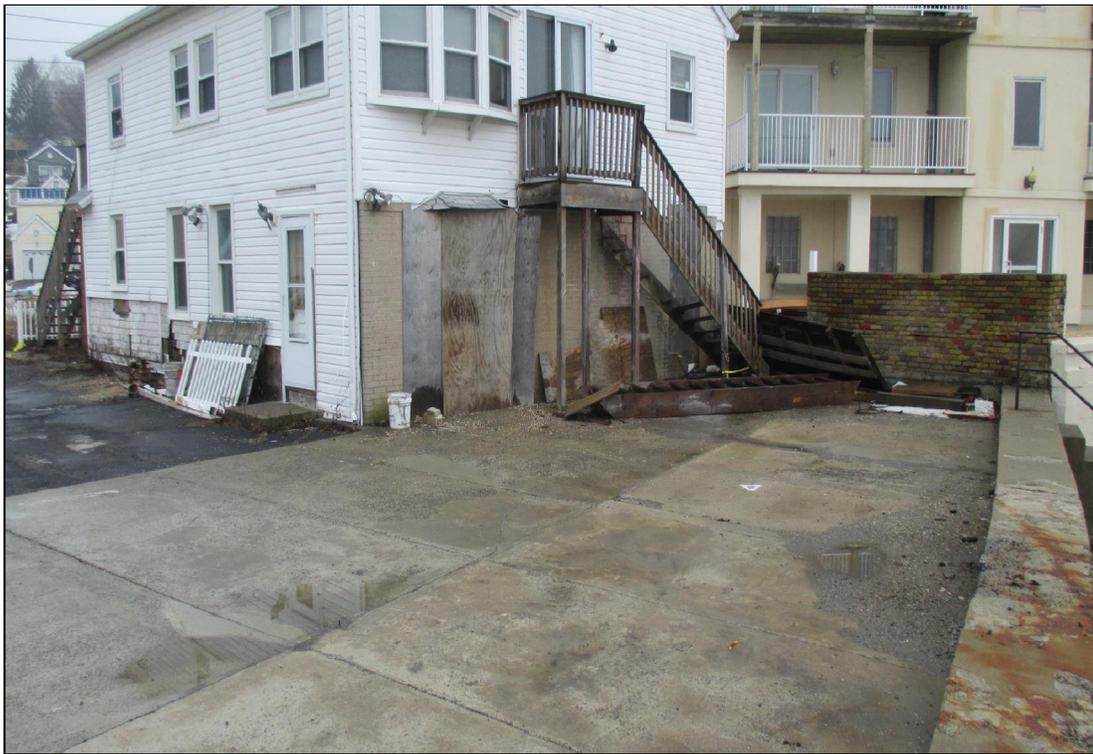
No poorly or very poorly drained soils (i.e. inland wetland regulated areas), watercourses, or tidal wetlands were identified on the overall property. However, coastal features were observed off-site to the east of the concrete seawall (see photo 2).

Photo 2: View of concrete seawall/pad and residence (JMM photo taken 3/17/15); facing northwesterly
