Subject: On-Call Asbestos, Lead, Air Quality & Demolition Compliance  
Agreement No. 04.27-01(15)  
HazMat Inspection - Bridge Nos. 02514A & 02514B, I-95 SB Goldstar Bridge and associated  
Sign Support Nos. 21216, 21217 & 21218 over the Thames River, Groton & New London, CT  
ConnDOT Assignment No. 514-5323  
ConnDOT Project No. 94-252  
TRC Project No. 222165.5323.0710

TRC performed a limited survey for hazardous building materials associated with the renovation of Bridge No. 02514A & 02514B (The SB side of the Goldstar Bridge) and 3 associated sign supports Nos. 21216, 21217 & 21218 over the Thames River in New London, Connecticut. Results of the survey identified lead paint to be present on the structural steel/metal bridge components (0.013% by weight) of Bridge Nos. 02514A and 02514B. Results of the survey also identified detectable levels of lead paint to be present on the drain pipes (0.1 mg/cm<sup>2</sup>) as well as the sign support structures 21216, 21217 & 21218 (0.0 mg/cm<sup>2</sup> – 0.3 mg/cm<sup>2</sup>). Results obtained from TCLP waste stream sampling and analysis for leachable lead from the paint on the structural steel/metal bridge components of Bridge Nos. 02

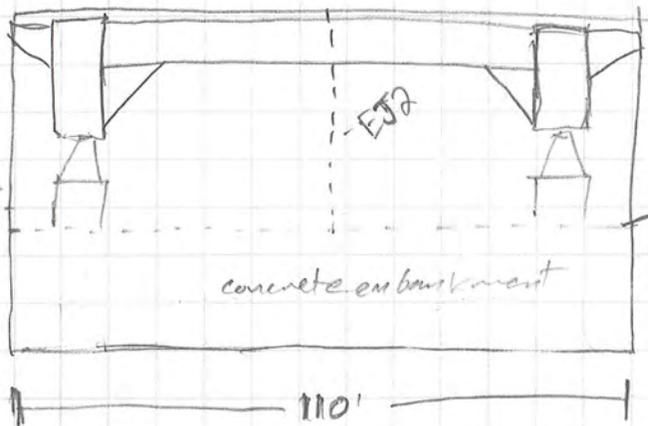
Abutment 95SB (North end)

ACM Samples

- C1 - Gray caulk along abutment/embankment
- EJ1 - tar board hard associated w/ C1
- EJ2 - black tar board
- C2 - gray caulk along sidewalk & abutment
- C3 - off white hard caulk
- C4 - tan caulk on sign #21216 support/base
- RT1 - Road tar on Asphaltic plugs
- C5 - black tar along abutment

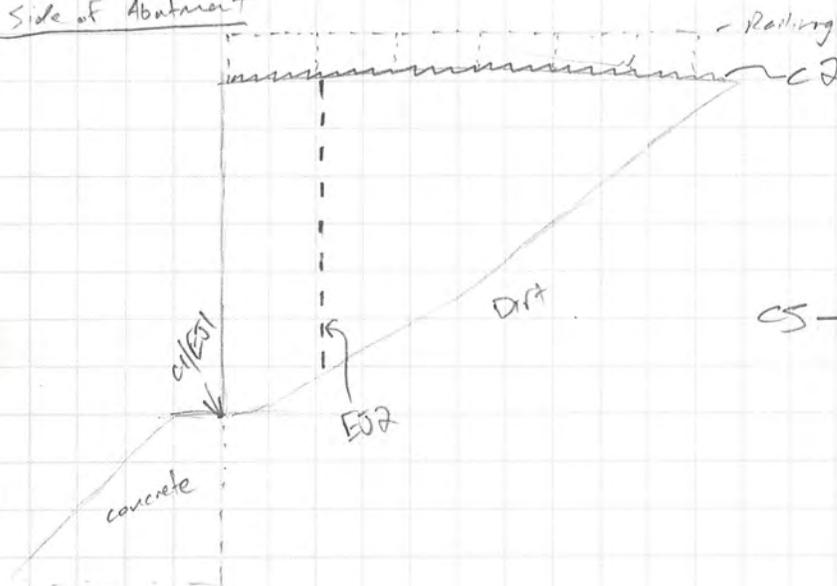
Side of Abutment

C2 along abutment on top (not on bridge)

C3 is every 16' in between concrete wall along sidewalk & divider (a lot has fallen off sporadic)

C3 also on base of street lights

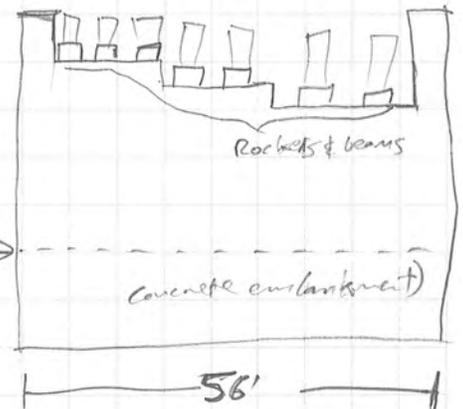
Abutment 95 SB (South end)

Notes: Railing & Fence unpainted w/ rubber pads on railing supports

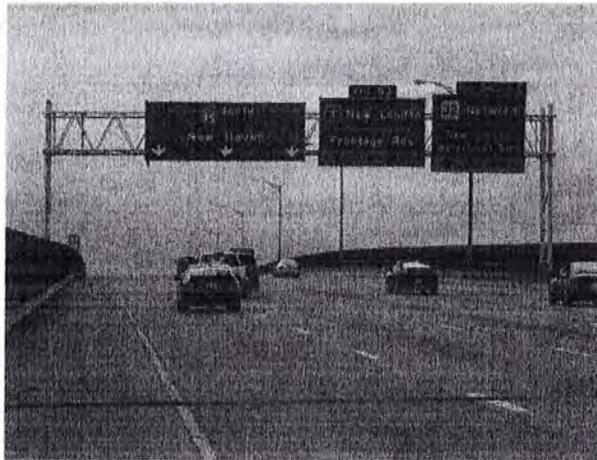
<b>Sign Structure No.</b>	<b>21216</b>
<b>Structure Type:</b>	<b>42 OTS</b>
<b>Town:</b>	<b>Groton</b>
<b>Route &amp; Direction:</b>	<b>I-95 SB</b>
<b>Mile Point:</b>	<b>94.41</b>
<b>KM Point:</b>	<b>151.94</b>

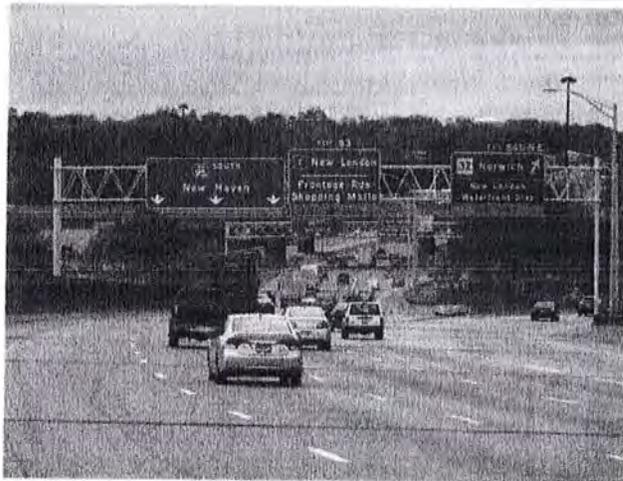
<b>Sign Structure No.</b>	<b>21218</b>
<b>Structure Type:</b>	<b>42OTS</b>
<b>Town:</b>	<b>New London</b>
<b>Route &amp; Direction:</b>	<b>I-95 SB</b>
<b>Mile Point:</b>	<b>93.64</b>
<b>KM Point:</b>	<b>150.70</b>
