Subject: On-Call Asbestos, Lead, Air Quality & Demolition Compliance  
Agreement No. 04.27-01(15)  
HazMat Inspection – Signage Replacement, Route 15 NB & SB, Mileage Points 0.00 to 38.30, CT  
ConnDOT Assignment No. 514-5578  
ConnDOT Project No. 173-472  
TRC Project No. 222165.5578.0710

TRC performed a limited survey for hazardous building materials associated with the Signage Replacement along Route 15 NB & SB, Mileage Points 0.00 to 38.30 in Connecticut. TRC's survey consisted of inspecting a representative amount (~10%) of side mounted signage poles (two leg I-beam support) and variable message sign supports, as well as, the sign supports associated with Site Nos. 1 through 4. No detectable amounts of lead were identified in the paint on the backside of the actual signs themselves that were associated with the side mounted signage supports. Detectable amounts of lead in paint were identified on the side mounted signage supports, VMS supports and the three (3) cantilever signage supports at Site Nos. 1, 2, & 3. The bridge mounted signage support inspected at Site No. 4 was found to be unpainted (galvanized), therefore no lead paint was identified. Results obtained from TCLP w

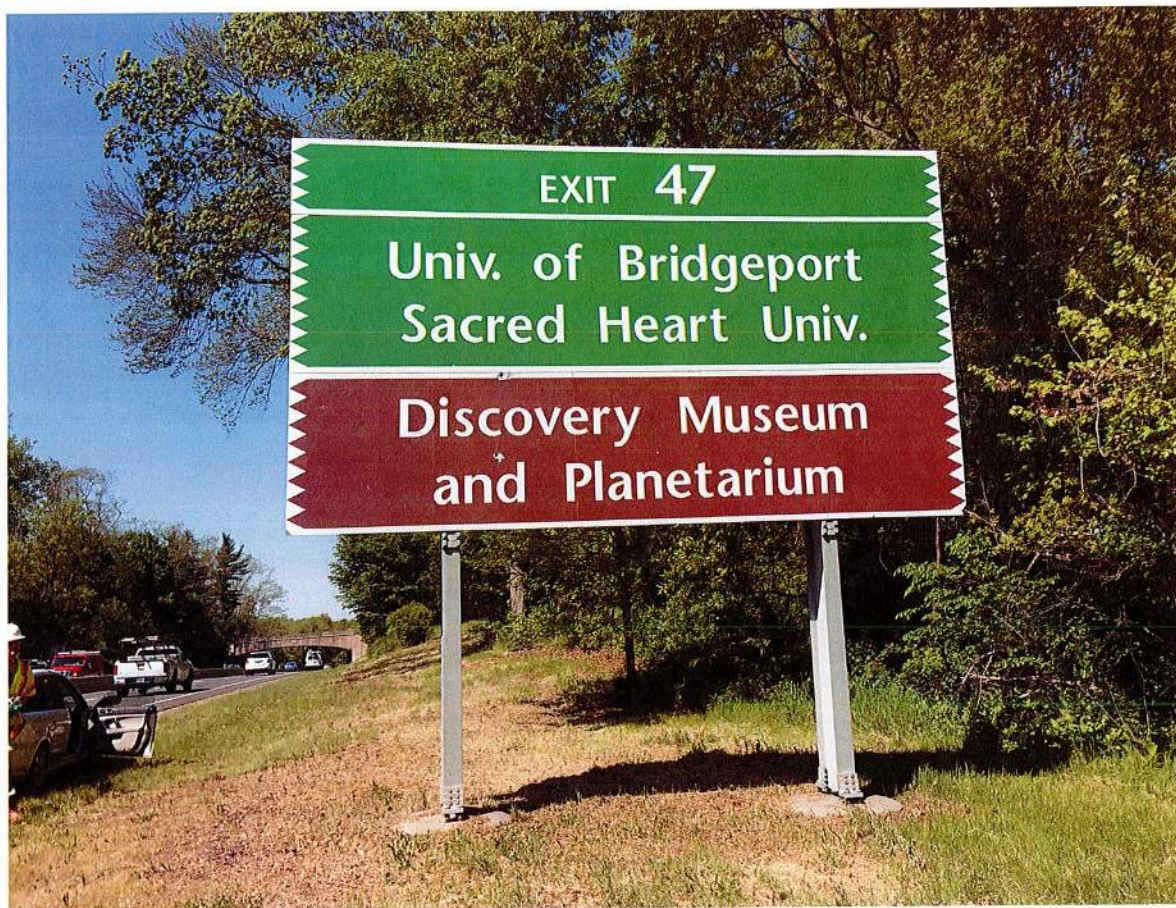
**PHOTO 1**

Typical Painted Side-Mounted Sign Support (2 leg I-beam support)

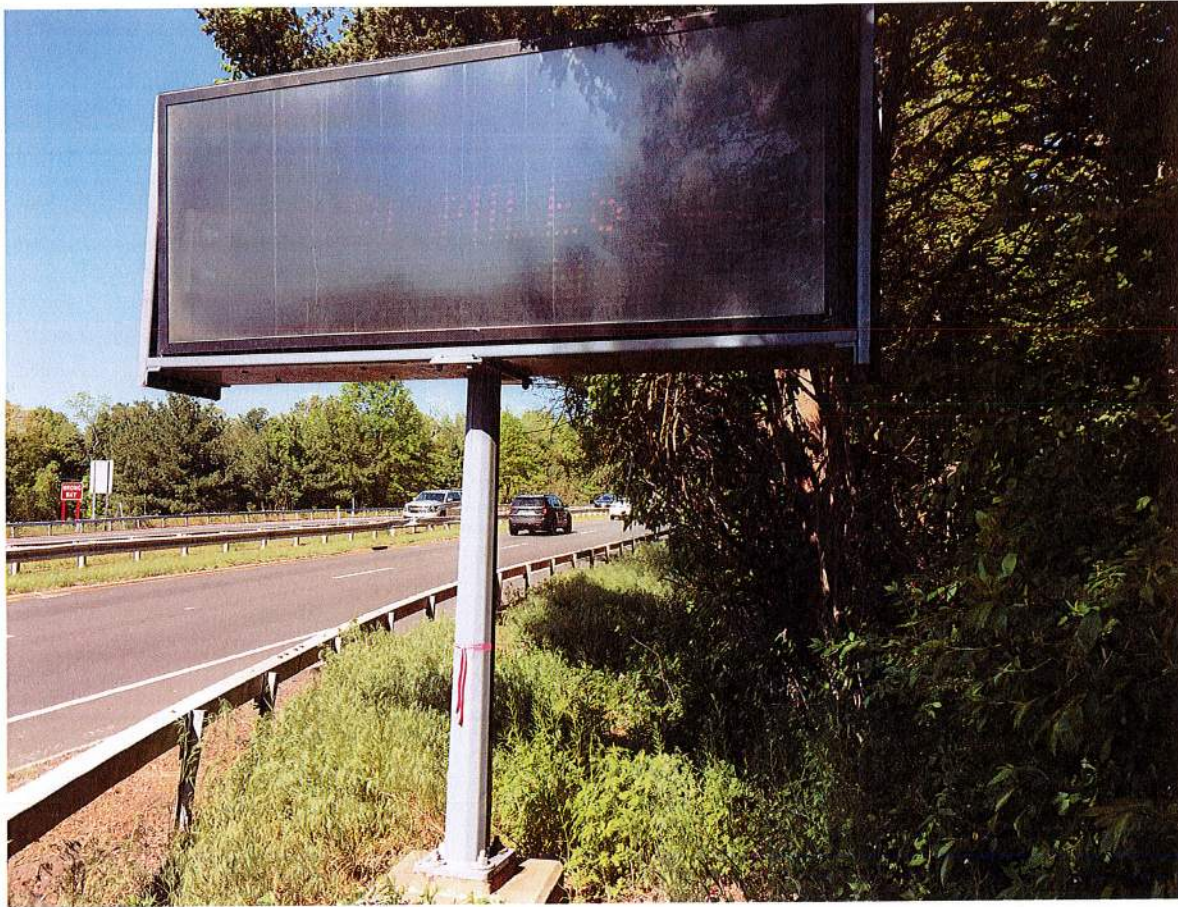
**PHOTO 2**  
Typical Painted VMS Sign Support

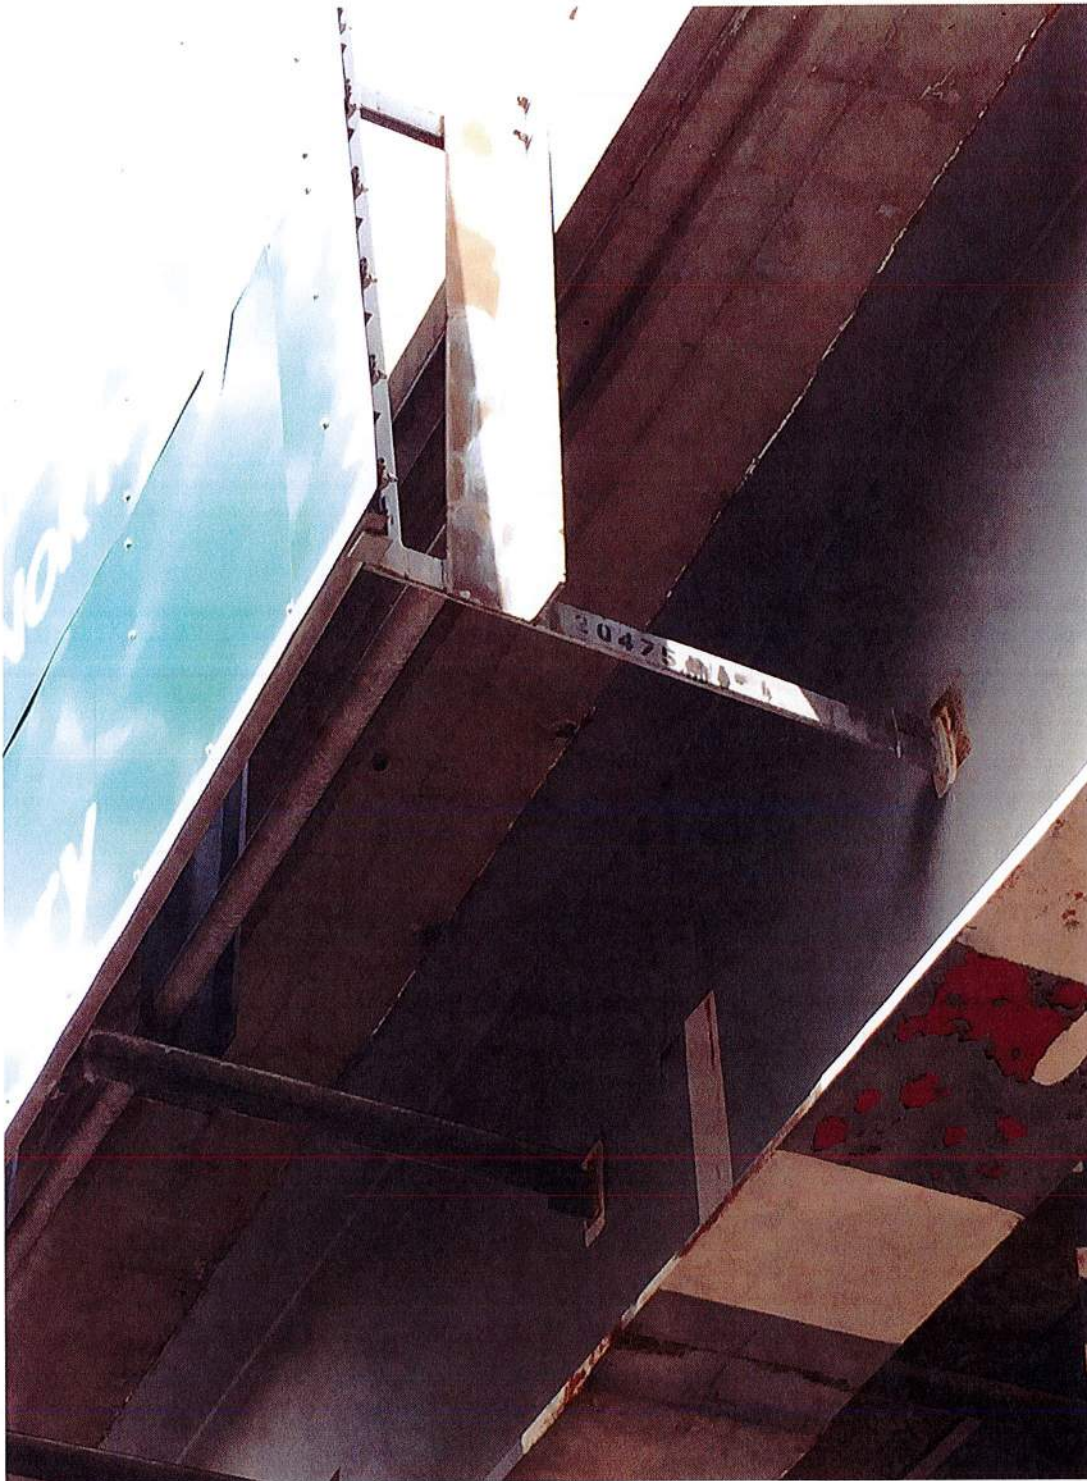
**PHOTO 3**

Site No. 4 (Sign Support No. 20475A) Galvanized Bridge-Mounted Sign Support

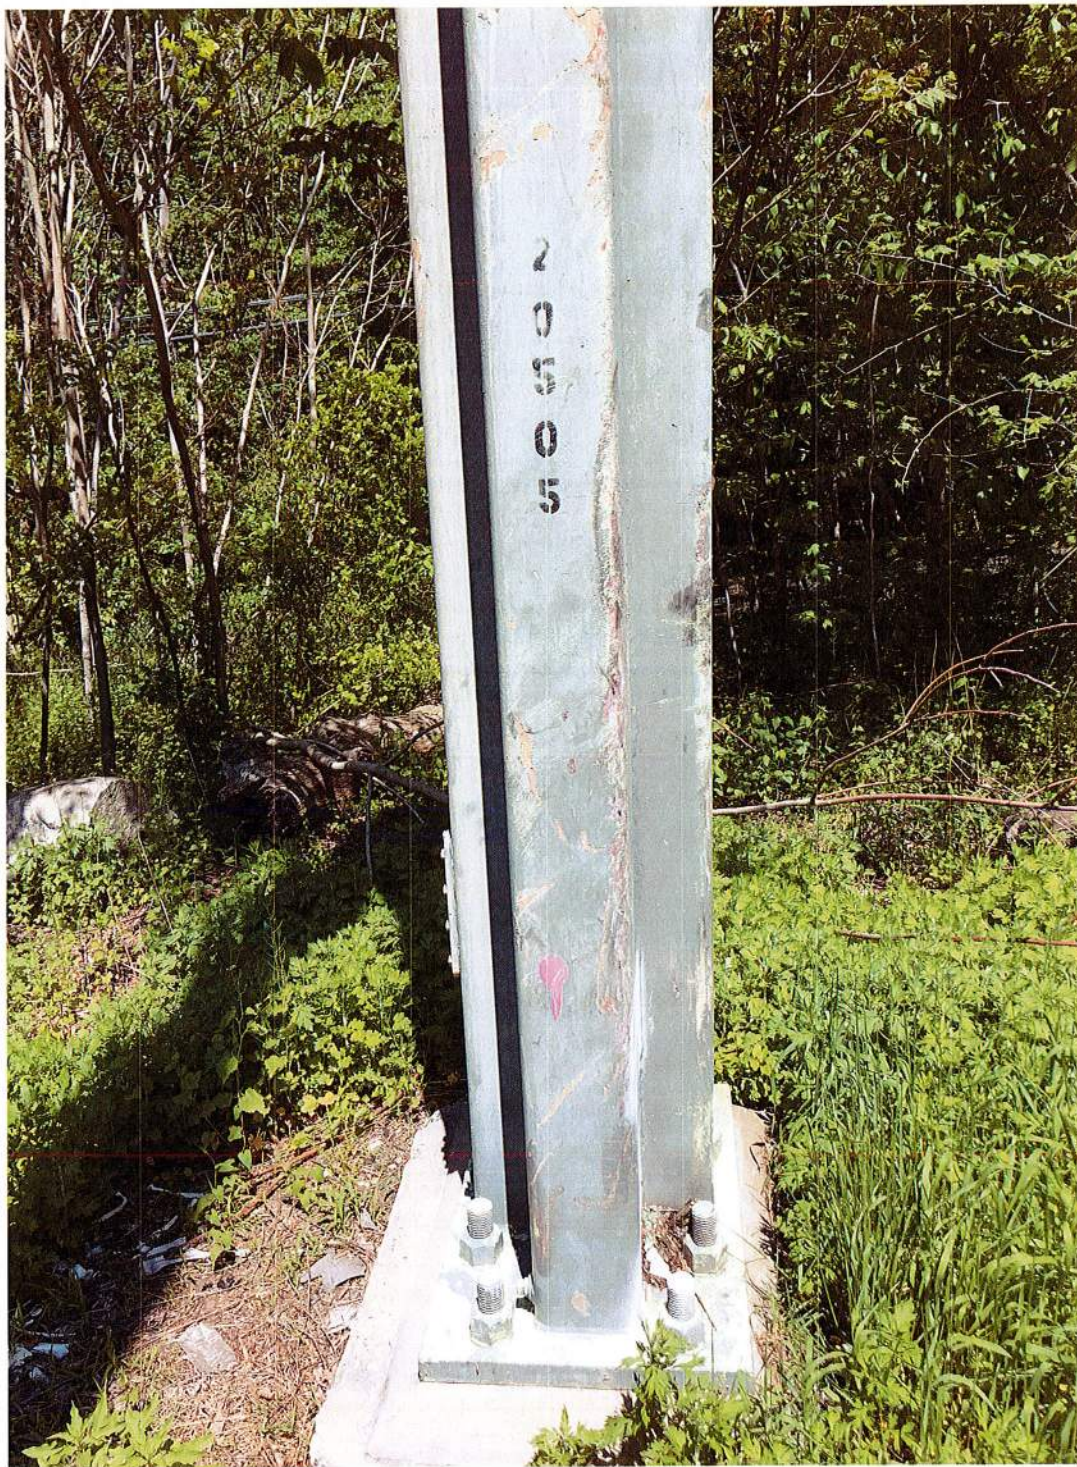
**PHOTO 4**

| Number | Interior/<br>Exterior | Type | Site No. | Structure | Feature | Material | Color | Condition | Reading<br>(mg/cm2) | Precision<br>(mg/cm2) | Depth<br>Index | Duration<br>(sec) | Date/Time |
|---|---|---|---|---|---|---|---|---|---|---|---|---|---|
| 15 | Exterior | cantilever-20505 | Site No. 3 | column | | Metal | Grey | Intact | 0.3 | 0.2 | 2.8 | 2.9 | 5/18/2017 11:52 |
| 16 | Exterior | cantilever-20505 | Site No. 3 | column | | Metal | Grey | Intact | 0.3 | 0.1 | 3.2 | 7.8 | 5/18/2017 11:52 |
| 17 | Exterior | cantilever-20505 | Site No. 3 | column | | Metal | Grey | Intact | 0.3 | 0.1 | 3.1 | 5.8 | 5/18/2017 11:53 |

| Laboratory ID | Client Sample ID | Result | RL | Units | Dilution | Batch | Prepared | Date/Time<br>Analyzed | Notes |
|---|---|---|---|---|---|---|---|---|---|
| 7050616-06 | 06 4-Sign 20505 | 0.79 | 0.013 | mg/L | 1 | B7E2217 | 05/22/2017 | 05/23/2017 11:17 | |

Site No. 3 (Sign Support No. 20505) Painted Cantilever Sign Support

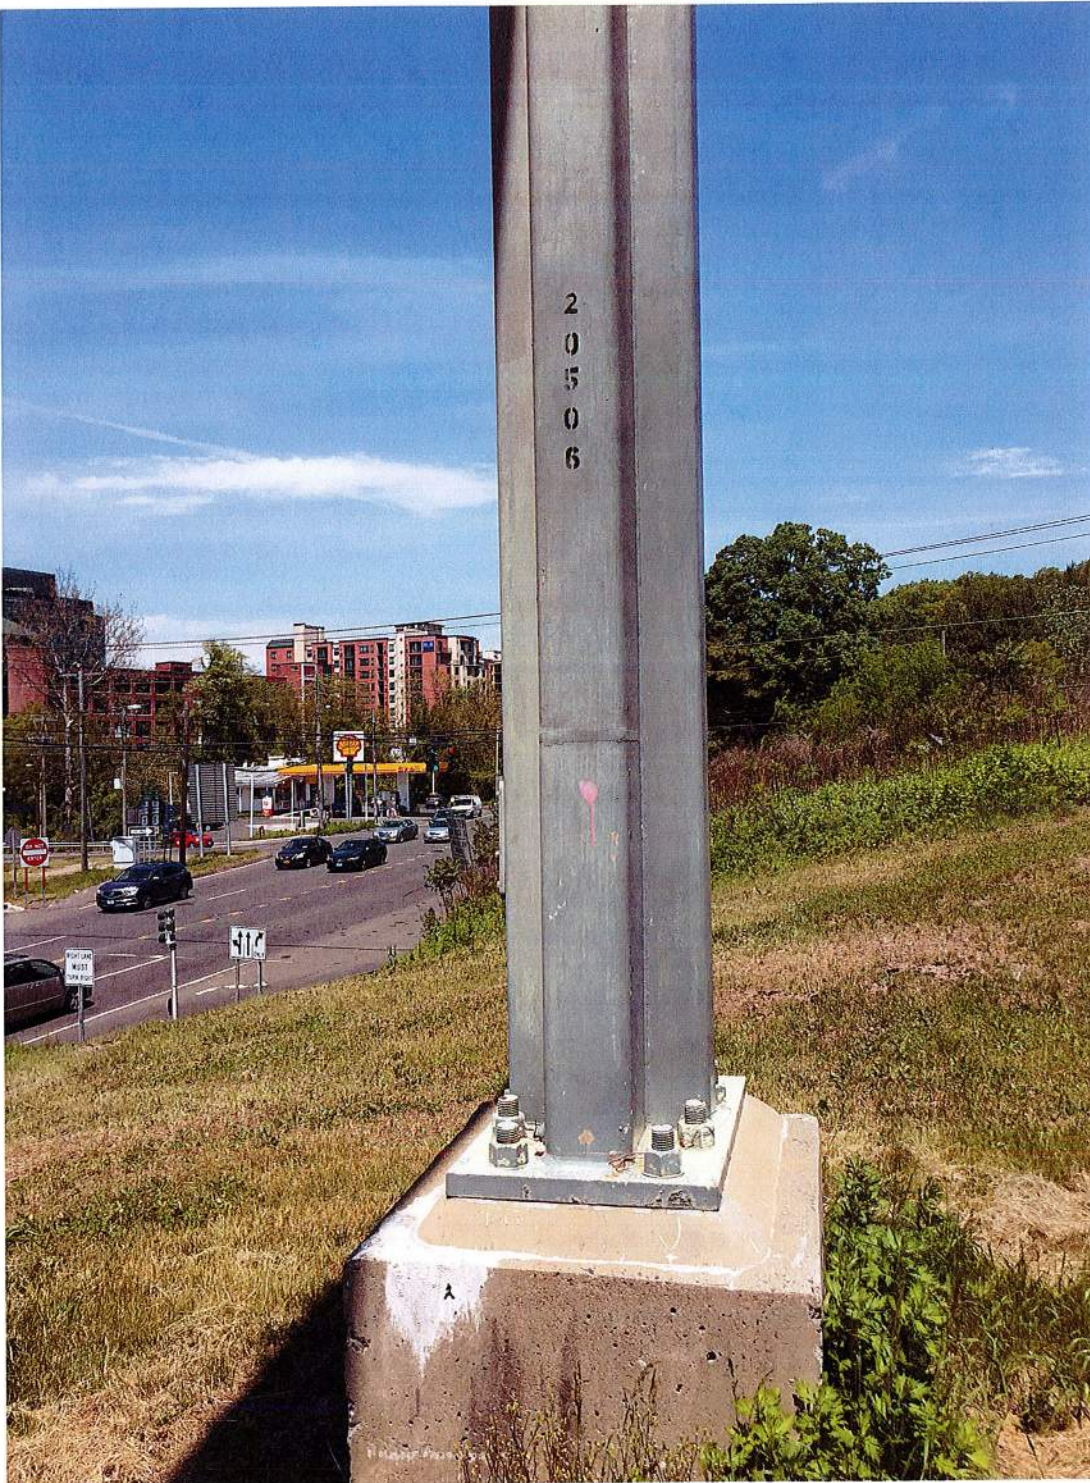
**PHOTO 5**

| Number | Interior/<br>Exterior | Type | Site No. | Structure | Feature | Material | Color | Condition | Reading<br>(mg/cm2) | Precision<br>(mg/cm2) | Depth<br>Index | Duration<br>(sec) | Date/Time |
|---|---|---|---|---|---|---|---|---|---|---|---|---|---|
| 18 | Exterior | cantilever-20506 | Site No. 2 | column | | Metal | Grey | Intact | 0.2 | 0.1 | 2.6 | 7.0 | 5/18/2017 12:10 |
| 19 | Exterior | cantilever-20506 | Site No. 2 | column | | Metal | Grey | Intact | 0.2 | 0.1 | 3.3 | 8.2 | 5/18/2017 12:11 |

| Laboratory ID | Client Sample ID | Result | RL | Units | Dilution | Batch | Prepared | Date/Time<br>Analyzed | Notes |
|---|---|---|---|---|---|---|---|---|---|
| 7050616-07 | 07 5-Sign 20506 | 1.5 | 0.013 | mg/L | 1 | B7E2217 | 05/22/2017 | 05/23/2017 11:22 | |

Site No. 2 (Sign Support No. 20506) Painted Cantilever Sign Support

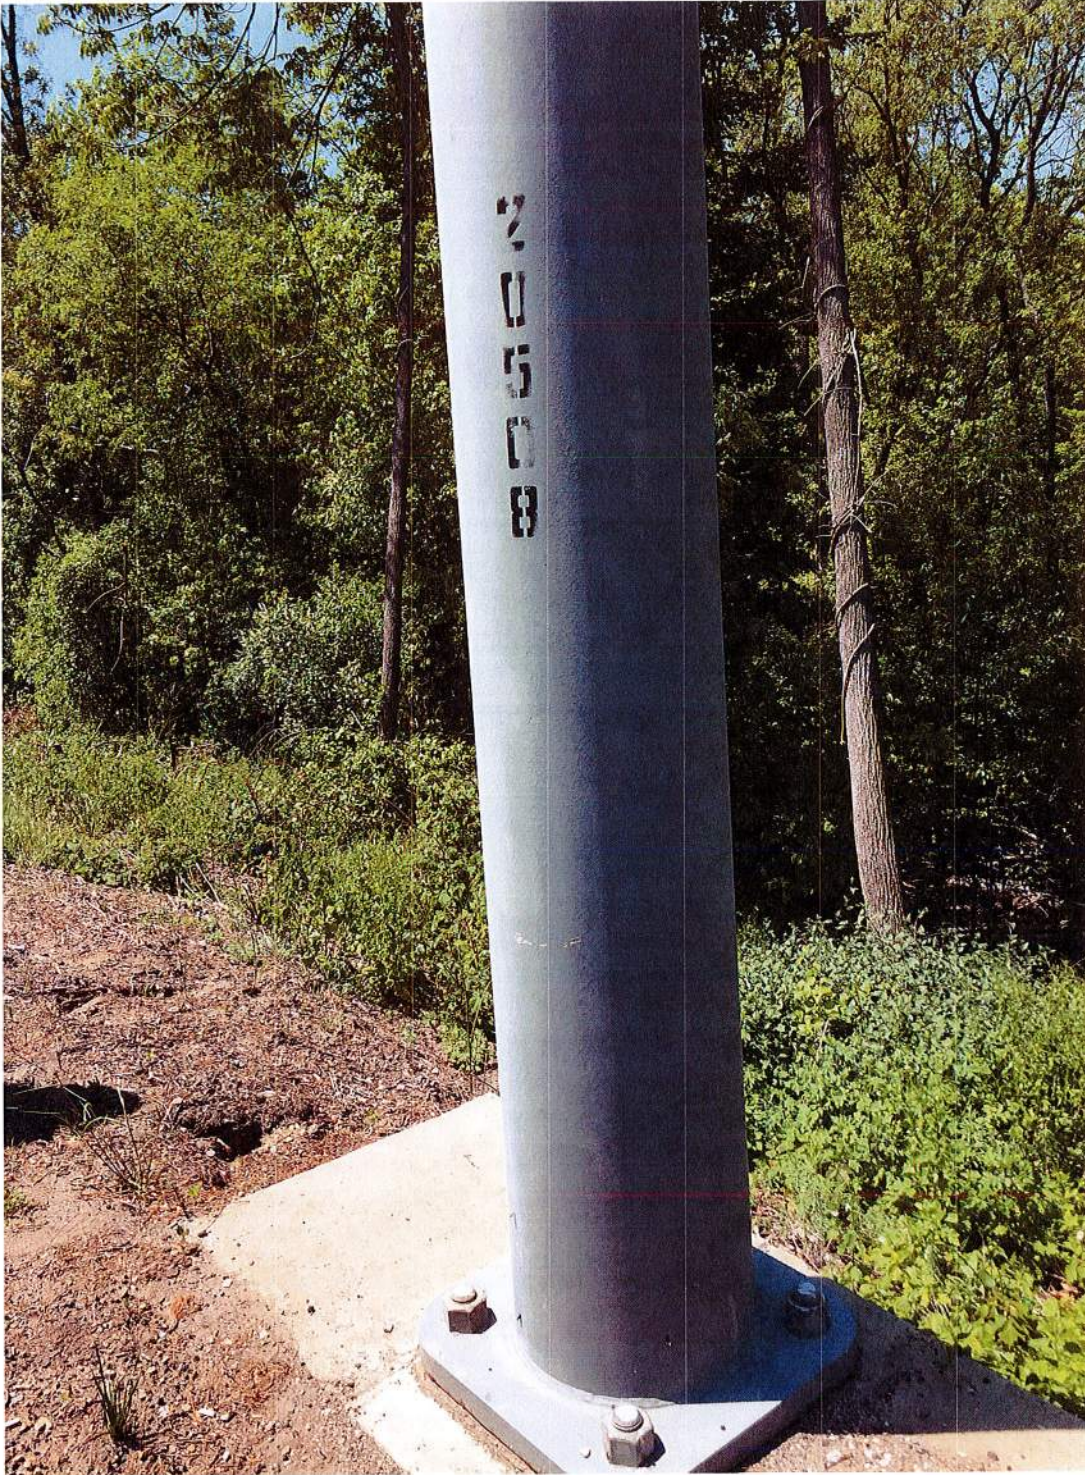
**PHOTO 6**

| Number | Interior/<br>Exterior | Type | Site No. | Structure | Feature | Material | Color | Condition | Reading<br>(mg/cm2) | Precision<br>(mg/cm2) | Depth<br>Index | Duration<br>(sec) | Date/Time |
|---|---|---|---|---|---|---|---|---|---|---|---|---|---|
| 20 | Exterior | cantilever-20508 | Site No. 1 | column | | Metal | Grey | Intact | 0.2 | 0.1 | 2.8 | 7.8 | 5/18/2017 13:22 |

| Laboratory ID | Client Sample ID | Result | RL | Units | Dilution | Batch | Prepared | Date/Time<br>Analyzed | Notes |
|---|---|---|---|---|---|---|---|---|---|
| 7050616-08 | 08 6-Sign 20508 | 3.2 | 0.013 | mg/L | 1 | B7E2217 | 05/22/2017 | 05/23/2017 11:35 | |

Site No. 1 (Sign Support No. 20508) Painted Cantilever Sign Support
