PRE-RENOVATION INVESTIGATIVE SURVEY FOR HAZARDOUS BUILDING MATERIALS

SALT SHED ROOF REPLACEMENTS PROJECT 5 NORTH CANAAN & THOMASTON, CONNECTICUT

Project No. 170-1877

Issued
August 2011

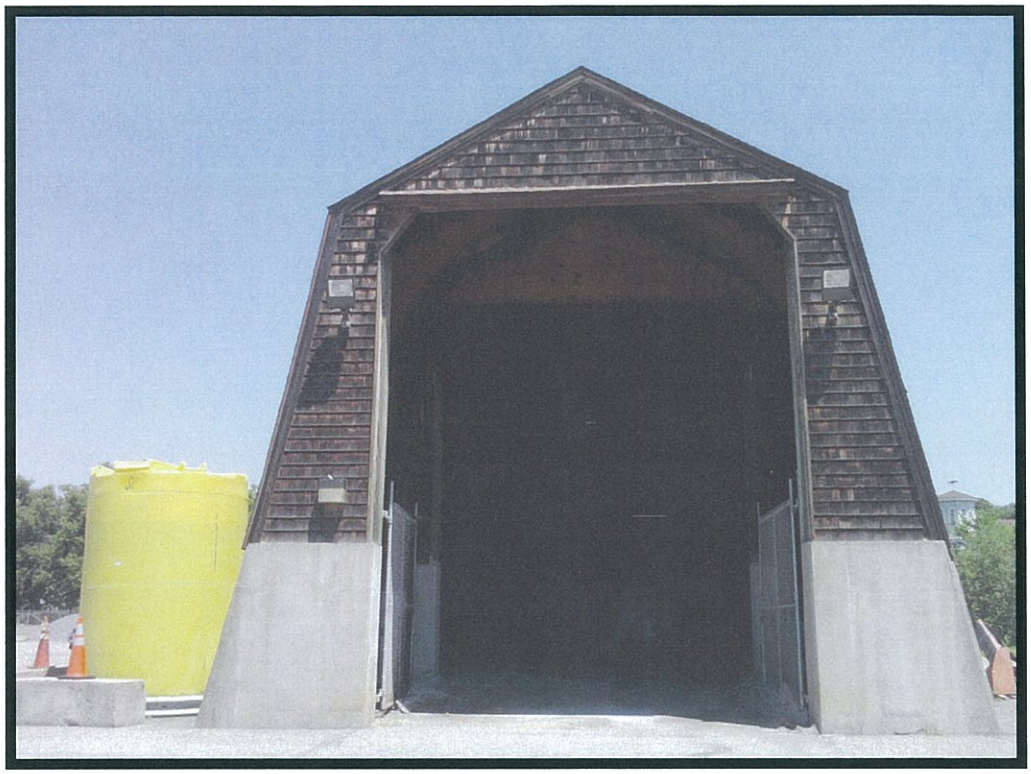
PHOTO 1
North Canaan Salt Shed: A Side.

PHOTO 2
North Canaan Salt Shed: B Side.

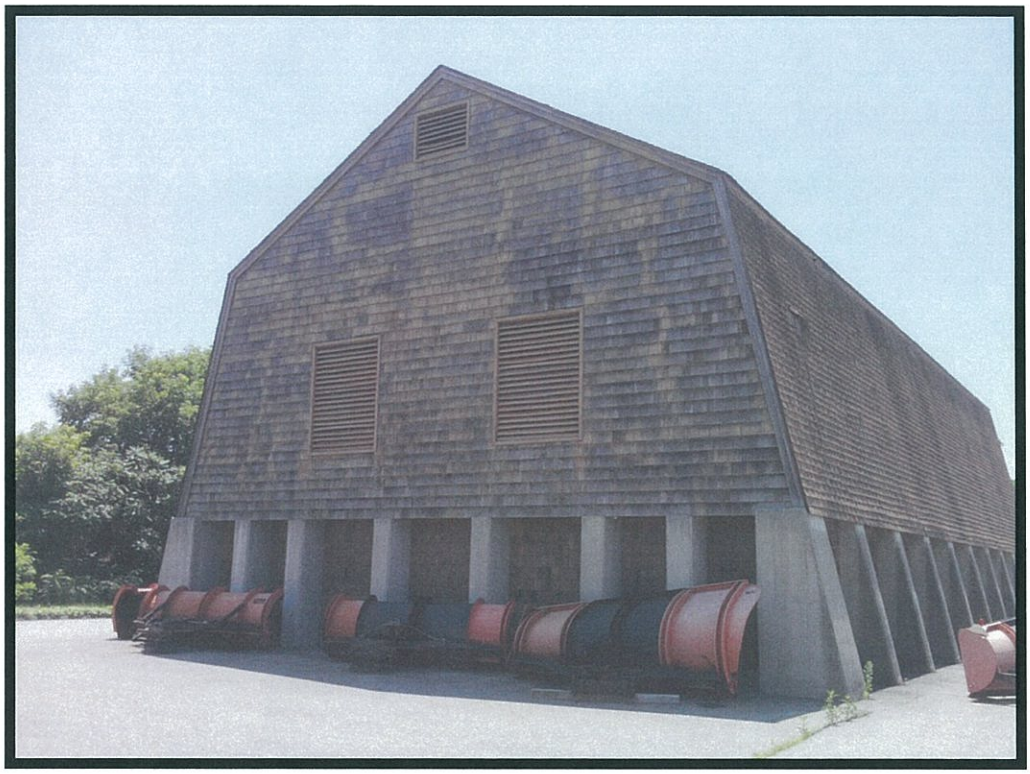
PHOTO 3
North Canaan Salt Shed: C Side.

PHOTO 4
North Canaan Salt Shed: D Side.

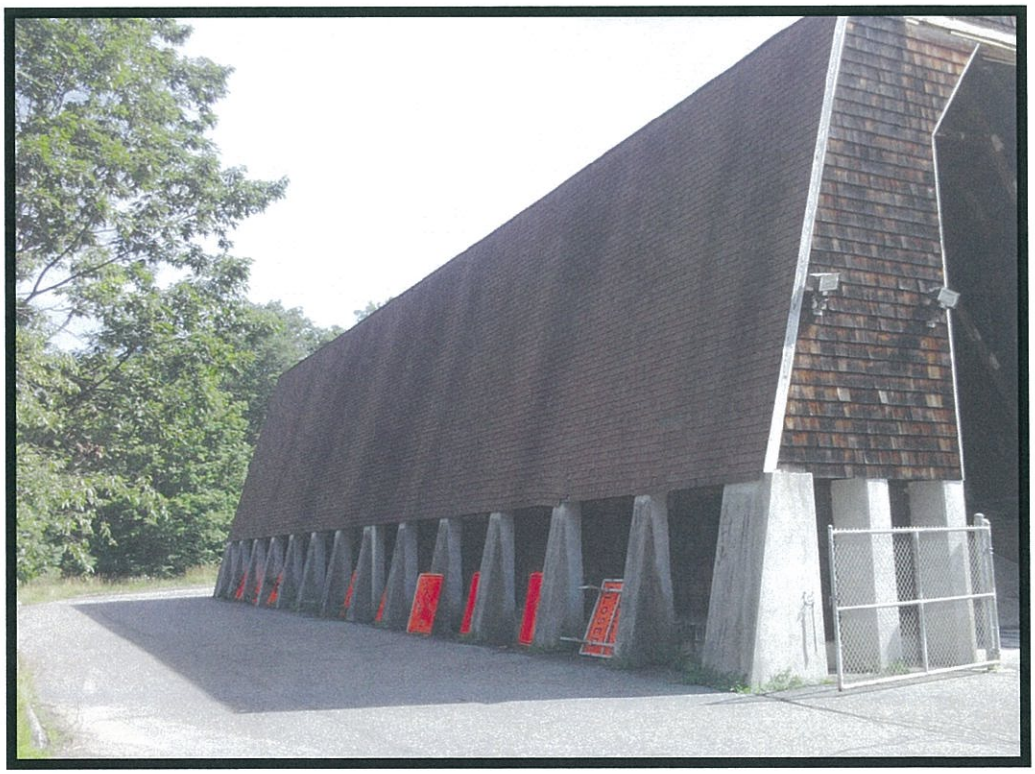
PHOTO 1
Thomaston Salt Shed: A Side.

PHOTO 2
Thomaston Salt Shed: B Side.

PHOTO 3
Thomaston Salt Shed: C/D Sides.

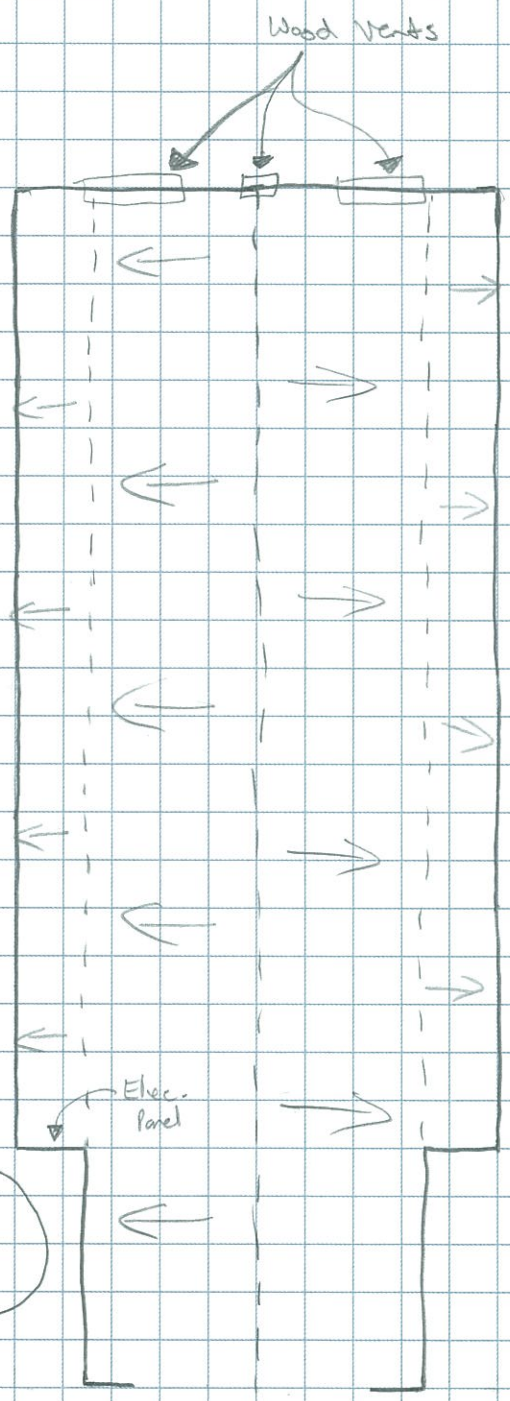
SUBJECT Salt Shed - North Canaan

- 36" to peak
- Colums are 1½' Thick
- Corner Columns are 3' Thick
- Wood Shake Siding
- Asphalt Shingle Roofing
- Interior Walls are wood beams

No Painted Surfaces

Tank of Magnesium Chloride

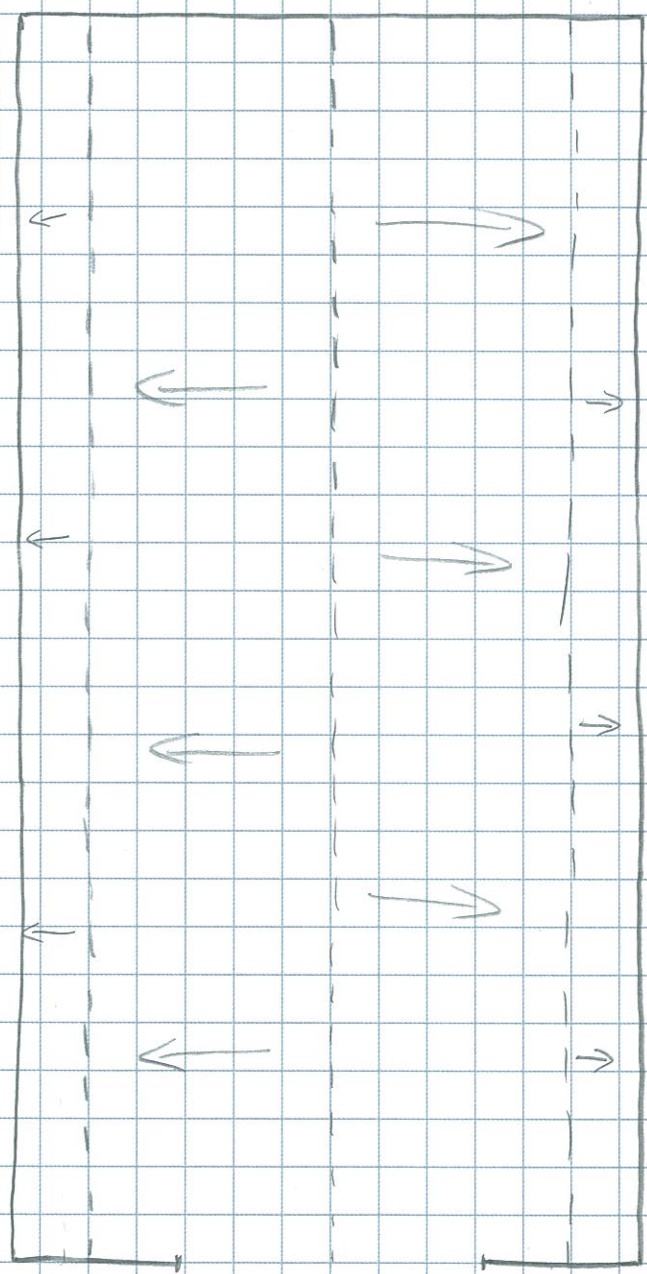
SUBJECT Salt Shed - Thomaston

- 40' Peak
- Columns are 1 ½' Thick
- Corner Columns are 3' Thick

- 8'H Wood Beam Walls on Interior

- Wood Shakes for Exterior Siding

- Asphalt Shingle ( ) 1 layer for Roofing
