# Exterior Renovations,

Fine Arts Building  
University of Connecticut  
Storrs, CT  
28 June 2011

SGH Project 110416

In May 2011, we completed the condition assessment of the Fine Arts Building. Our review focused on the ribbed-concrete-block veneer walls and various fenestrations, the concrete terraces, low-slope built-up membrane roofs, batten-seam metal panel roofs and soffits, and the sloped glazing system. Additionally, we reviewed the existing landscaping, site drainage, and performed a site survey. The attached report provides a summary of our observations, discussion of our findings, and our recommendations for remedial work. Photographs are included in Appendix A.

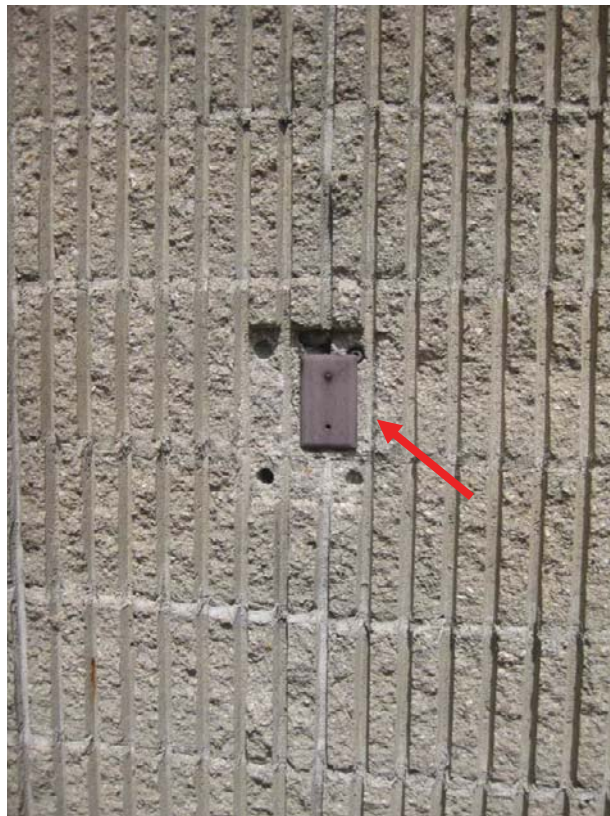
**Photo 27**

Abandoned light fixture on the south elevation.

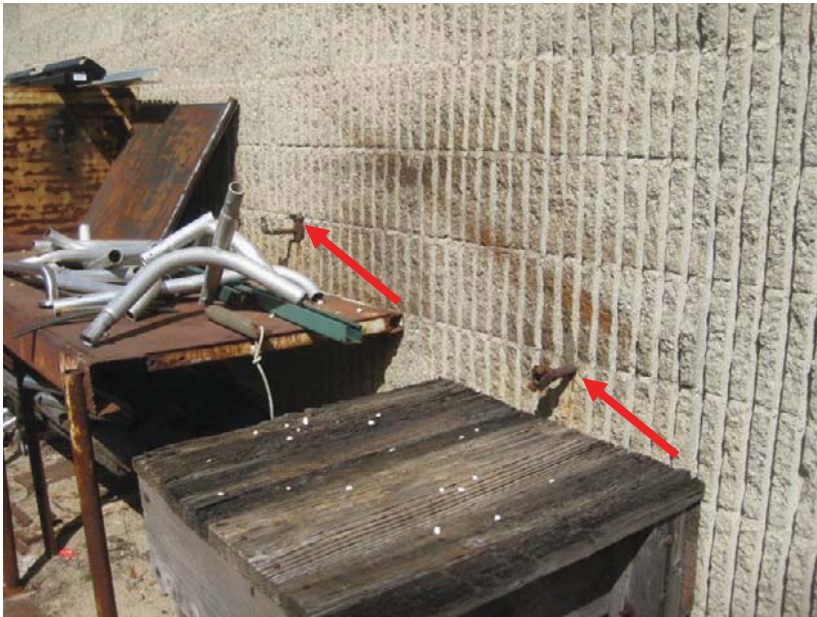
**Photo 28**

Abandoned pipe fixtures on the south elevation.

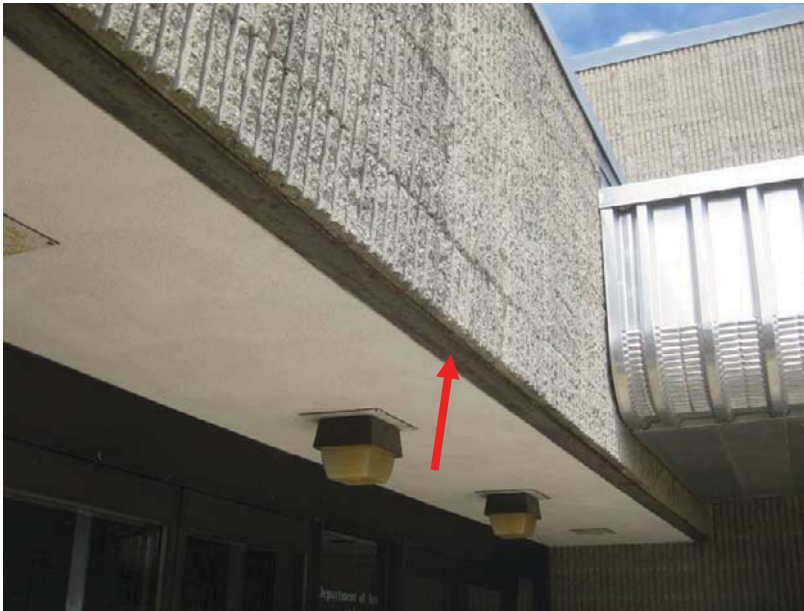
**Photo 36**

Surface corrosion on structural steel beam at the east elevation main entrance soffit.

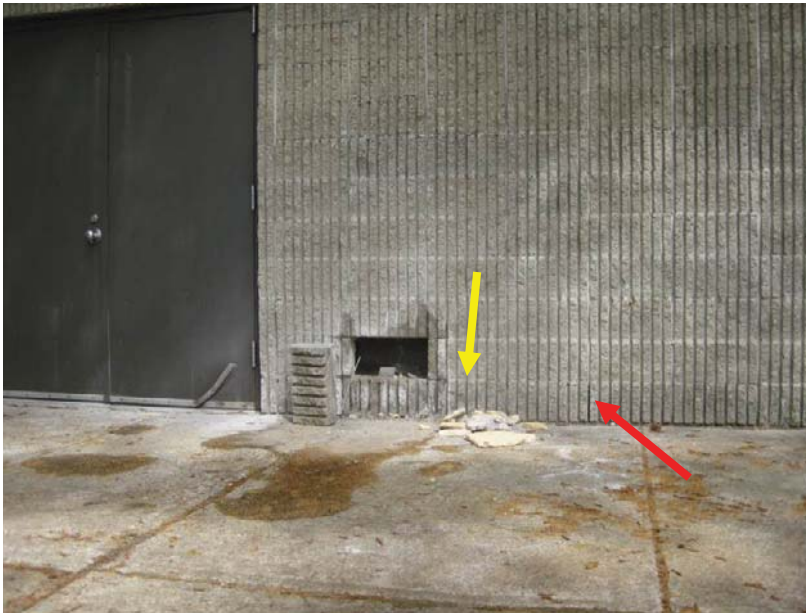
**Photo 39**

- Except on the north elevation, weeps for the masonry veneer are located at the bottom course of masonry, below the elevation of the fabric through-wall flashing (Photo 39). On the north elevation, weeps are located at the same elevation as the fabric through-wall flashing.

Location of weep (red arrow) below the level of the through-wall fabric flashing (yellow arrow).

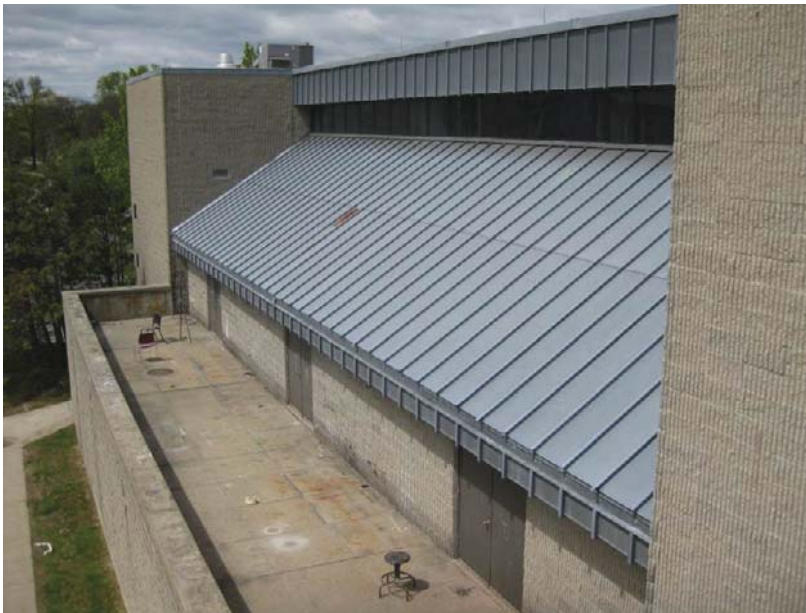
**Photo 40**

Batten-seam metal panel roof on the west elevation.

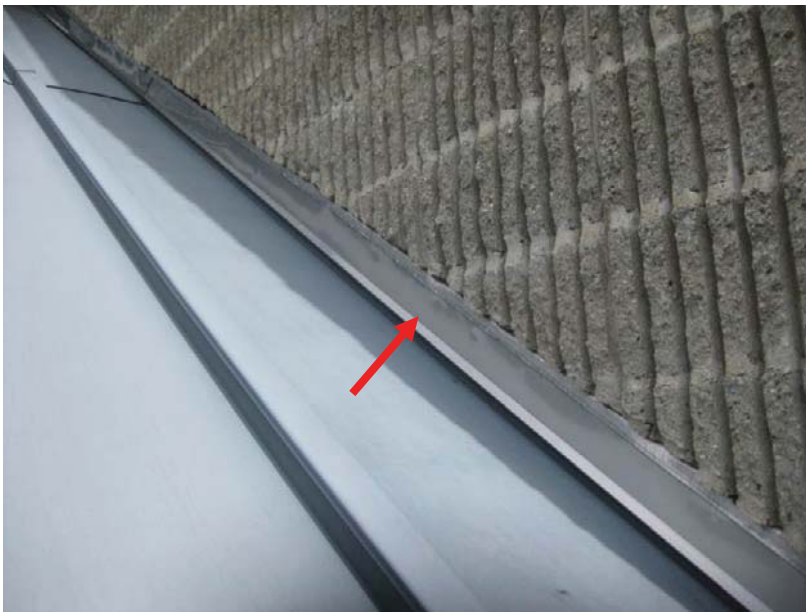
**Photo 41**

Rake flashing at batten-seam metal panel roof.

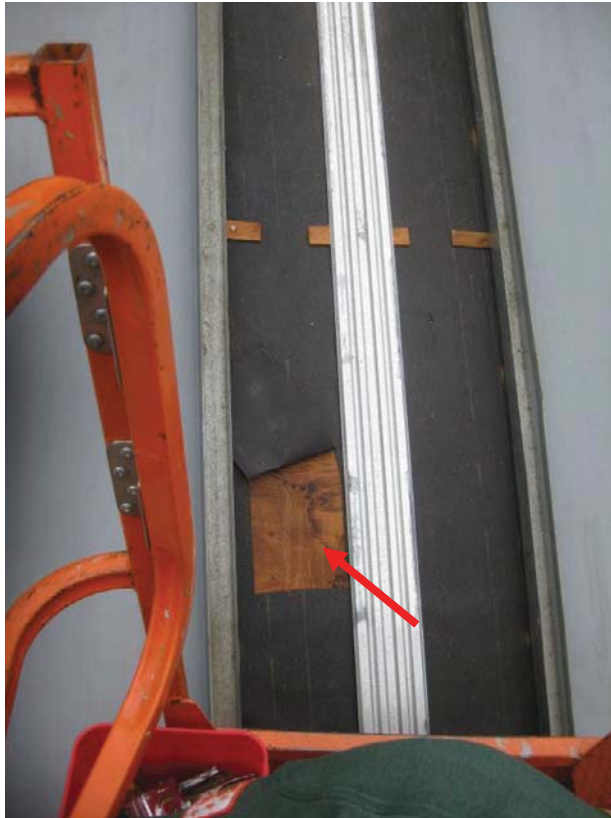
**Photo 42**

Exploratory opening at batten-seam metal panel roof. Plywood is slightly damp below felt underlayment.

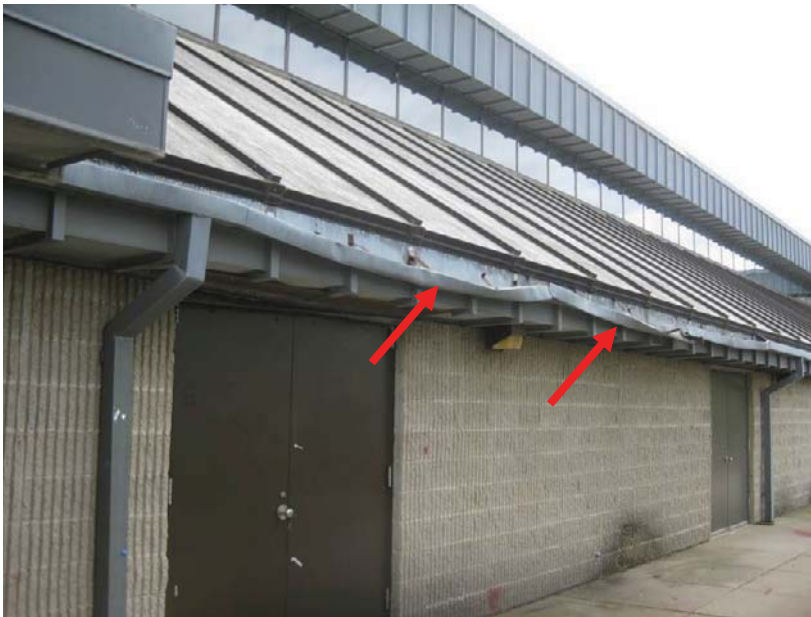
**Photo 56**

Water flowing down the metal roof and Kalwall panels is collected in hung gutters along the eaves. The gutters are supported by metal braces fastened back to the roof-eave framing (Photo 54). Gutters are typically in poor condition and the metal braces are corroded. Transverse gutter joints are open and appear unsealed (Photo 55). The north elevation gutter is partially collapsed (Photo 56). On the west elevation, the gutter and down leaders at the metal

Collapsed gutters on the north elevation.

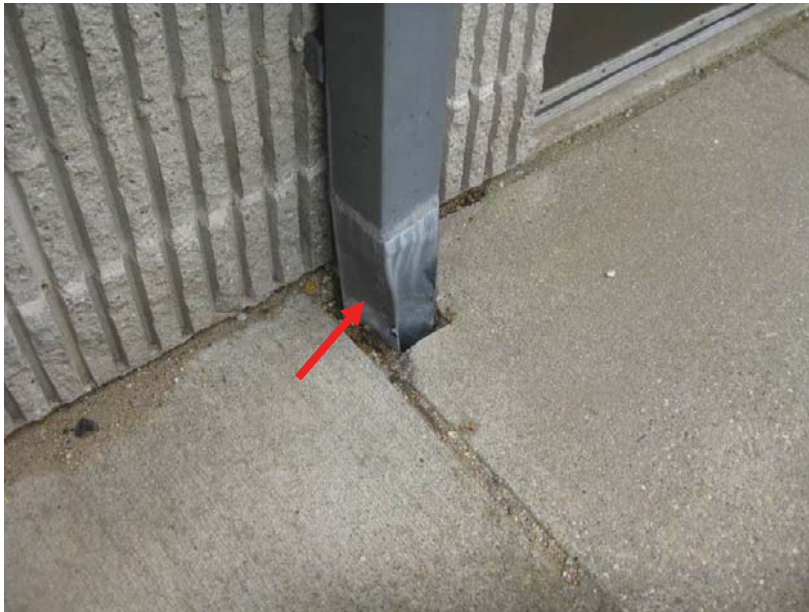
**Photo 59**

The down leaders are connected to the gutters and drain to a location below the terrace pavers (Photo 59). Joints in the down leaders are soldered. Down leaders are deformed or broken on the north elevation and are missing on the west elevation (Photo 60).

Deformed down leader on the north elevation. Down leader termination is unclear.

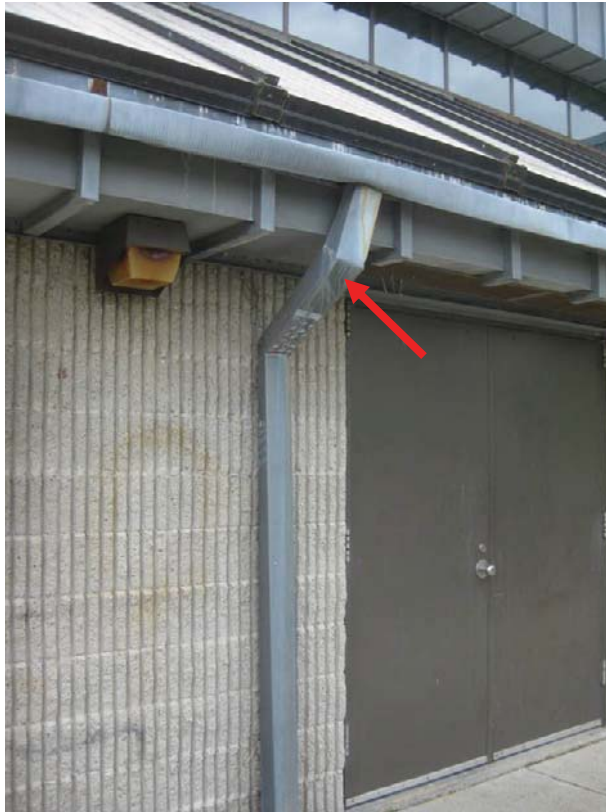
**Photo 60**

Deformed down leader on the north elevation.

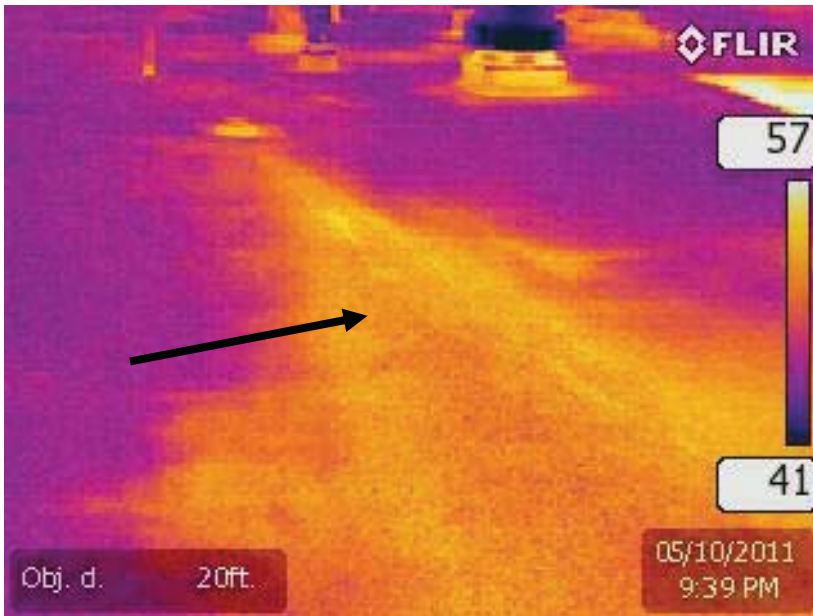
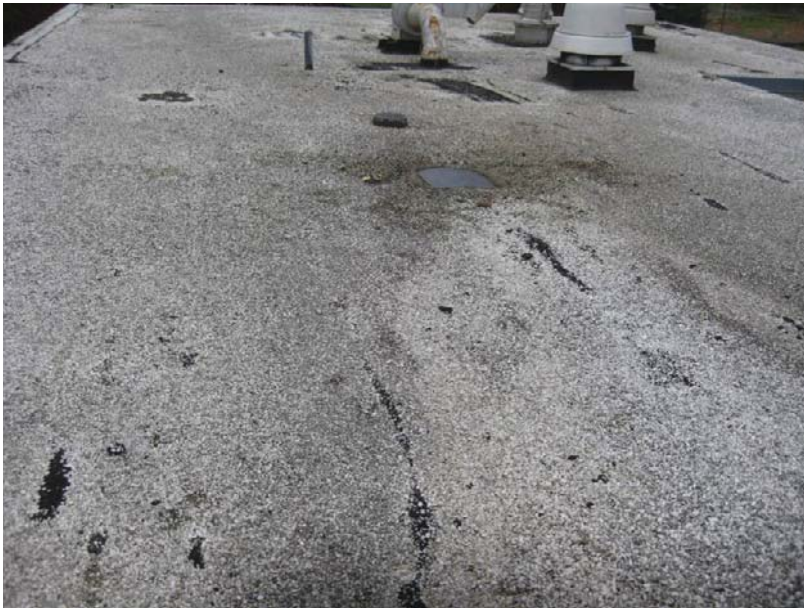
**Photo 61**

- BUR roof materials appear significantly warmer at the tapered insulation crickets aligned with the roof drains (Photos 61 and 62).
- On the east-wing low BUR, roof materials appear significantly warmer adjacent to rising masonry and glass curtain walls (Photos 63 and 64).
- On the west-wing low BUR, roof materials appear warmer at the roof perimeter tapered insulation crickets (Photos 65 and 66).
- On the east-wing high BUR, roof materials appear warmer adjacent to the expansion joint curb between the east and north wings (Photos 67 and 68).
- Isolated warm areas appear near mechanical equipment penetrations on the west-wing high BUR (Photos 69 and 70).

West-wing high roof.

Elevated surface temperatures aligned with tapered insulation valleys leading to roof drain.

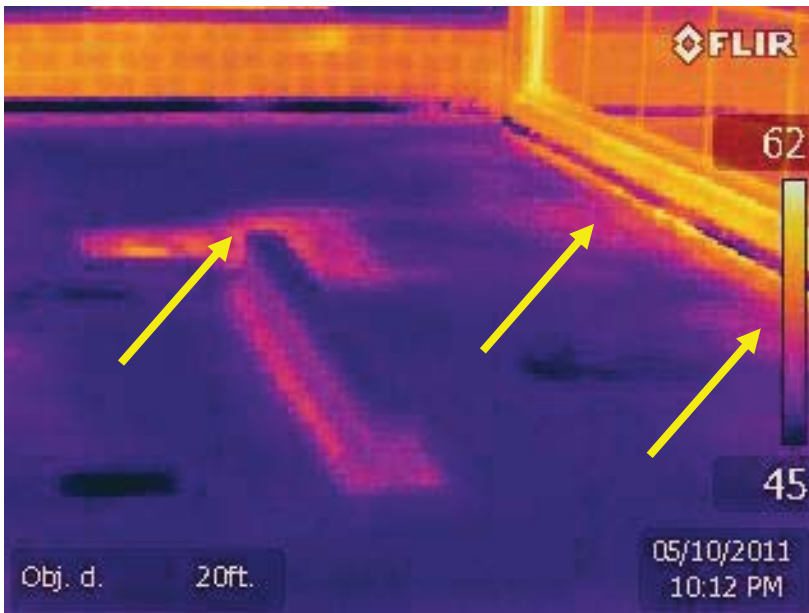
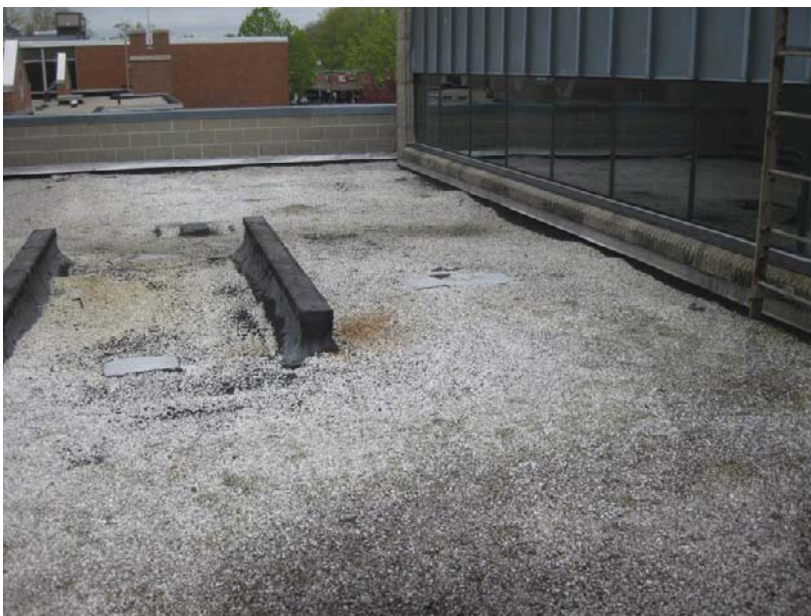
**Photo 63**

East-wing low roof.

Elevated surface temperatures adjacent to rising curtain wall and roof drain.

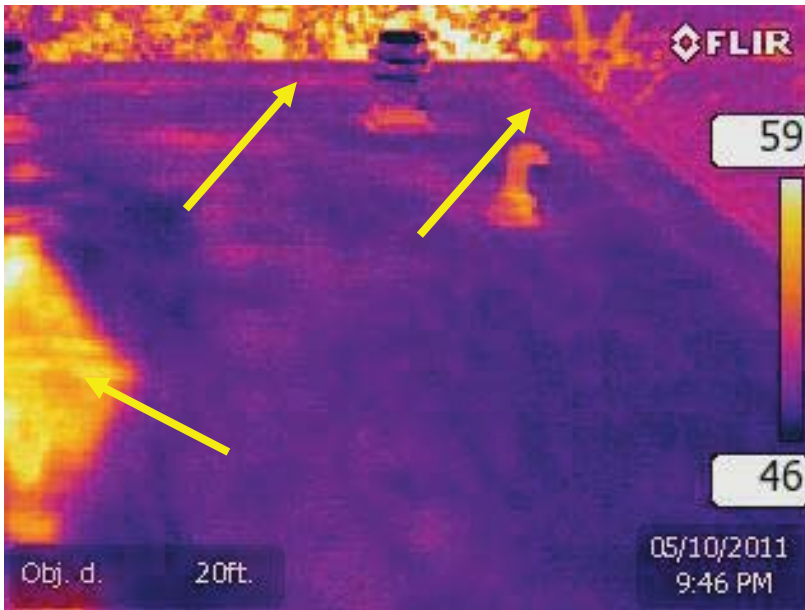
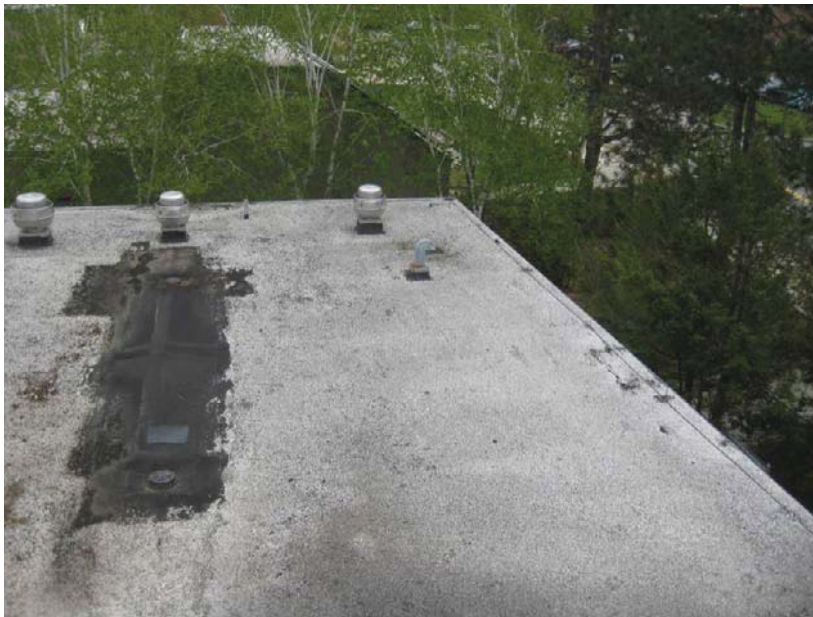
**Photo 65**

West-wing low roof.

Elevated surface temperatures at roof perimeter tapered insulation crickets and at roof drain valleys.

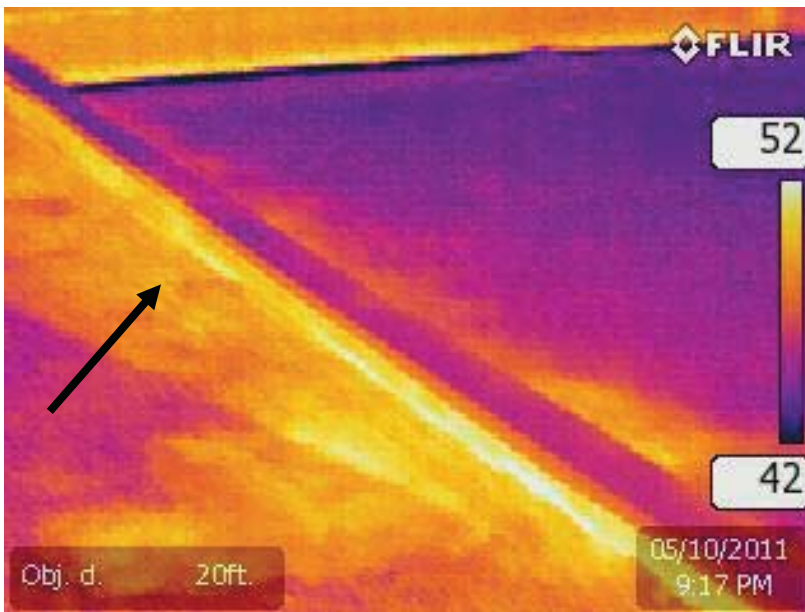
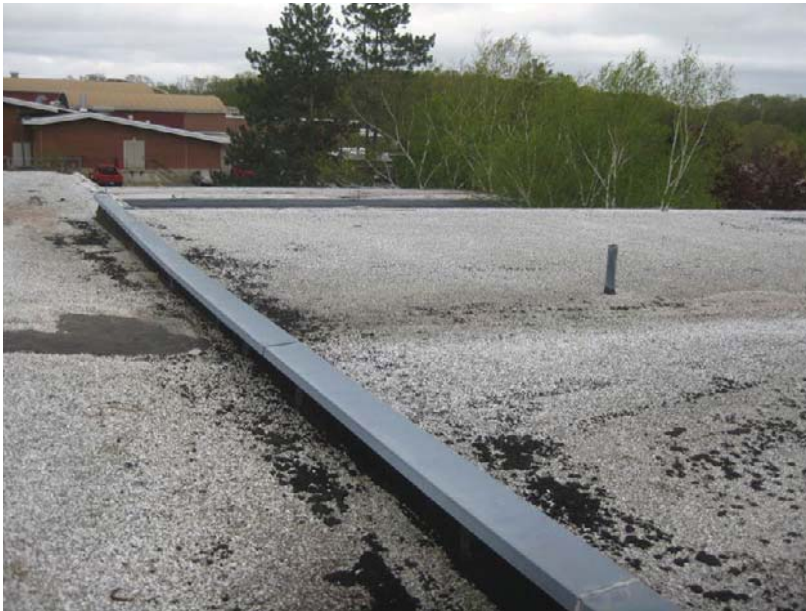
**Photo 67**

East-wing high roof – north-wing high roof.

Elevated surface temperatures adjacent to expansion joint.

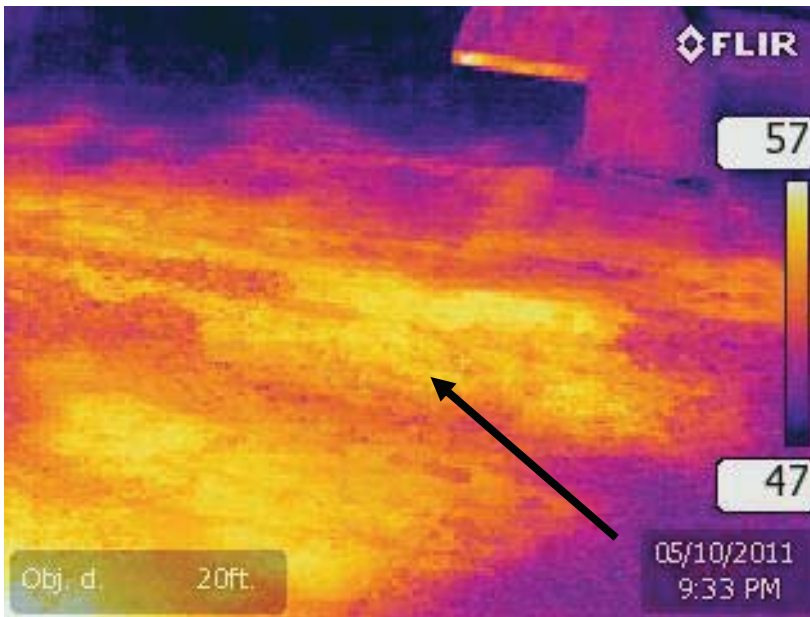
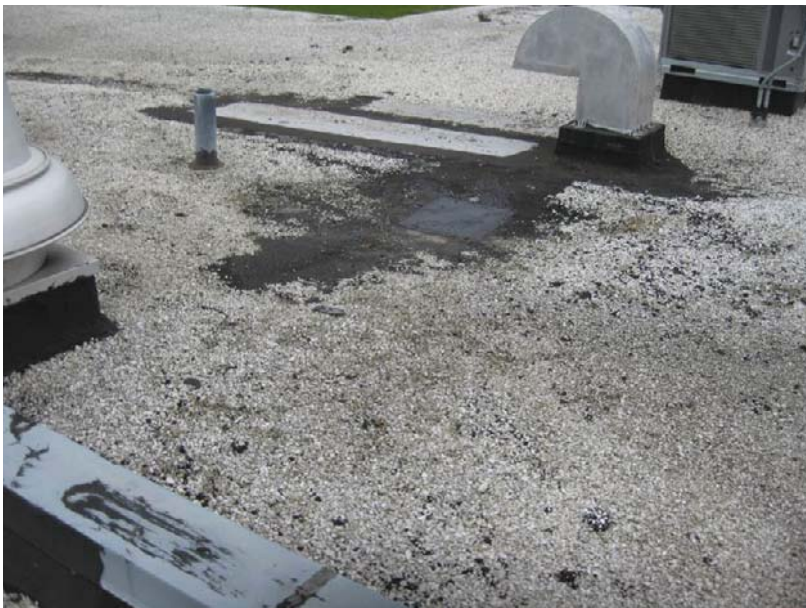
**Photo 69**

West-wing high roof.

Elevated surface temperatures adjacent to mechanical equipment.

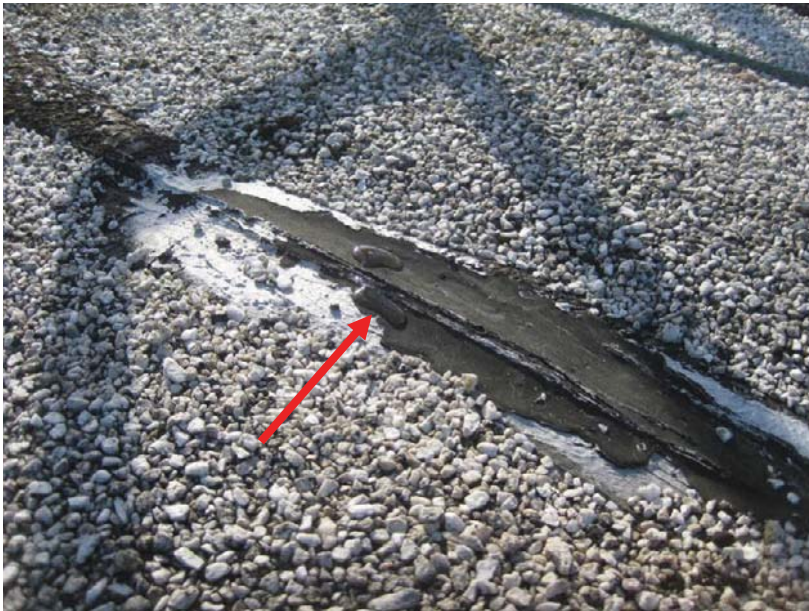
**Photo 71**

The BUR is visibly worn. In several areas the gravel is displaced, resulting in BUR membrane exposed to UV radiation. We identified numerous soft spots in the BUR, indicative of delaminated BUR or water trapped within the roof assembly. Several areas of the BUR are split allowing water to enter the roof system (Photo 71).

Split in built-up-roof membrane and water from below roof surface.

- The built-up roofs are worn and require replacement. Multiple system options are available for replacement, but EPDM was selected as the basis for design based on the University's current practice.

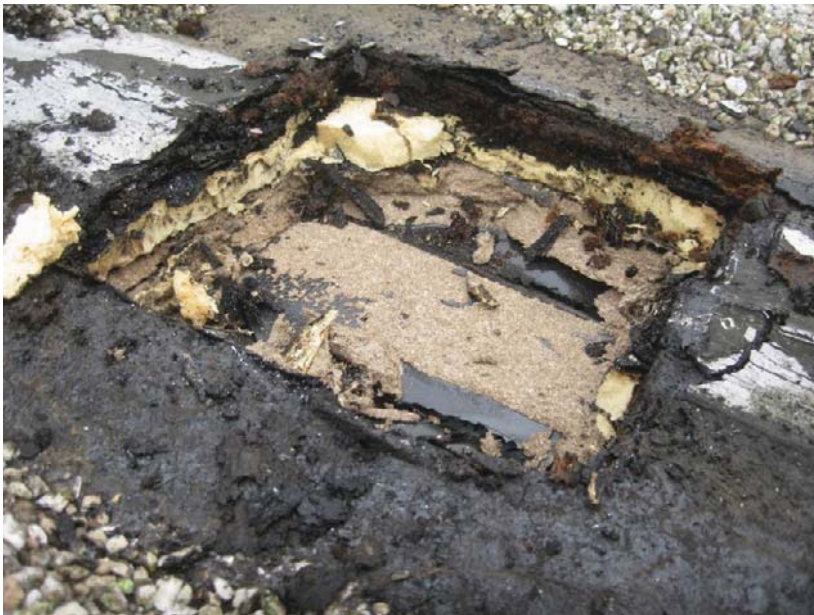
**Photo 72**

Based on our eight exploratory openings, we found that the building roof typically consists of (from interior to exterior) 1-1/2 in. metal deck, asphalt vapor retarder, 1-1/2 in. polyisocyanurate insulation, 1 to 4 in. of fiberboard depending on location of the opening, and four-ply asphalt impregnated felt set in hot-applied asphalt and covered with gravel as the wearing surface and for UV protection (Photos 72).

Built-up roof opening at spilt in membrane shown in Photo 71. From exterior to interior, BUR membrane, fiberboard, polyisocyanurate insulation, fiberboard, vapor retarder, metal deck.

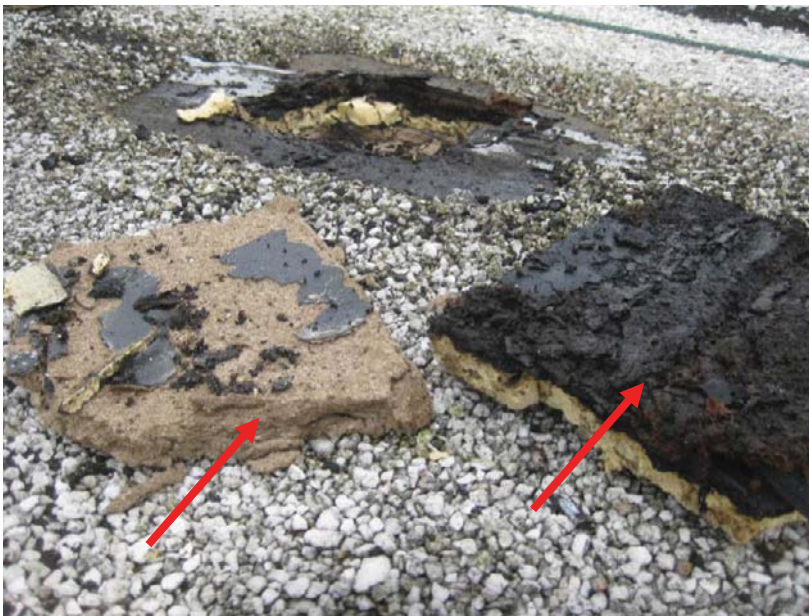
**Photo 73**

All except one of our exploratory openings identified wet BUR components. The wet openings included water-saturated fiberboard and polyisocyanurate insulation (Photo 73). Most of the trapped moisture occurs in the upper layers of fiberboard or insulation, and it does not reach the metal deck. However, the metal deck was wet at two exploratory roof openings. Additionally, we noted multiple previous BUR repair patches in the roof, which were either wet or soft.

Water saturated fiberboard and insulation from top layers of opening shown in Photo 72 (right arrow).

Mostly dry fiberboard from bottom layer of opening shown in Photo 72 (left arrow).

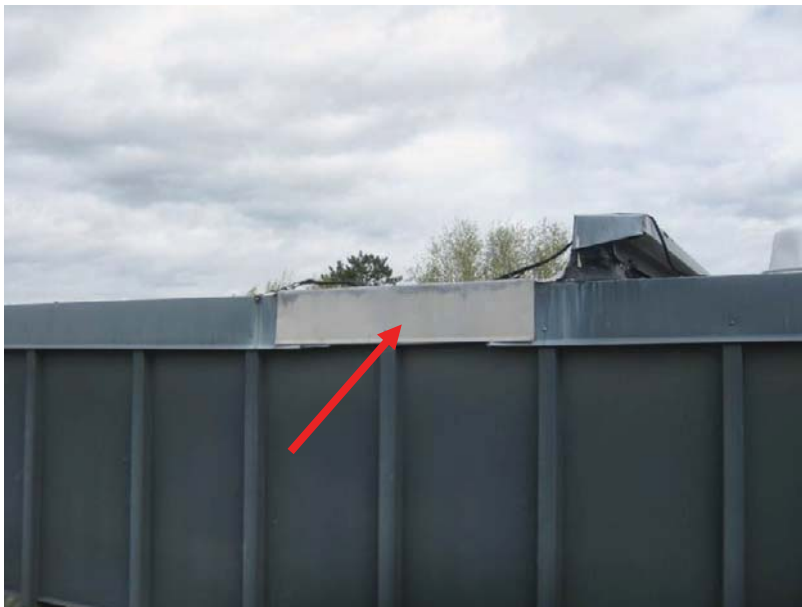
**Photo 75**

At multiple locations, the roof-edge metal flashing appears to be repaired, resulting in voids and unsealed laps in the flashing (Photo 75). At the base of masonry walls, solder joints in the existing skirt flashing are typically broken (Photo 76). Additionally, we observed hard, cracked surface-applied sealant at the broken solder joints presumably installed to function as a temporary repair. The sealant at these joints are split (Photo 77).

Previous BUR perimeter flashing cut and repair.

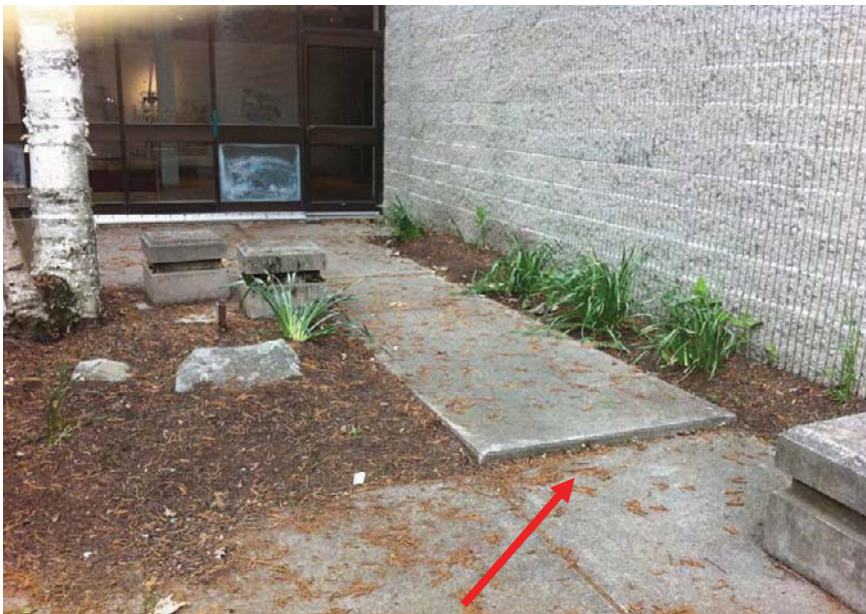
**Photo 86**

Settlement in northwest section of Courtyard Area 1.

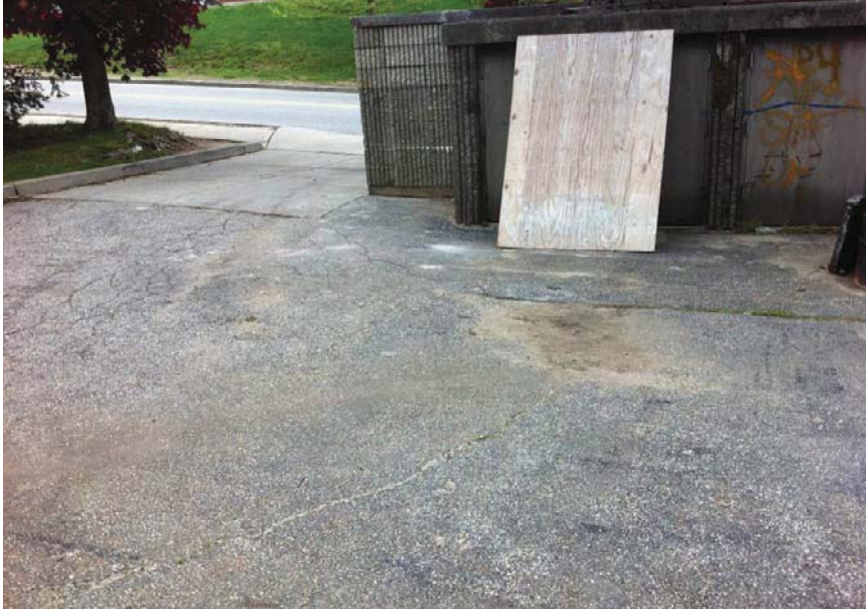
**Photo 107**

Low-severity alligator scaling at entrance to the west parking lot.

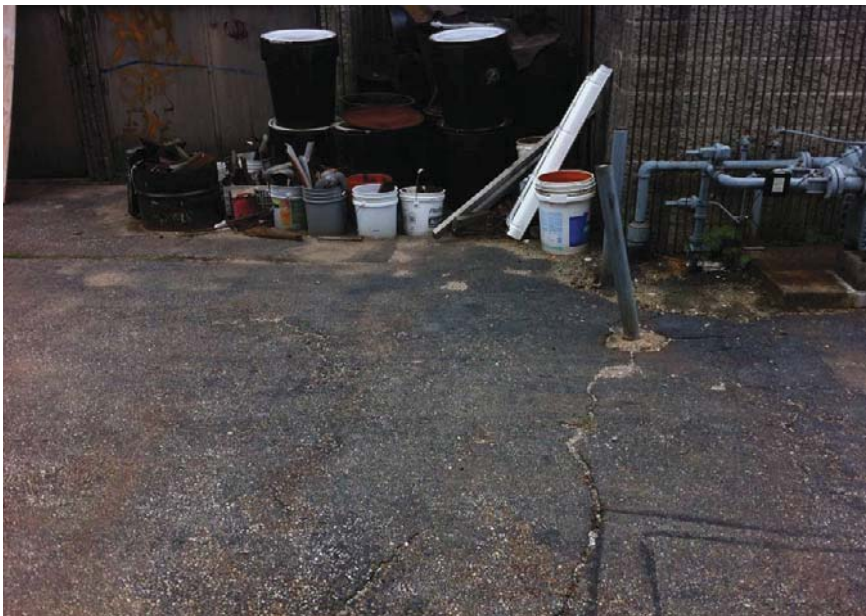
**Photo 108**

Low-severity alligator scaling, vegetation growing through the pavement at paved dumpster location.

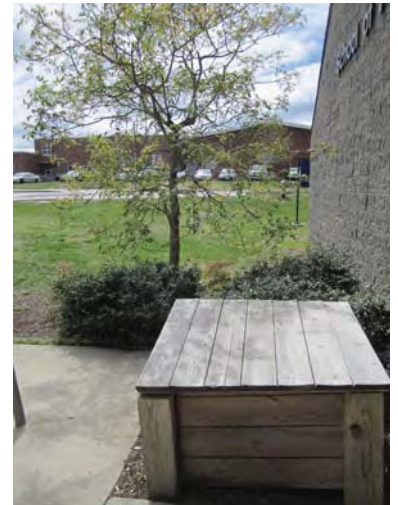
Image #4

All street trees are missing.

Recommend replanting street trees along Bolton Street.

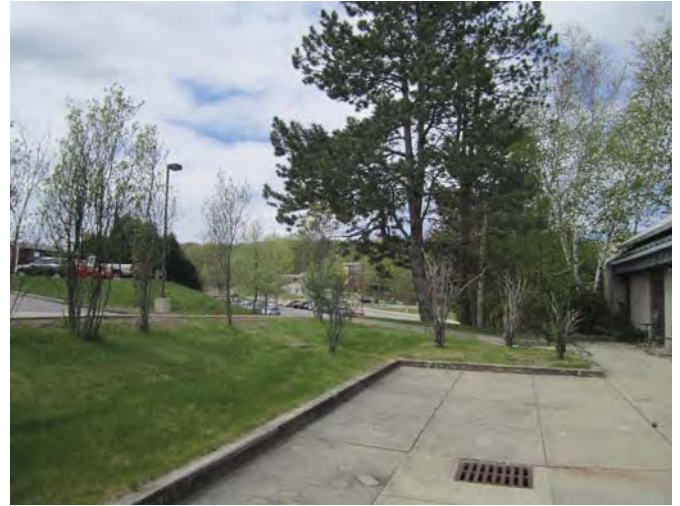
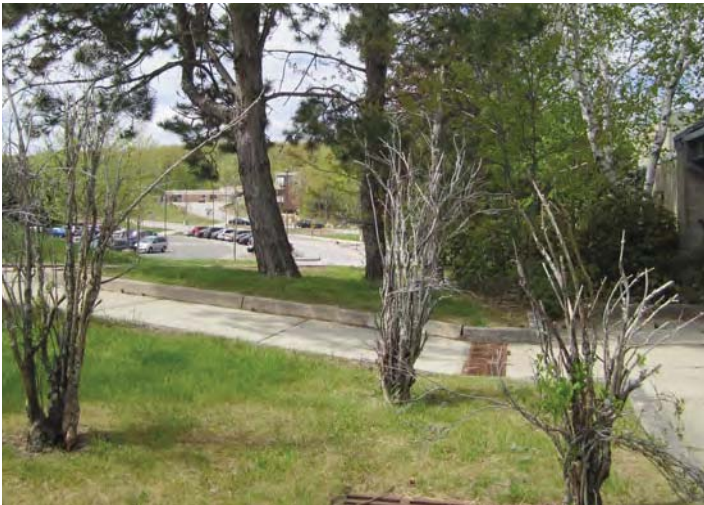
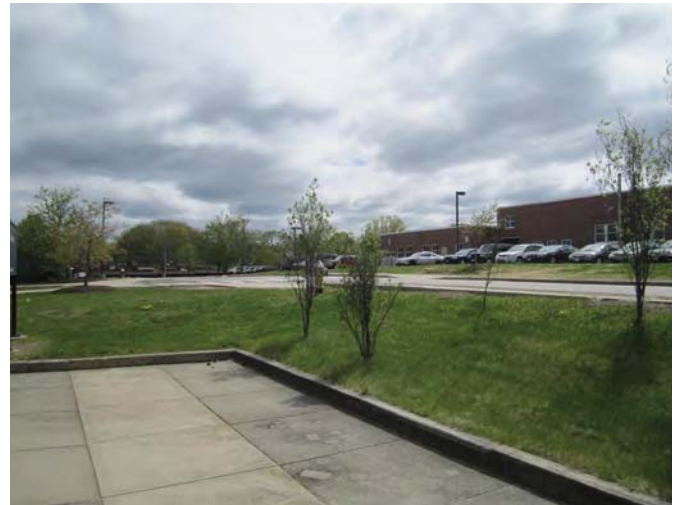
Image #8

2 *Quercus sp*  
Oak

Possible volunteer planting.

Recommend removing smaller tree given  
space constraints.

**2 Quercus sp**  
Oak  
Possible volunteer planting.  
Recommend removing smaller tree given space constraints.  
See image #8

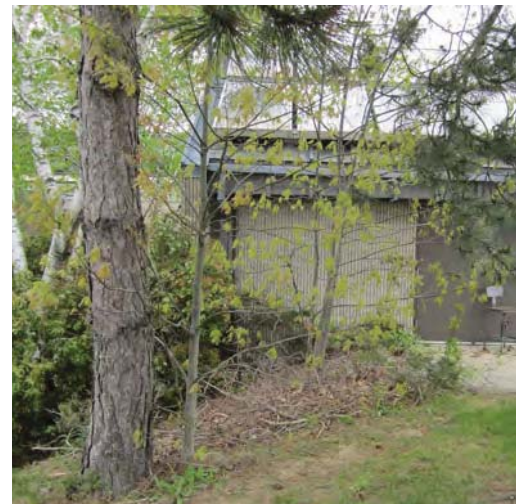
Images #9,10

3 *Pinus nigra*  
Austrian Pine

Trees need to be carefully pruned  
by certified arborist.

**3 Pinus nigra**  
Austrian Pine  
Trees need to be carefully pruned by certified arborist.  
See images #9, 10

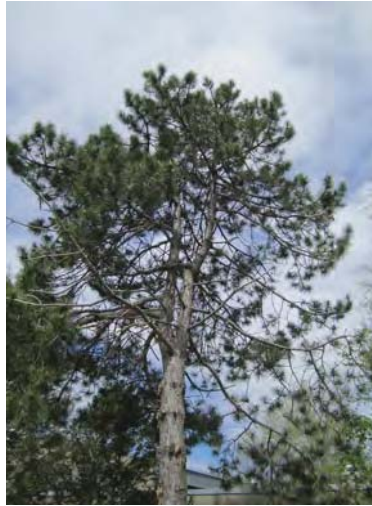
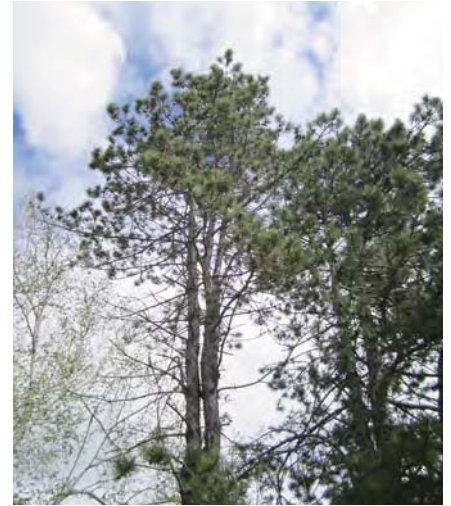
Image #11

2 *Tsuga canadensis*  
Canadian Hemlock

Trees are showing signs of stress and disease and are not  
providing sufficient screening for the loud vent nor the loading  
dock.

Recommend evaluation by arborist to determine level of disease.  
If removed, replace with sufficient planting/structure to provide  
better screening. If trees are not removed, additional planting/  
structures are also needed to provide screening.

**2 Tsuga canadensis**  
Canadian Hemlock  
Trees are showing signs of stress and disease and are not providing sufficient screening for the loud vent nor the loading dock.  
Recommend evaluation by arborist to determine level of disease. If removed, replace with sufficient planting to provide better screening.  
For pricing, assume removal of existing Hemlocks and replacement with four new trees and 20 evergreen shrubs.  
See image #11

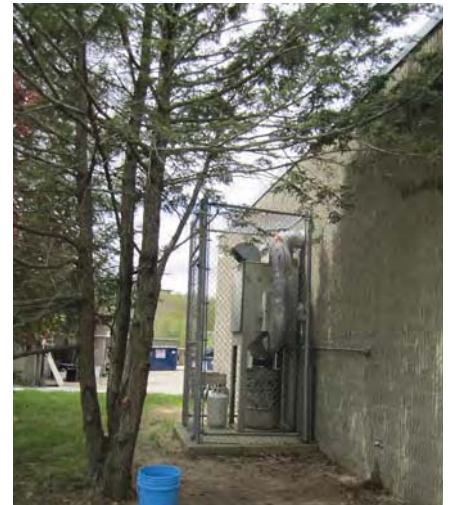
Image #12

*Deceased Tsuga canadensis*

Recommend removal.

**Deceased Tsuga canadensis**  
Recommend removal.  
See image #12

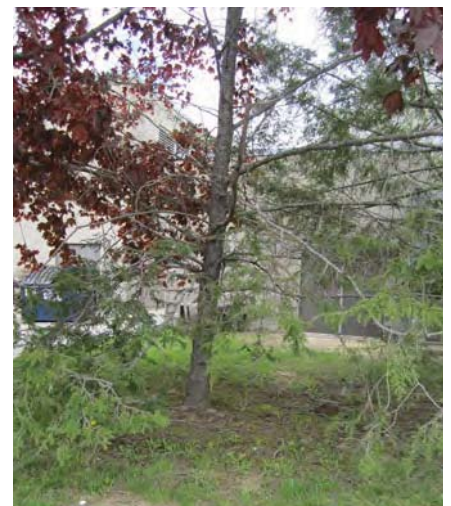
Images #13,14,15

3 *Acer platanoides* 'Crimson King'  
Crimson King Maple

Mature trees are in relatively good health, but need evaluation by arborist. Root areas are being negatively impacted by surface erosion and foot traffic and need better protection.

**3 Acer platanoides 'Crimson King'**  
Crimson King Maple  
Mature trees are in relatively good health, but need evaluation by arborist.  
See images #13,14,15

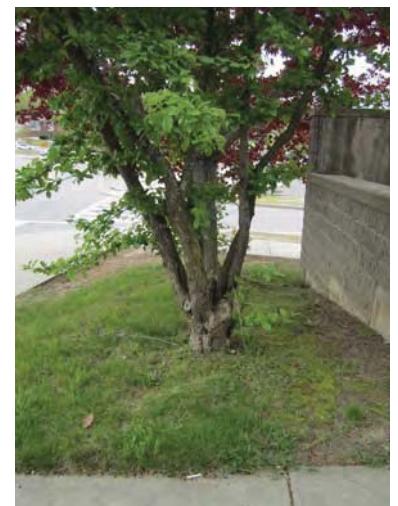
Images #17,18,19

Plants are in reasonable health but offer no shading or screening for the patio or sidewalk.

Recommend relocation and replacement with row of canopy trees to provide screening and shade.

**4 Viburnum sp.**  
Viburnum  
Plants are in reasonable health but offer no shading or screening for the patio or sidewalk.  
Recommend relocation and replacement with row of canopy trees to provide screening and shade.  
For pricing, assume relocation of four large shrubs and replacement with 10 canopy trees.  
See images #17,18,19

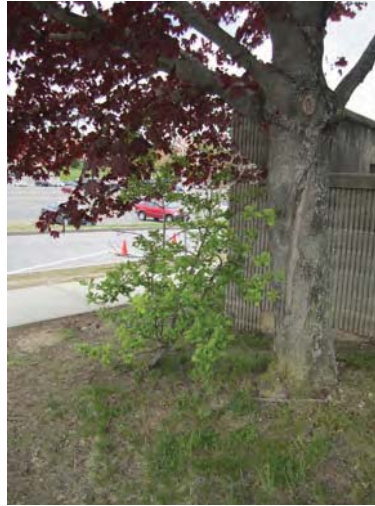
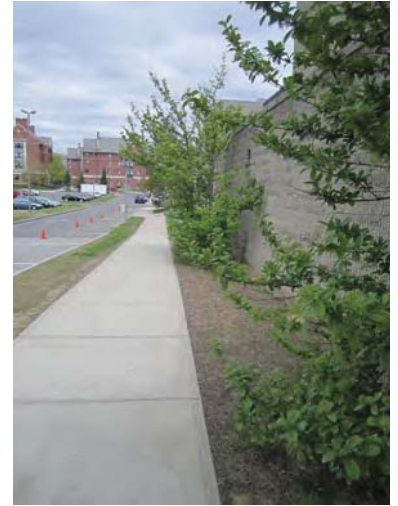
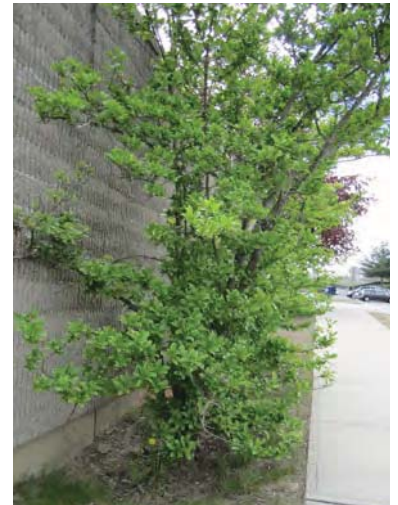
Images #20,21

*Malus sp.*  
Crabapple

Planted too close to wall

Recommend replacement with row of canopy trees to screen patio from adjacent parking lot.

**Malus sp.**  
Crabapple  
Planted too close to wall  
Recommend removal.  
See images #20, 21

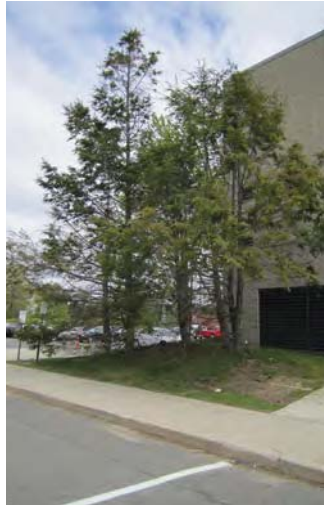
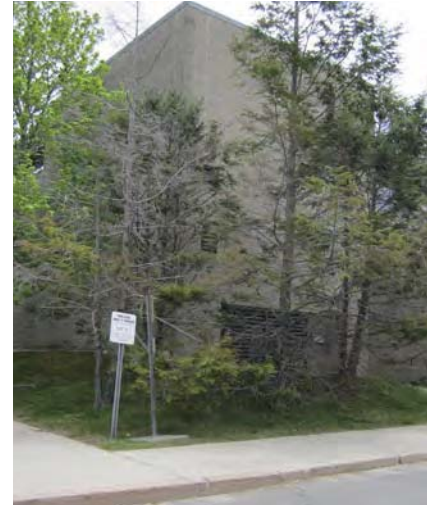
Image #24

*Deceased Tsuga canadensis*

Recommend removal.

**Deceased Tsuga canadensis**  
Recommend removal.  
See image #24

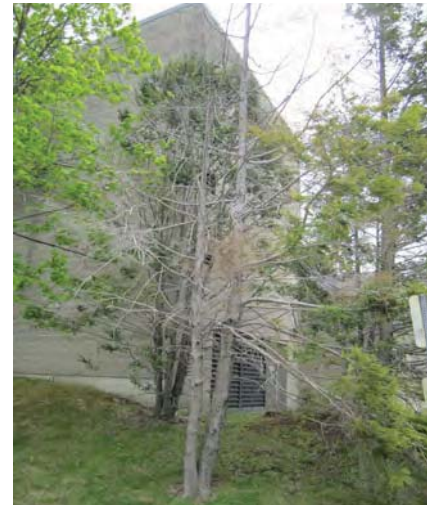
Images #25,26,27,28

*5 Acer platanoides*  
Norway Maple

Recommend evaluation by independent certified arborist.

If removed, replace with canopy trees to shade patio and provide screening from adjacent parking lot.

**5 Acer platanoides**  
Norway Maple  
Trees are showing signs of stress.  
Recommend evaluation by independent certified arborist.  
If removed, replace with canopy trees to shade patio and provide screening from adjacent parking lot.  
See images #25,26,27,28

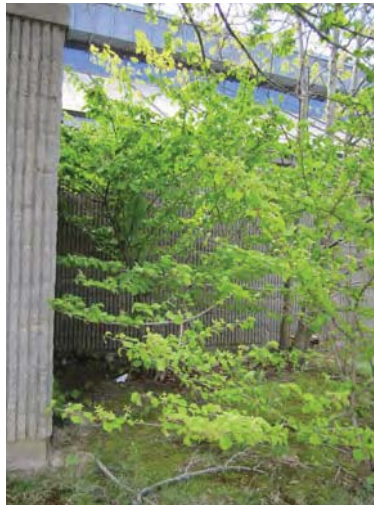
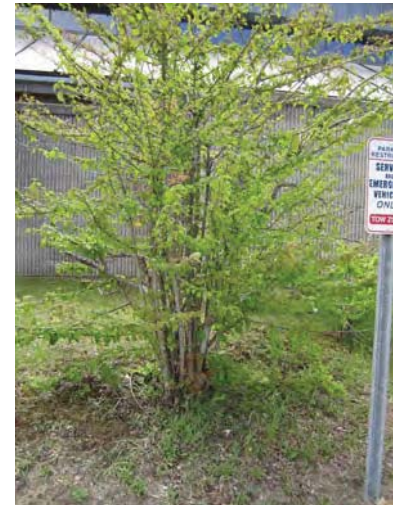
Images #29,30

4 *Viburnum* sp.  
Viburnum

Plants are in reasonable condition but are not providing needed shade nor screening for the patio.

Recommend relocation and replacement with row of canopy trees.

**4 Viburnum sp.**  
Viburnum  
Plants are in reasonable condition but are not providing needed shade nor screening for the patio.  
Recommend relocation and replacement with three canopy trees.  
See images #29,30

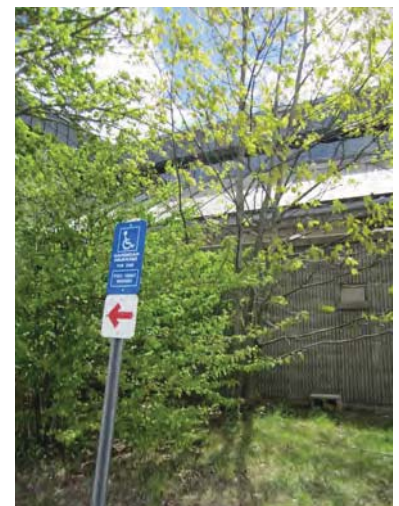
Image #31

*Quercus* sp.  
Oak

Possible volunteer planting.  
Located too close to patio wall.  
Recommend replacement with canopy tree.

**Quercus sp.**  
Oak  
Possible volunteer planting. Located too close to patio wall. Recommend removal and replacement with canopy tree.  
See image #31

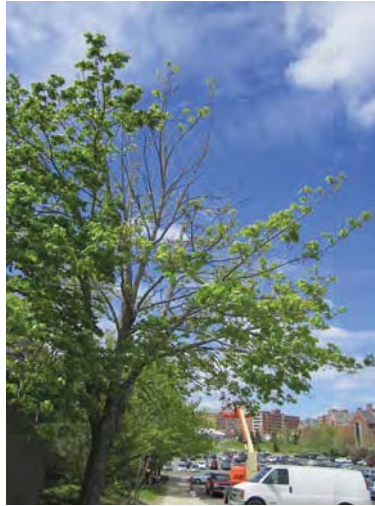
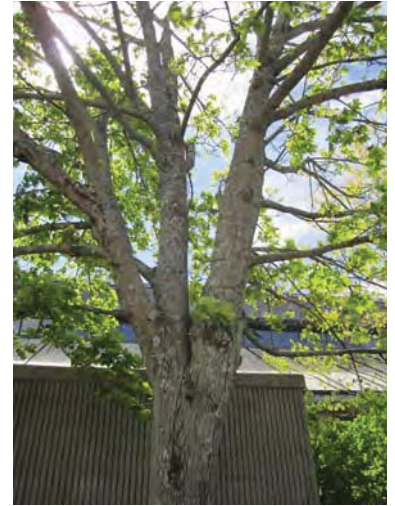
Images #32,33

Tree is showing signs of distress.  
Recommend evaluation by independent  
certified arborist.

If removed, replace with  
canopy tree.

**Acer platanoides**  
Norway Maple  
Tree is showing signs of distress. Recommend evaluation by independent certified arborist.  
If removed, replace with canopy tree.  
See images #32, 33

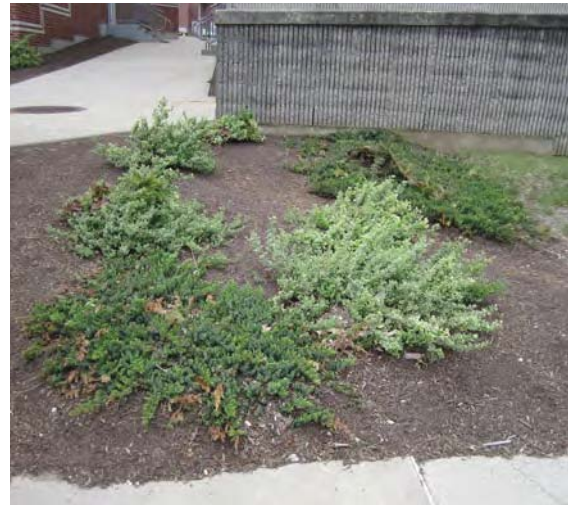
Image #34

*Juniperus sp.*  
Juniper

*Euonymus sp.*  
Euonymus

Recommend replacement with more  
substantial planting along full length  
of building. Area is showing signs of  
surface erosion and needs to be better  
protected from runoff.

**Juniperus spp**  
Juniper  
Recommend replacement with more substantial planting along full length of building. Area is showing signs of surface erosion and needs to be better protected from runoff.  
For pricing, assume removal of existing shrubs and replacement with four canopy trees.  
See image #34

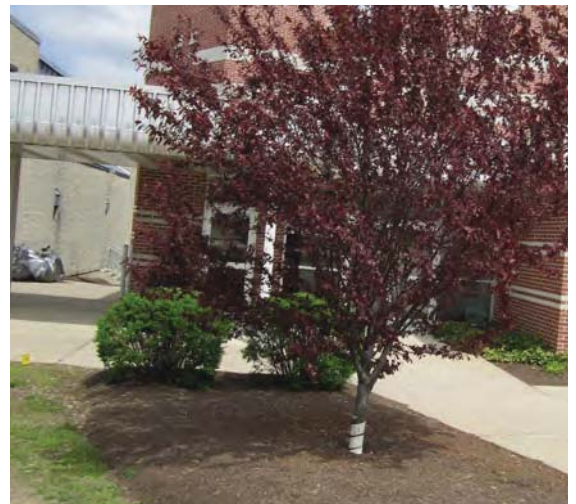
Image #35

*Prunus sp.*  
Plum

Tree is in reasonable condition despite  
being planted too high.

Trunk wrap needs to be removed.

**Prunus sp.**  
Tree is in reasonable condition despite being planted too high.  
Trunk wrap needs to be removed.  
See image #35

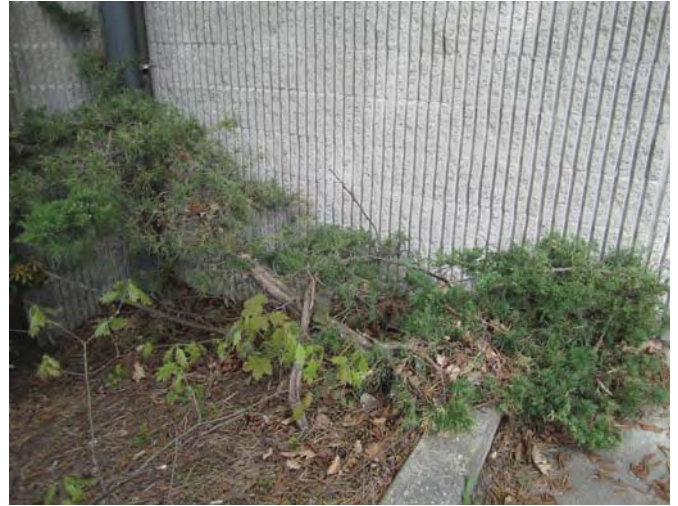
Image #36

Not providing any landscape function.

Recommend removal.

**Juniperus sp.**  
Juniper  
Recommend removal.  
See image #36
