# Exterior Renovations,

Fine Arts Building  
University of Connecticut  
Storrs, CT  
28 June 2011

SGH Project 110416

In May 2011, we completed the condition assessment of the Fine Arts Building. Our review focused on the ribbed-concrete-block veneer walls and various fenestrations, the concrete terraces, low-slope built-up membrane roofs, batten-seam metal panel roofs and soffits, and the sloped glazing system. Additionally, we reviewed the existing landscaping, site drainage, and performed a site survey. The attached report provides a summary of our observations, discussion of our findings, and our recommendations for remedial work. Photographs are included in Appendix A.

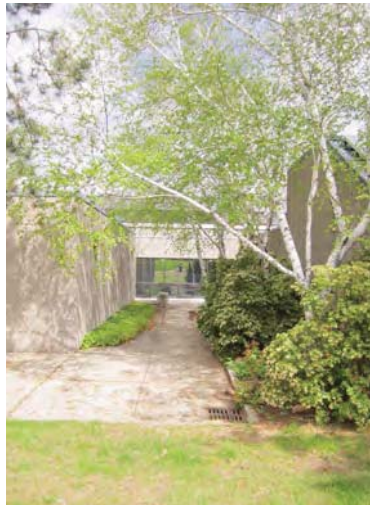
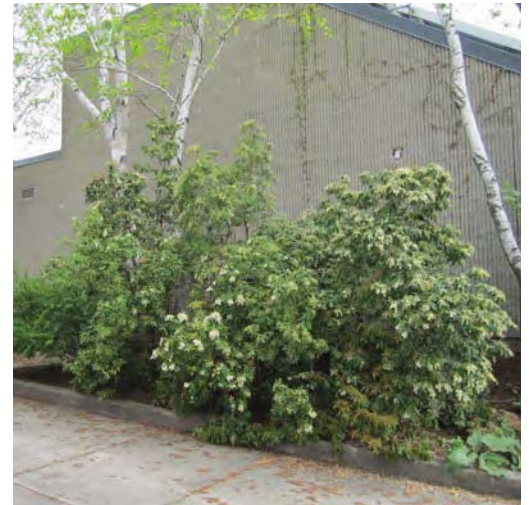
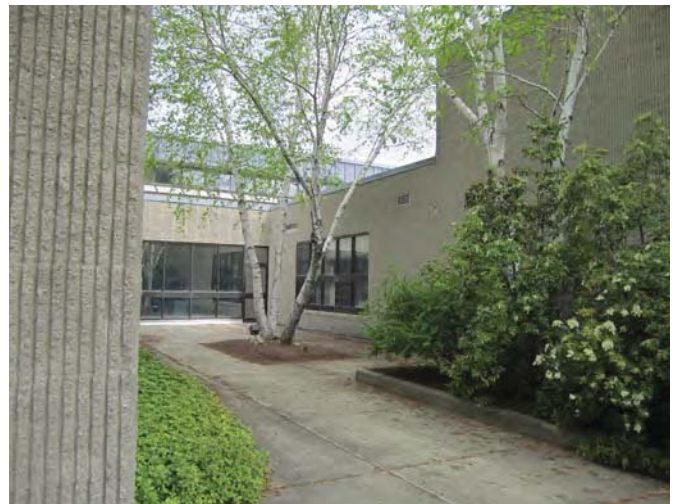
Images #39,40,41

*3 Betula alba*  
*European Birch*

*Important specimen trees that should be retained.*

*Needs careful pruning by certified arborist to trim branches that are potentially impacting the roof.*

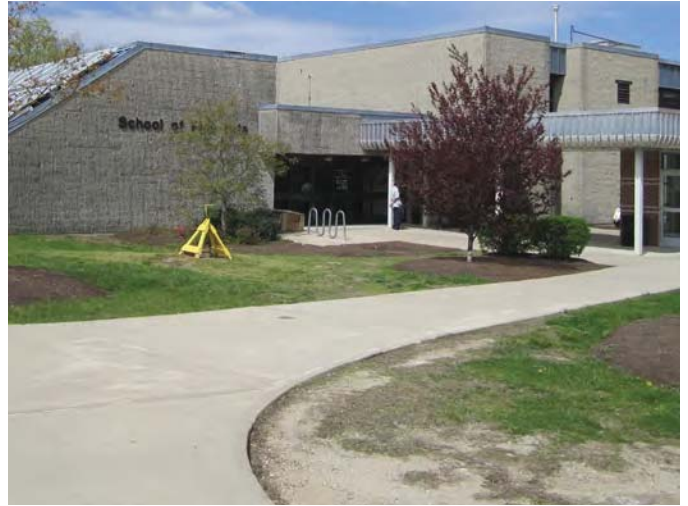
Image #49

*Surface erosion*

Likely caused by pedestrian traffic.

Recommend adding more substantial planting along sidewalk.

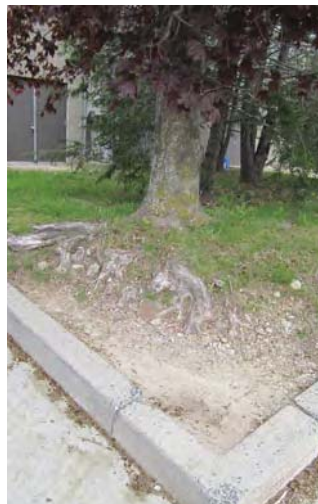
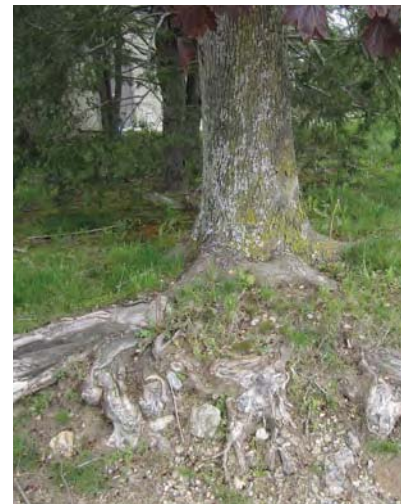
Images #55,56

Caused by stormwater runoff and poor site drainage.

Runoff from sidewalks and adjacent patio is scouring planting bed at corner as well as planting strip at street edge. This is having a negative impact on the shade tree in this location.

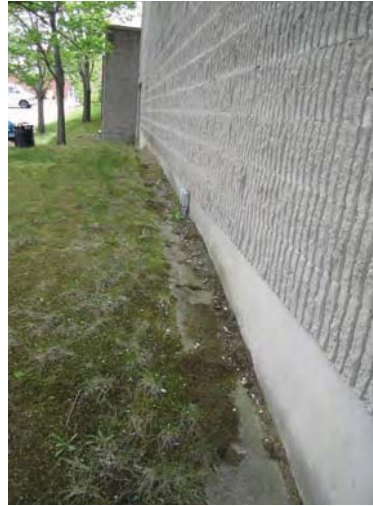
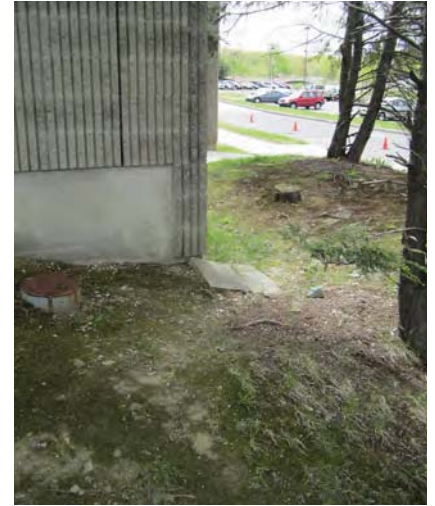
Images #67,68

### *Surface erosion*

Due to pedestrian use and runoff.

Recommend comprehensive stormwater management strategy to address building and surface drainage.

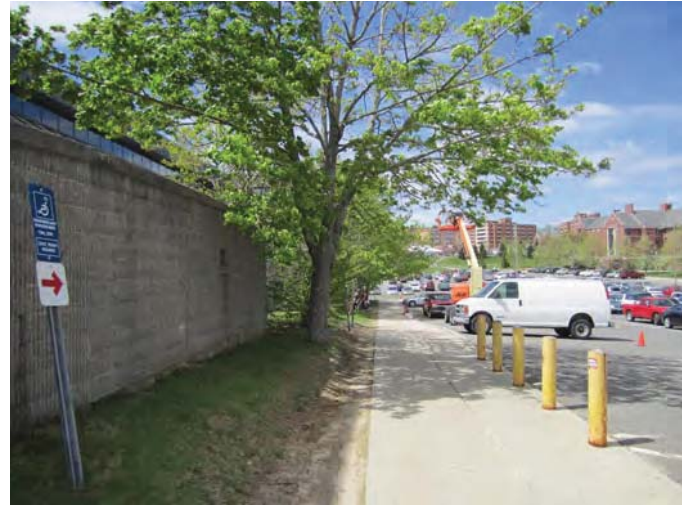
Image #78

Caused by poor runoff management and pedestrian traffic.

Recommend comprehensive site-wide stormwater management strategy.

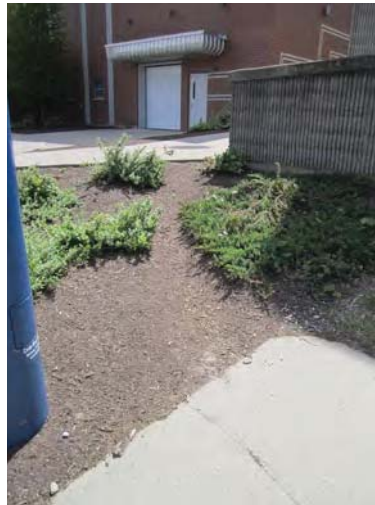
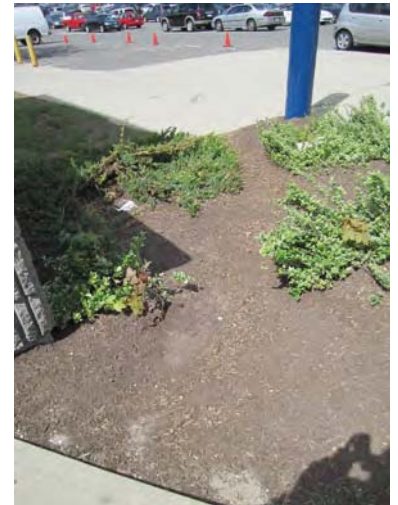
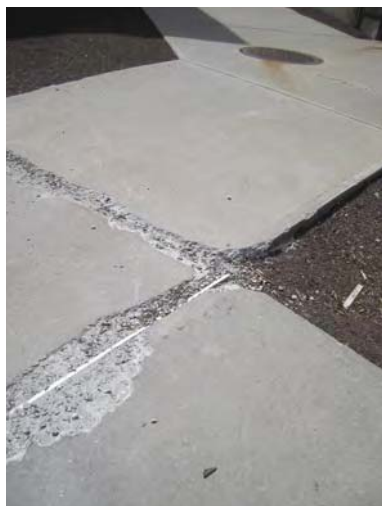
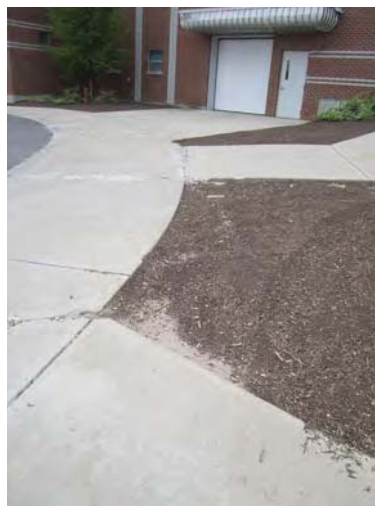
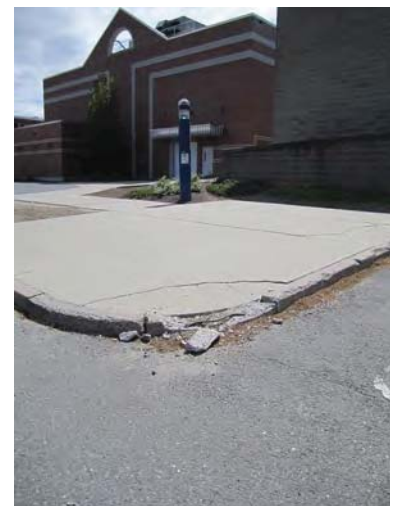
Images #79,80,81,82,83

### *Surface erosion*

Caused by poor runoff management and pedestrian traffic.

Erosion is causing damage to planting area and adjacent concrete sidewalks and curbs.

Recommend development and adoption of comprehensive site-wide stormwater management strategy.

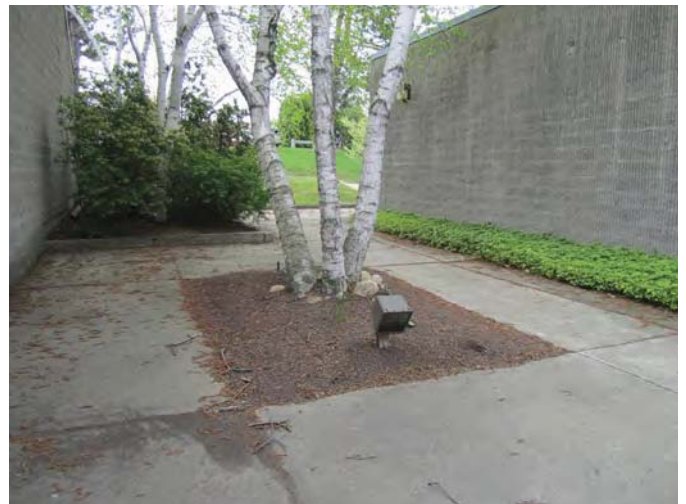
Images #87,88

*Uplifted paving*

Recommend regrading of patio to correct drainage issues. Implement tree protection measures during construction.

Recommend increasing size of planting bed to accommodate mature specimen birch.

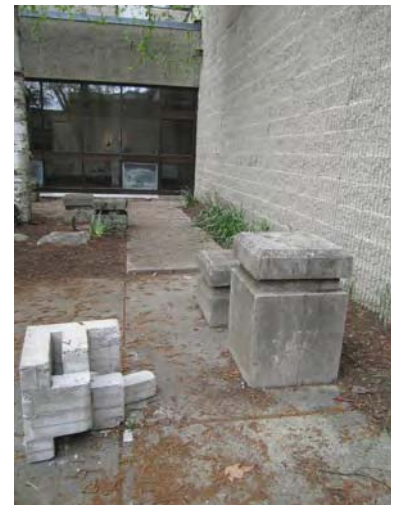
Image #89

### *Concrete pedestals*

Display pedestals are in poor condition.

Survey faculty and staff to determine usefulness of pedestals and replace if needed.

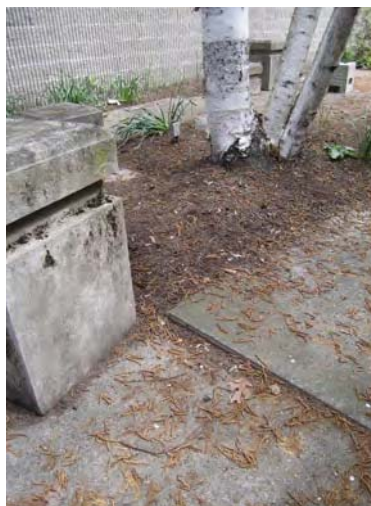
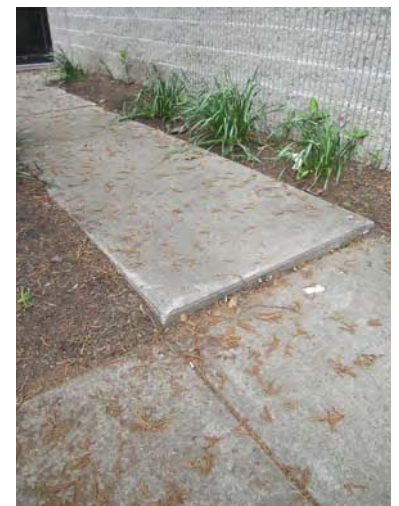
Images #90,91

### *Uplifted paving*

Recommend regrading of patio to correct drainage issues. Implement tree protection measures during construction.

Recommend increasing size of planting bed to accommodate mature specimen birch.

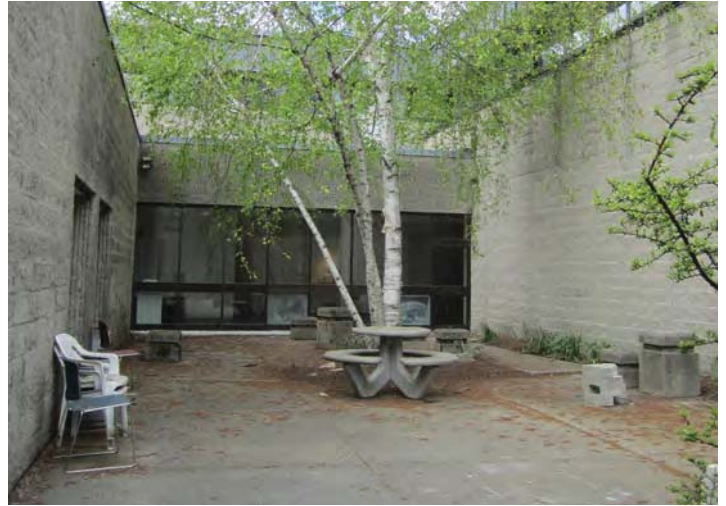
Image #92

*Lack of seating*

There is a clear lack of sufficient seating in the courtyard space.

Recommend incorporating integrated seating into new site design.

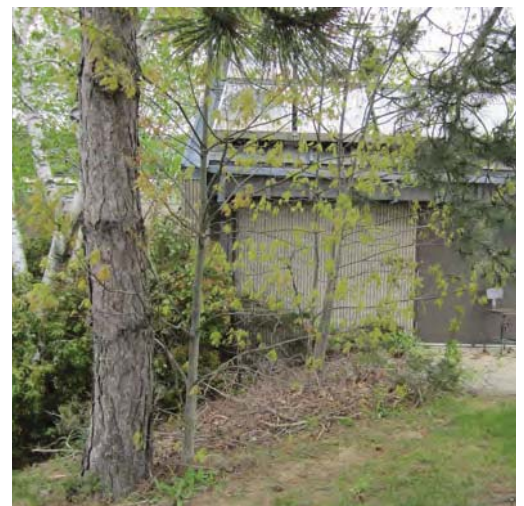
Possible volunteer planting.

Recommend removing smaller tree given  
space constraints.

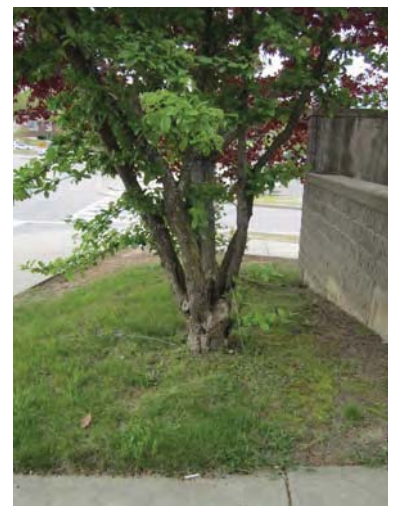
*Viburnum sp.*  
Viburnum

This is the largest of the viburnums in this area and is in relatively good health. Surface drainage is eroding soil at base. Plants in this zone need better protection from erosion.

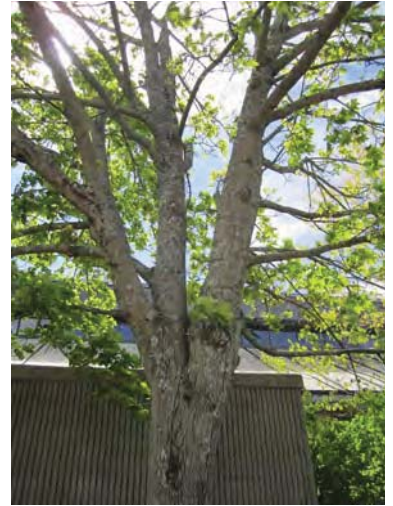
Tree is showing signs of distress.  
Recommend evaluation by independent  
certified arborist.

If removed, replace with  
canopy tree.

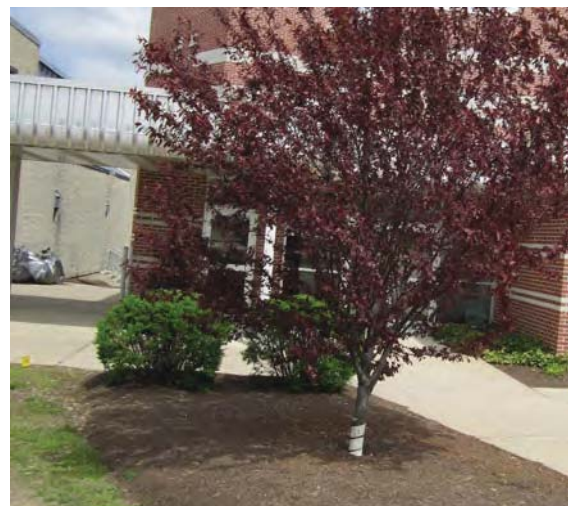
Tree is in reasonable condition despite  
being planted too high.

Trunk wrap needs to be removed.

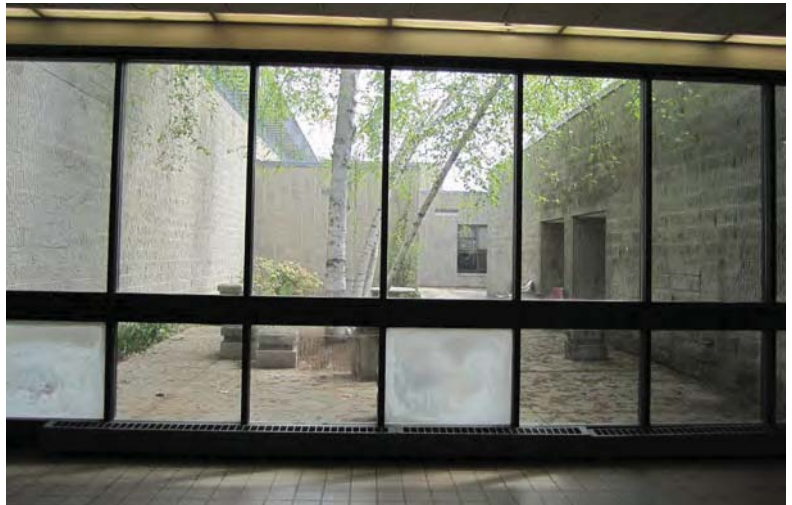
Image #46

Interior view into courtyard garden

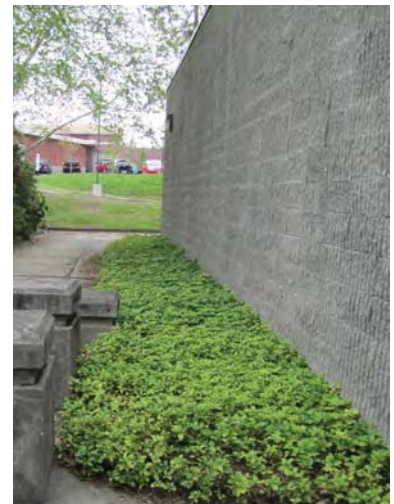
Image #47

*Pachysandra terminalis*

Established bed of healthy groundcover.

Protect during construction.

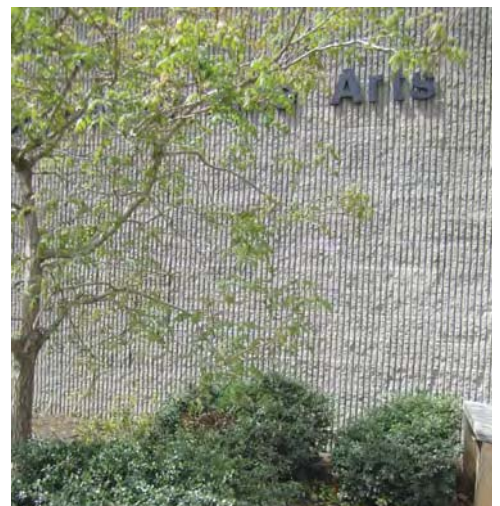
*Existing signage*

Wall mounted entrance signage is obscured by planting. Recommend that new signage strategy is incorporated into new landscape planting design.

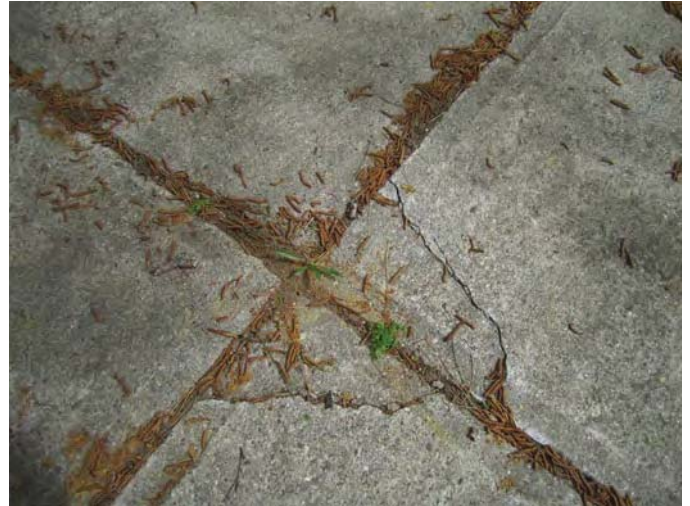
Image #51

*Cracked concrete*

Likely due to poor drainage.

Recommend regrading entire patio area to address site drainage. Trees and other plant material should be protected during regrading. See Civil Engineer report.

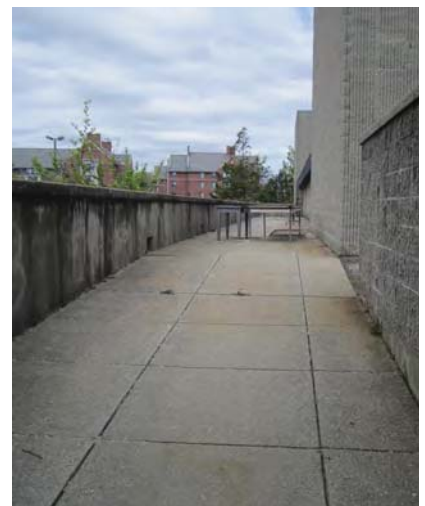
Images #57,58,59,60,61,62

### *SW Patio*

Patio is in critical need of renovation. Drains and scuppers are no longer functioning due to settling and/or heaving. Current design also lacks integrated seating as well as sufficient shading (south facing) and screening. Roof drains have been disconnected.

Recommend reconstruction including the addition of integrated seating and landscape planting to provide shade and screening from parking lot. See Civil Engineer report for details.

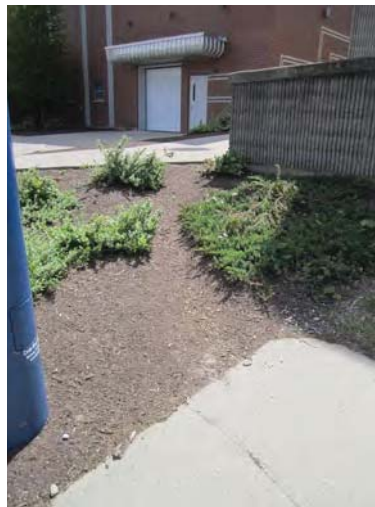
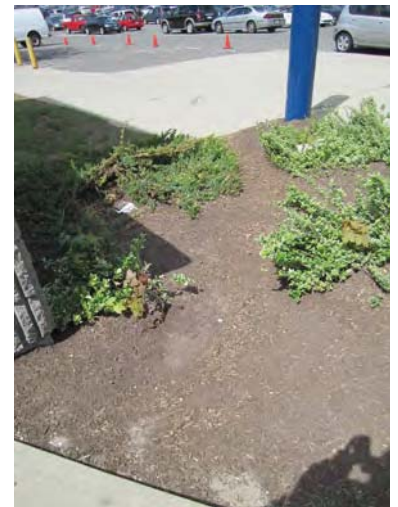
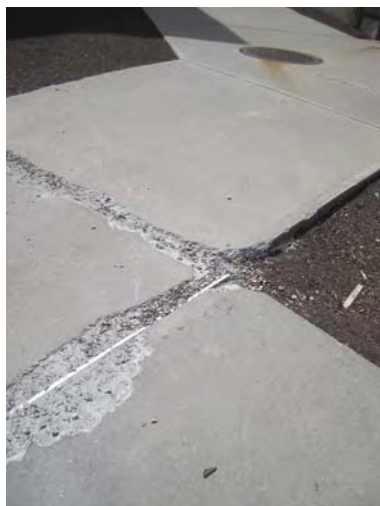
Image #78

Erosion is causing damage to planting area and adjacent concrete sidewalks and curbs.

Recommend development and adoption of comprehensive site-wide stormwater management strategy.

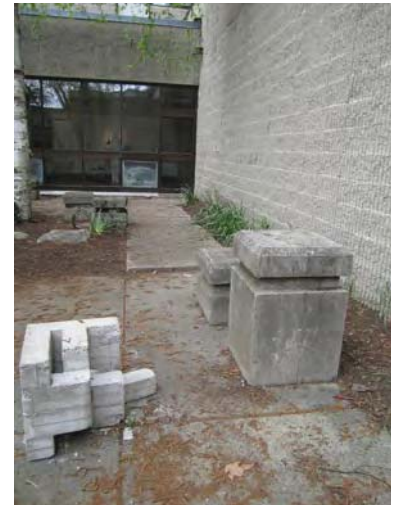
Images #87,88  
(continued)

Display pedestals are in poor condition.

Survey faculty and staff to determine usefulness of pedestals and replace if needed.
