**PROJECT 1533 - 2210 PARK AVENUE,
BRIDGEPORT, CONNECTICUT 06604**

**SCHEMATIC
ROOF LAYOUT**

JOB NO.	DRAWING NUMBER	SHEET
33-262-1533	BASEMAP 33-262-1533.dwg	A-2.0

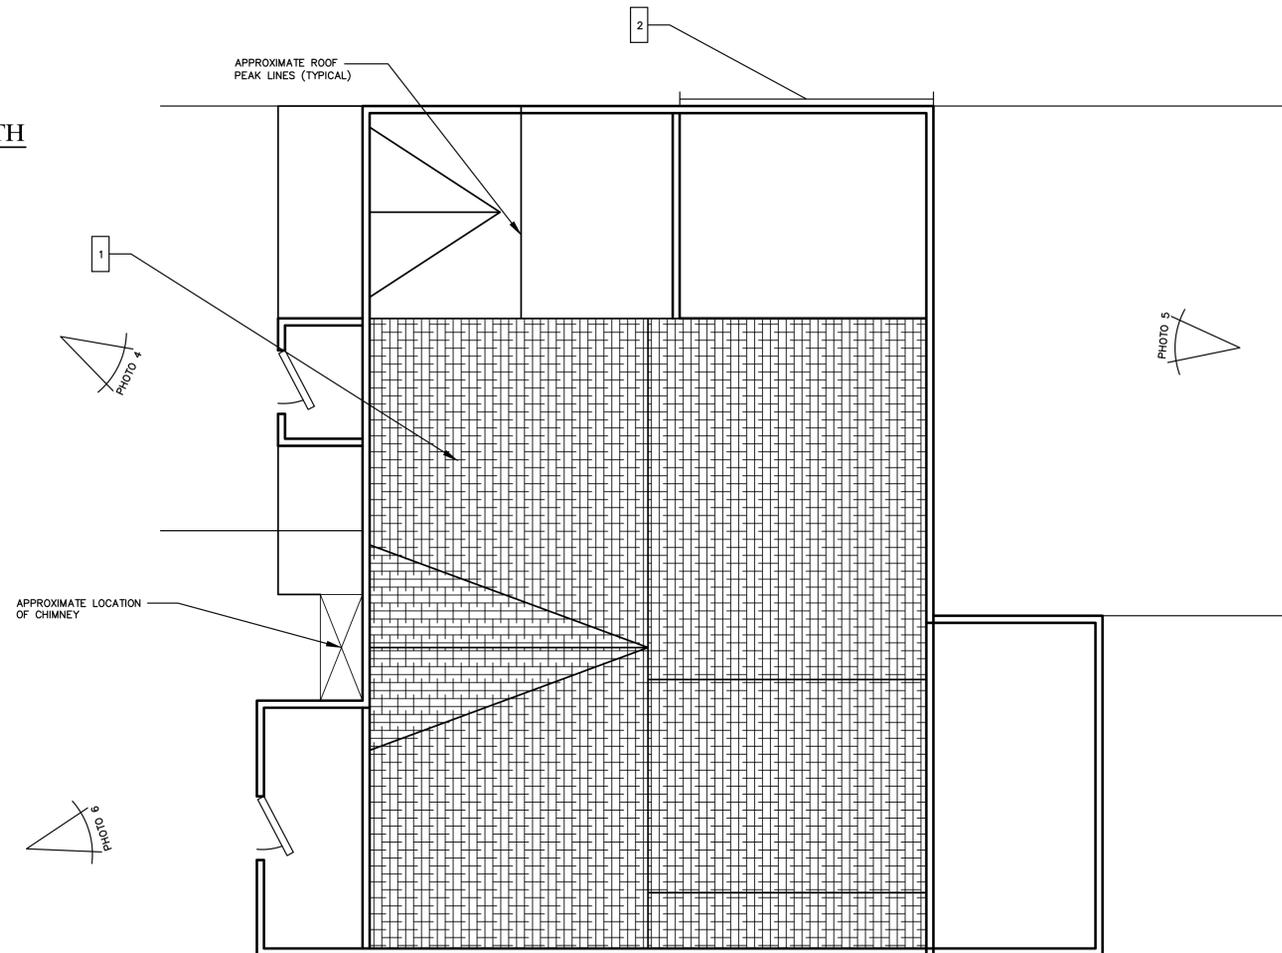
SECOND FLOOR

- 1 ROOFING WORK ACCORDING TO CONTRACT DOCUMENTS
- 2 GUTTER AND DRIP EDGE DAMAGE, REPAIR ACCORDING TO CONTRACT DOCUMENTS
