STRUCTURE NO. 03312

INTERSTATE-84 EB

ROUTE 72, QUINN RV, B&M, RT

Routine & Special Inspection

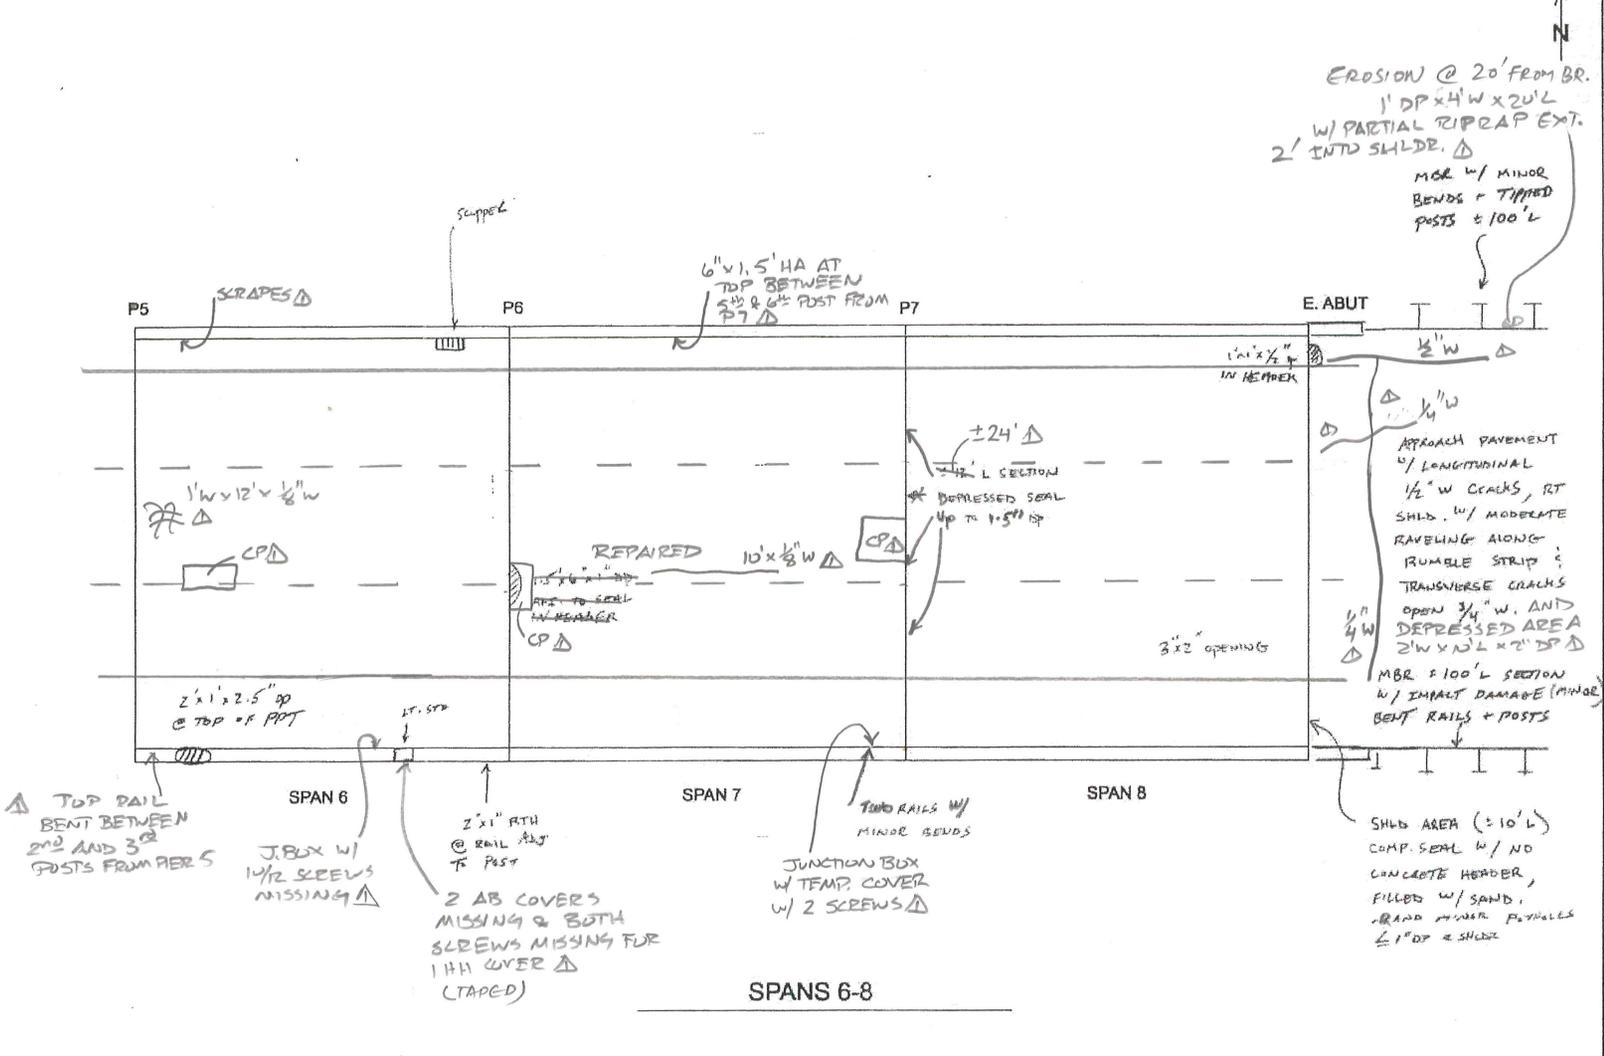
DATE: 4/16/2012
SHEET 27/104-10/74

EROSION @ 20' FROM BR.
 1' DP x 4' W x 2' L
 W/ PARTIAL RIPRAP EXT.
 2' INTO SLIDE. Δ
 MBR W/ MINOR
 BENDS + TIPPED
 POSTS ± 100' L

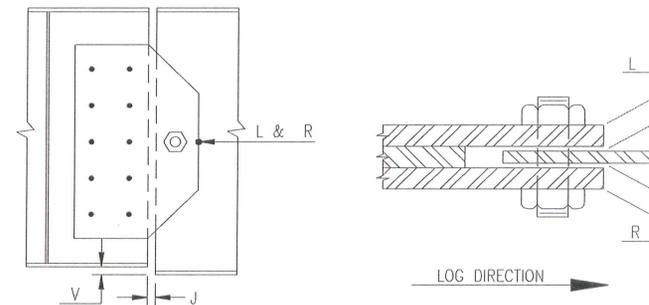
HINGE ANALYSIS SHEET

All measurements are within 1/16" of previous inspection
 All measurements were double checked. No signs of distress were noted.

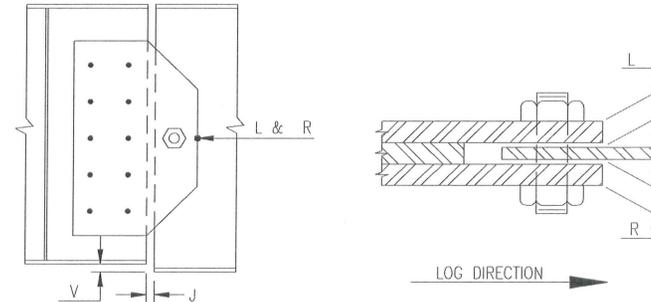
HINGE ANALYSIS SHEET

All measurements are within 1/16" of the previous inspection, except as highlighted above. All measurements were double checked. No signs of distress were noted.

Difference in "V" measurements is possibly due to the fact that measurements were taken on wrong side (supposed to be taken on right side as per sheet). Also, the additional measurement taken on the left side during this inspection is within reasonable limit of the previous measurement. Moreover, the difference in "V" measurements indicate that the girders did not drop but raised since the last inspection (which is not possible).

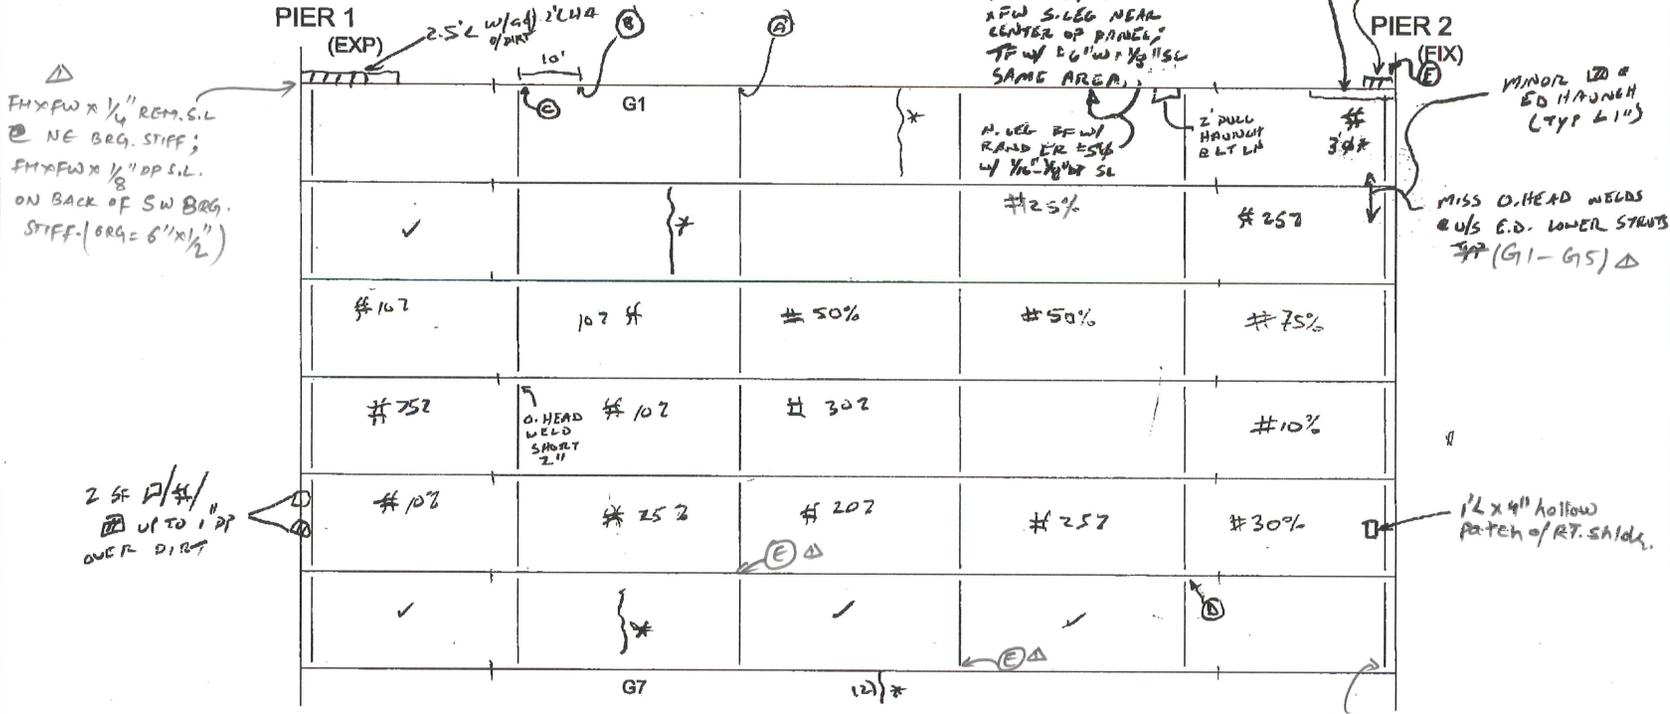
Ⓔ = TOP 10" OF WEB & N. ELEV W/ LR 2.15"W
 W/ 1/16" EST LOSS; S. ELEV WEB W/
 2"H + 1"W LR W/ 1/16" EST LOSS
 (LR DIFFICULT TO REMOVE) RAND OTHER
 NON CRIT LOSSES THIS AREA

BF W/ LR THIS
 PANEL W/ 1/2" MIN
 XFW S-LEG NEAR
 CENTER OF PANEL;
 TF W/ 1/16" W/ 1/8" SL
 SAME AREA.

△ FH x FW x 1/4" REM. S.L.
 ⊙ NE BRG. STIFF;
 FH x FW x 1/8" DP S.L.
 ON BACK OF SW BRG.
 STIFF. (ORG = 6" x 1/2")

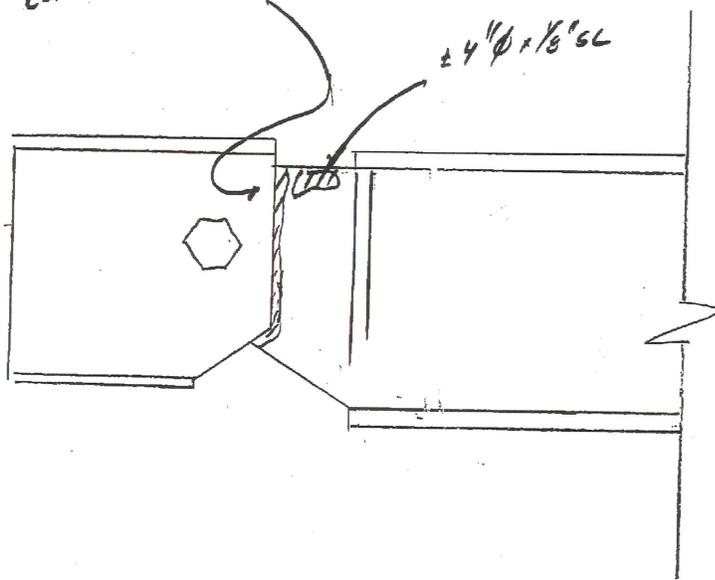
SPAN 3, GIRDER 1, @ PIER 2
SOUTH ELEVATION

FH₁ UP TO 15" W LR
W/ 1/8" DP EST LOSS
(DIFFICULT TO REMOVE)

25' HT UP TO 15" W LR W/
1/8" SL & AREAS REMOVED

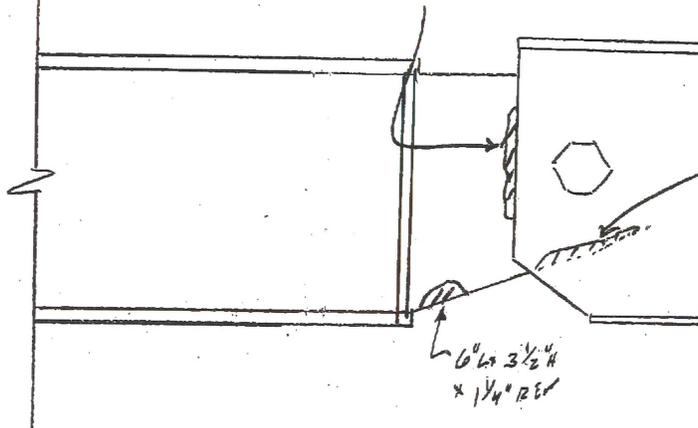
SPAN 3, GIRDER 1, @ PIER 2
NORTH ELEVATION.

BOT EDGE WGD
W/ 1/4" TOT LOSS
AS VIEWED FROM
BELOW

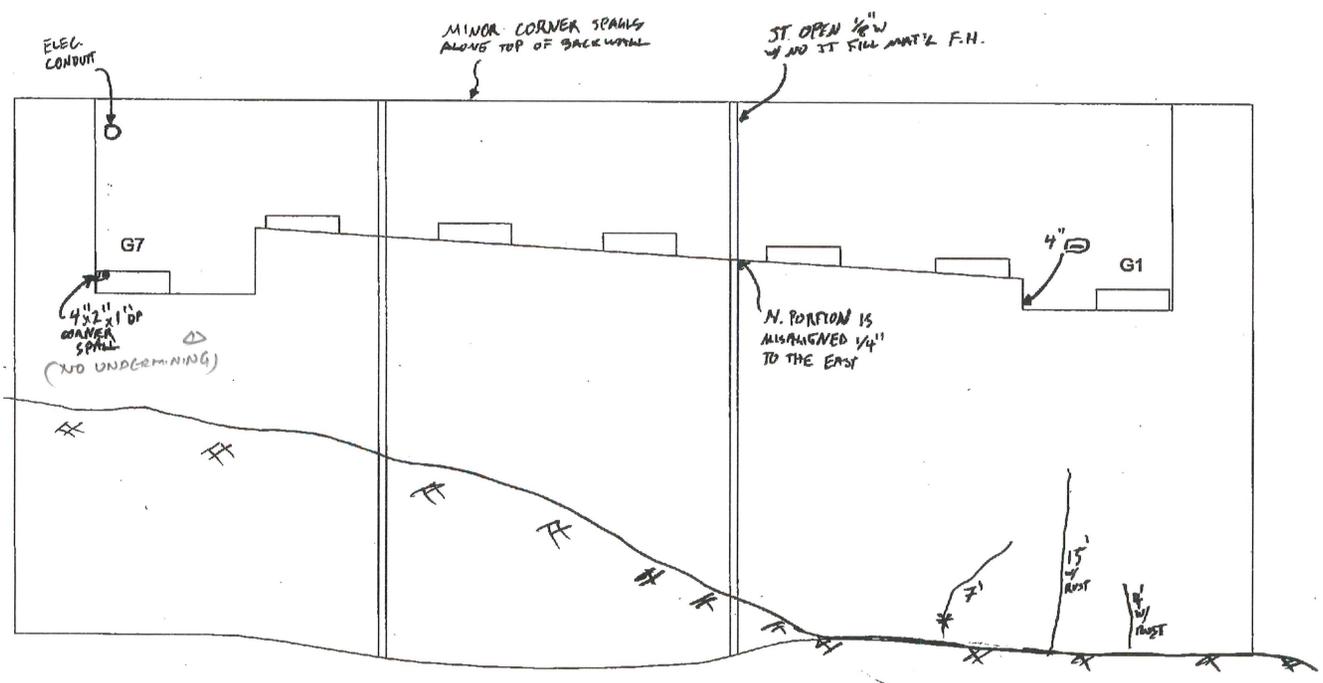
WEST ABUTMENT

- LT-MOD DEBRIS ON SEAT, TYP. @ FASCIAS.
- EVIDENCE OF PREVIOUS JT LEAKAGE (COPY ET.O.I.)
- PAINTED OVER GRAFFITI ON STEM
- Slope w/ BEDDEN STONES Δ
- AREAS OF ACTIVE LEAKAGE ON BACKWALL

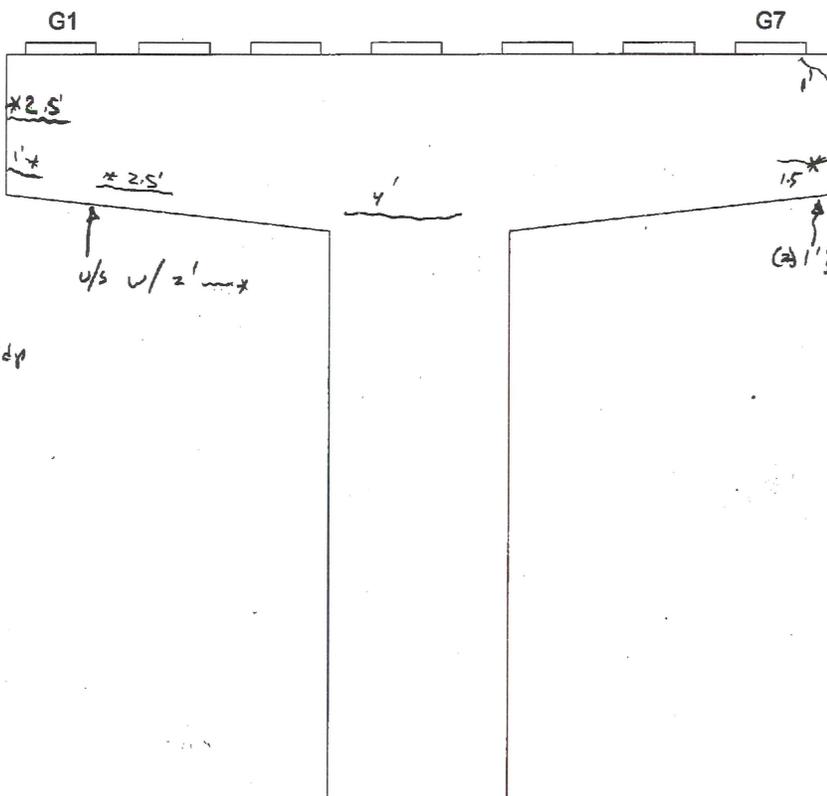
CRKS UP TO
1/16" w along
patch boundary
w/ minor spalls
up to 3" x 2" x 1/2" dp

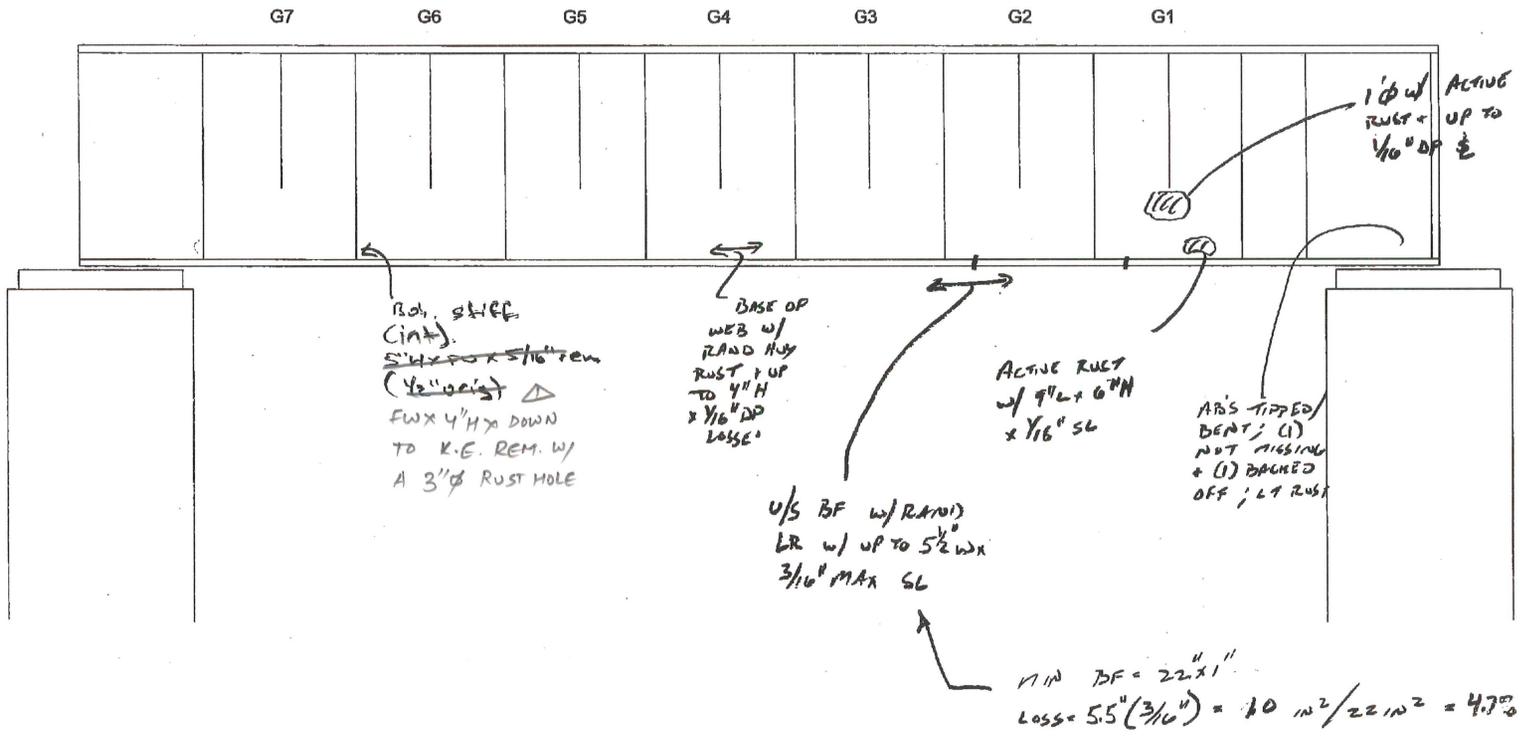
PIER 2
EAST ELEVATION

- Areas of peeling paint & mod-hug rust (most @ interior portions)
 - Isol. loc's of pigeon debris + nesting pigeons B/w CAP BEAM'

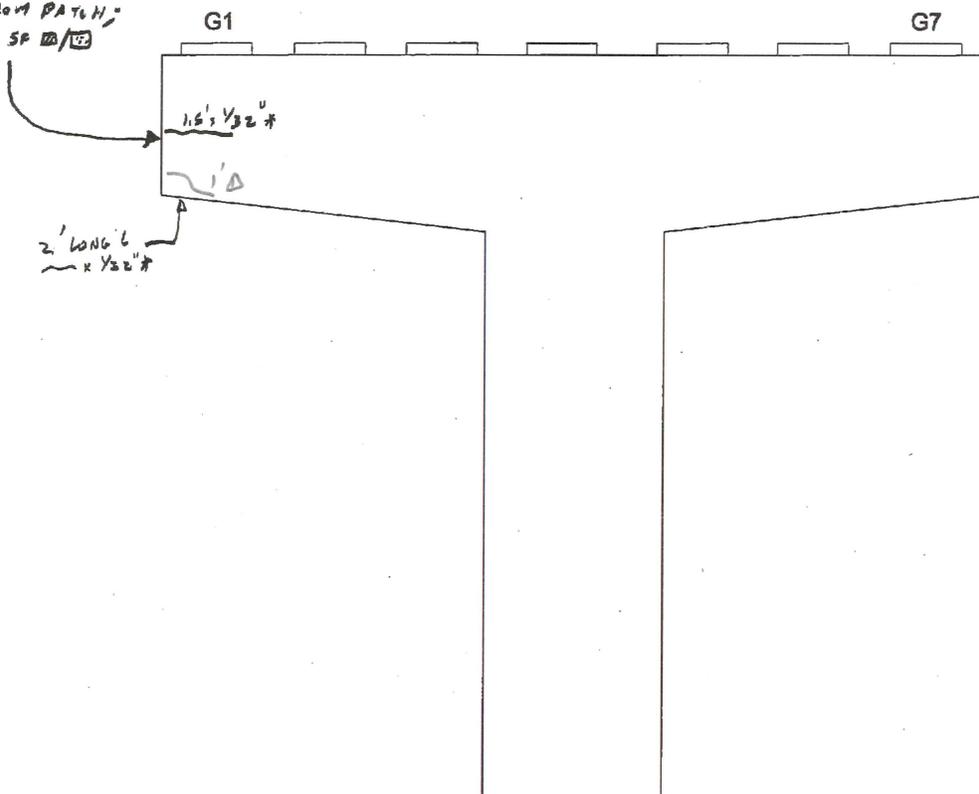
WEST ELEVATION, PIER 4

END FACE W/
AROUND PATCH
BOUNDARY + VT 3/4" S
EXTEND FROM PATCH =
ALSO 2 1 SP 1/2"
1" DP

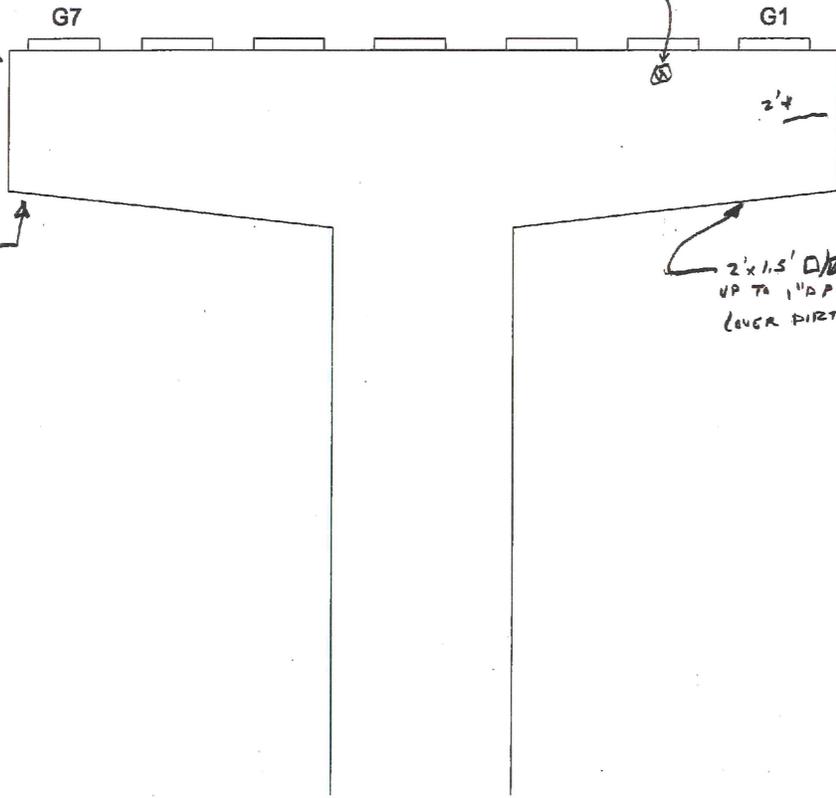
EAST ELEVATION, PIER 4

2' x 1.5' D/B
UP TO 1" DP
(LOWER PART)

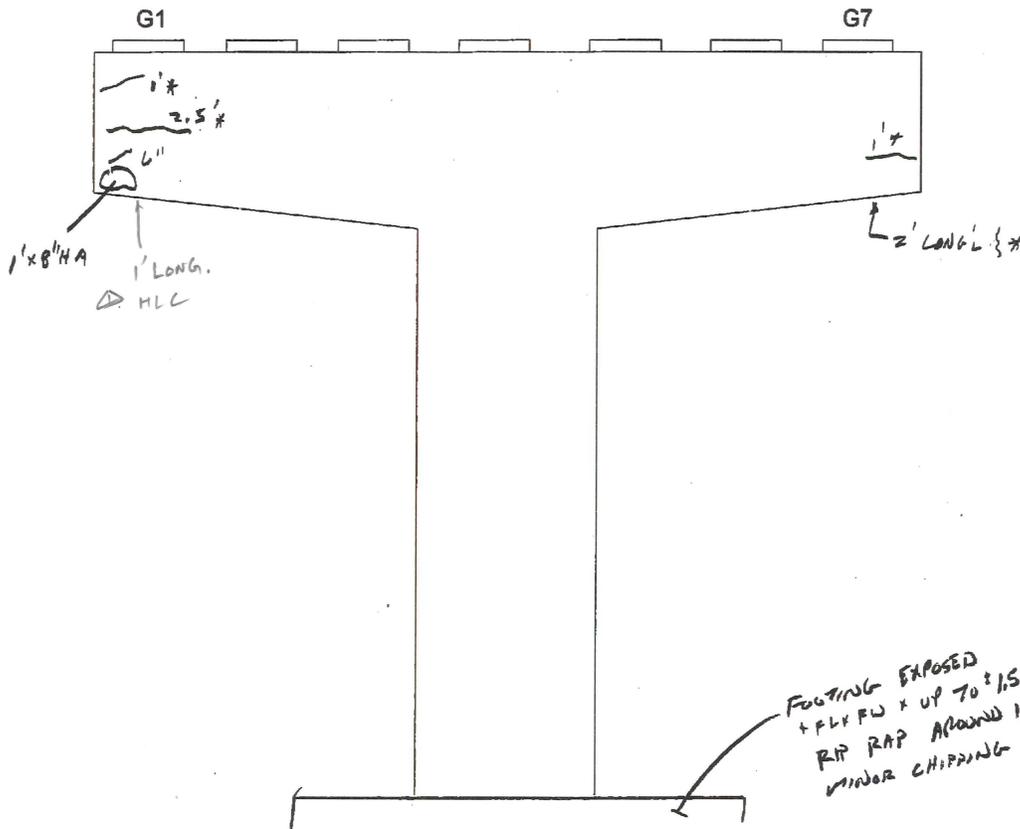
WEST ELEVATION, PIER 5

- MINOR GRAFFITI @ BASE OF COL.
- ACTIVE LEAKAGE ON PIER CAP @ RANDOM LOCATIONS.

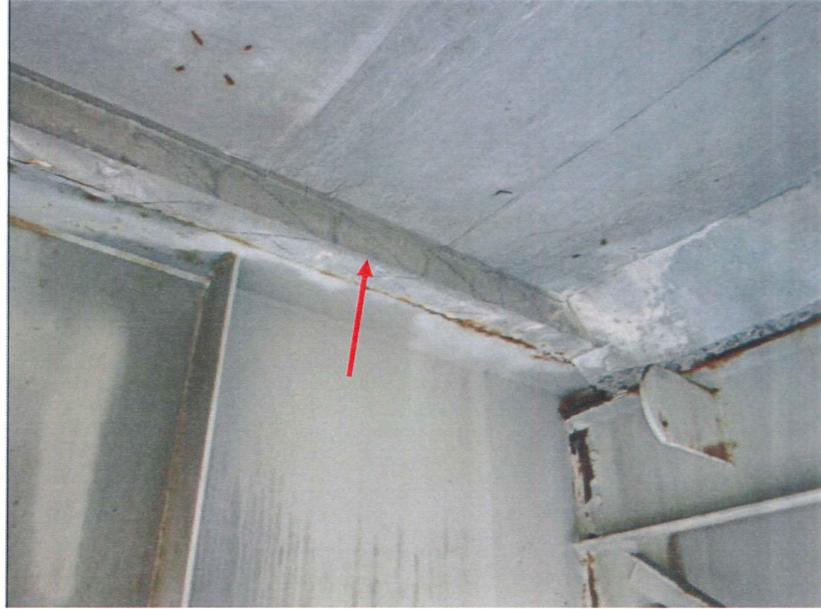
Photo # 10: Hollow haunch on south side of Girder G1 at Pier 2 in Span 2 over left shoulder of Route 72 EB.

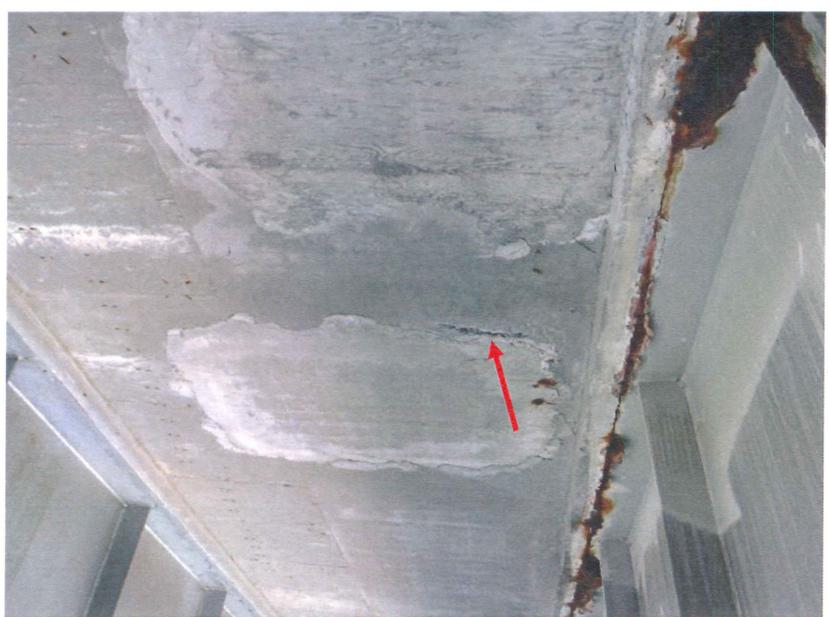
Photo # 11: Hollow area at the corner of the patch near mid-span in Bay 1 of Span 7.

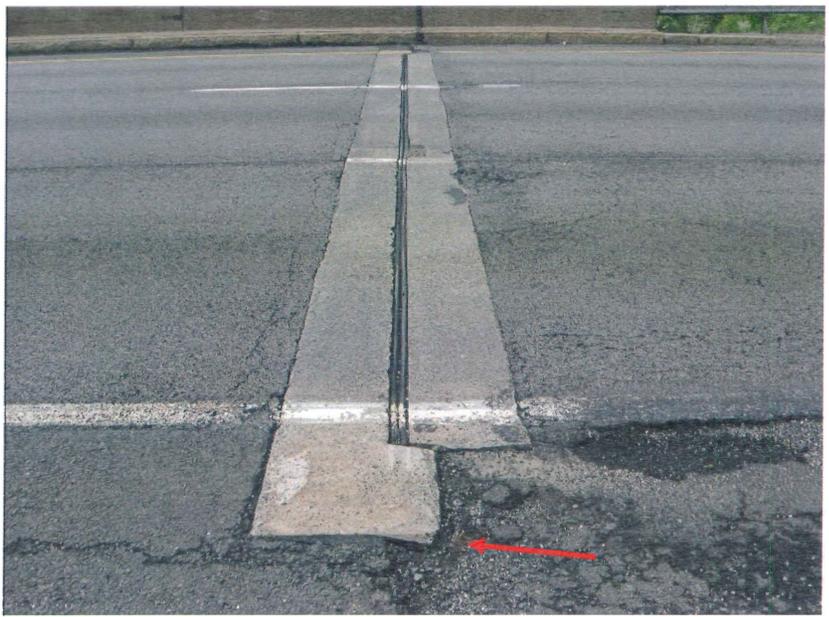
Photo # 17: Deck joint at the East Abutment. Note that the deck joint does not extend for full length and the overlay exhibits minor potholes in the right shoulder.

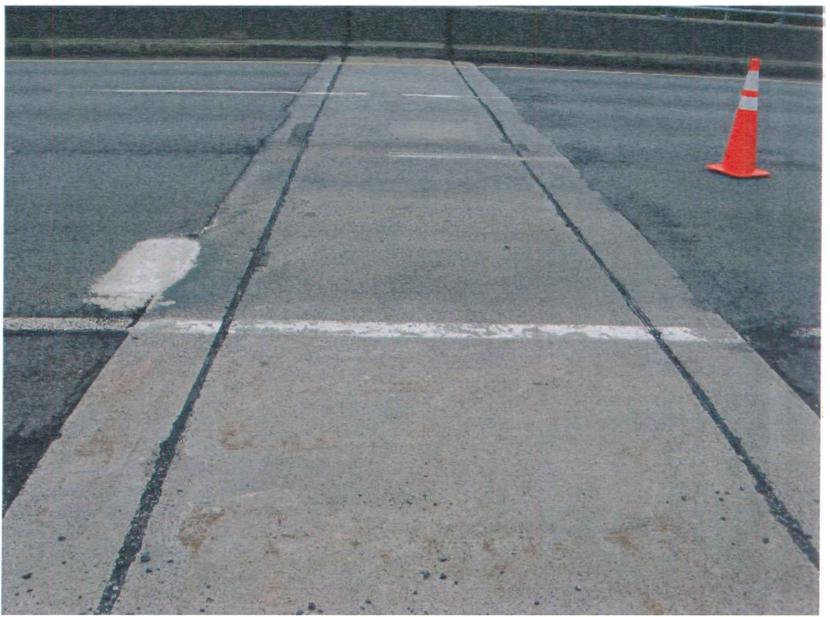
Photo # 18: Deck joint at Pier 2. Note the accumulation of sand in the joint.

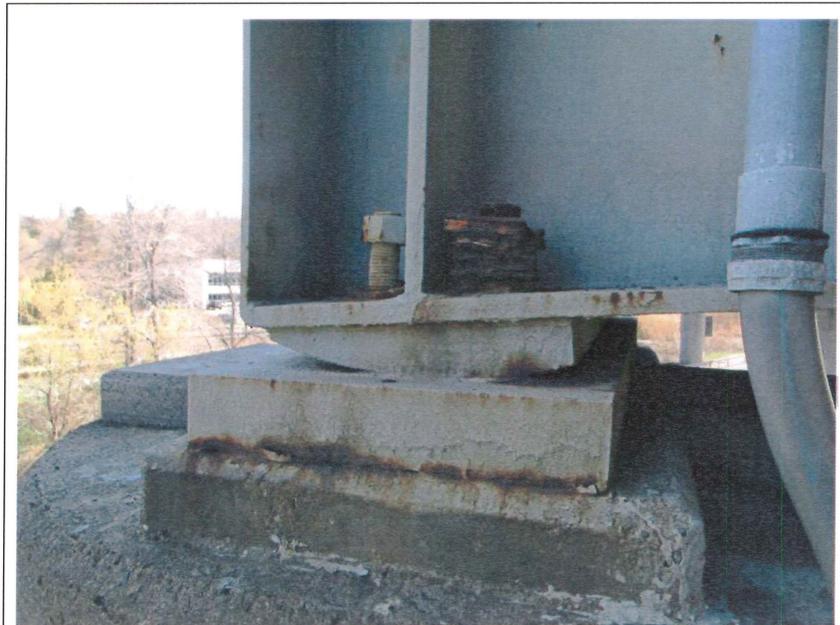
16.	South side of G1 b/w 1 st & 2 nd X-frames from Pier 2 in Span 2. Note dull sounding launch, but not loose.
17	Fixed bry. for Pier 2 cap girder. Note AB not backed off up to 3".

Photo # 23: Fixed bearing for cap girder at the north column of Pier 2. Note the backed off anchor bolt nut and stack of washers.

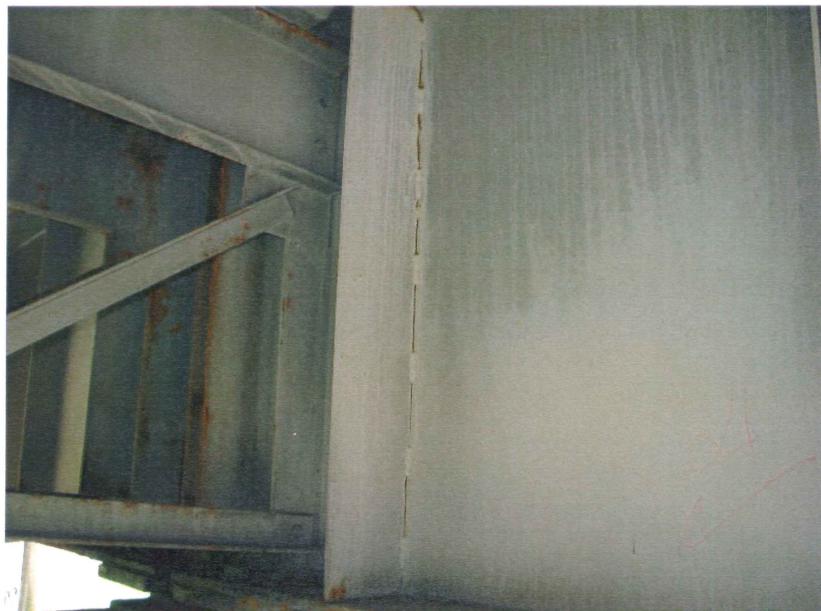
Photo # 37: Stitch welded stiffener on south side of Girder G3 at Pier 3 in Span 4 (typical).

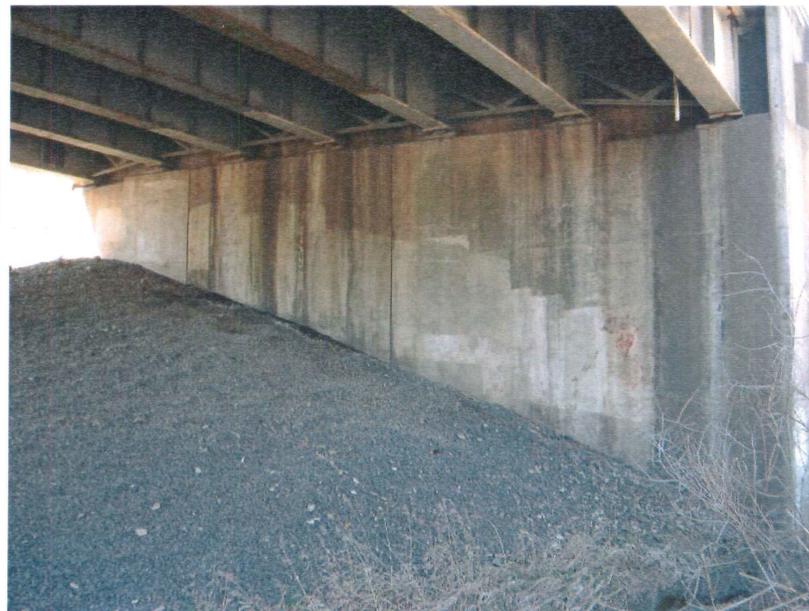
Photo # 38: West Abutment elevation.

ABUTMENTS-STEM:	7	Abutment stems have areas of silt staining, isolated locations of shallow rebars, and vertical hairline cracks with and without rust and efflorescence. The pedestal for Girder G7 at the West Abutment has a 4" x 2" x 1" deep spall. The north portion of the West Abutment is misaligned 1/4" to the east of the center portion (no change since the last inspection) and the vertical joint is open up to 1/8" wide at this location. Vertical joints in the East Abutment stem are open 1/8" and 1/2" wide (no change since the last inspection). See Field Notes Sheets 40 and 42 and Photo No. 38.
ABUTMENTS-BACKWALL:	7	The backwalls have areas of slit staining, hairline cracks with efflorescence, and spalls up to 1" deep along the top of the backwall. There are voids in the East Abutment backwall near the cheekwalls due to missing joint fill material (no change). One vertical joint at the West Abutment backwall is open up to 1/8" wide. The vertical joints at the East Abutment backwall are open up to 3/16" and 5/8" wide (no change since the last inspection). See Field Notes Sheets 46 and 47 and Photo No. 38.

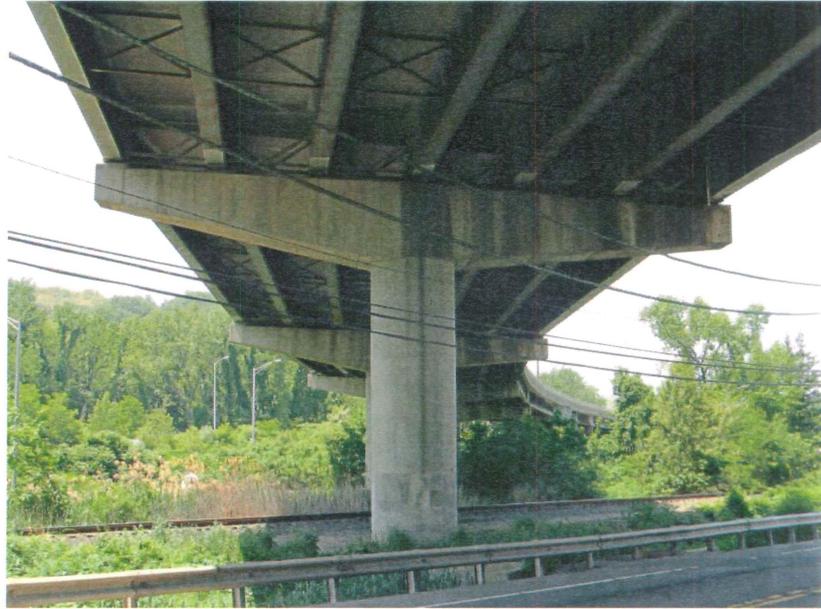
Photo # 40: East elevation of Pier 6.

PIERS/BENTS-PILE BENT:	N	-
PIERS/BENTS-COLUMNS:	7	Concrete pier columns have popouts and shallow tie wires at random locations. Pier 7 column has random shrinkage cracking. See Field Notes Sheets 50 through 64 and Photo Nos. 40 and 44.
PIERS/BENTS-FOOTING:	7	Pier 5 footing is exposed up to 1.5' high and has minor chipping along the edges. As per plans, footing is founded on piles. See Field Notes Sheet 59 and Photo No. 47.
PIERS/BENTS-SETTLMT:	8	None noted.
EROSION-SCOUR:	6	The drainage swale at the base of the Northwest Wingwall is broken out and eroded up to 3' x 2' x 1' deep. There is also a 6' x 2' x 6" deep erosion area at the Northeast Wingwall. Pier 5 footing is exposed up to ±1.5' high (no change since last inspection) and has rip rap around it. This appears to be as-built condition but as per plans, this footing is founded on piles and is not to be exposed. See Field Notes Sheets 49 and 59 and Photo No. 47.

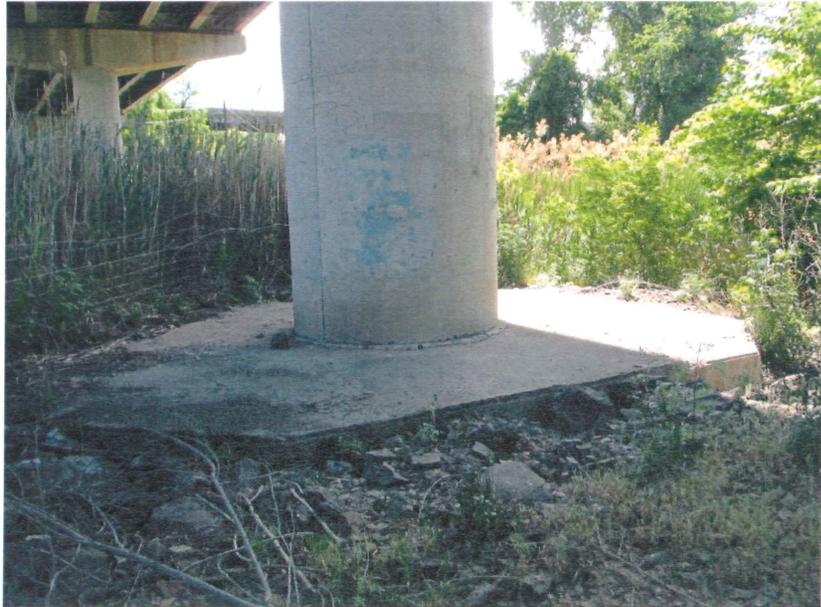
Photo # 47: Exposed footing of Pier 5.

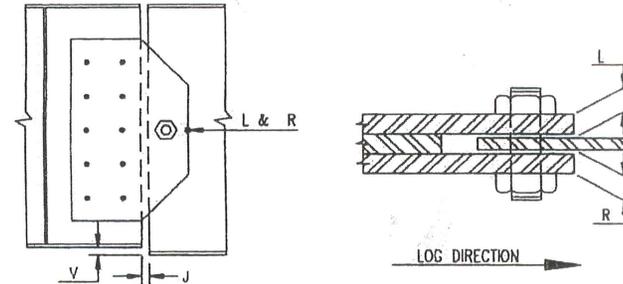
* MEAS TAKEN @ BOTH SIDES DUE TO DIFF W/ PREV MEAS (SHOULD BE RT SIDE PER SHEET 35)

Note for G4, Bleeding nut in range 'N. Nut w/ 1/16" gap b/w web, pl. & nut. & bleed. nut around the south. nut.
