STRUCTURE NO. 03093

INTERSTATE 91
over
N FRONT ST & QUINN RIVER
New HAVEN

Routine Inspection
on
6/16/2014

**BRIDGE NO. 03093
INTERSTATE 91**

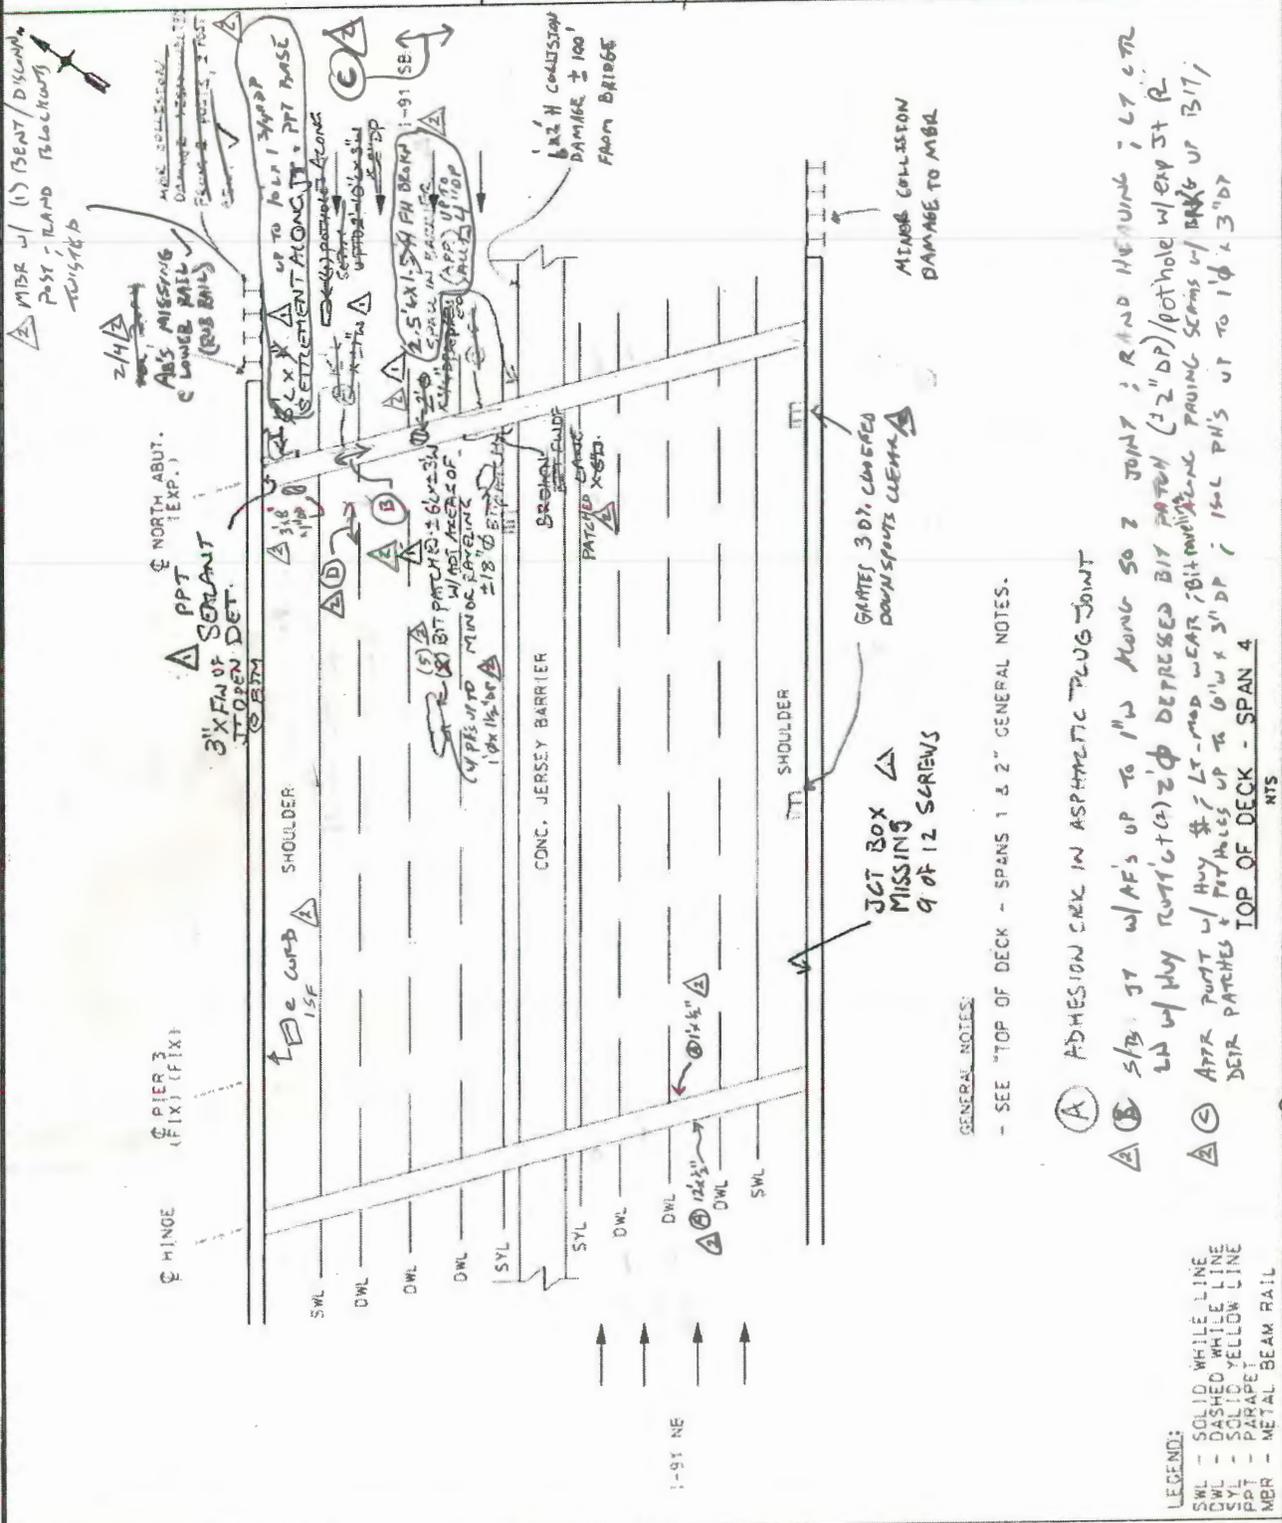
JOB NO. 170-3013	BRIDGE NO. 03093
	DATE: 9/14/10	SHEET 24 OF 41
	CREW: PHH, GM

GENERAL NOTES:
 - SEE "TOP OF DECK - SPANS 1 & 2" GENERAL NOTES.

- (A) ADHESION CRK IN ASPHALTIC PLUG JOINT
- (B) STRUT W/AF'S UP TO 1" W/ HUNG SO 2 JOINT; R AND HEAVING; LT CR
- (C) LN W/ HUY TUNING (G) 2" DECREASED BIT PATCH (1.2" DP) / POT HOLE W/ HUY ST R
- (D) ATTR PATCH W/ HUY #1 LT-MOD WEAR BIT MILDLY CONC TRAVING SCAMS W/ DARK UP BIT; DETR PATCHES UP TO 6" W X 3" DP; 1/2" PH'S UP TO 1' W X 3" DP

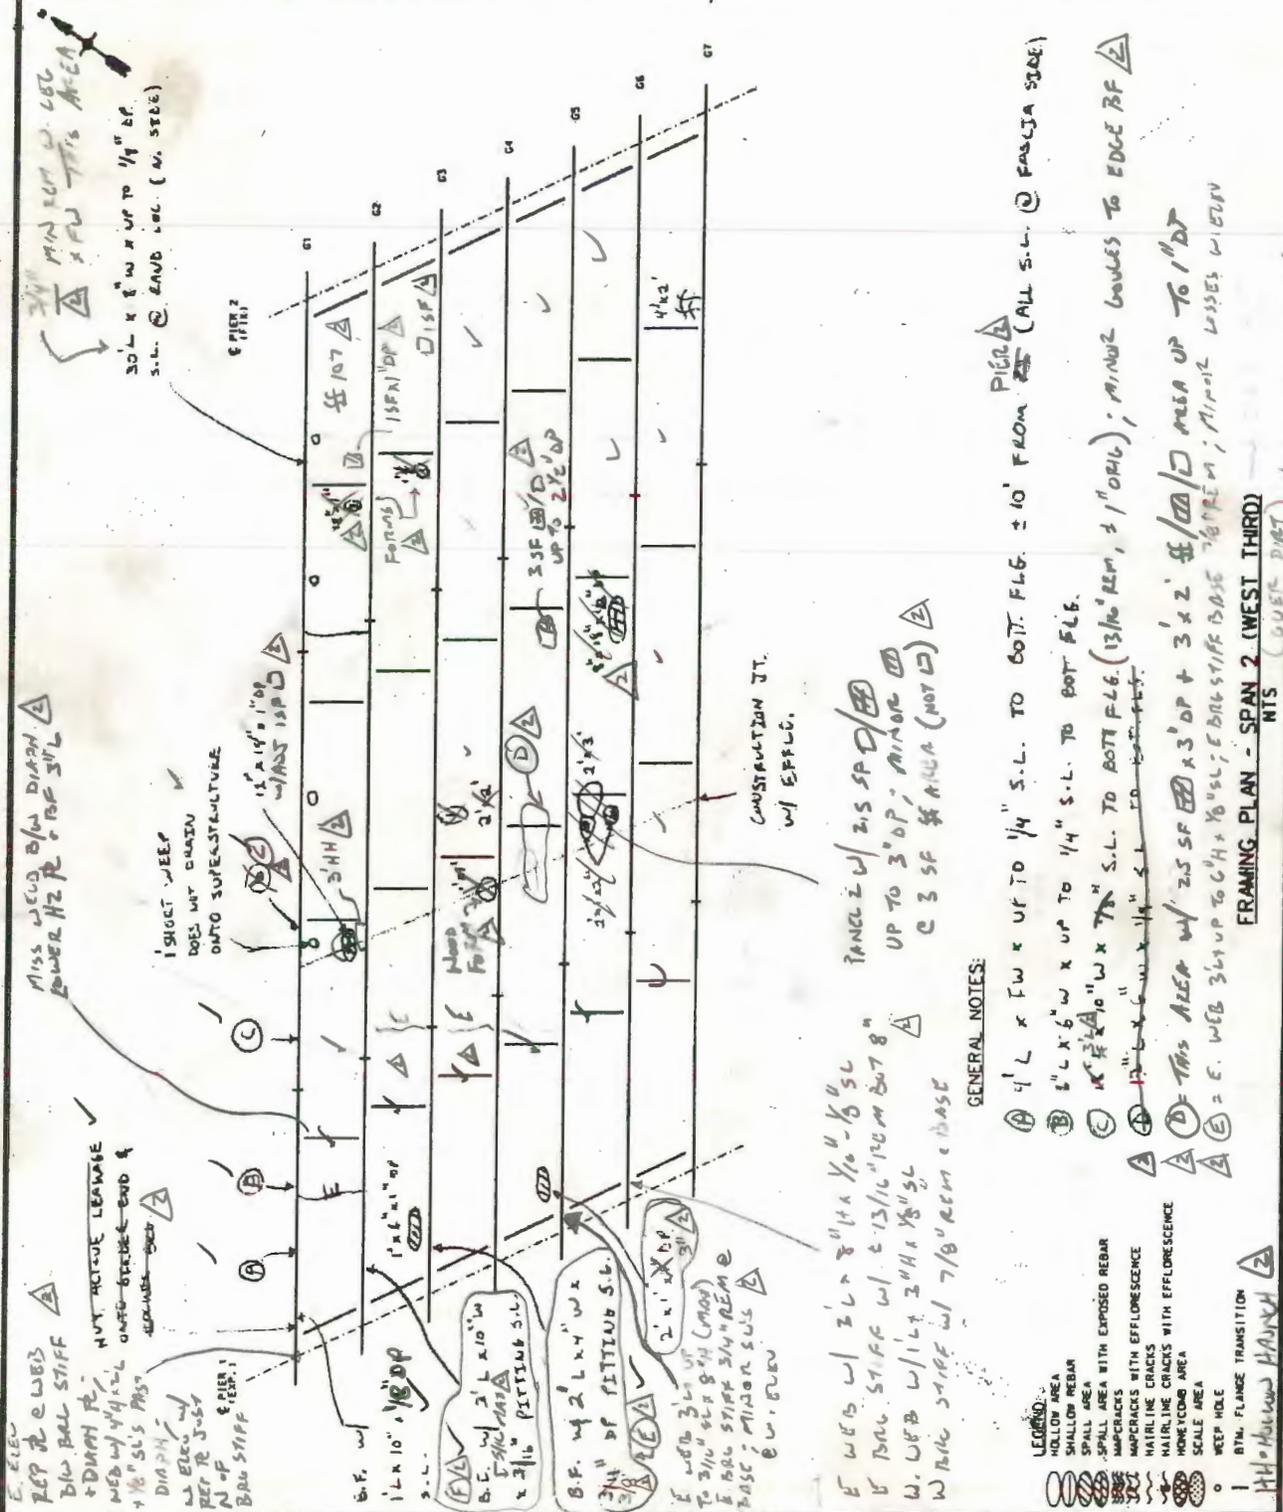
SHEET 37 OF 49

- GENERAL NOTES:**
- A 4" L x 1/4" x 1/4" UP TO 1/4" S.L. TO BOT. F.L.G. ± 10' FROM PIER (CALL S.L. @ FASCIA EDGE)
 - B 8" L x 6" W x UP TO 1/4" S.L. TO BOT. F.L.G.
 - C 1/4" x 10" W x 7/8" S.L. TO BOT. F.L.G. (13/16" REM, 3" OHG); MINOR BOLDS TO EDGE BF
 - D THIS AREA W/ 2.5 SF 3" DP + 3' x 2' 1/2" MESA UP TO 1" DP
 - E = E. WEB 3/4" UP TO 3/4" x 1/8" S.L.; E. BRG STIFF BASE 7/8" REM; MINOR LOSSES W/ 1/2" W
 - F W. WEB W/ 1/4" 3" H x 1/8" S.L. TO BOT. F.L.G.

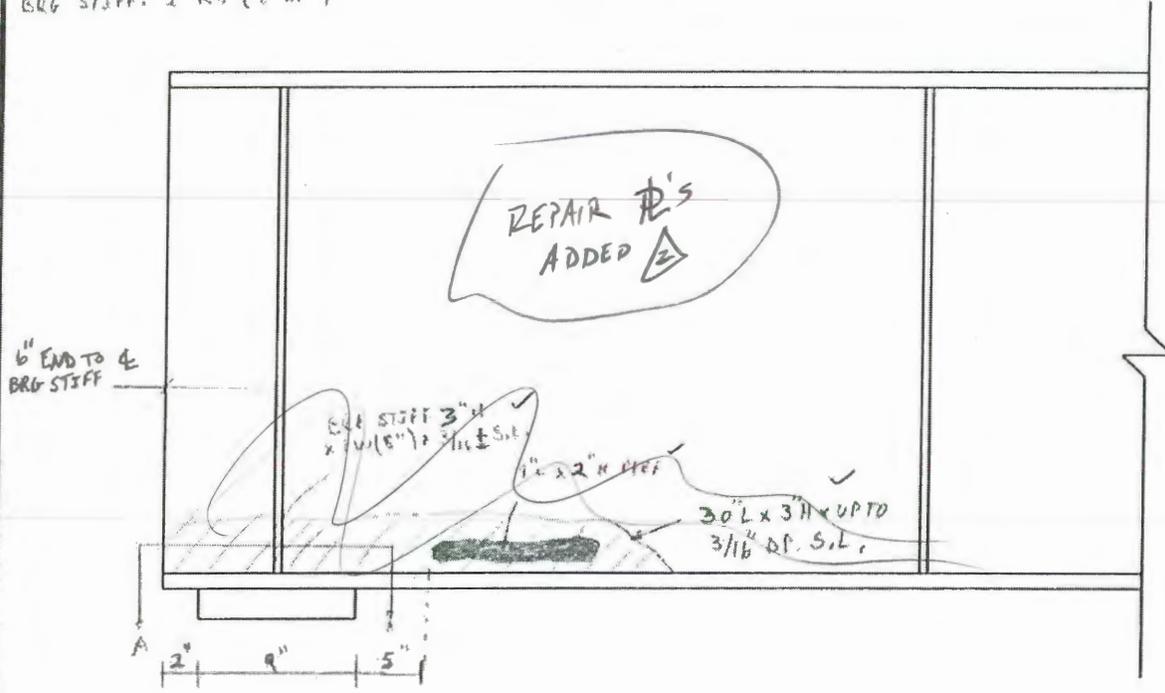
SPAN 2, GIRDER G10 AT PIER 1, EAST ELEVATION
NTS

~~WEB LOSS FOR SHEAR: < 5%
 WEB LOSS FOR BENDING: A7A
 EFF WEB LENGTH = 18' x 3/8" = 6.75"
 (AASHTO 12.24.4)
 ORIG BRG AREA = (6.75" x 3/8") + (2 x 9" x 1") = 14.531 in²
 S. LOSS AREA = (6.75" x 3/16") + (8" x 3/16") = 2.77 in²
 % S. LOSS = $\frac{2.77}{14.53} \times 100 = 19\%$~~

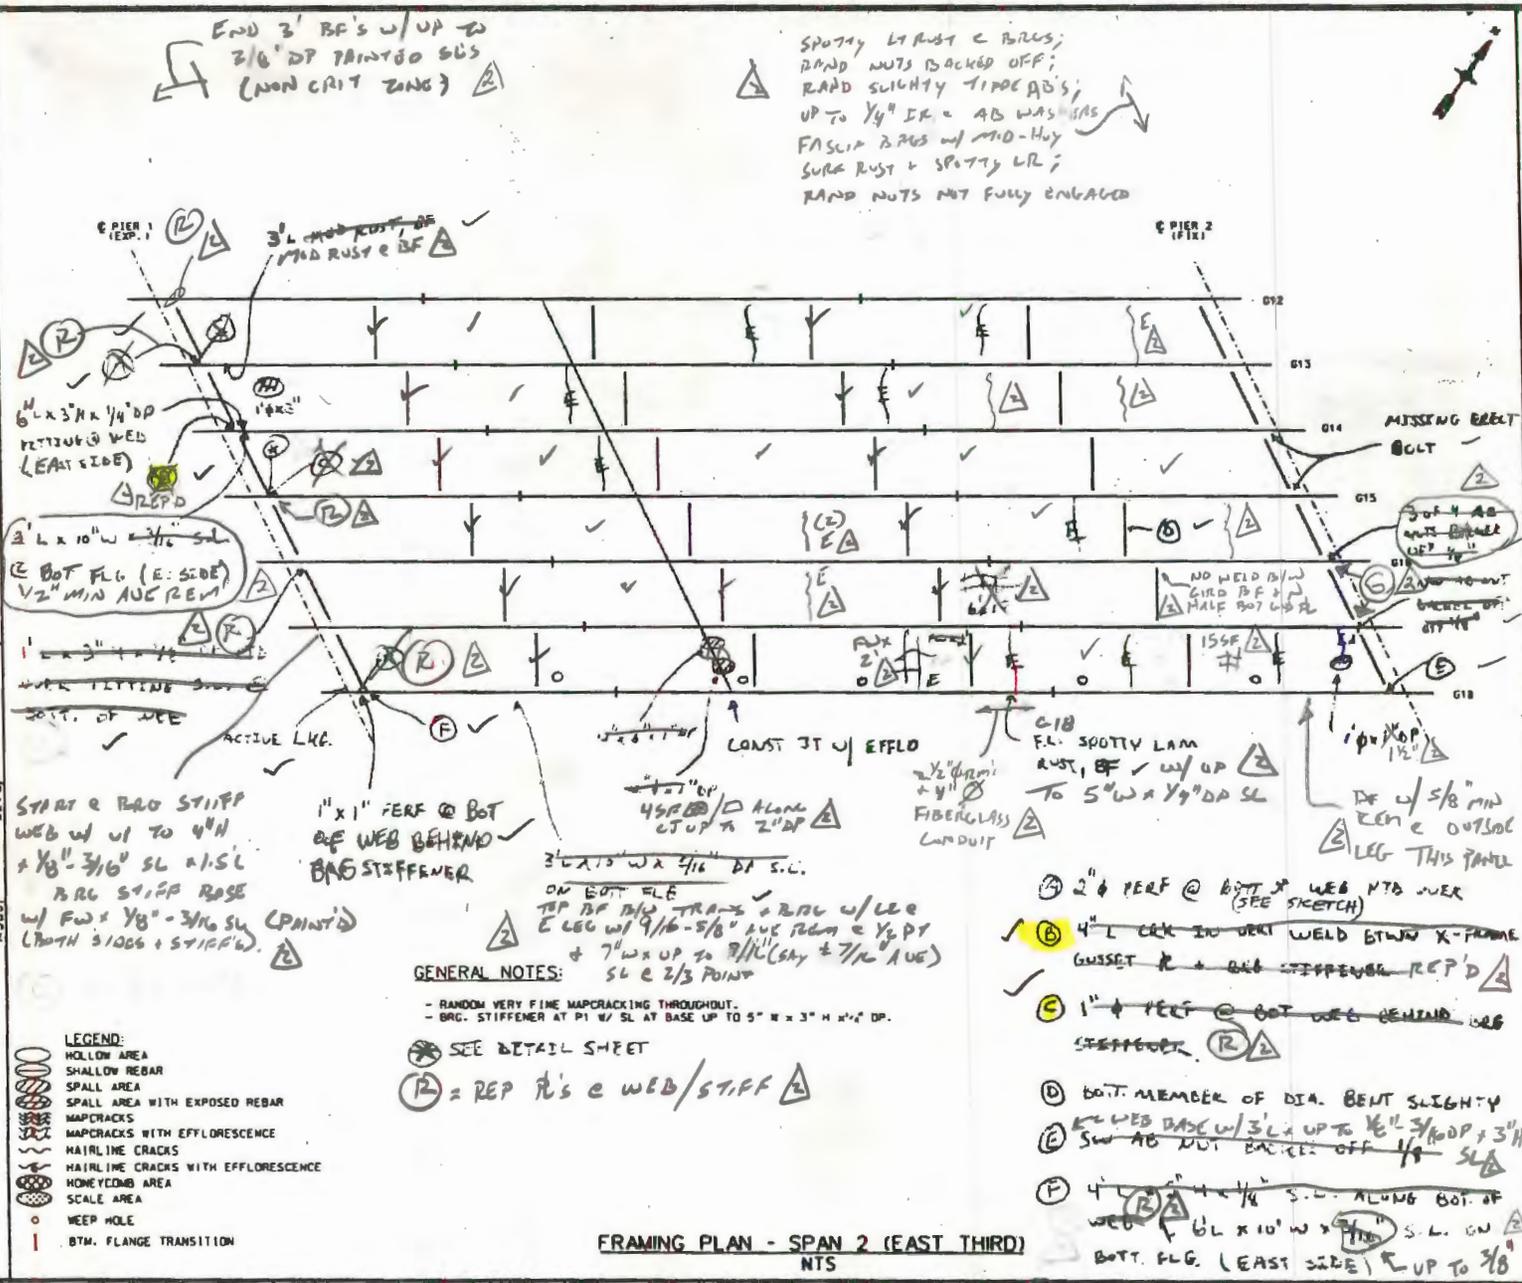
- ⓐ 2" PERF @ BOT OF WEB MTS OVER (SEE SKETCH)
- ⓑ 4" L CRK IN VERT WELD BTWN X-FRAME GUSSET R + BRG STIFFENER REP'D
- ⓒ 1" FERF @ BOT WEB BEHIND BRG STIFFENER
- ⓓ BOT. MEMBER OF DIA. BENT SLIGHTY
- ⓔ SW AB NUT. BACKED OFF 1/4" SL
- ⓕ 4" L CRK W/ 1/4" S.L. ALONG BOT. OF WEB + 6" L X 10" W 4" S.L. ON BOT. FLG. (EAST SIDE) UP TO 3/8"
- ⓖ UP TO 3/4 AB NUTS BACKED OFF

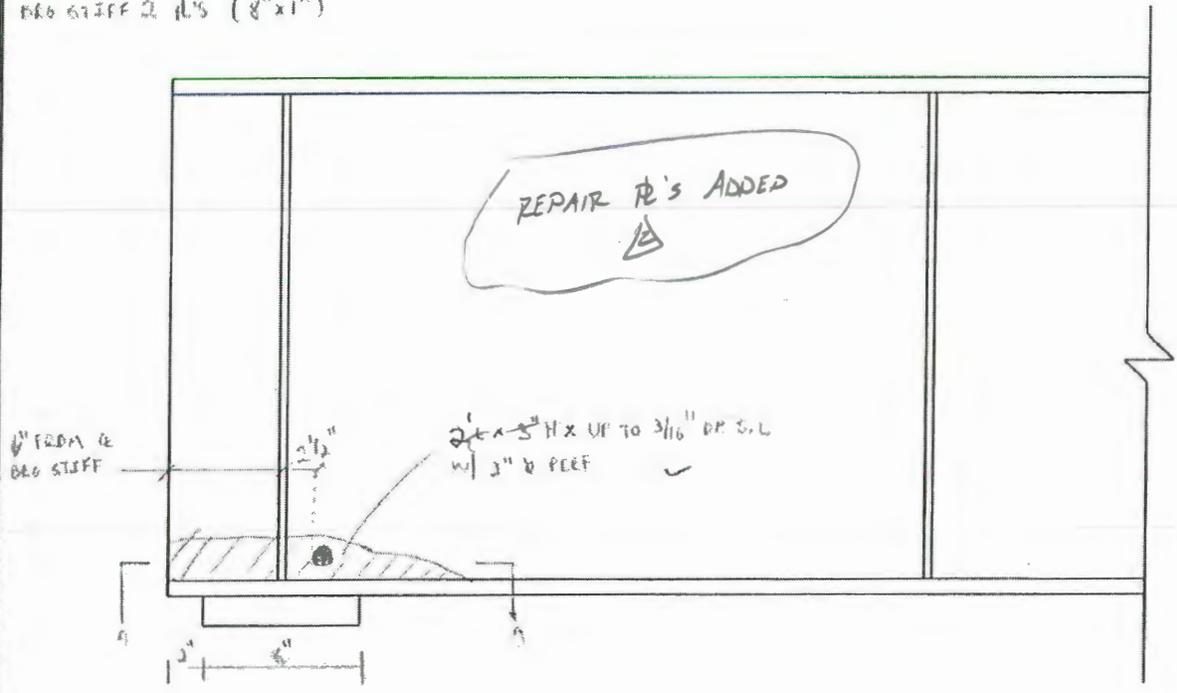
BRIDGE NO. 03093
SHEET 11 OF 19

WEB LOSS FOR SHEAR ; $< 5\%$

WEB LOSS FOR BRG : A-A

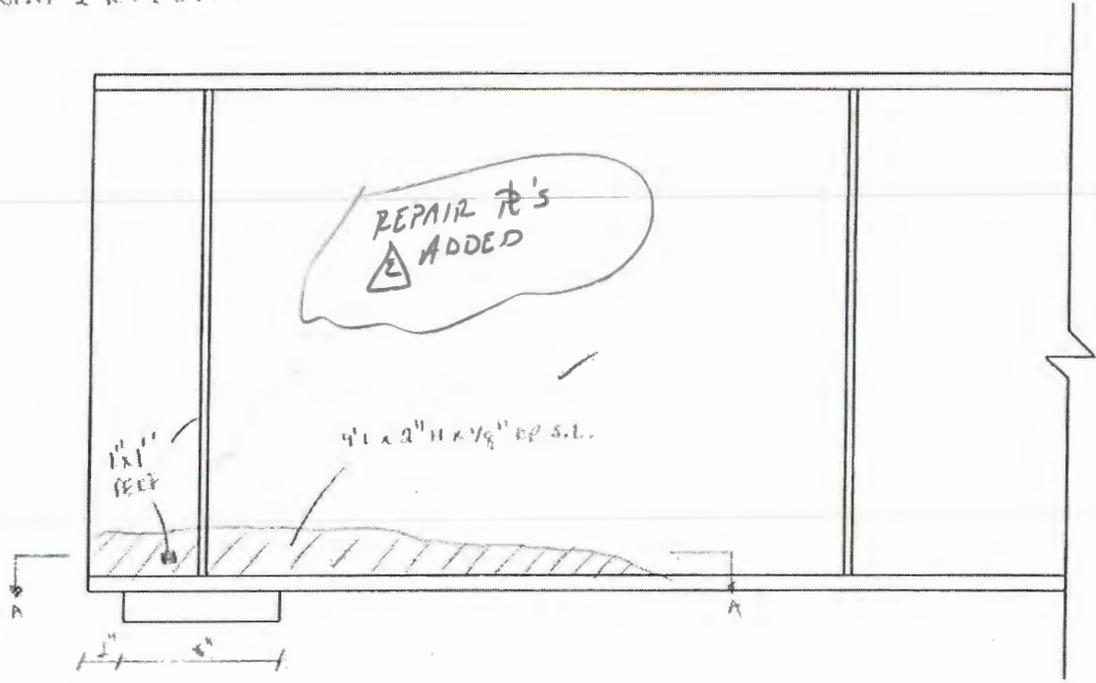
HAKS FIELD NOTES	JOB NO. 170-3013	BRIDGE NO. 03093
	DATE: 9/28/10	SHEET 52 OF 119
	CREW: PHH, GM

NOTE: WEST SIDE OF WEB HAS 3" x 3/16" DP. S.L. AROUND PERF. ✓

WEB LOSS FOR SHEAR: 2.5%

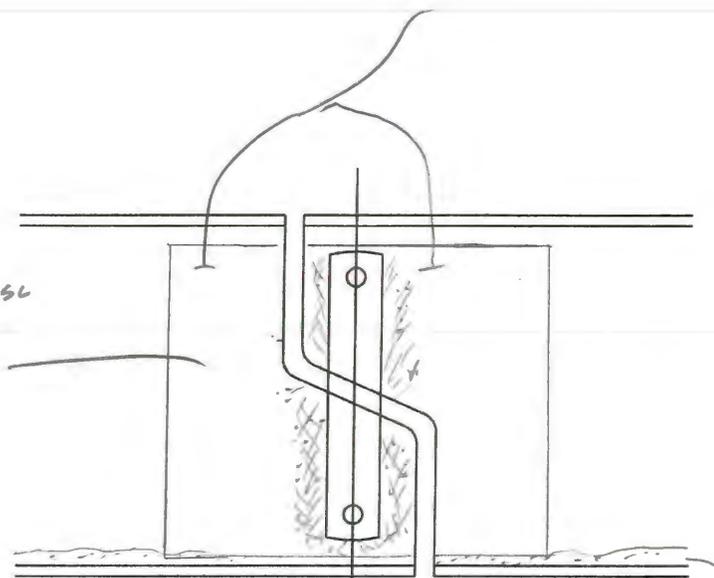
TYP UP TO $3/16$ " DP SL
 UP TO 1' FROM
 HANGER PL

HUNG SPAN BF
 LEGS w/ AS LITTLE
 AS $3/4$ " REM & END 8'
 ($\pm 1 - 3/8$ ORIC); SUSPEND SPAN
 SIMILAR, BUT TYP $\pm 3/2$

WEB BASES w/ $4 - 6$ " SL'S
 $\pm 1/8$ " & NON THICKENED WEBS
 + UP TO $3/16$ " DP & THICKENED WEBS
 ADJ TO BF LOSS;
 RAMP STIFF BASES
 w/ UP TO 50% LOSS
 THESE AREAS

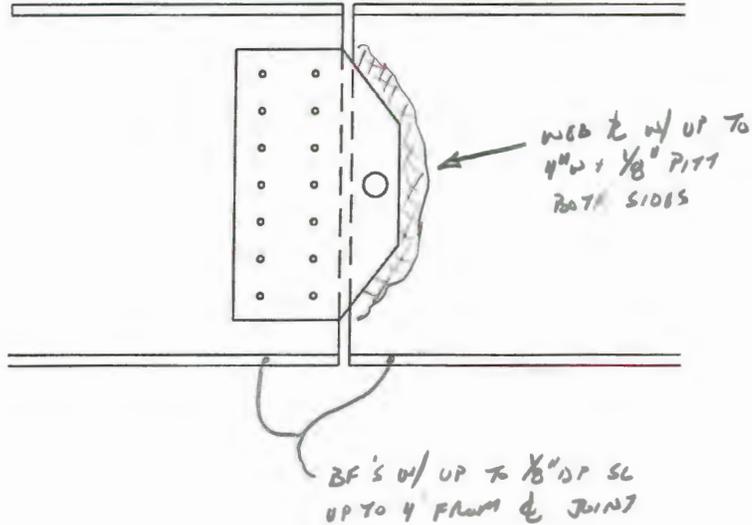
DESCRIPTION: SL'S AT FIXED HINGES, TYP

TYP LOSSES AT HINGES (SP#3)

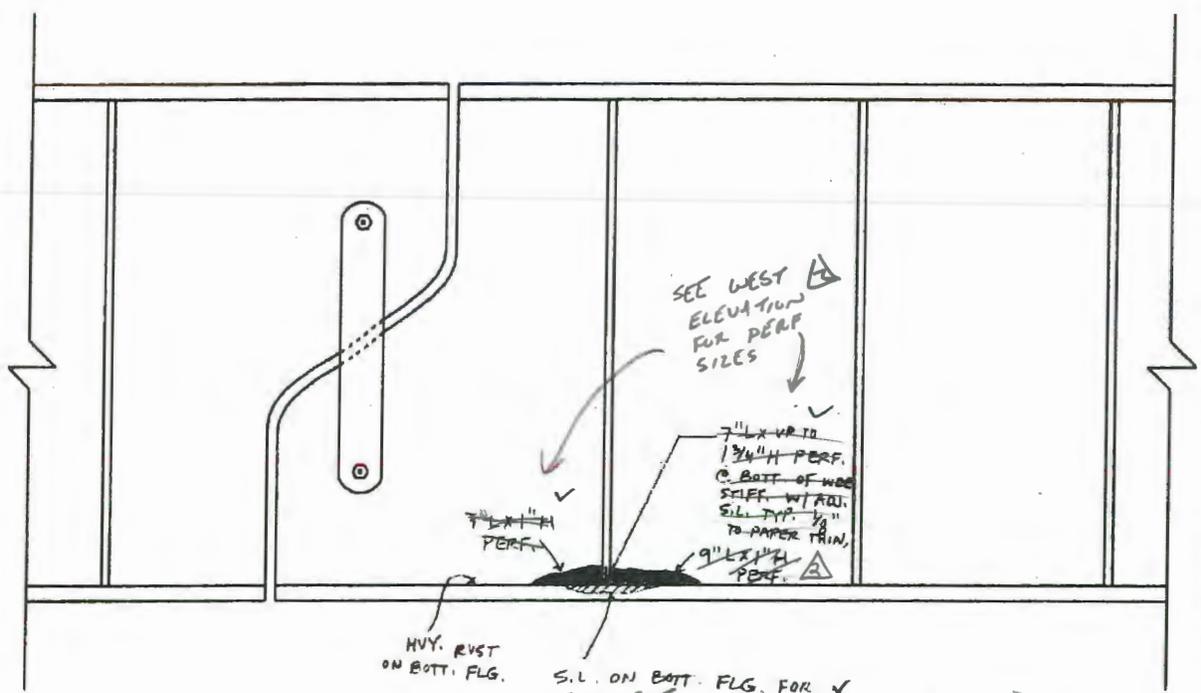
HAKS FIELD NOTES	JOB NO. 170-3013	BRIDGE NO. 03093
	DATE: 7/20/10	SHEET 46 A OF 147
	CREW: PHH, GM

SEE WEST ELEVATION FOR PERF SIZES

7" x 1/4" V.R. TO 1/4" PERF.
C. BOTT. OF WOOD SLEEP. W/ 1/4" SILL TYP. 1/4" TO PAPER THIN.

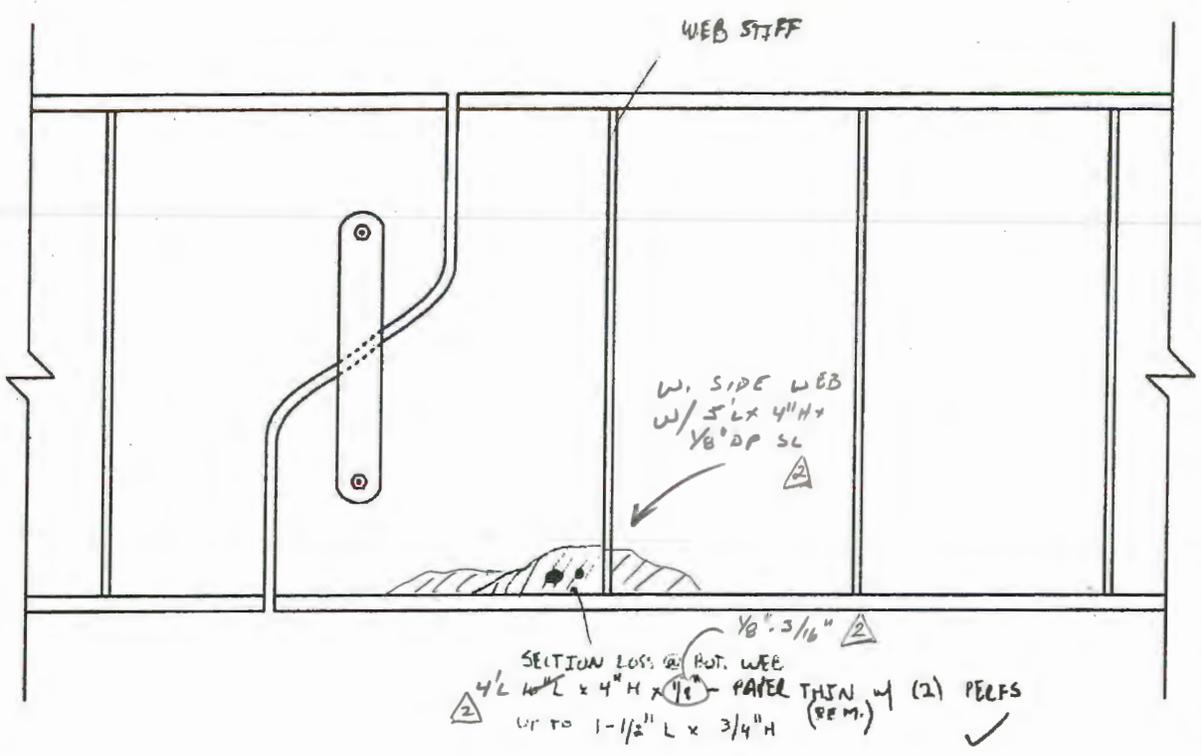
SPAN 3, GIRDER G3, EAST ELEVATION
NTS

1/2 WEB LOSS = < 5%

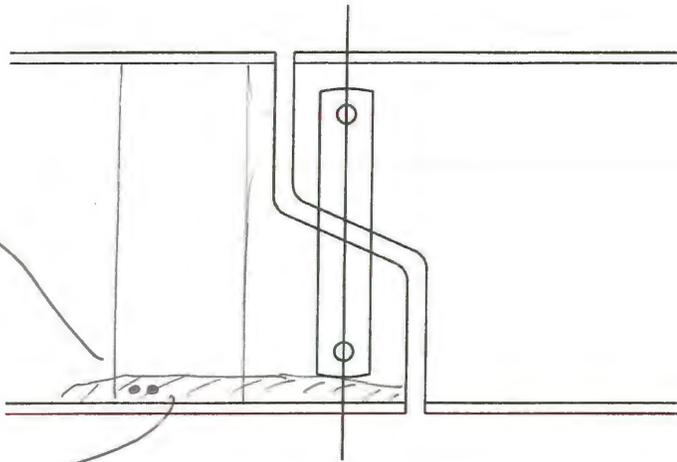
SP# 3 66, W. ELEV

STIFF BASE @
EAST w/ Hvy SL
@ BOT 2" w/
SMALL RTH'S

W. ELEV w/ 5" Hx 5" L x 3/16" - 1/4" DP
S.L w/ 2 1/2" THIN AREA w/ RTH'S;
SIMILAR @ E. ELEV

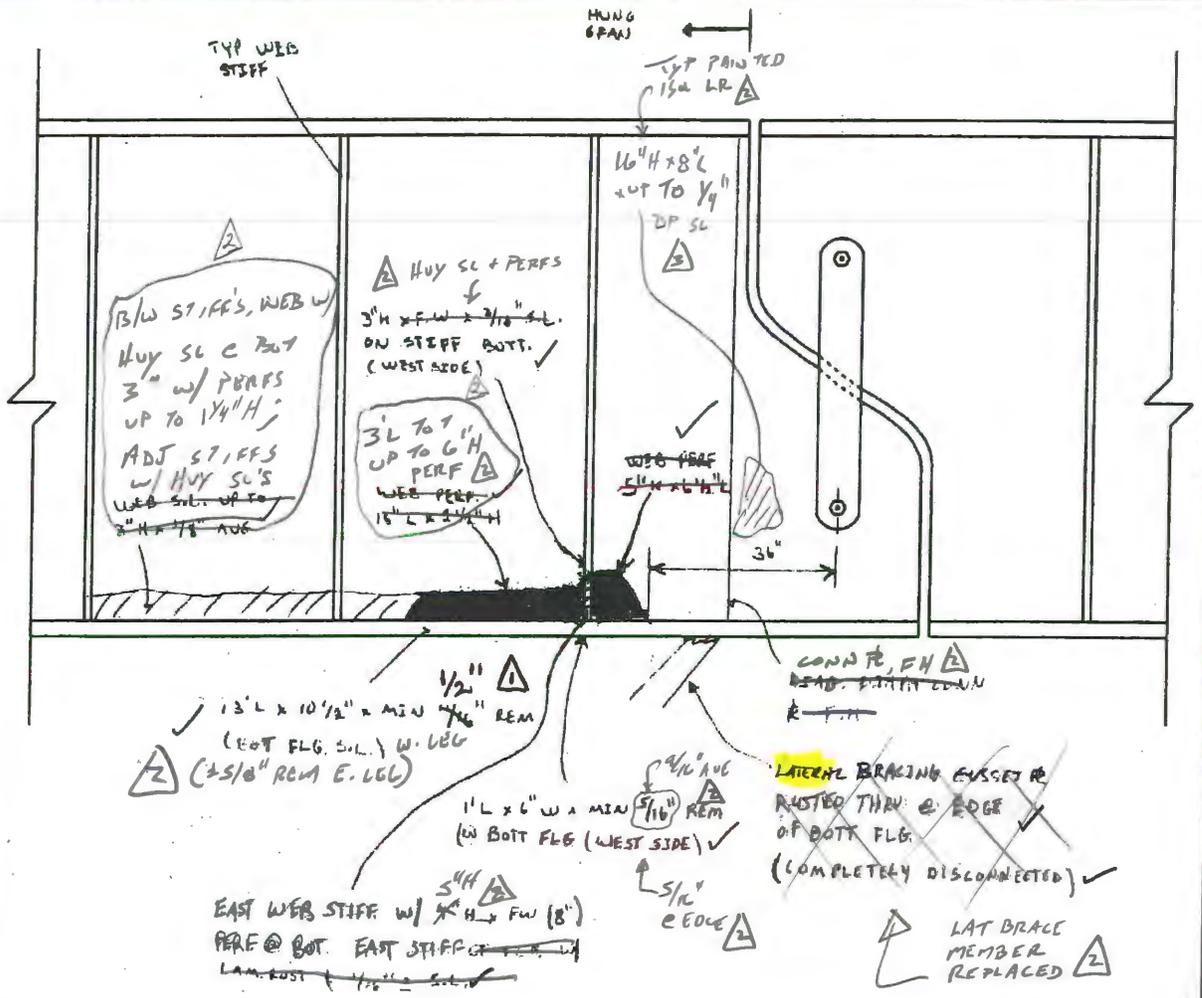
SPAN 3 GIRDER G9 WEST ELEVATION (U.O.N.)
NTS

% WEB LOSS @ PERF. = < 5%

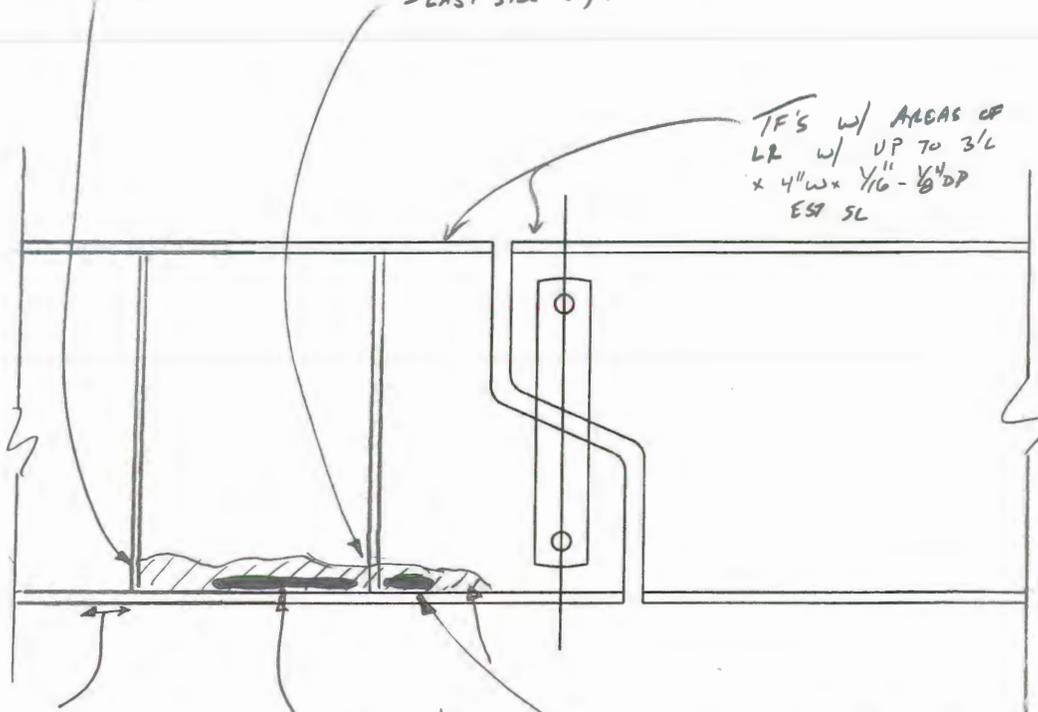
STIFF BASE
- WEST SIDE w/ FWx UP TO 3" H PERF
- EAST SIDE w/ FWx UP TO 3" H PERF

TF'S w/ AREAS OF
LR w/ UP TO 3/4"
x 4" w x 1/16" - 1/8" DP
EST SL

BF w/ FITTING UP
TO 5/16" DP x 10' L
(W. LEG w/ 11/16" REM +
E. LEG w/ 5/8" REM
WITHIN 6' OF P&H)

W. E. ELEV'S w/ UP TO
4' L x UP TO 3" H x 1/8"
DP SL, DOWN TO KE
± 2" H ADS TO 35"
3" RTH

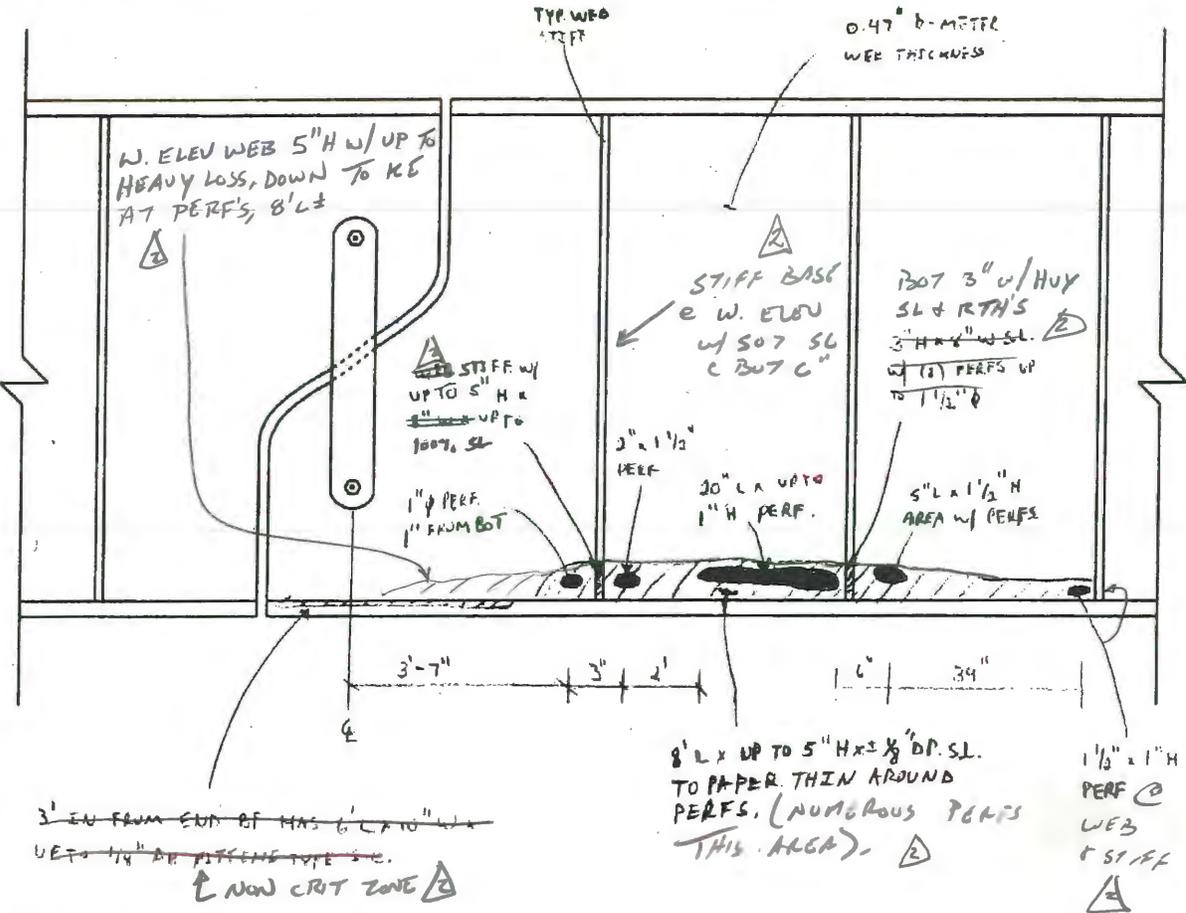
SHEET 50 OF 119

1/4" WEB LOSS = < 5%

△ NO CHANGE

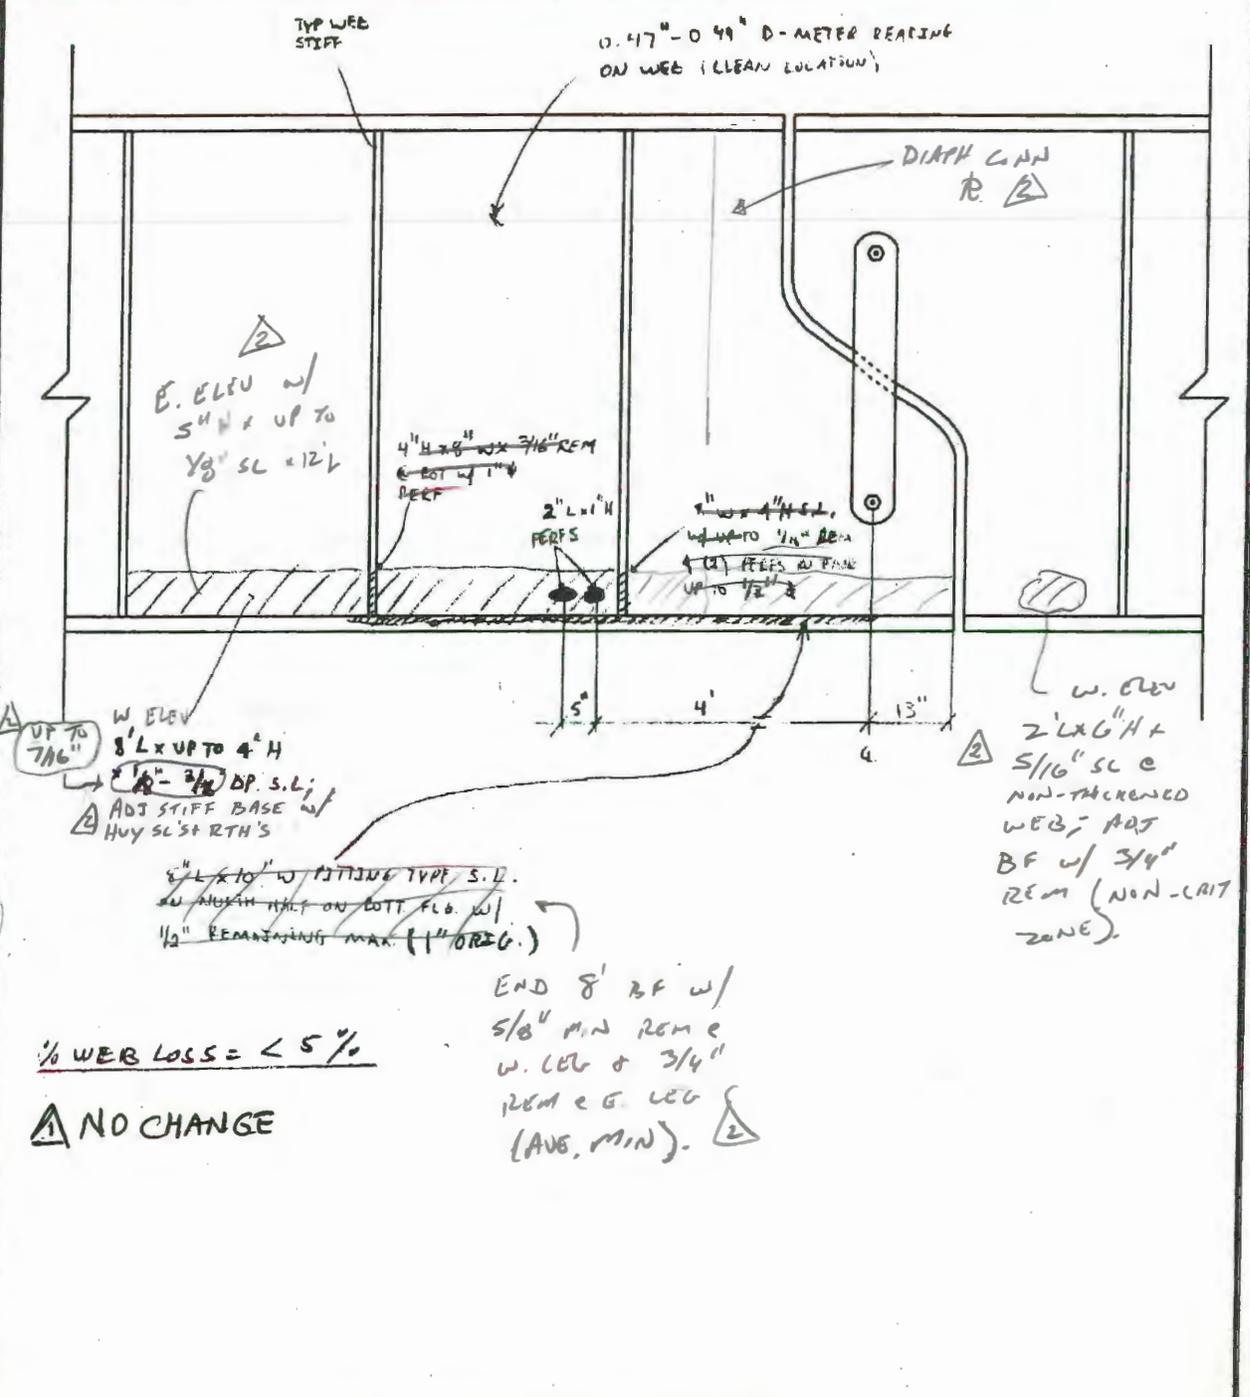
SHEET 51 OF 119

1/2 WEB LOSS = < 5%

NO CHANGE

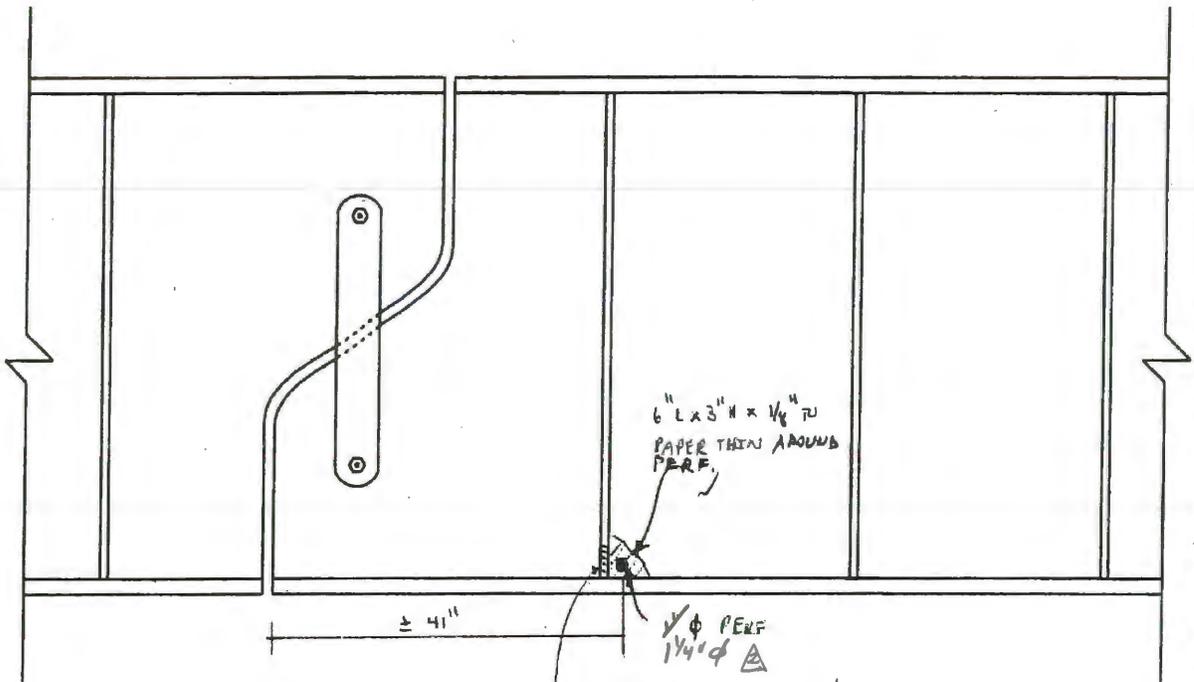
HAKS FIELD NOTES	JOB NO. 170-3013	BRIDGE NO. 03093
	DATE: 7/22/10	SHEET 52 OF 119
	CREW: PMA, BM

6" L x 3" H x 1/4" TH
PAPER THIN AROUND
PERF.

1/4" PERF
1/4" Δ

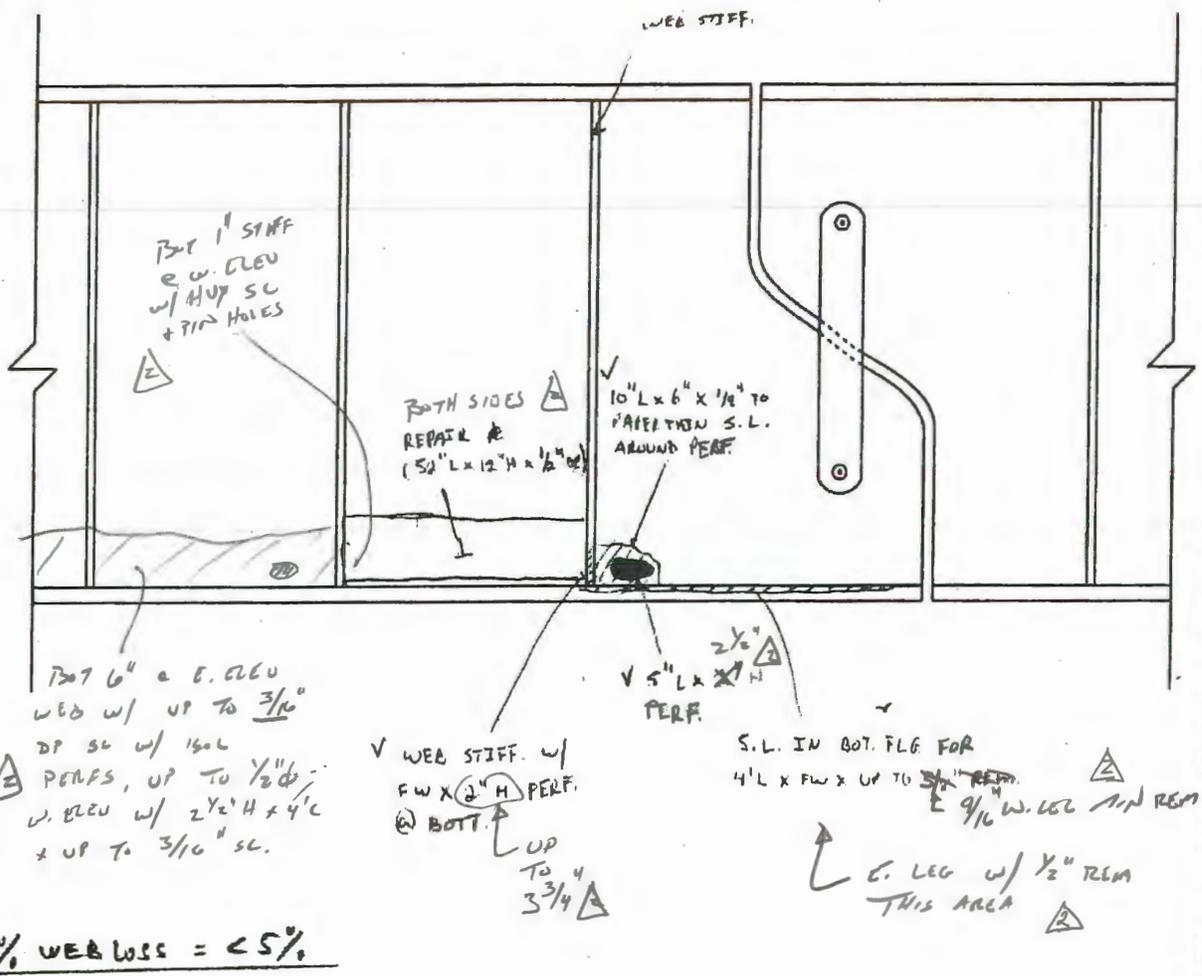
SPAN 3. GIRDER G18. WEST ELEVATION

NO CHANGE

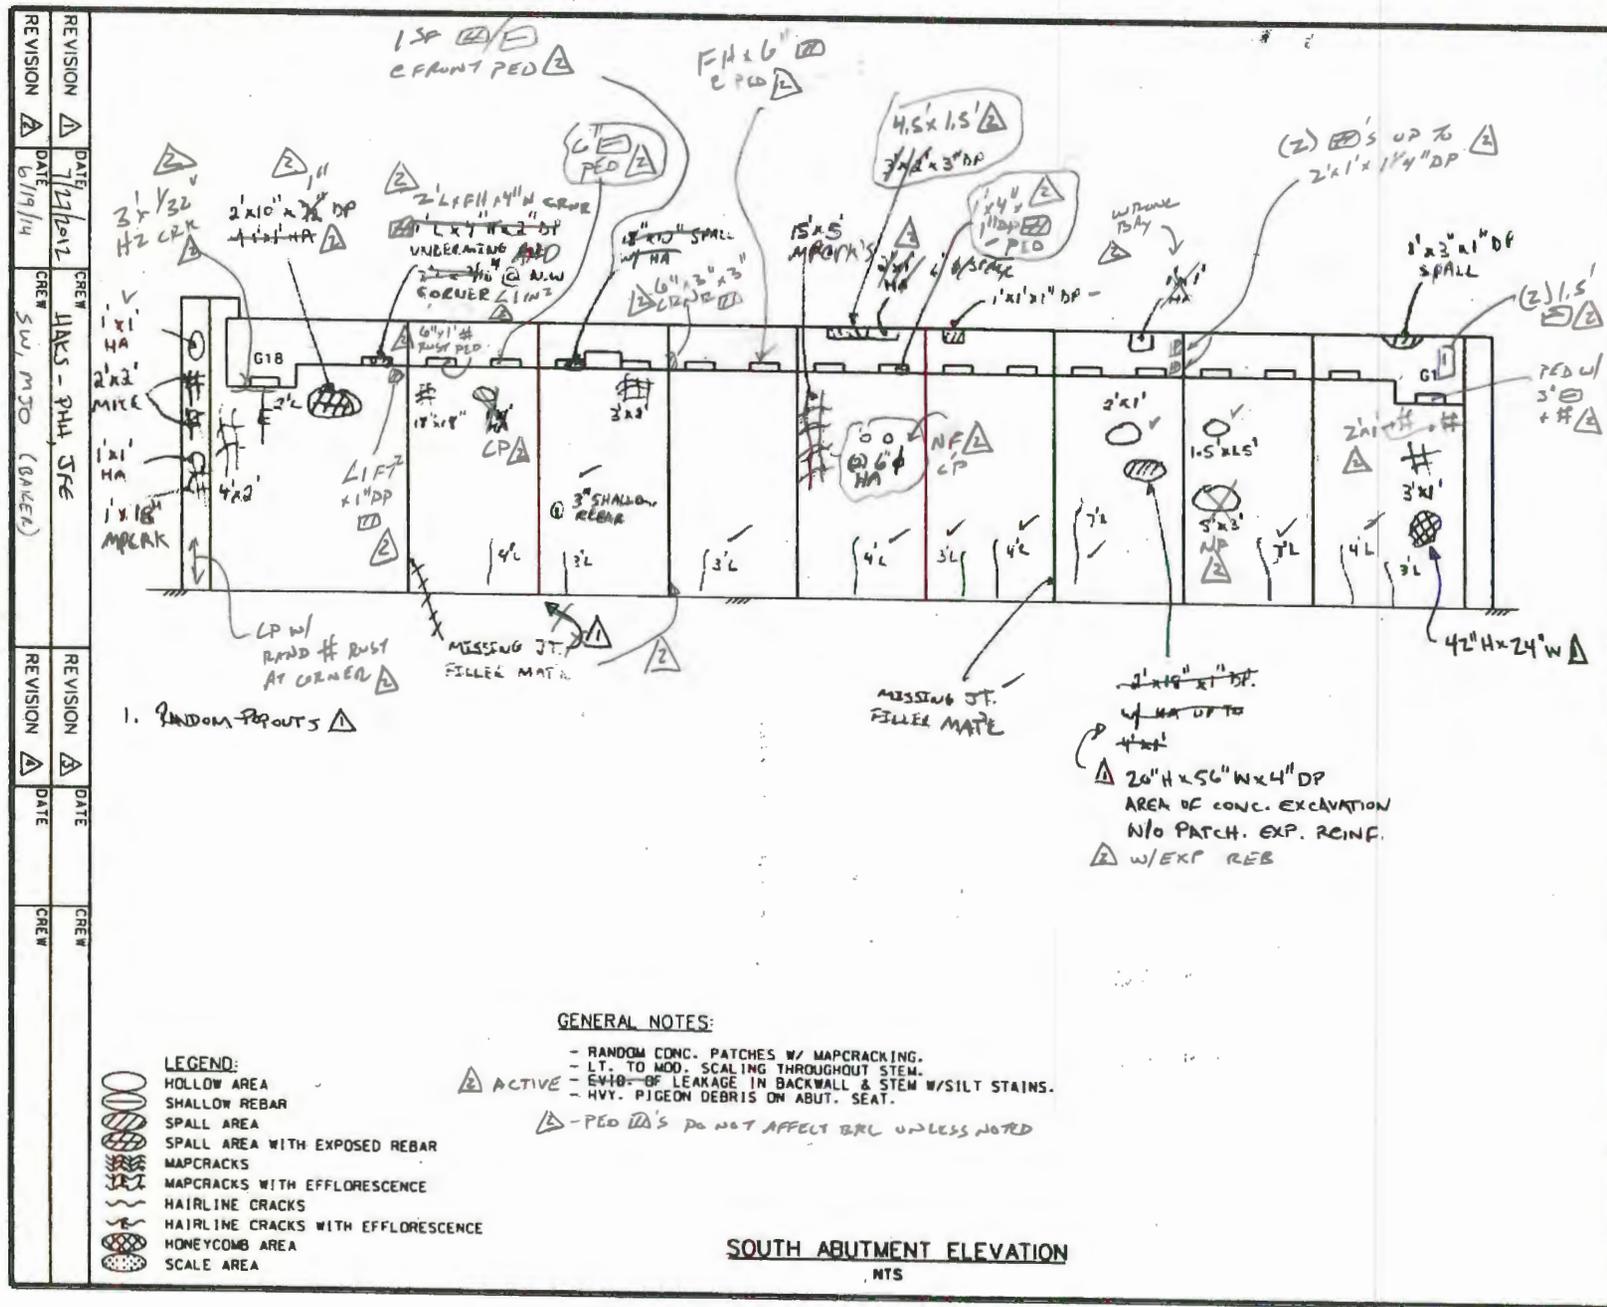
- RANDOM CONC. PATCHES W/ MAPCRACKING.
- LT. TO MOD. SCALING THROUGHOUT STEM.
- EVID. OF LEAKAGE IN BACKWALL & STEM W/SILT STAINS.
- HVY. PIGEON DEBRIS ON ABUT. SEAT.
- △ - PED ID'S DO NOT AFFECT BRL UNLESS NOTED
- △ ACTIVE

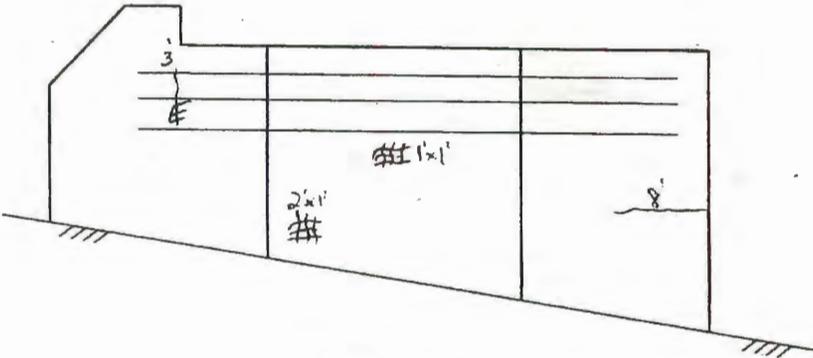
S.E. WINGWALL

- EXPANSION JT MATERIAL MISSING/DETERIORATED AT ALL JOINTS.
- HVY. VEG. GROWTH ALONG WINGWALLS.
- LT. SCALE AT RANDOM LOCATIONS.
- LT. GRAFFITI ON S.E. WINGWALL.

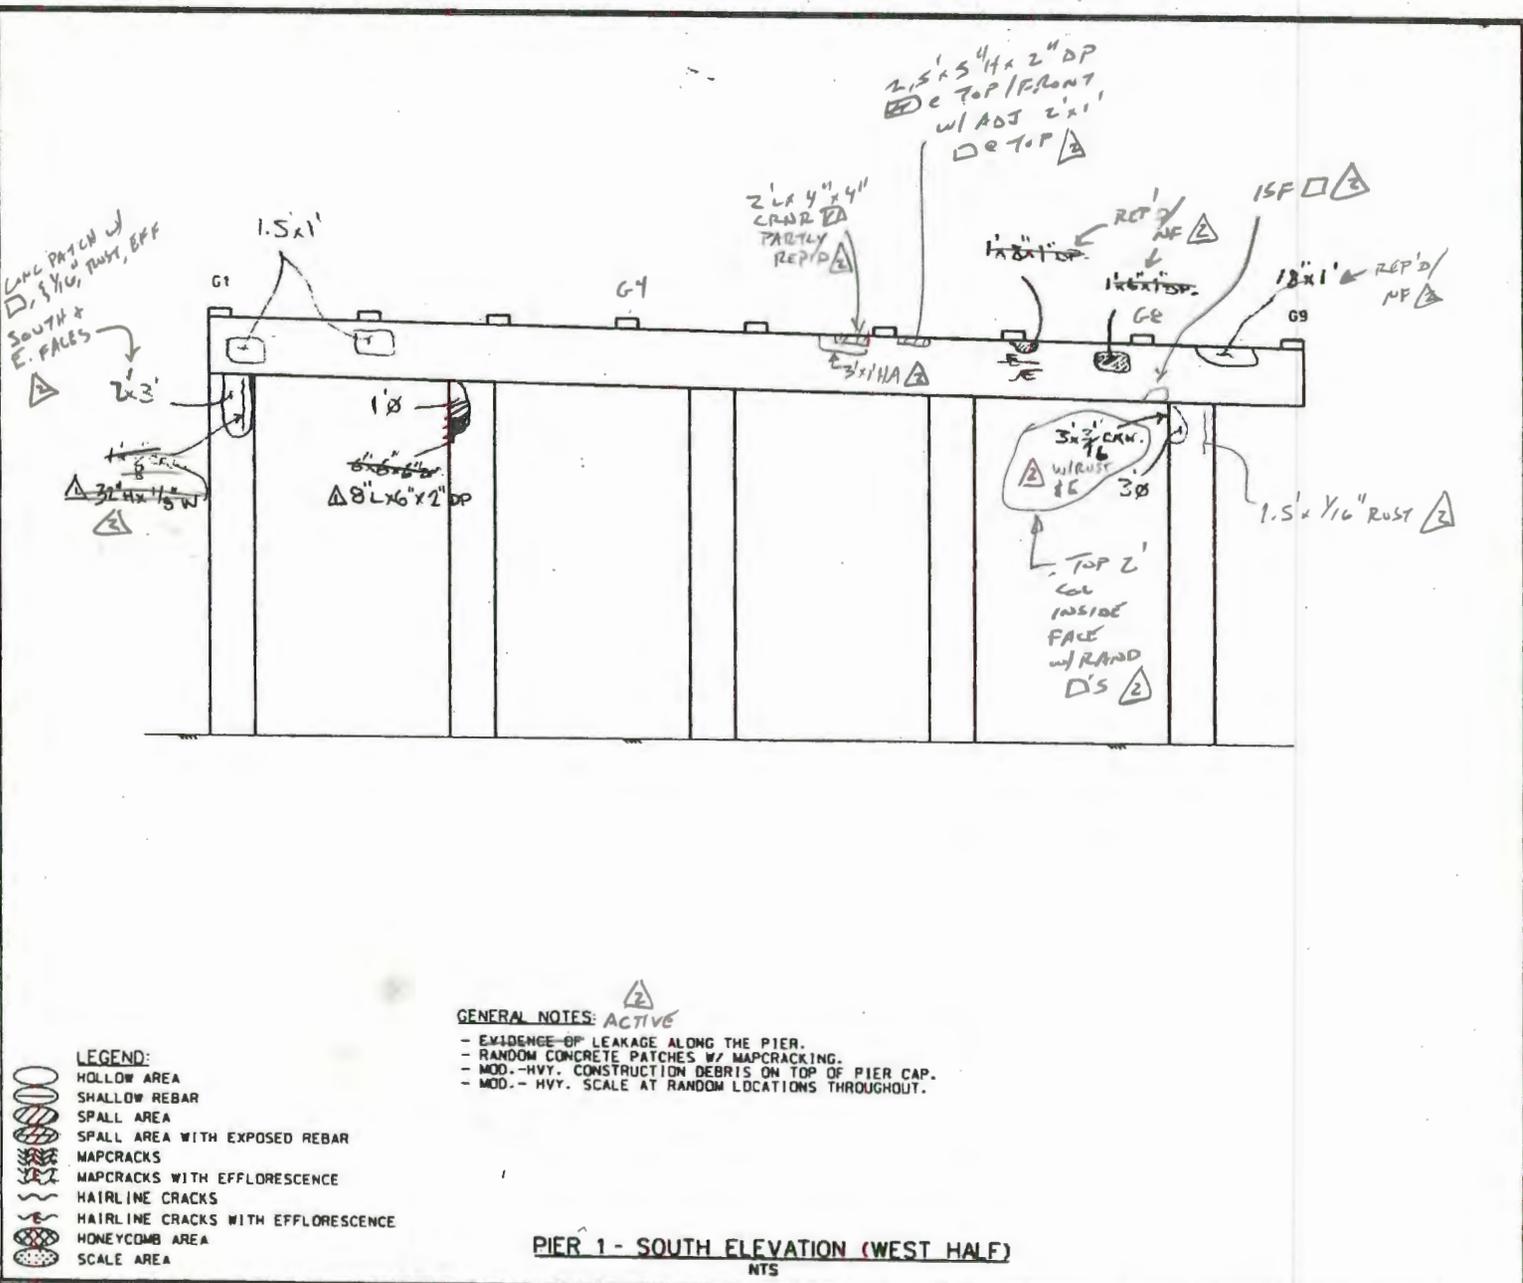
- GENERAL NOTES: ACTIVE**
- EVIDENCE OF LEAKAGE ALONG THE PIER.
 - RANDOM CONCRETE PATCHES w/ MAPCRACKING.
 - MOD.-HVY. CONSTRUCTION DEBRIS ON TOP OF PIER CAP.
 - MOD.-HVY. SCALE AT RANDOM LOCATIONS THROUGHOUT.
