STRUCTURE NO. 03093

INTERSTATE 91
over
N FRONT ST & QUINN RIVER
New HAVEN

Routine Inspection
on
6/16/2014

**BRIDGE NO. 03093
INTERSTATE 91**

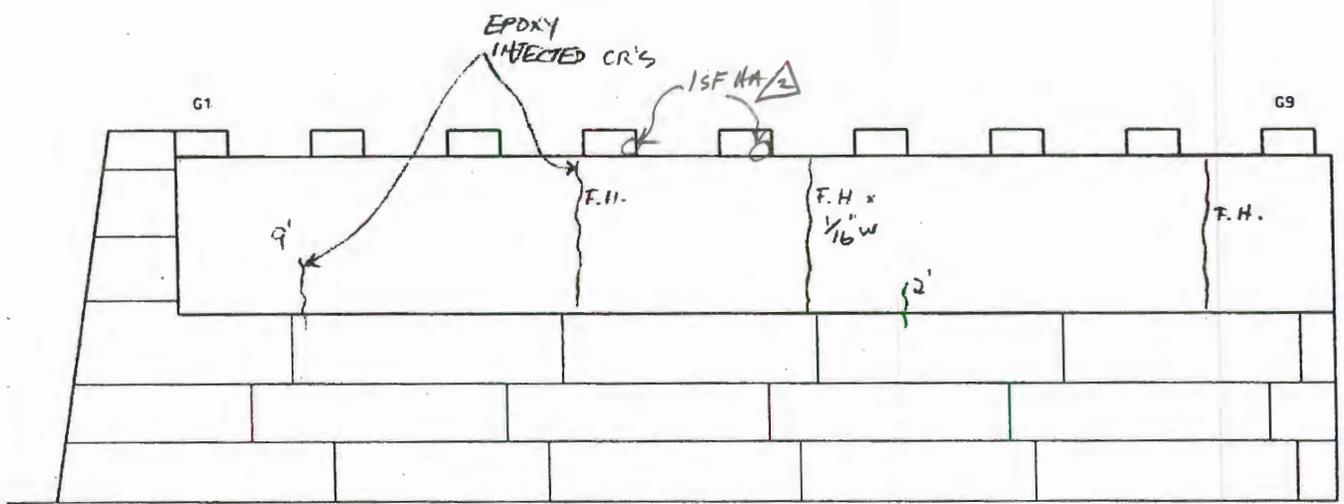
GENERAL NOTES:
 - LT. SCALE AT RANDOM LOCATIONS THROUGHOUT PIER.

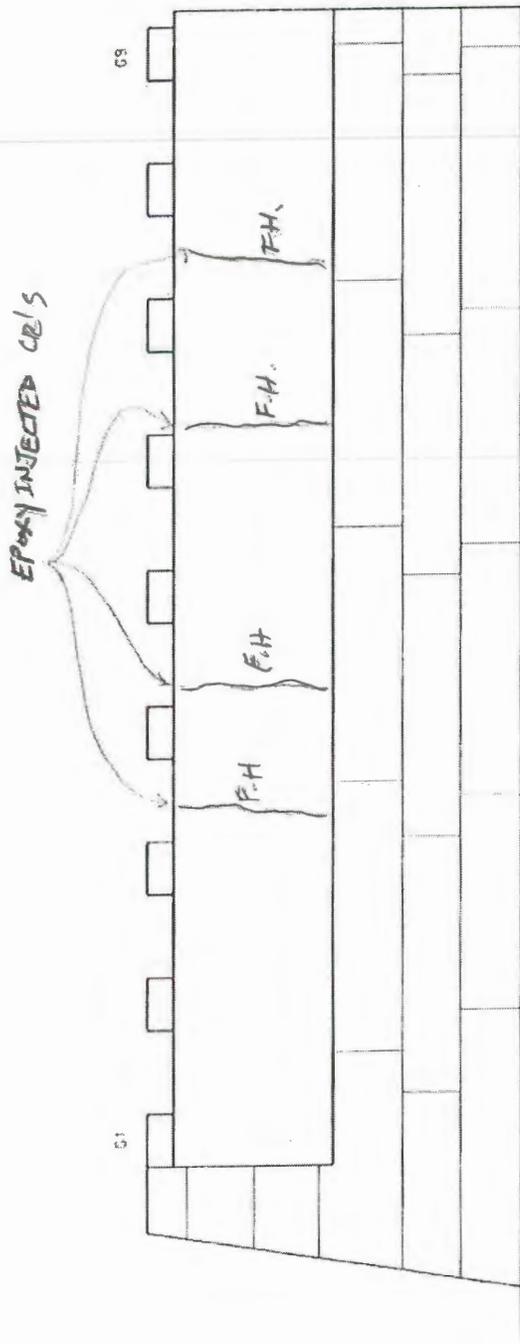
GENERAL NOTES:
- LT. MOSS GROWTH & RUST STAINS AT STEM & MASONRY BASE AT WATERLINE.
- LT. TO MOD. ABRASION ALONG WATERLINE.
NO CHANGE

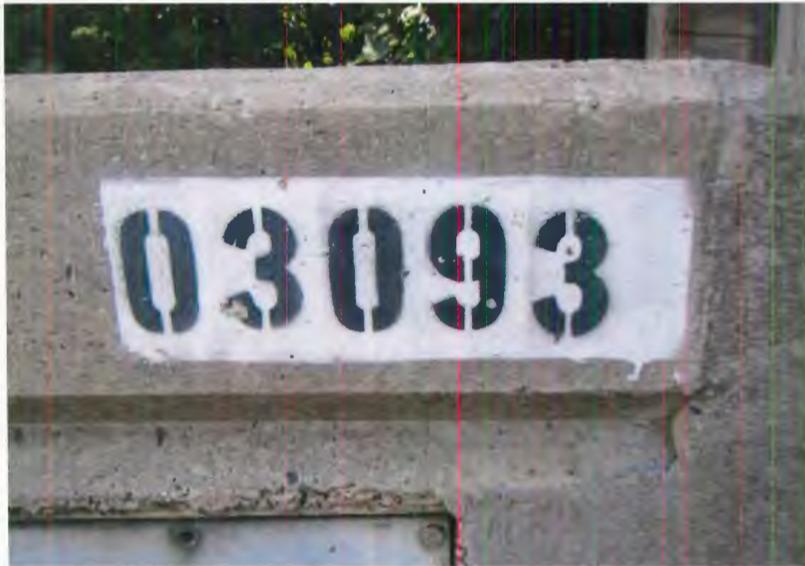
Photo #1 :
Bridge ID.

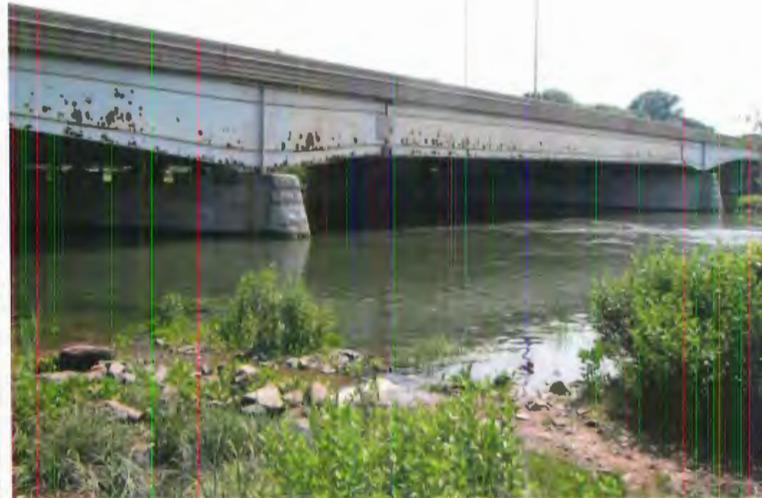
Photo #2 :
West elevation.

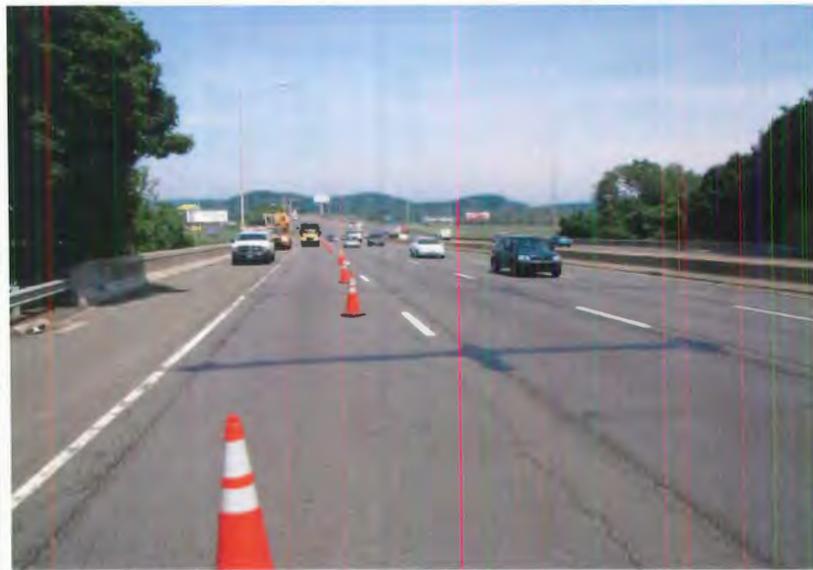
Photo #3 :
Bridge from the south approach, southbound.

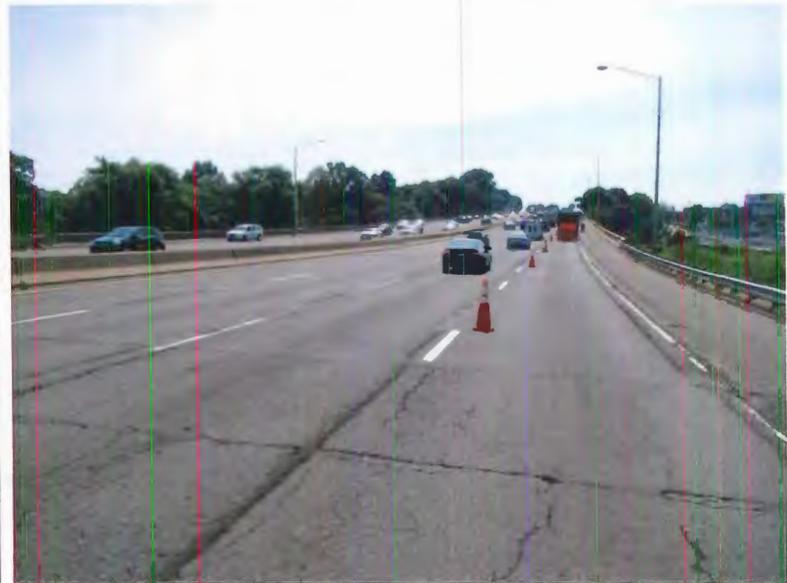
Photo #4 :
Bridge from the north approach, southbound. Note the cracking in the approach pavement.

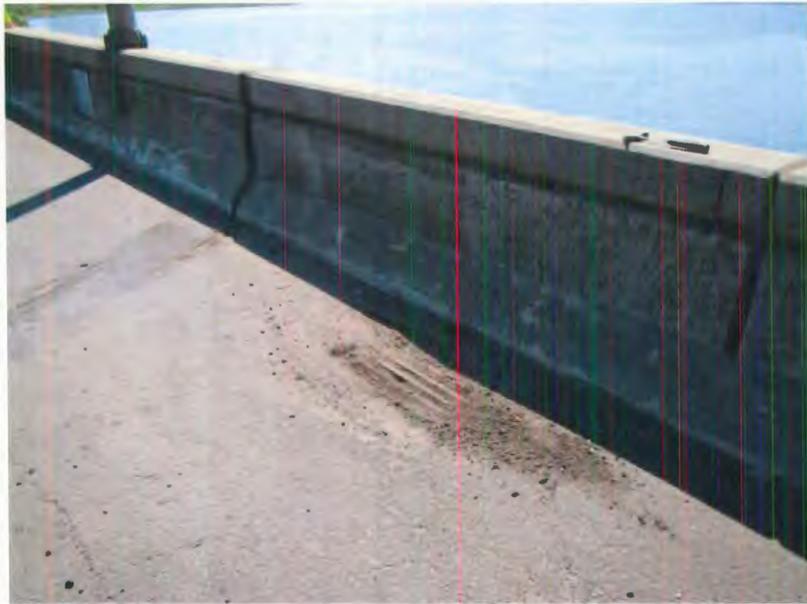
Photo #15 :
Span 3, northbound: Clogged scupper in the right (east) shoulder.

2. There are two clogged and two partially clogged scuppers along the structure. See report photo 15.
3. There are approximately fifteen missing or short weeps that drain or may drain onto bridge elements below in bays 1, 8 & 10 in span 3 and bays 1, 8, 9, 10 & 17 in span 4. See report photos 16-17.

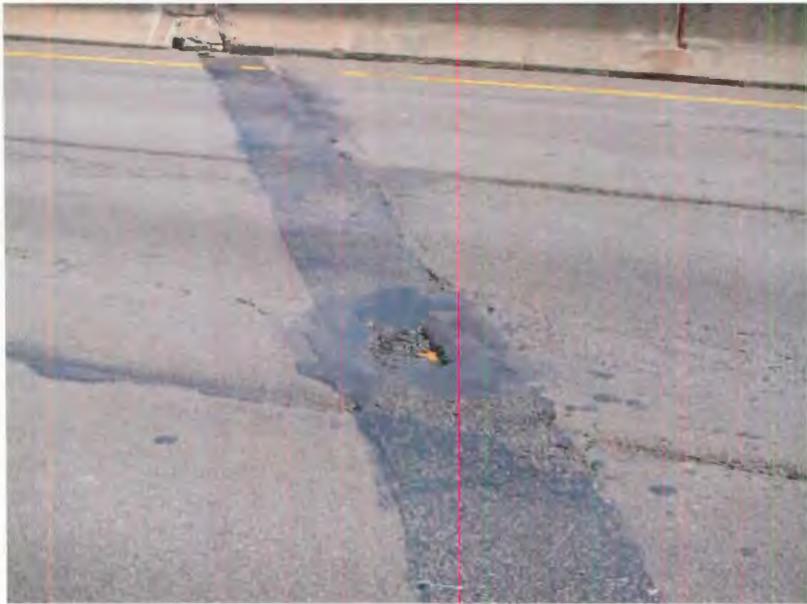
Photo #23 :
Asphaltic plug joint at the north abutment joint, southbound:
Pothole with exposed joint plate in the left-center lane.

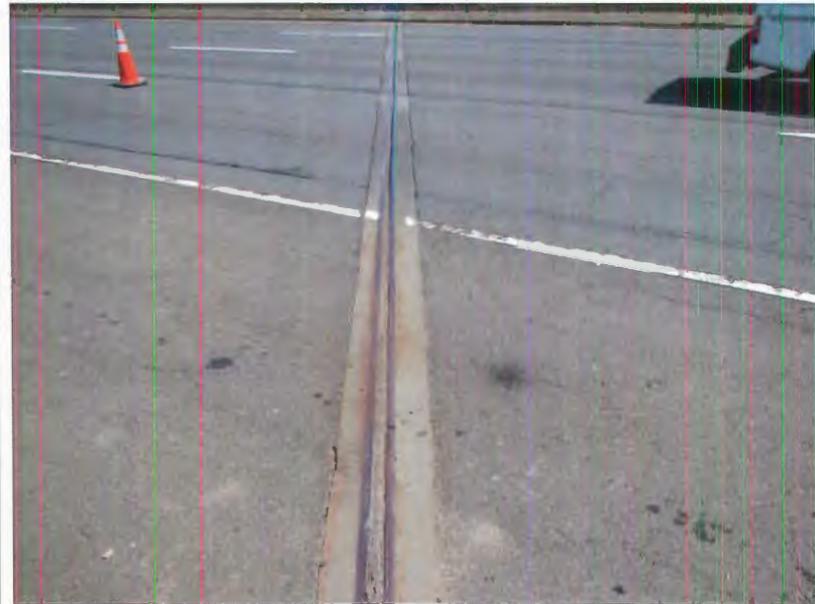
Photo #24 :
Strip seal joint at the span 3, south hanger line, southbound.
Note the debris in the joint.

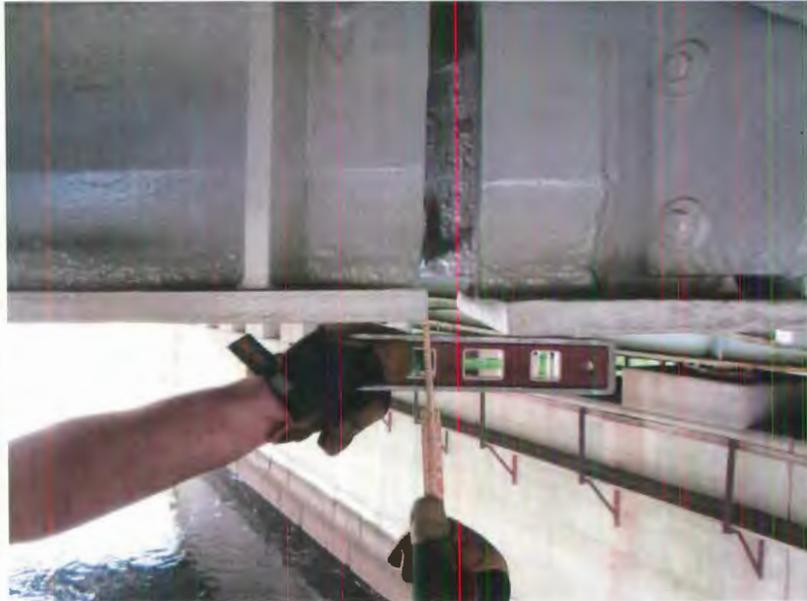
Photo #31 :
Span 3, girder 7, south line "V" pin and hanger measurement: Note that the hung span (left side of photo) is higher, and therefore is a "negative" measurement for pin and hanger measurement sheet. Positive measurement last inspection indicates rise of hung span this inspection.

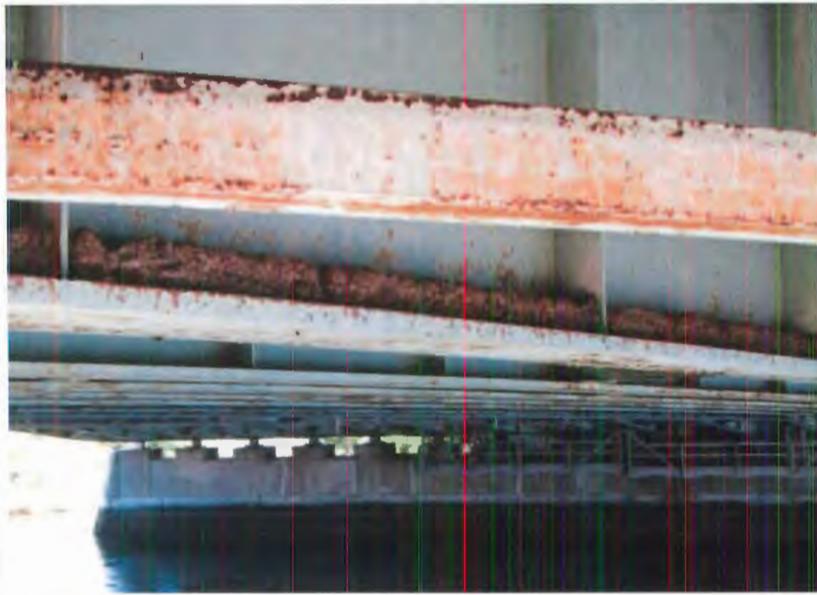
Photo #47 :
Span 3, girder 17: Heavy pigeon debris along the east leg of the girder bottom flange throughout.

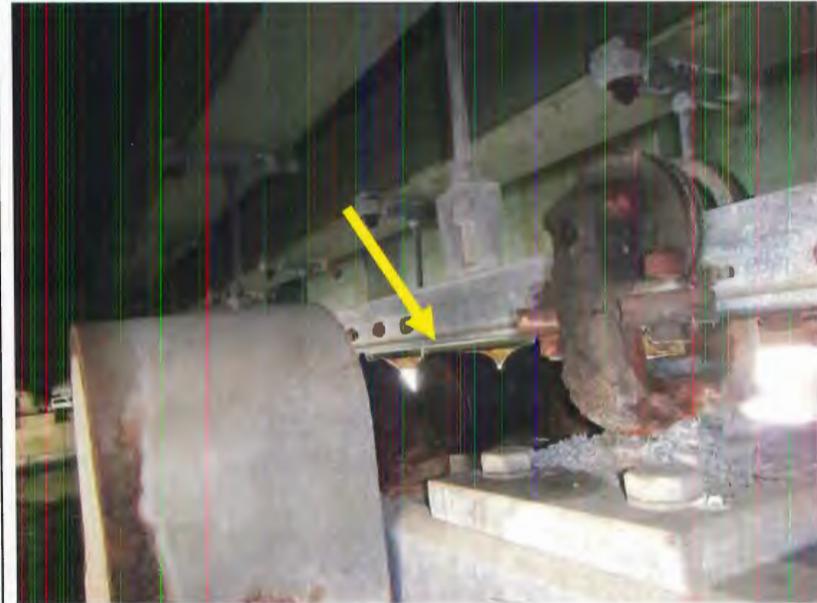
There is a BMM associated with this report.
 Also, note that the span 3, west rolling platform has a broken drive wheel (rubber has peeled/fallen off), causing the platform to get stuck at some locations within the span. The only way to move this platform when stuck is to tie the platform off to the adjacent platform. See photo 48.

Photo #48 :
West rolling platform, east drive wheel: Rubber has peeled/ fallen off the drive wheel.

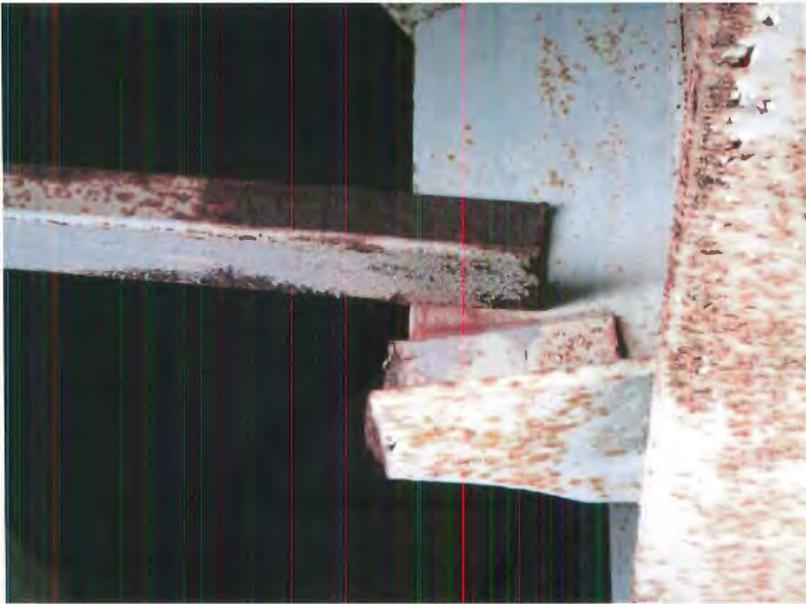
Photo #55 :

Span 3, bay 6, first intermediate diaphragm: No welds between the diaphragm angle and the lower vertical gusset plate at the east elevation of girder 6. Note the abrasion rust and cut-off angle.

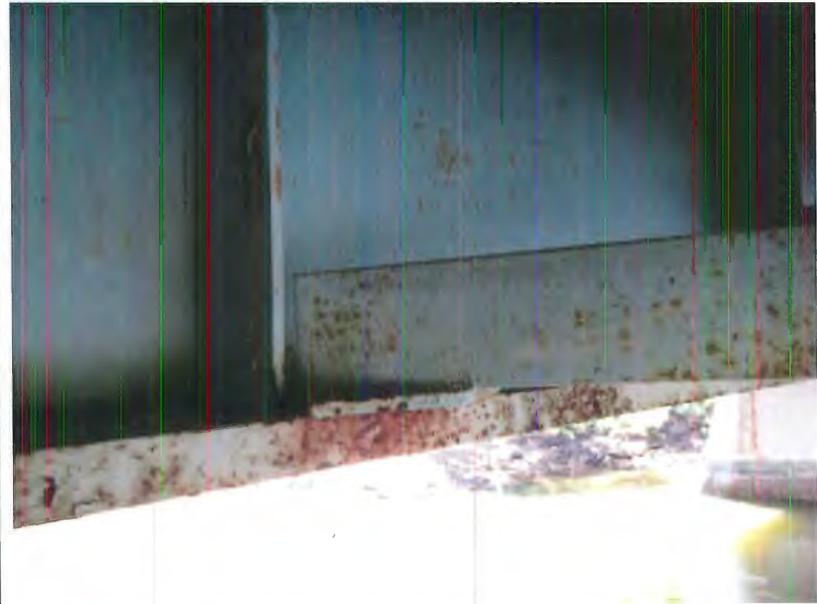
Photo #56 :

Span 3, girder 14, west elevation near midspan. No weld between the lateral bracing gusset plate and the girder bottom flange. Note the abrasion rust.

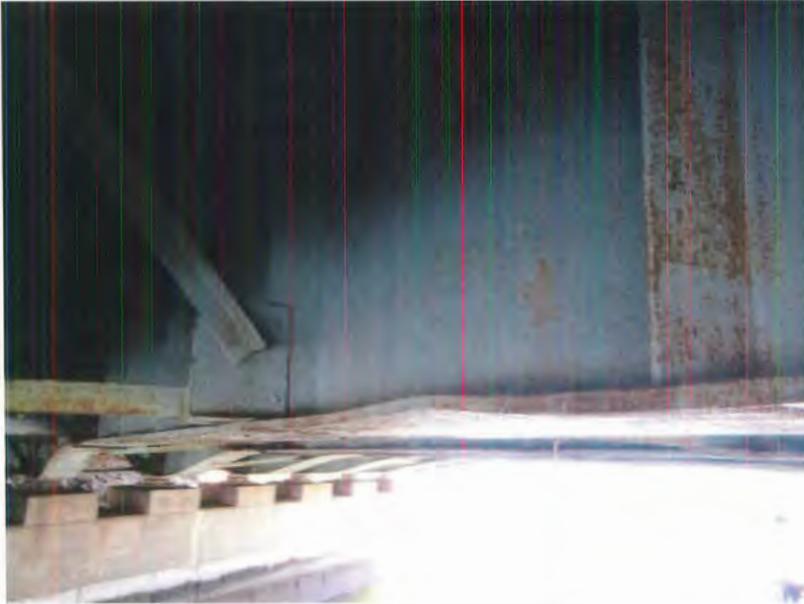
Photo #57 :
Span 3, girder 13: Bent bottom flange leg near the north fixed hinge.

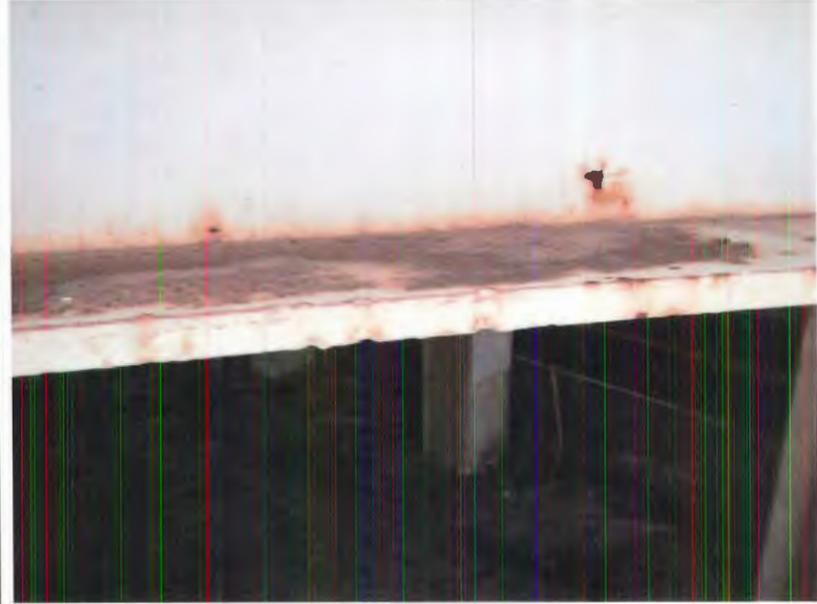
Photo #58 :
Gouges along the edges of the span 2, girder 1 bottom flange.

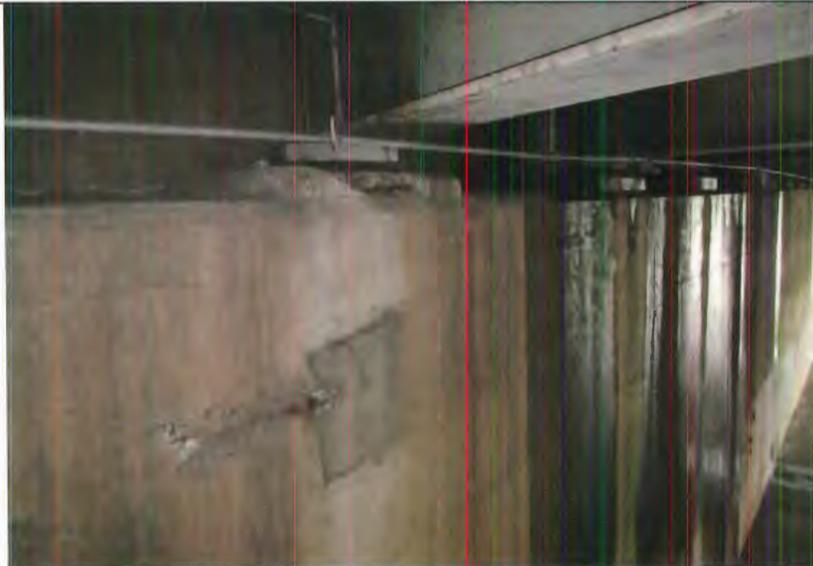
Photo #61 :
 South abutment: Spalls with exposed rebar in the stem and girder 17 pedestal. Also note the active joint leakage.

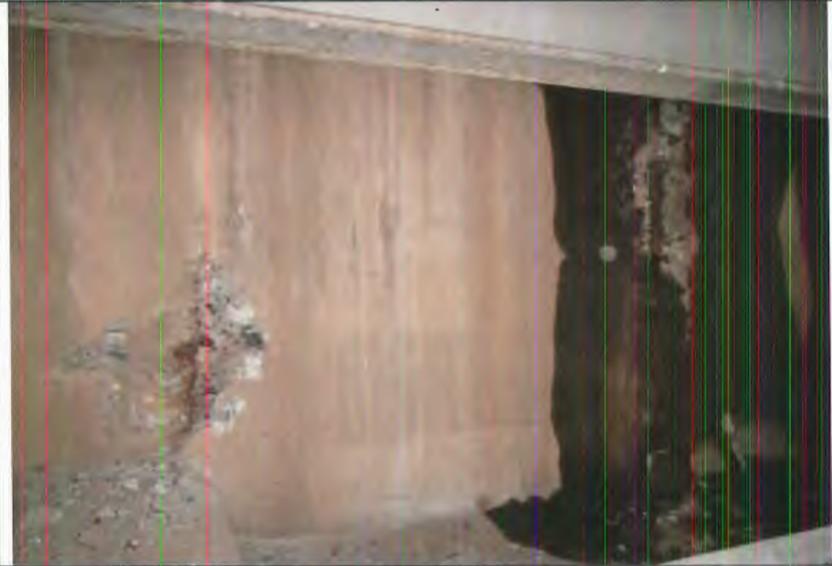
ABUTMENTS-STEM:	6	The abutment stems have random vertical hairline cracks (up to full height), isolated short horizontal cracks up to 1/32" wide, random small popouts, areas of light to moderate scaling, areas of hairline map cracking, random hollow areas up to 2' x 1.5', and spalls with random exposed rebar up to 2' x 10" x 1" deep. At the south abutment under girder 5, there is a 20" x 56" x 4" deep area of previously removed concrete and exposed rebar (area prepared for repair, but repair not completed). The pedestals have random hairline cracks, map cracking, shallow rebars and spalls up to 1' x 4" x 1" deep with isolated minor undermining of bearings (Girder 17 pedestal at the south abutment – 1 square inch undermining). See sheets 73-74 and photos 59-61.
ABUTMENTS-BACKWALL:	6	The backwalls have random short hairline vertical cracks, isolated areas of map cracking, random shallow rebar, and spalls with random exposed rebar, up to 4.5' x 1.5' x 3" deep. There is silt staining from past joint leakage at both backwalls. See sheets 73-74 and photo 62.

Photo #62 :
 South abutment backwall, bay 4 with spalls with exposed rebar. Note the active joint leakage.

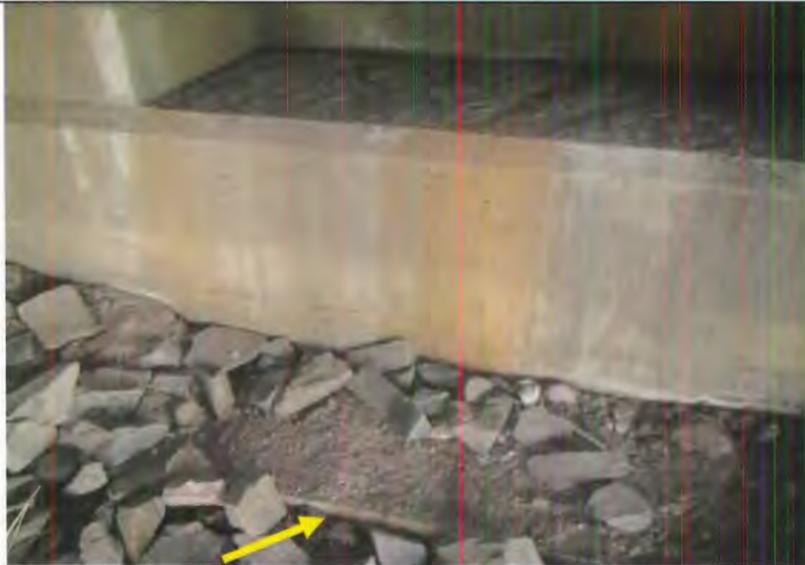
ABUTMENTS-FOOTINGS:	7	The north abutment footing is intermittently exposed up to 6' long x 10" high with no significant deficiencies. The footing is founded on piles. Rip rap has been placed in front of the footing. See sheet 74 and photo 63.
ABUTMENTS-SETTLEMENT:	8	None noted.
ABUTMENTS-WINGWALLS:	7	The wingwalls have isolated hairline cracks, areas of light scale, areas of map cracking and isolated graffiti. There is up to heavy vegetation growth along the wingwalls. The joint material is missing/deteriorated along the wingwall joints. See sheets 75-76 and photo 21.
PIERS/BENTS-CAPS:	5	The concrete pier cap at pier 1 has random hollow areas up to 4' x 1', and the underside of the cap is 15% hollow between columns 9 & 10. There are random corner spalls with exposed rebar, up to 3" deep x up to 2.5' long x 8" high/wide. Concrete is hollow adjacent to random spalls. There is also moderate to heavy scaling and map cracking with random rust and efflorescence. Pier 1 pedestals have isolated spalled and hollow concrete that does not affect the bearings. Random previously reported deteriorated areas were not found or were repaired since the last inspection. Piers 2 & 3 are solid stem piers and are rated under the "Piers/Bent – Columns" item below. See sheets 77-80 and photos 64 & 66.

PIERS/BENTS-SETTLMT:	8	None noted.
EROSION-SCOUR:	5	There is minor erosion along wingwalls and north abutment. The north abutment footing is slightly exposed, but is founded on piles. Rip-rap has been placed in front of the footing. See sheets 73-88 and photo 63. Per the March 15, 2013 underwater inspection: The footings for piers 2 and 3 are partially exposed up to 3.6' high, and the sheet piling at pier 2 is exposed up to 17' high (see "Piers/Bents-Footings" item above), despite up to 15' of aggradation along the north elevation of pier 2 since the 2011 underwater inspection. Note that these piers are founded on piles.
CONCRETE CRACK-SPALL:	5	See above items.
STEEL CORROSION:	N	-
PAINT:	N	-
TIMBER DECAY:	N	-
COLLISION DAMAGE:	8	-
DEBRIS:	6	There are areas pigeon and concrete debris on the bridge seats. See sheets 73-88.

Photo #63 :
Exposed footing at the north abutment.

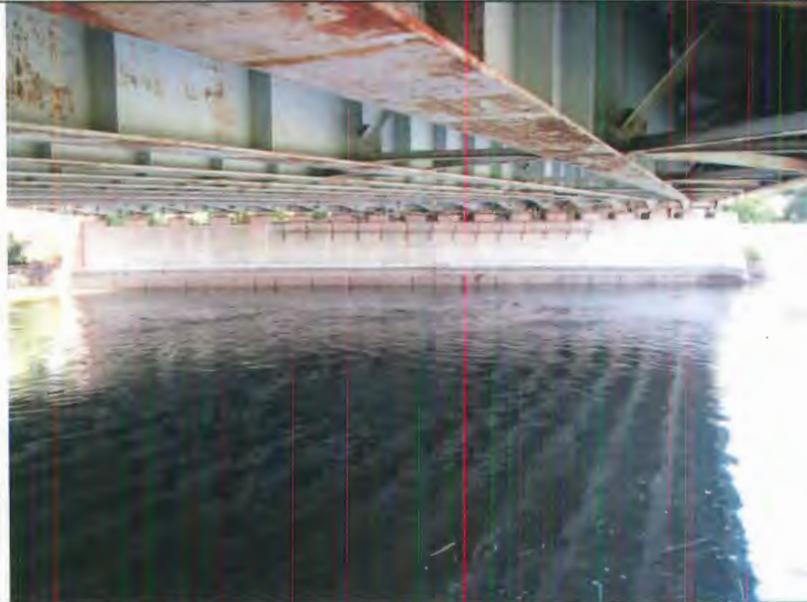
Photo #65 :
 Pier 3, north elevation, typical for piers 2-3. Note the platform attached to the pier stem below the center portion of the bridge.

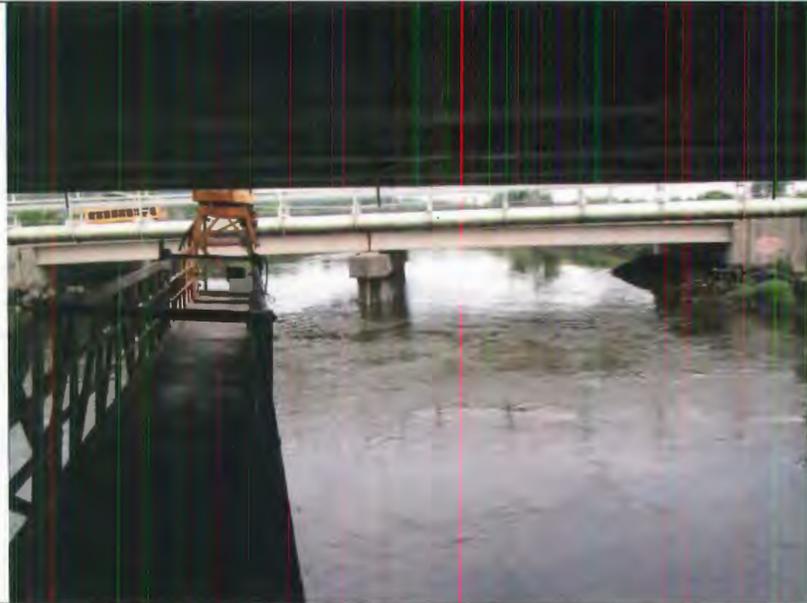
Photo #69 :
Channel looking upstream (west).

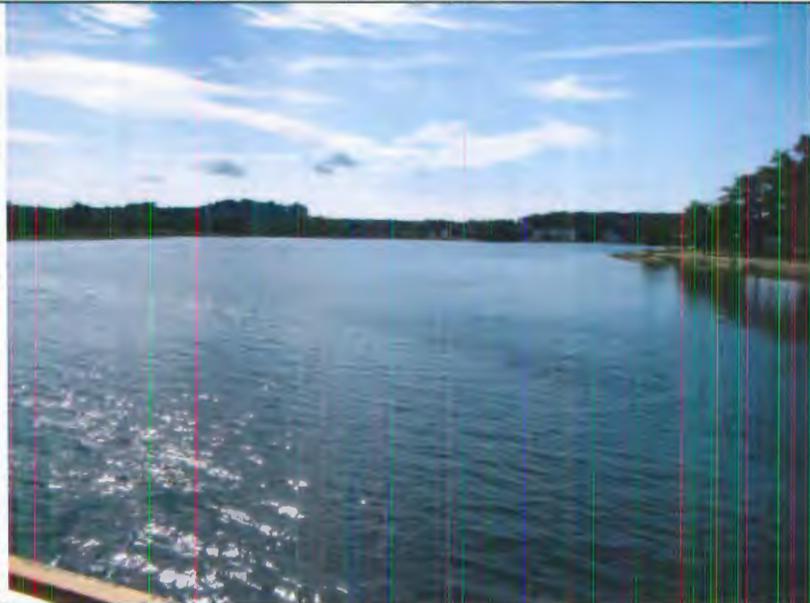
Photo #70 :
Channel looking downstream (east).

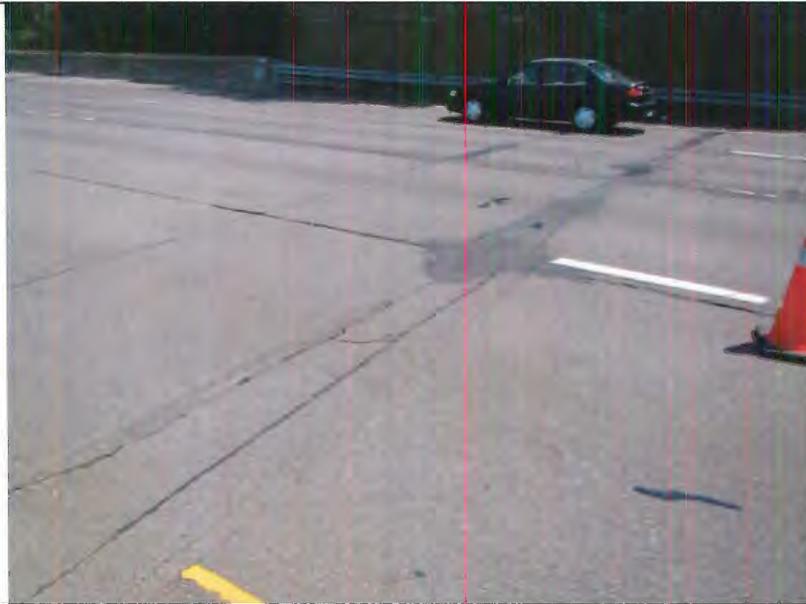
APPROACH SLAB:	N	No approach slabs are indicated in the plans. Rating changed to "N".
RELIEF JOINTS:	6	There are transverse saw-cuts in the approaches with random depressed and cracked bituminous patches in these areas. See sheets 24 & 26 and photo 71.
APPROACH GUIDE RAIL:	5	The southbound approach guide rails have random twisted/slightly bent posts, random twisted block-outs, and random scrapes. The northwest approach rail also has a disconnected post and two of four anchor bolts are sheared/cut-off at the rub-rail connection to the parapet end. The northbound metal beam rails have random minor impact damage and one bolt is sheared off at the southeast guide rail transition. The concrete median has a 2.5' long x full height broken, hollow, and spalled area at the north abutment joint (southbound side). At approximately 100' north of the bridge, the approach median barrier has a 6' long x 2' high area of collision damage, southbound side; no change. See sheets 24 & 26 and photos 3, 4, 13, 14 & 72.

Photo #71 :
 South approach, northbound: Milled area of pavement at the transverse saw cuts. Note the bituminous patches at the saw cuts.

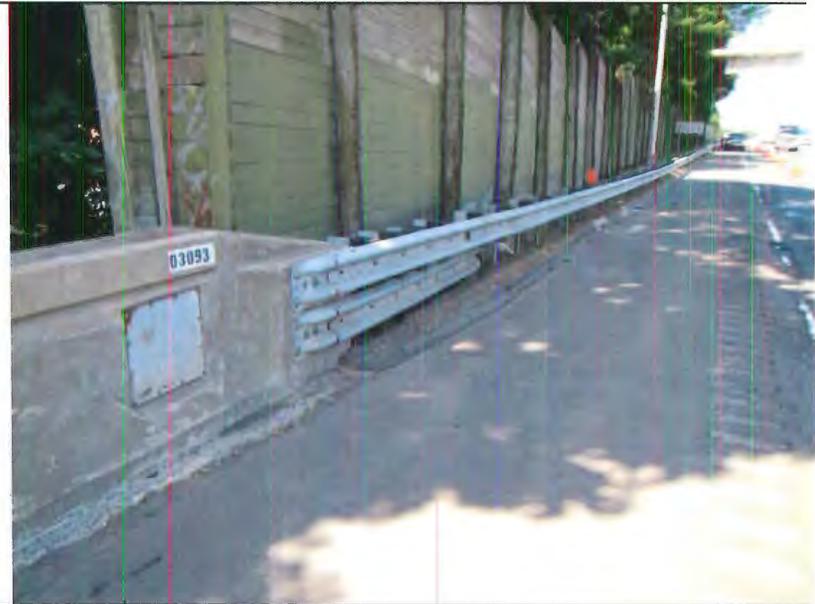
BRIDGE RAILINGS:	Last Inspection: 1 Current: 1	Meet current standards for NHS bridges.
TRANSITIONS:	Last Inspection: 1 Current: 1	Leading edges meet R-B 350 standards. See photo 72.
APPROACH GUARDRAILS:	Last Inspection: 1 Current: 1	Leading edges meet R-B 350 standards within 100' of bridge.
APPR. GUARDRAIL ENDS:	Last Inspection: 1 Current: 1	Continuous with highway rails within 100' of bridge.

Photo #72 :
 Southeast approach (northbound): Typical leading edge guide rail transition.

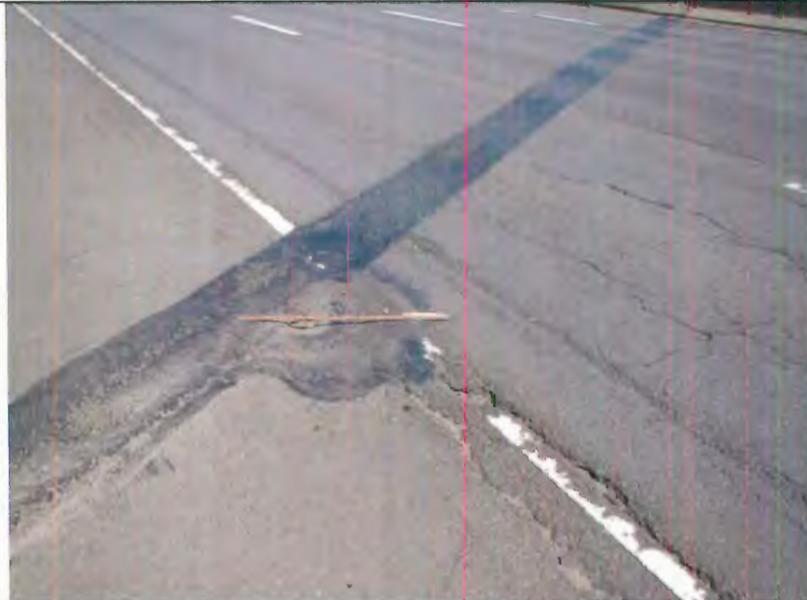
Photo #75 :
 South approach pavement, southbound: Settlement of a bituminous patch in the approach pavement adjacent to the asphaltic plug joint at the south abutment.

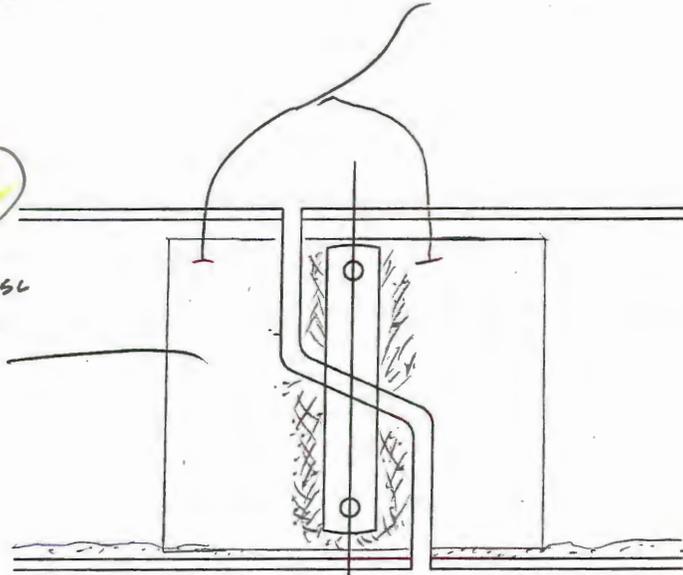
THICKENED WEB
± 3/8" ORIG → TAPERS
to ± 1/2" @ TOP/BOT

UP TO 3/16"
TYP W/ 3/16" DP SL
UP TO 1" FROM
HANGER PL

1/8" AT
NON-THICKENED

UP TO 3/16"
THICKENED
PORTION OF
WEB
