PRE-RENOVATION INVESTIGATIVE SURVEY FOR HAZARDOUS BUILDING MATERIALS

**SOUTHINGTON MAINTENANCE FACILITY
476 MULBERRY STREET
SOUTHINGTON, CONNECTICUT
Project No. 131-205**

**State of Connecticut
Department of Transportation**
Newington, Connecticut

Issued
March 2016

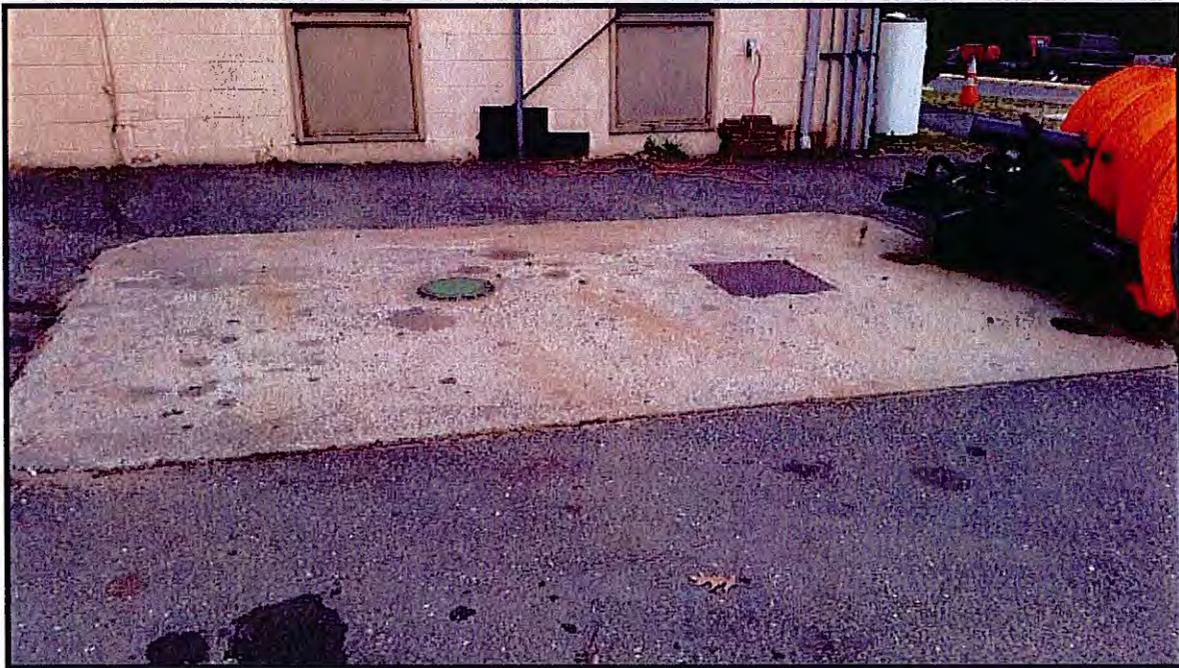
PHOTO 24. Fuel Oil UST.

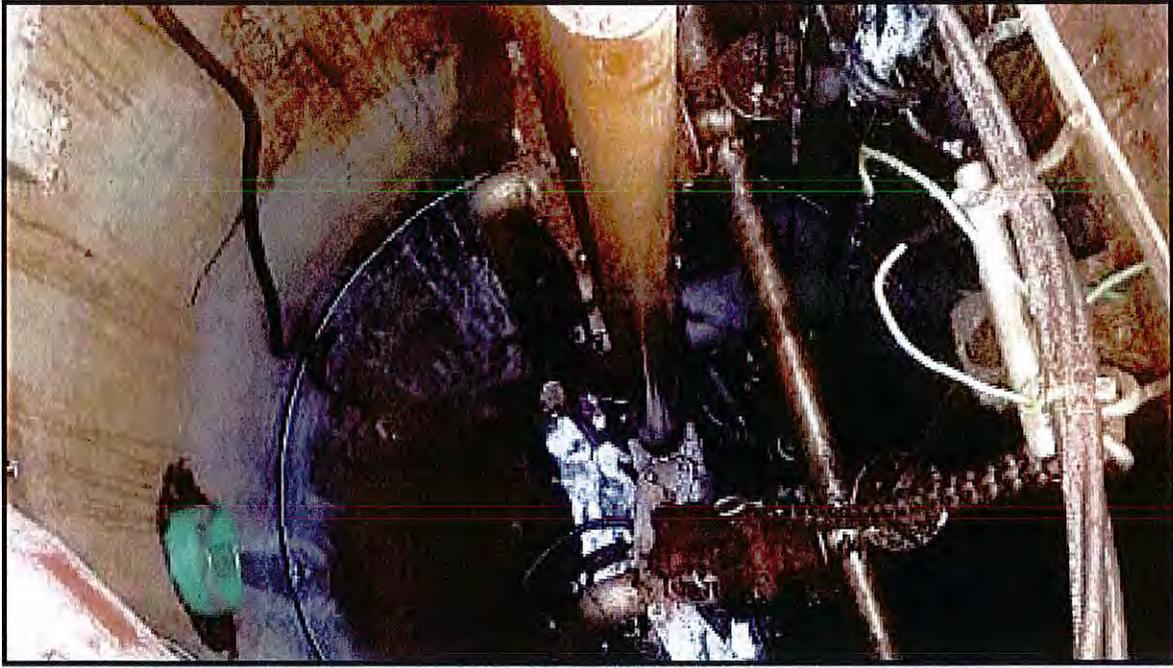
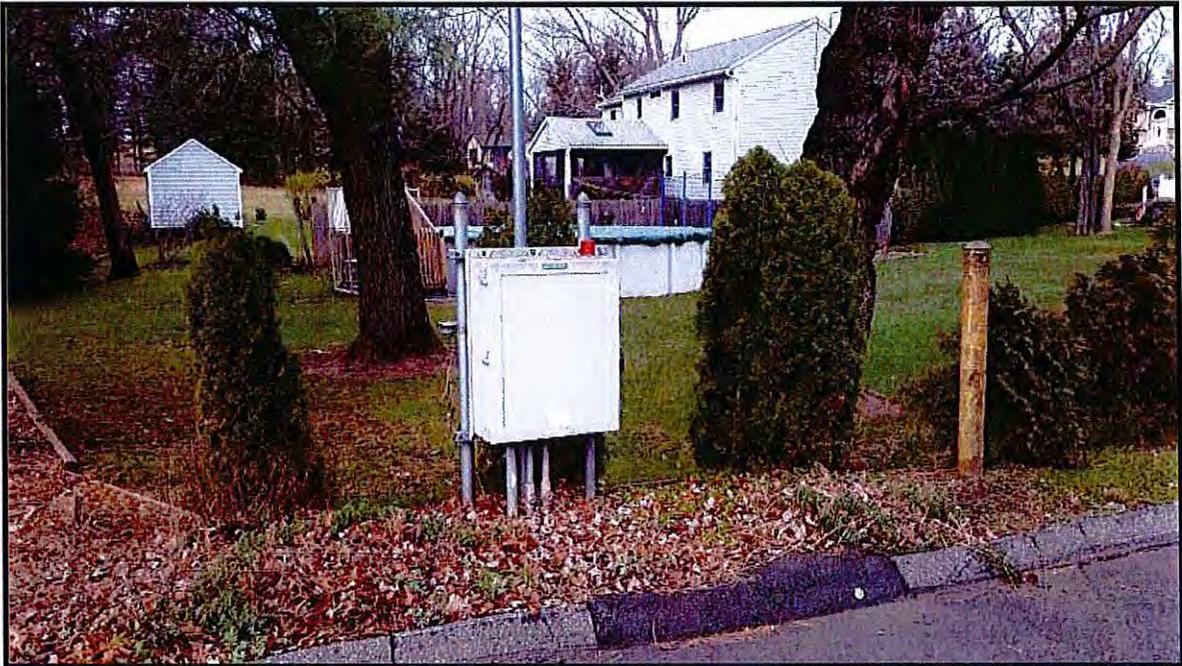
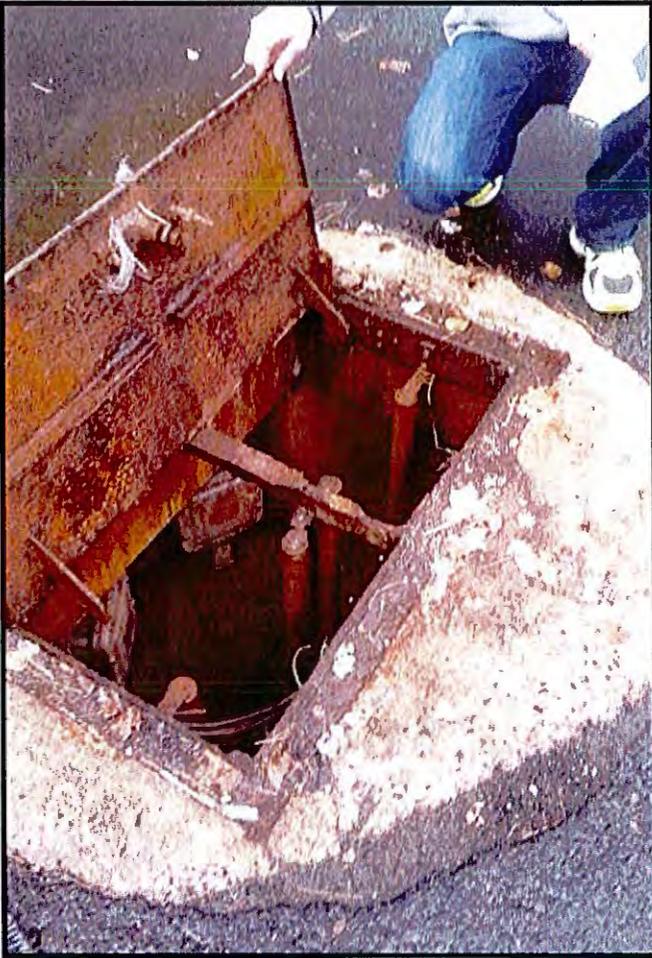
PHOTO 31. Grinder Pump.

PHOTO 32. Grinder Pump.

PHOTO 33.
Grinder Pump.

REPLACE PUMP AND FLOATS INSIDE GRINDER PUMP STATION. ✓

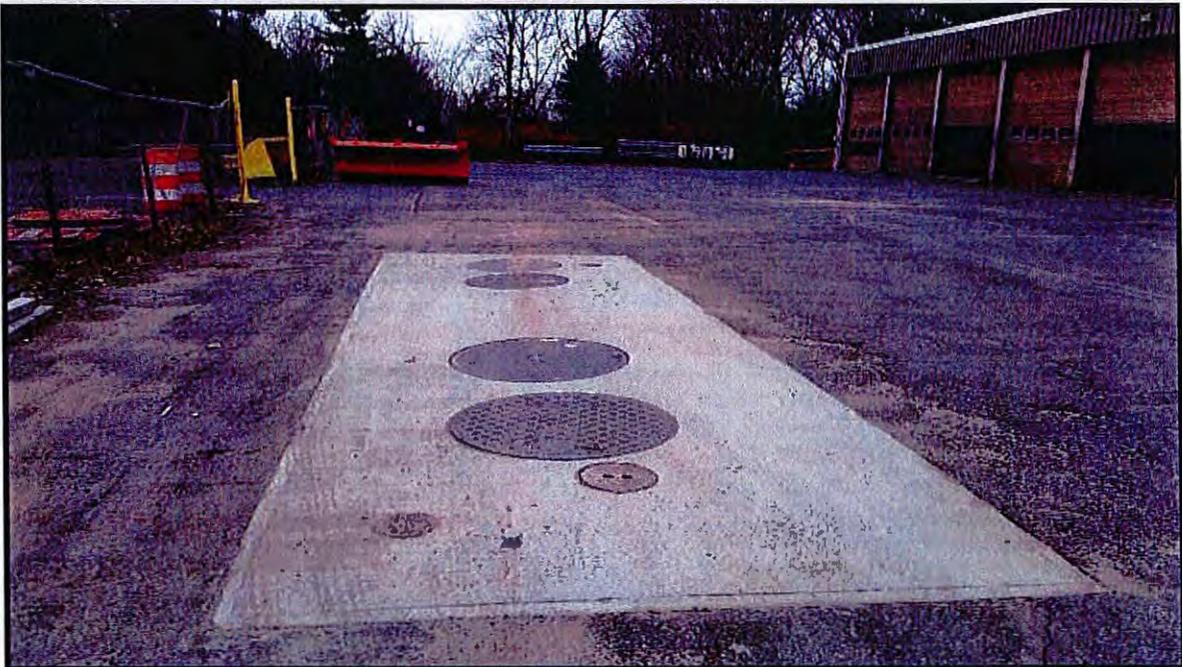
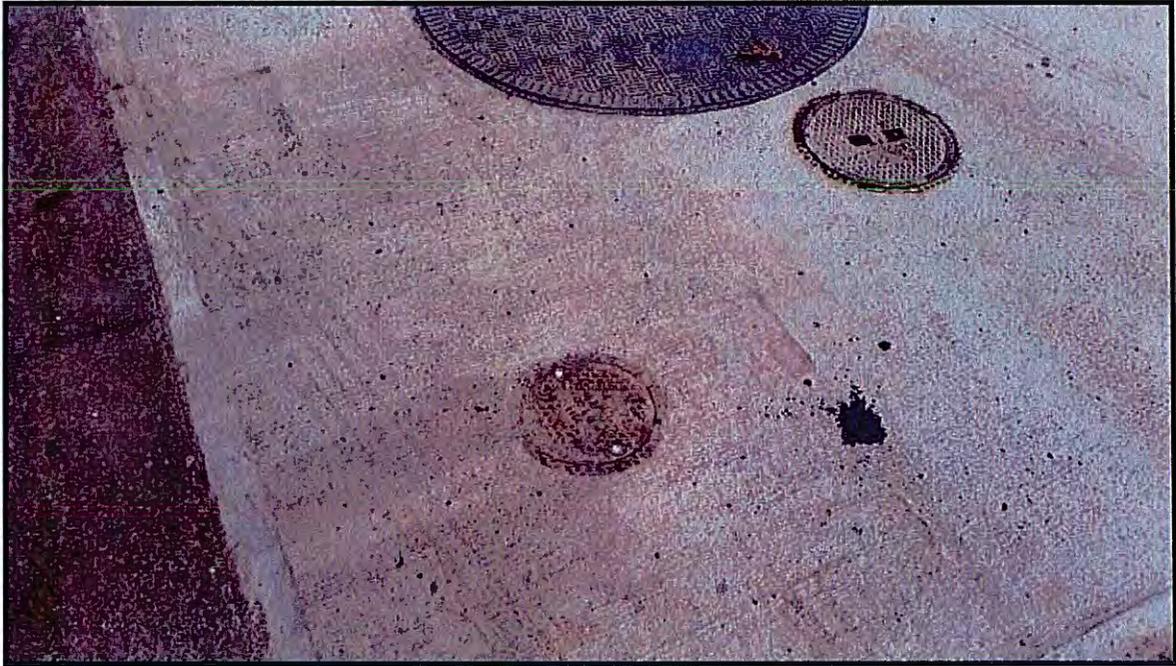
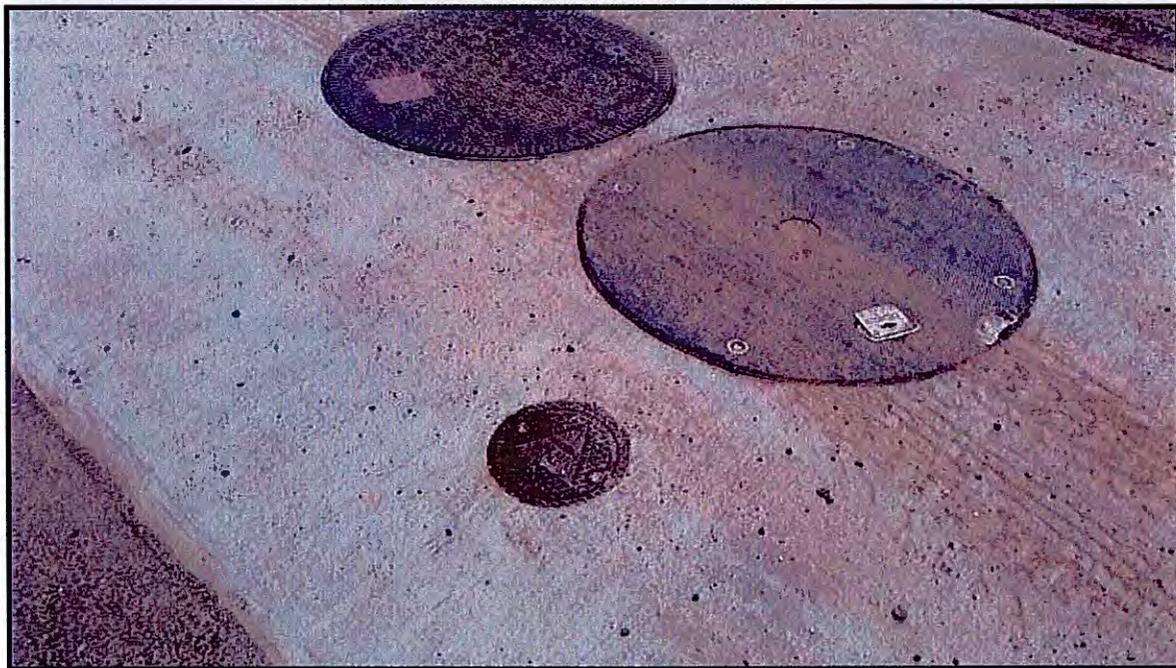
PHOTO 34. Oil and Water Separator.

PHOTO 35. Oil and Water Separator.

PHOTO 36. Oil and Water Separator.

REMOVE 1000 GALLON OIL-WATER SEPARATOR. ✓

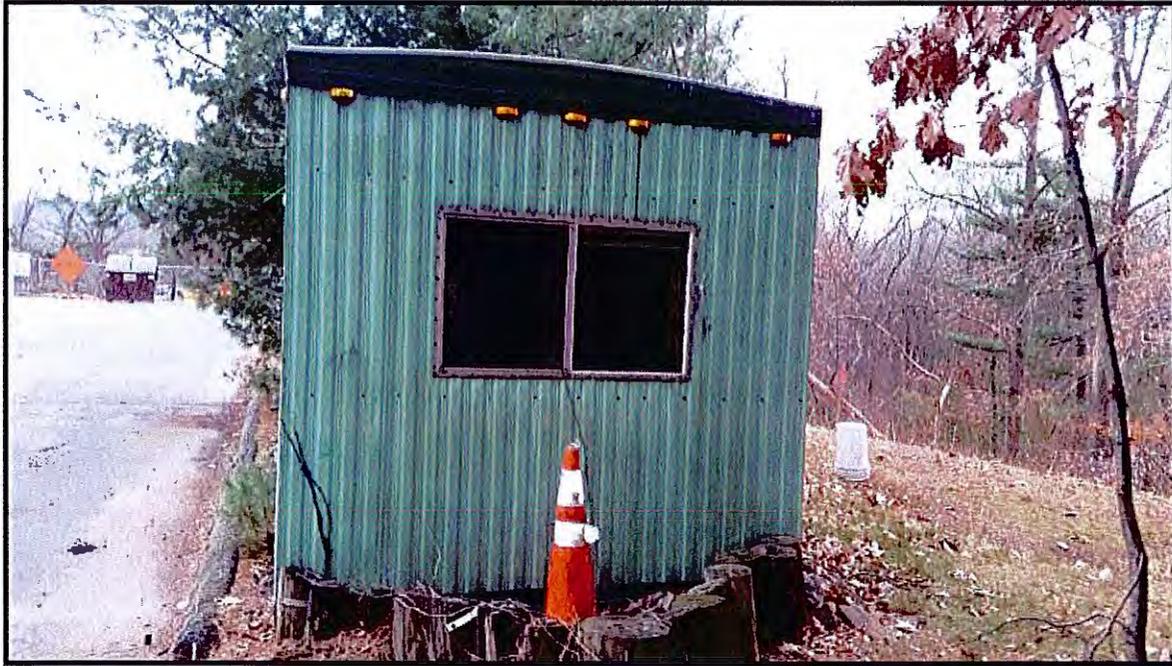
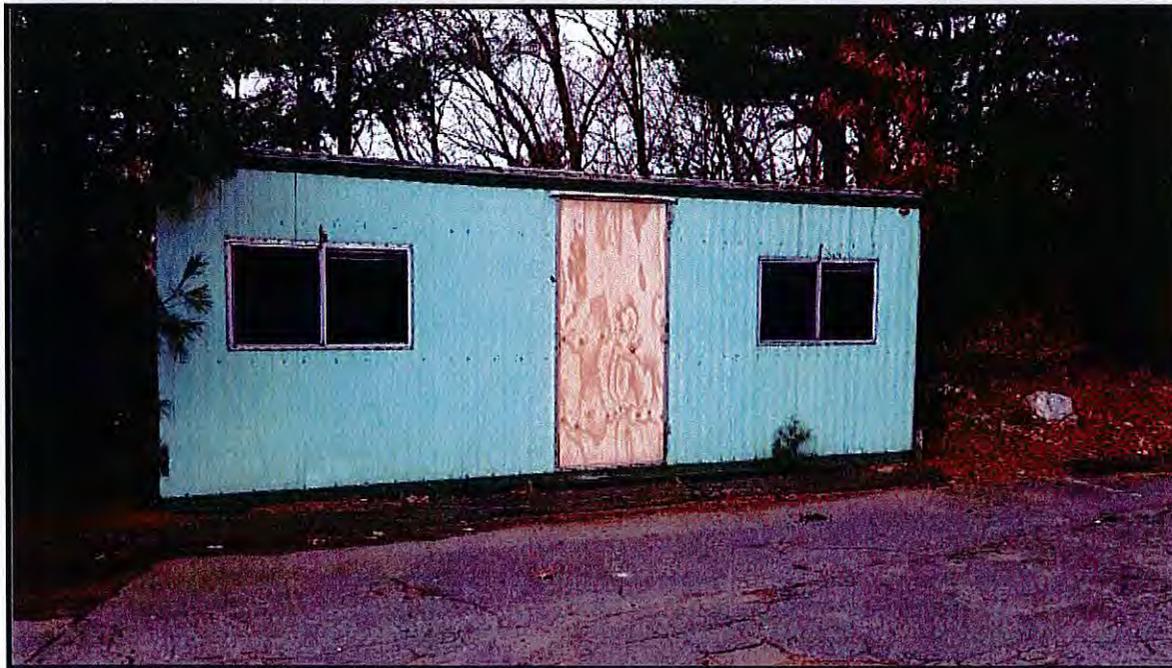
PHOTO 37. Trailer.

PHOTO 38. Trailer.

REMOVE OFFICE TRAILER. ✓

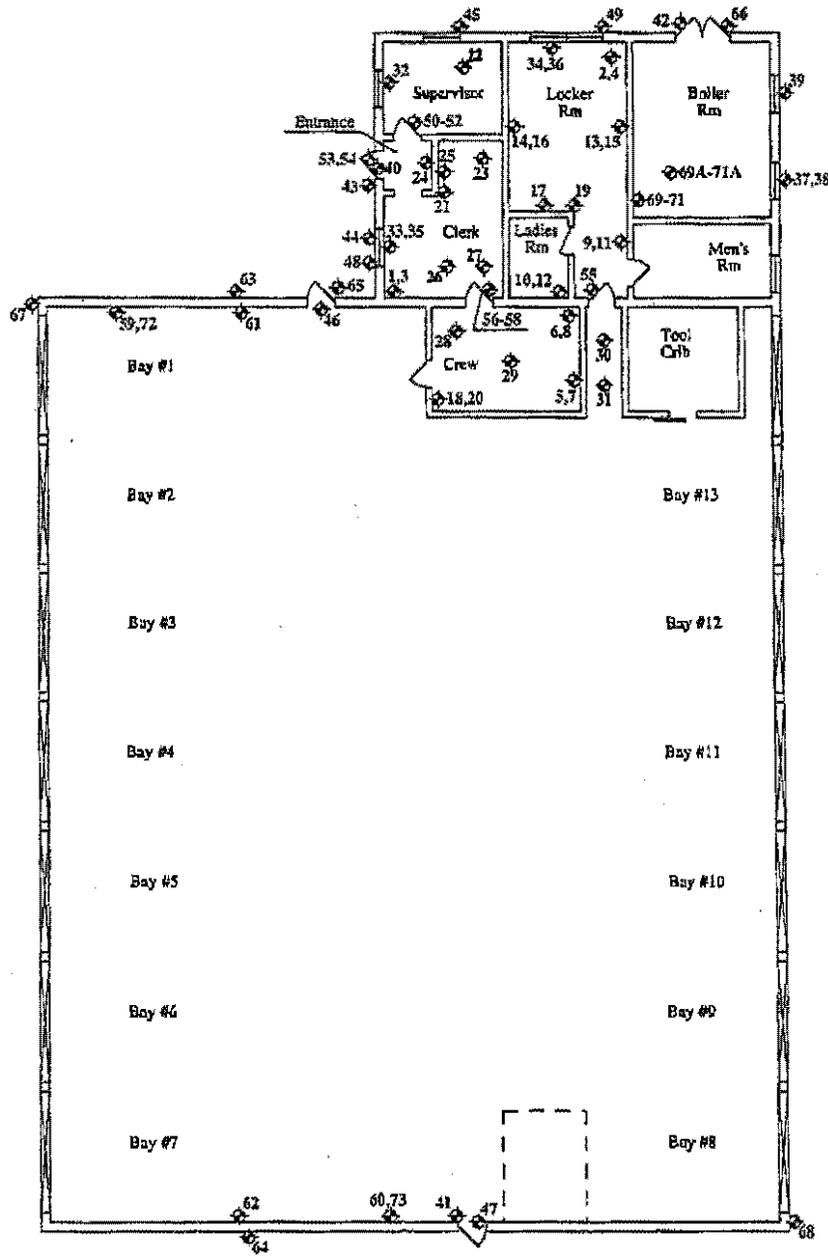
Drawing Title:		Asbestos Bulk Sample Location Diagram	
Prepared by:	EnviroMed Services, Inc. 25 Science Park, New Haven, CT 06511	Date:	7/06,07/01
Project:	DOT Maintenance Garage Bldg # 81-369 Floor Plan Southington, Connecticut	Scale:	N.T.S.
Prepared for:	State of Connecticut Department of Transportation Newington, Connecticut	Drawn By:	DER
EMS # IH-01-604		Approved By:	J.F.
		Drawing No.	1
		of 3

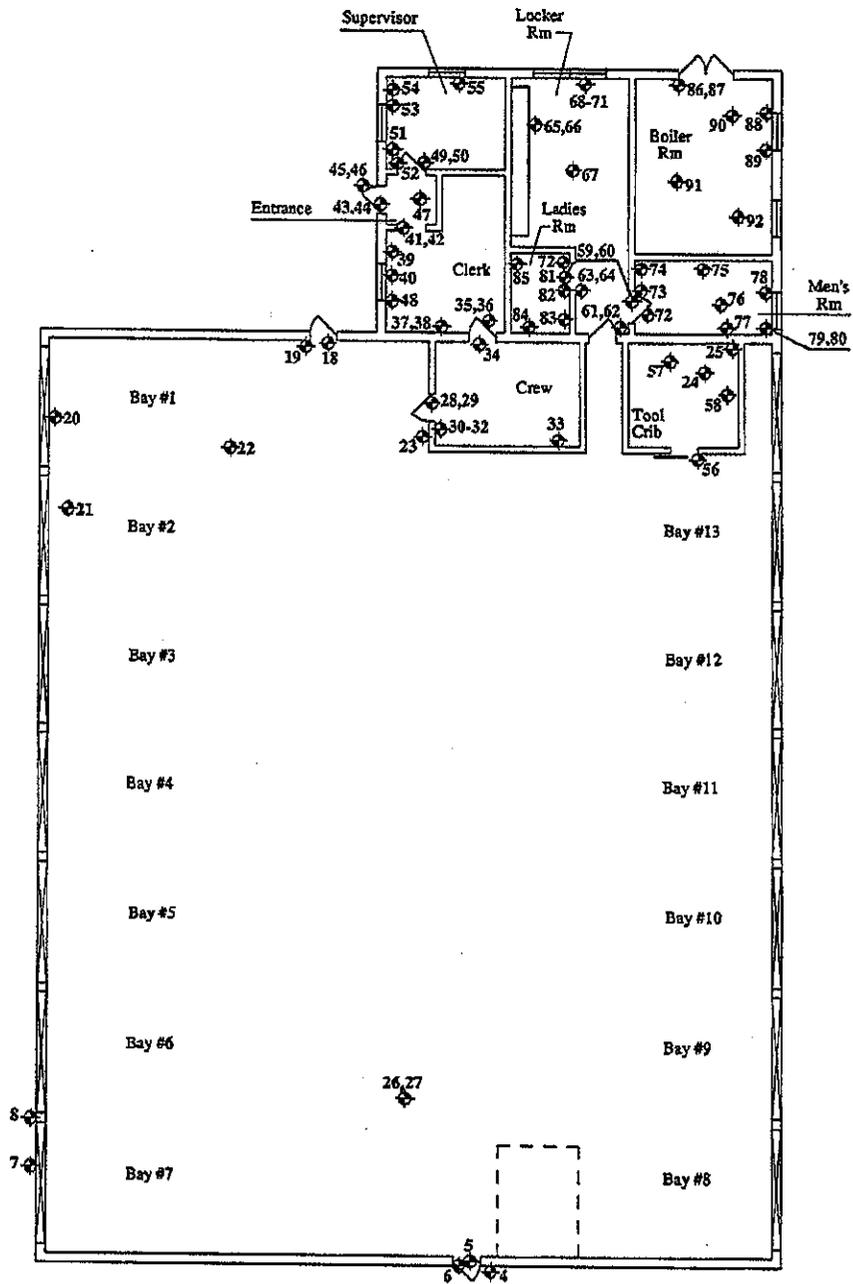
IV. SAMPLE LOCATION DIAGRAMS

Summary of Toxic Level (≥ 1.0 mg/cm ²) Results			
Sample Number	Sample Location (mg/cm ²)	Component (s) Tested	Results
10	Fuel Island	curb	1.4
12	Fuel Island	yellow pump	1.8
56	Tool Crib	door	9.1
57	Tool Crib	white floor stripe	7.4
