BRIDGE NO.06842

15910 - COLCHESTER
ROUTE 2 E/B
over
BROOK

Routine Inspection

2/06/2019

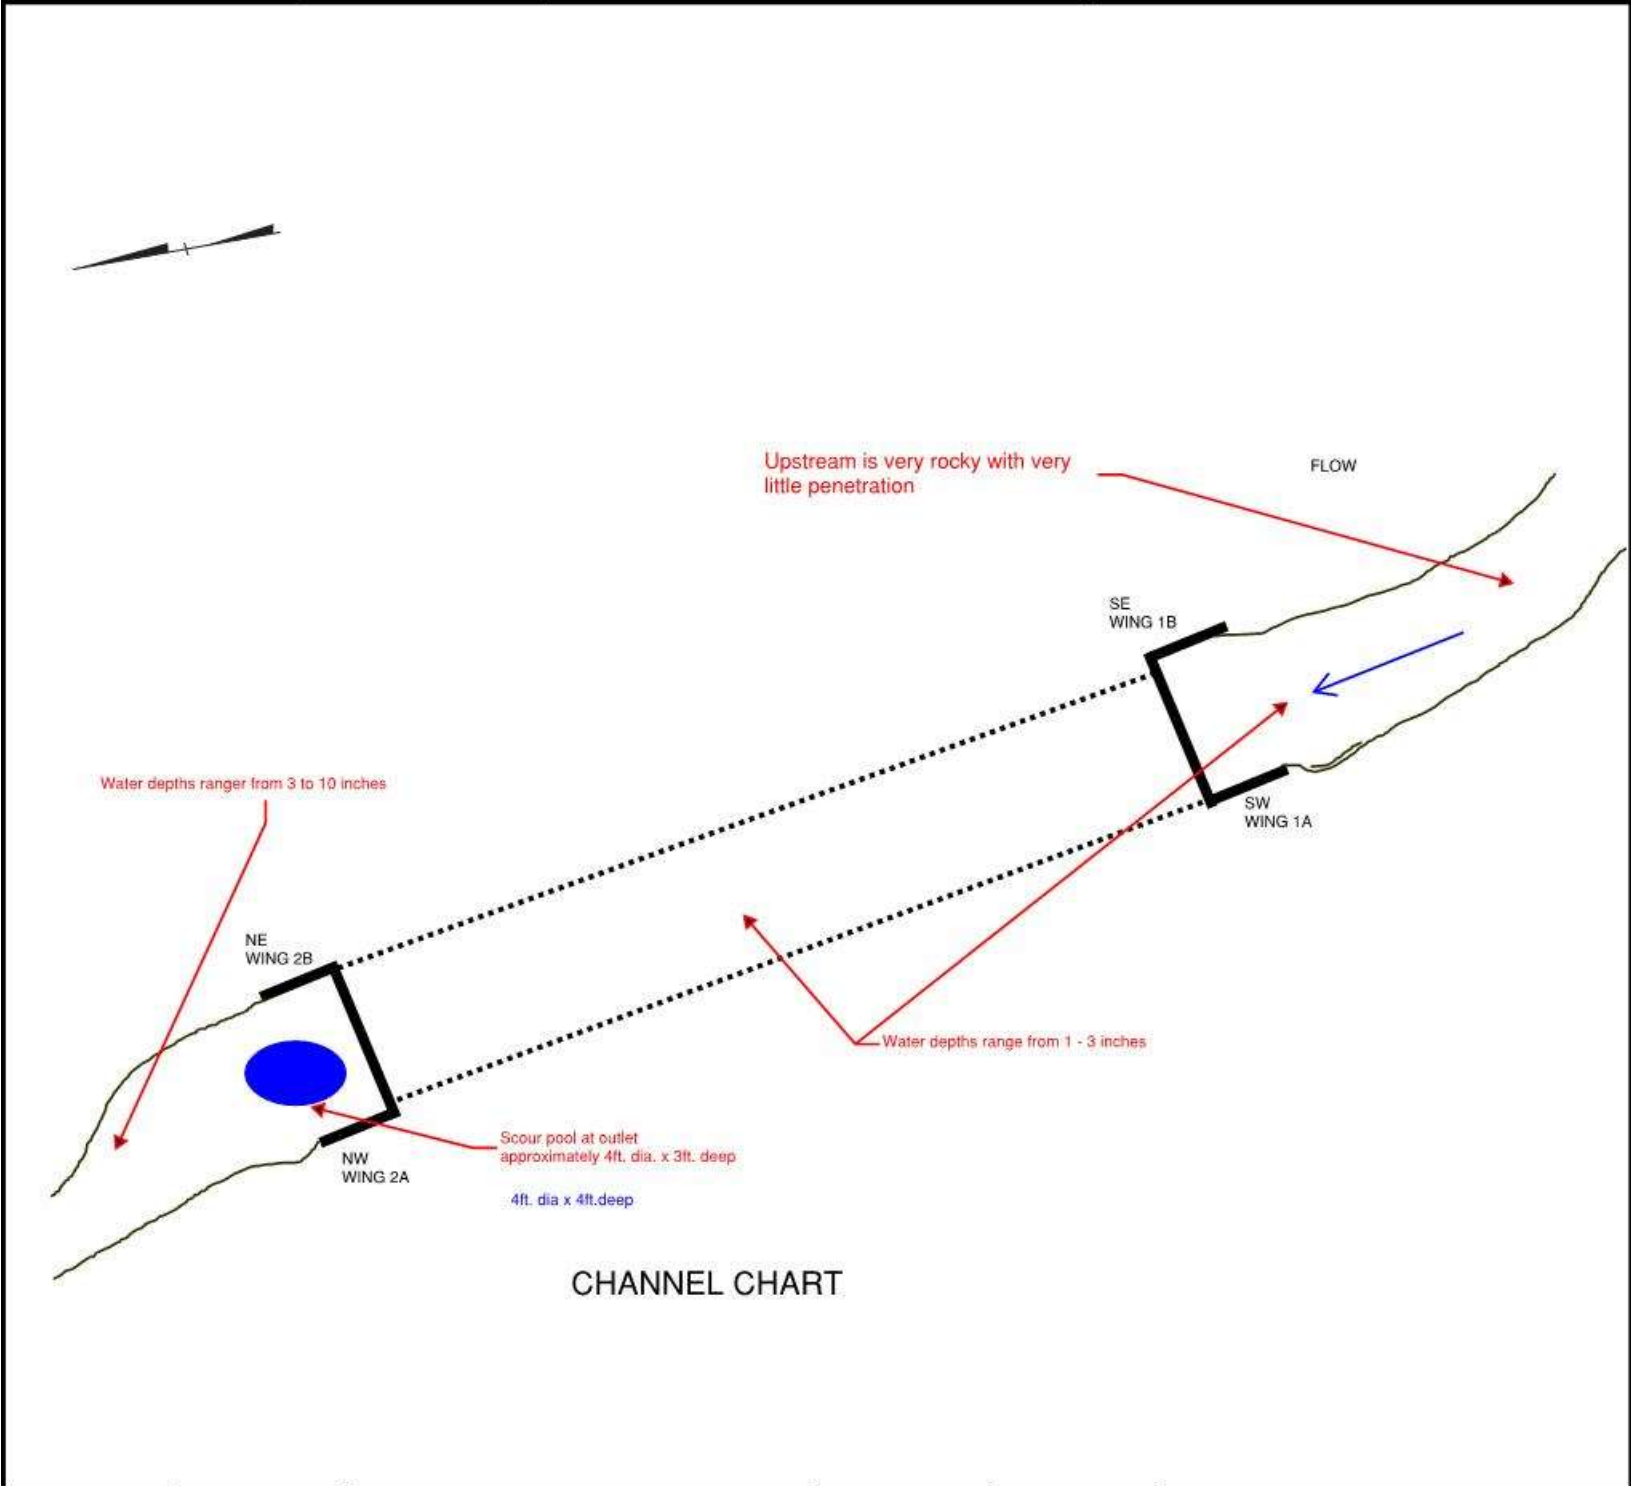
CHANNEL CHART

Channel - Scour:	<input type="text" value="5"/>	<p>Minor scour noted at the outlet:</p> <p>A 4ft. dia. scour pool between the wingwalls at the outlet with water depths up to 48" deep.</p> <p>Scour at the outlet has exposed the cut-off wall full width x up to 28" high.</p> <p>The top of the footing on the northeast wingwall is approx. 3ft. long.</p> <p>Water depths upstream range from 1" to 3".</p> <p>Water depths in the pipe are 1" to 3".</p>
Embankment - Erosion:	<input type="text" value="7"/>	<p>Minor around the inlet and outlet pipe ends.</p> <p>Behind the north headwall there's</p>
Debris:	<input type="text" value="6"/>	Dead branches and some natural debris along the embankments.
Vegetation:	<input type="text" value="8"/>	Embankments are well vegetated.
Channel Change:	<input type="text" value="8"/>	
Fender - System:	N	
Spur Dikes and Jetties:	N	
Rip Rap:	N
