EAGLE
Environmental, Inc.

**RE: Environmental Assessment Report
Department of Housing
CDBG-DR – Sandy Disaster Recovery Program
125 Hickory Street
Norwich, Connecticut
Application #1971
Eagle Project No. 14-028.12T15**

This assessment and report is intended to satisfy the review process of the National Environmental Policy Act (NEPA) Statutory Checklist Sections 13C (Lead-Based Paint), 13D (Asbestos), 13E (Radon) and 13F (Mold).

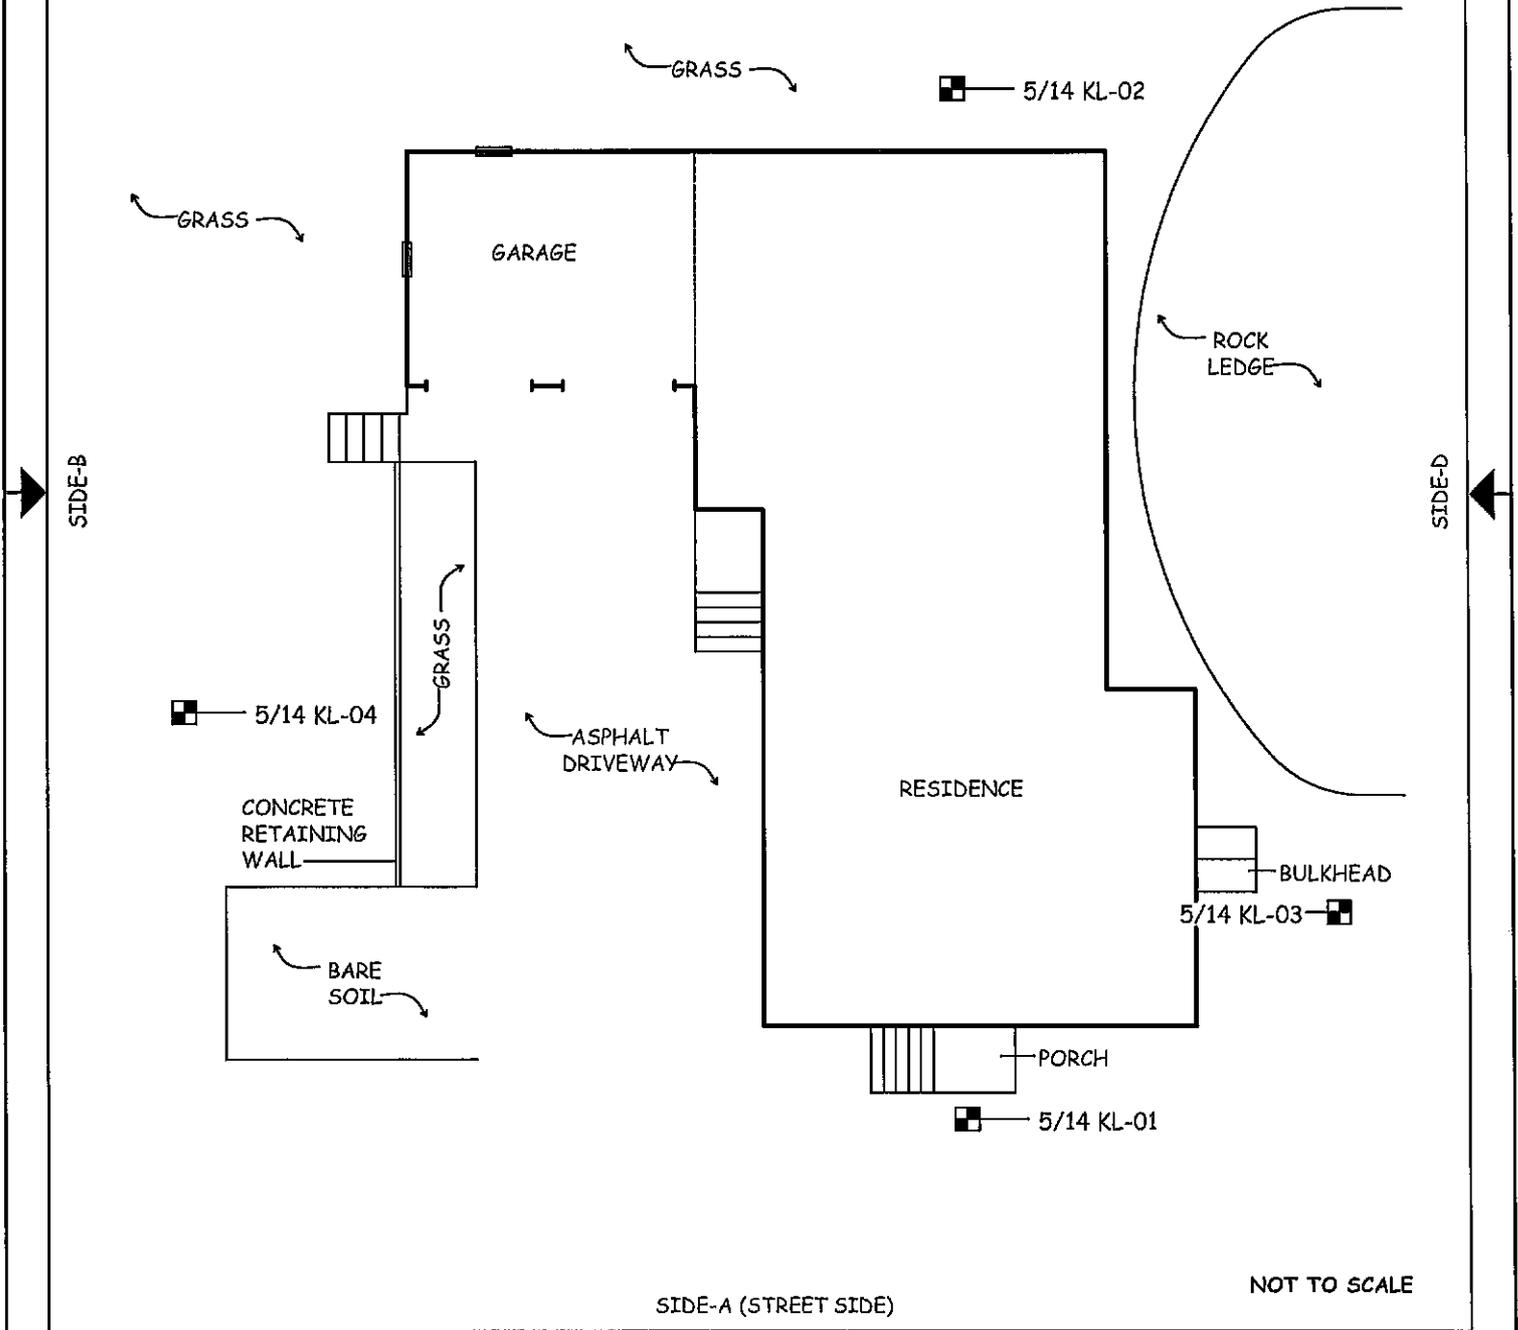
☐ = NUMBER AND LOCATION OF SOIL SAMPLES
5/14 KL SOIL-01

BOLD TEXT INDICATES A DUST OR SOIL-LEAD HAZARD FOUND

SP-1 SITE PLAN WITH SOIL SAMPLE LOCATIONS
FP-1 BASEMENT PLAN
FP-2 FIRST FLOOR PLAN
FP-3 SECOND FLOOR PLAN

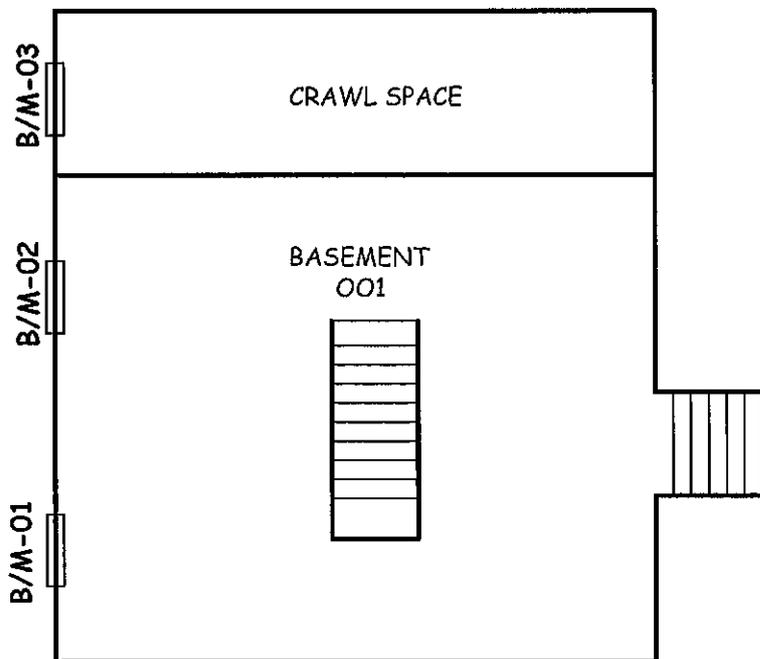
SIDE-A (STREET SIDE)

= INACCESSIBLE
PHOTO TAKEN

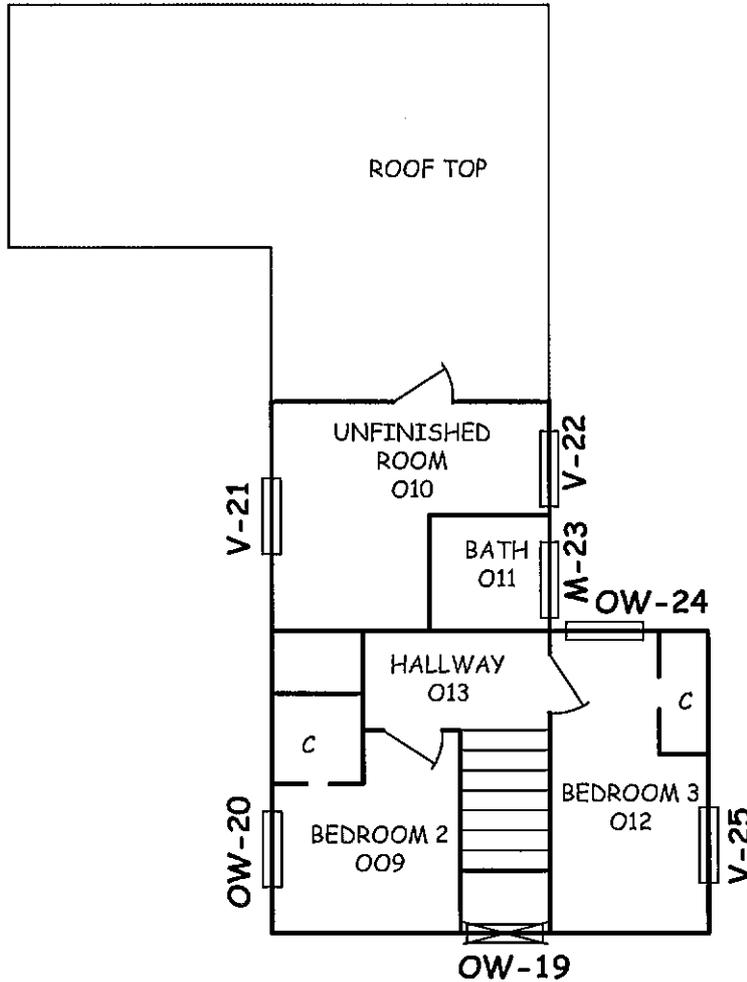
SIDE-A (STREET SIDE)

= INACCESSIBLE
PHOTO TAKEN

C = CLOSET EVALUATED WITH
ADJACENT ROOM
