RE: Applicant 2035, 8 Third Avenue, Stratford, CT

This letter is provide a summary description of the Statutory Checklist for CDBG-DR Applicant – 2035 William Onkey.

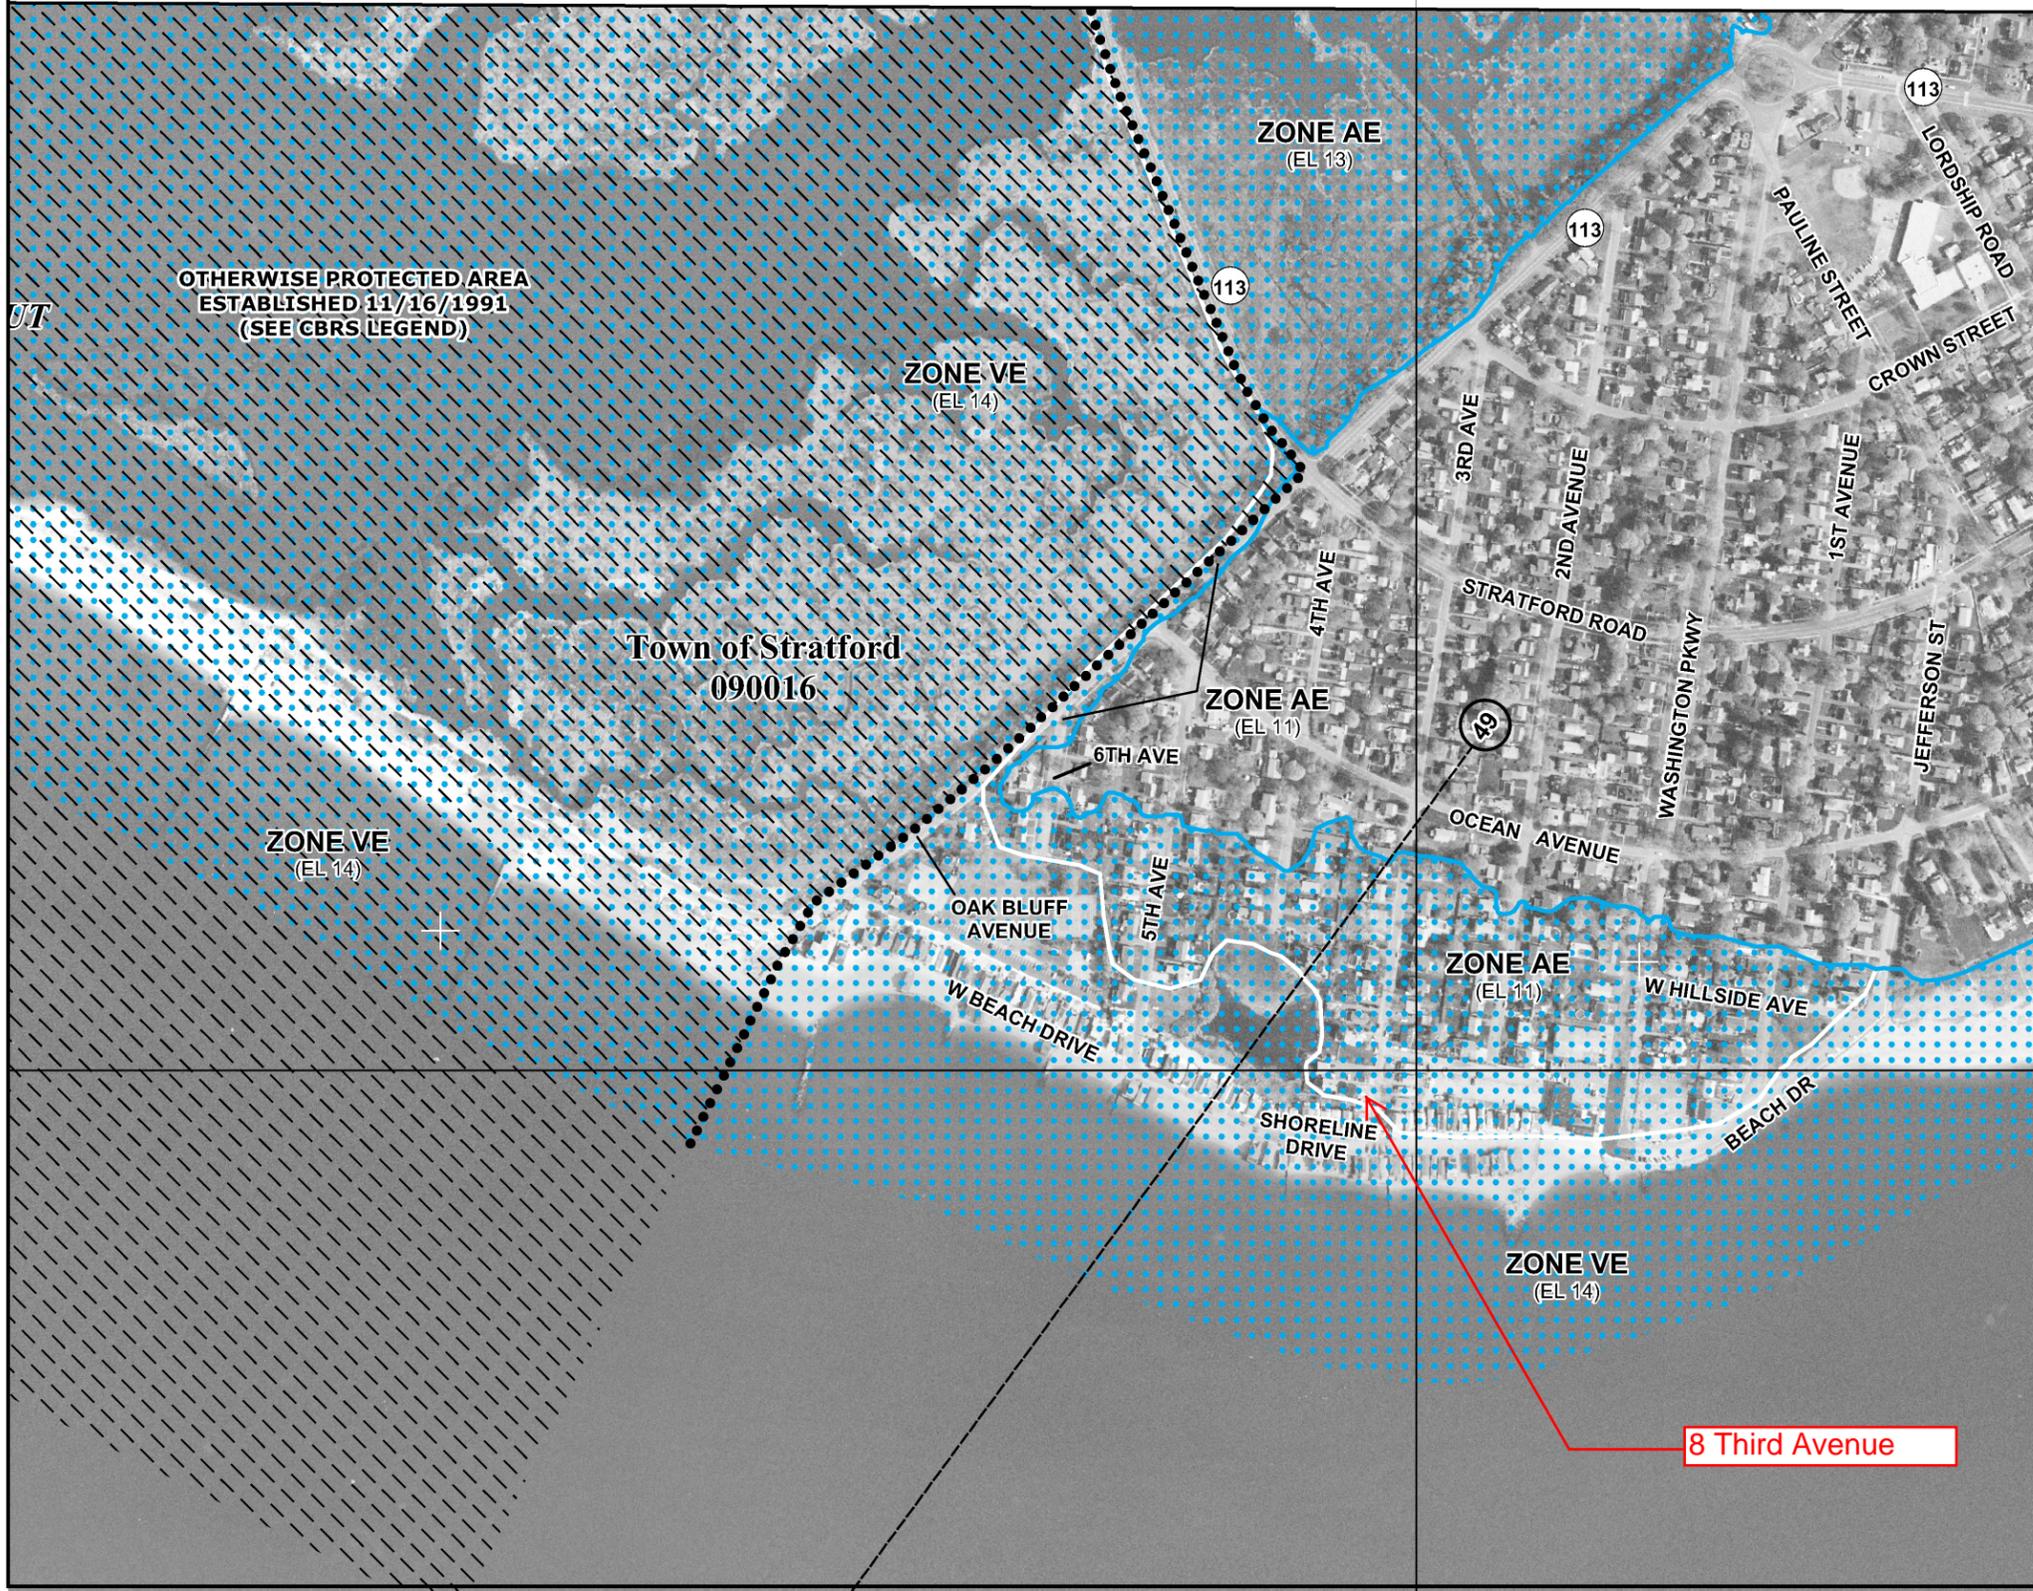
MAP SCALE 1" = 500'

- Item 1 – CT State Historic Preservation Office (SHPO) Determination Statement
- Item 2 – National Flood Insurance Program FIRMette Map
- Item 3 – U.S. Fish and Wildlife Service, National Wetlands Inventory Mapping

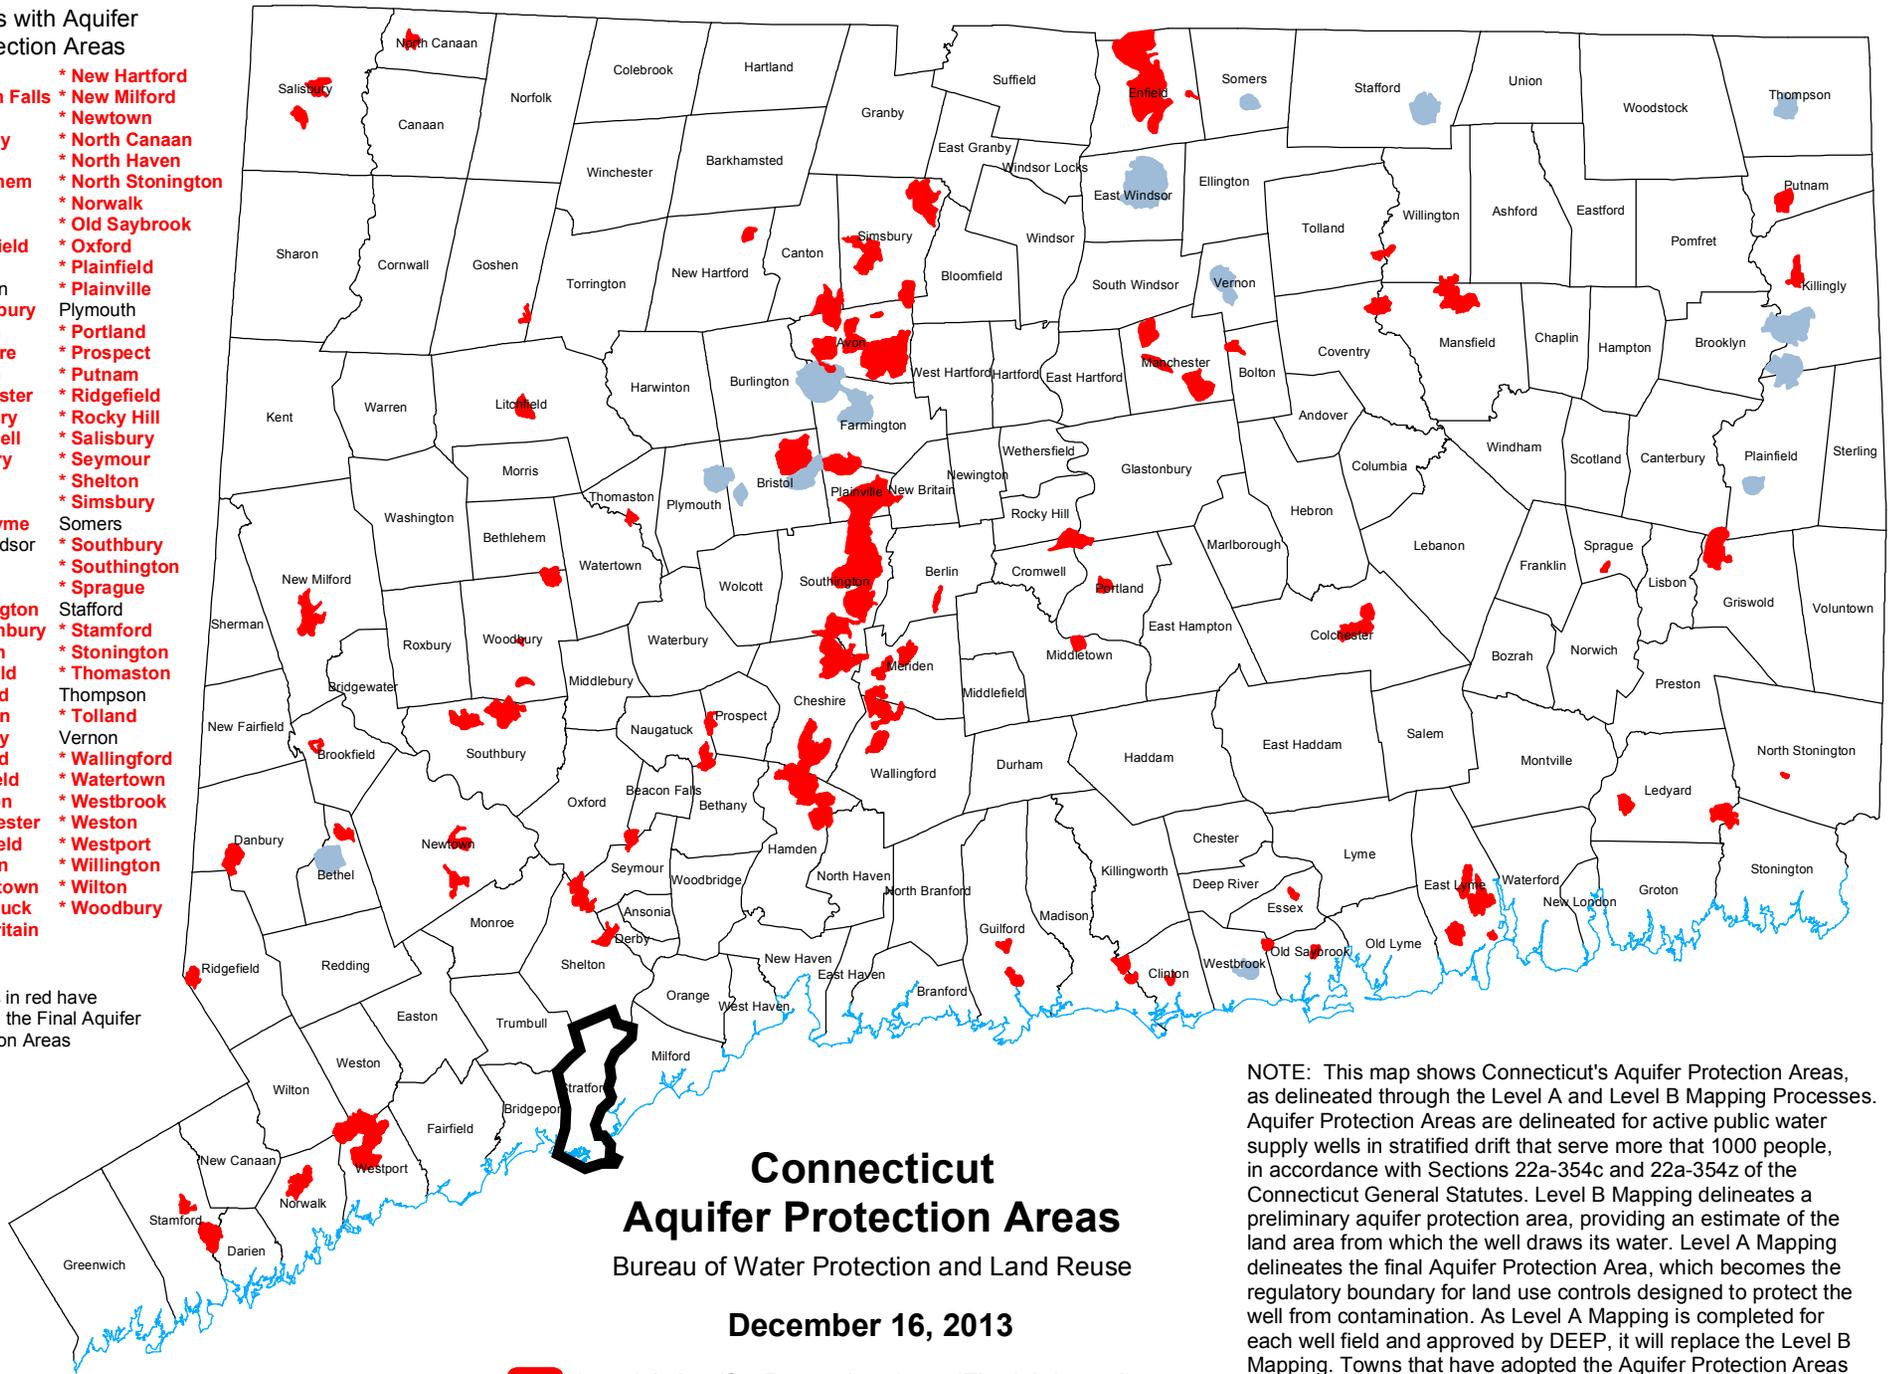
Connecticut Aquifer Protection Areas

* Towns in red have adopted the Final Aquifer Protection Areas

- Item 4 – Connecticut Coastal Boundary Mapping
- Item 5 – Connecticut Aquifer Protection Area Mapping
- Item 6A – Natural Diversity Database Mapping
- Item 6B – U.S. Fish and Wildlife, Information Planning and Conservation List
