# **ENVIRONMENTAL REVIEW REPORT**

**Community Development Block Grant – Disaster Recovery  
Owner Occupied Rehabilitation and Rebuilding Program**

**13 Blair Street  
Milford, Connecticut**

**Diversified Technology Consultants  
2321 Whitney Avenue  
Hamden, Connecticut 06518**

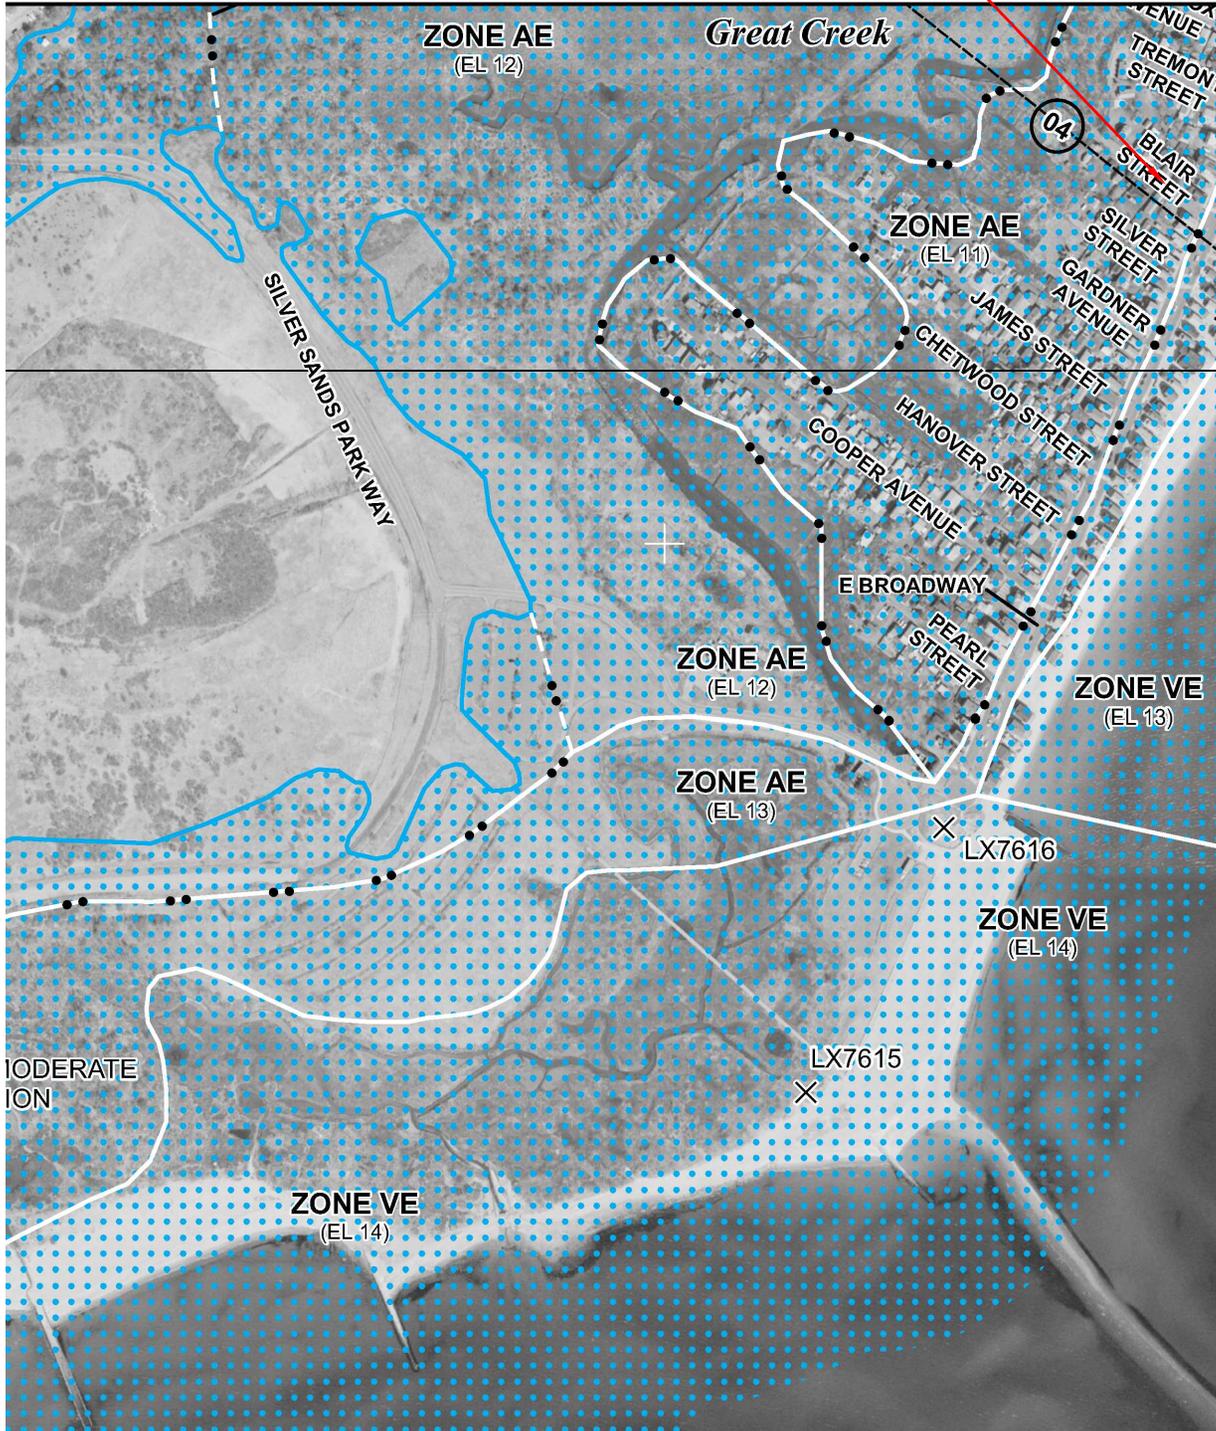
MAP SCALE 1" = 500'

This is an official copy of a portion of the above referenced flood map. It was extracted using F-MIT On-Line. This map does not reflect changes or amendments which may have been made subsequent to the date on the title block. For the latest product information about National Flood Insurance Program flood maps check the FEMA Flood Map Store at [www.msc.fema.gov](http://www.msc.fema.gov)

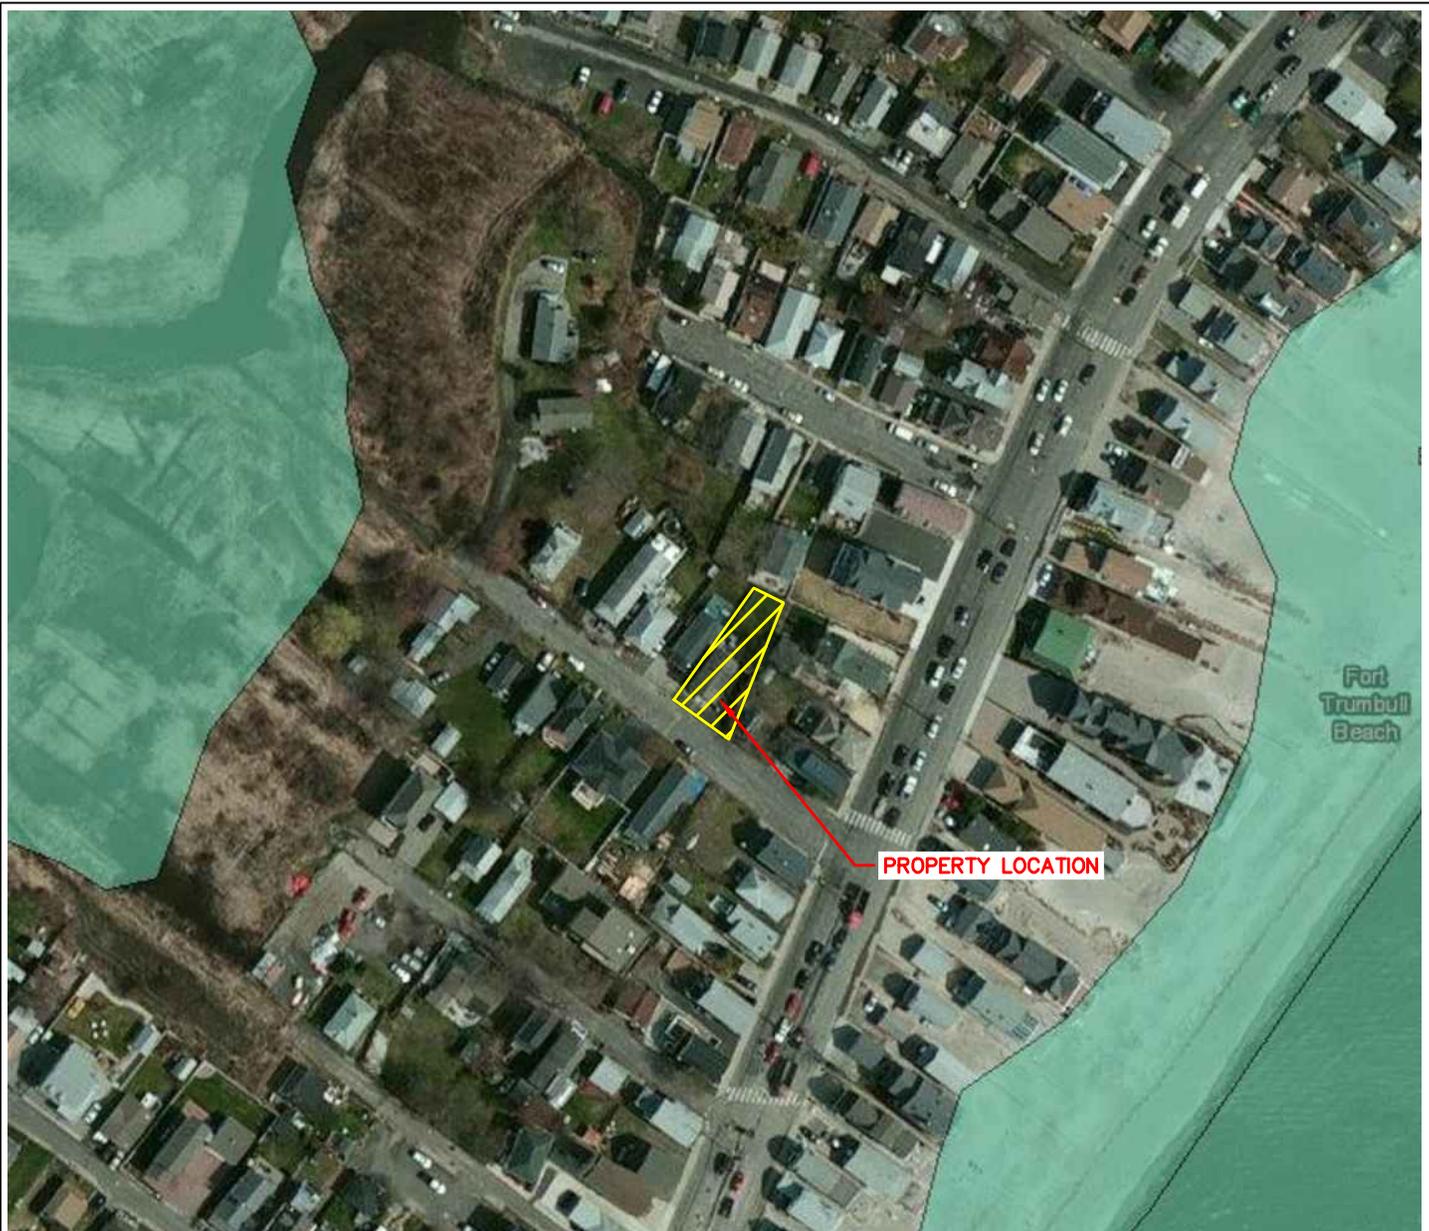
ATTACHMENT 2  
 WETLANDS MAP

**Wetlands**

Estuarine and Marine Deepwater
	Estuarine and Marine Wetland
	Freshwater Emergent Wetland
	Freshwater Forested/Shrub Wetland
	Freshwater Pond
	Lake
	Other
	Riverine

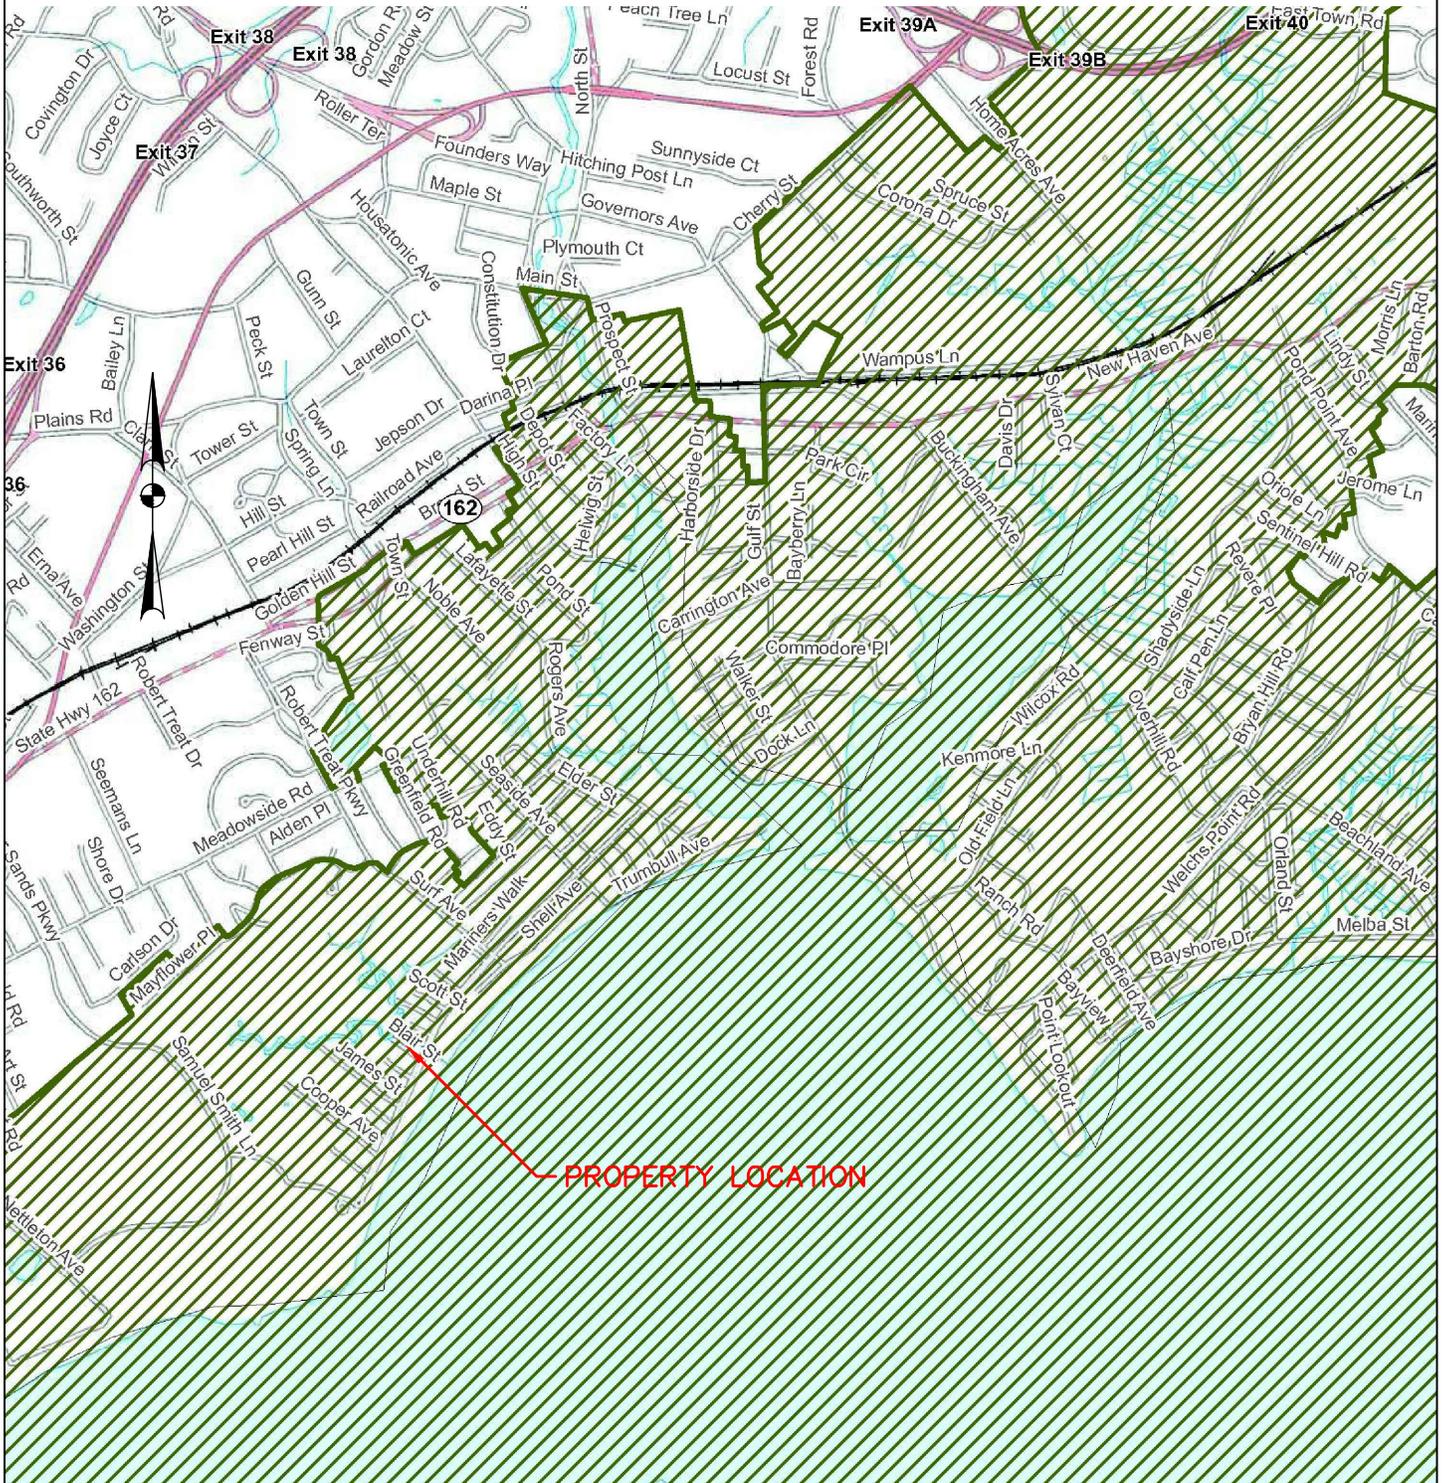
Coastal Boundary

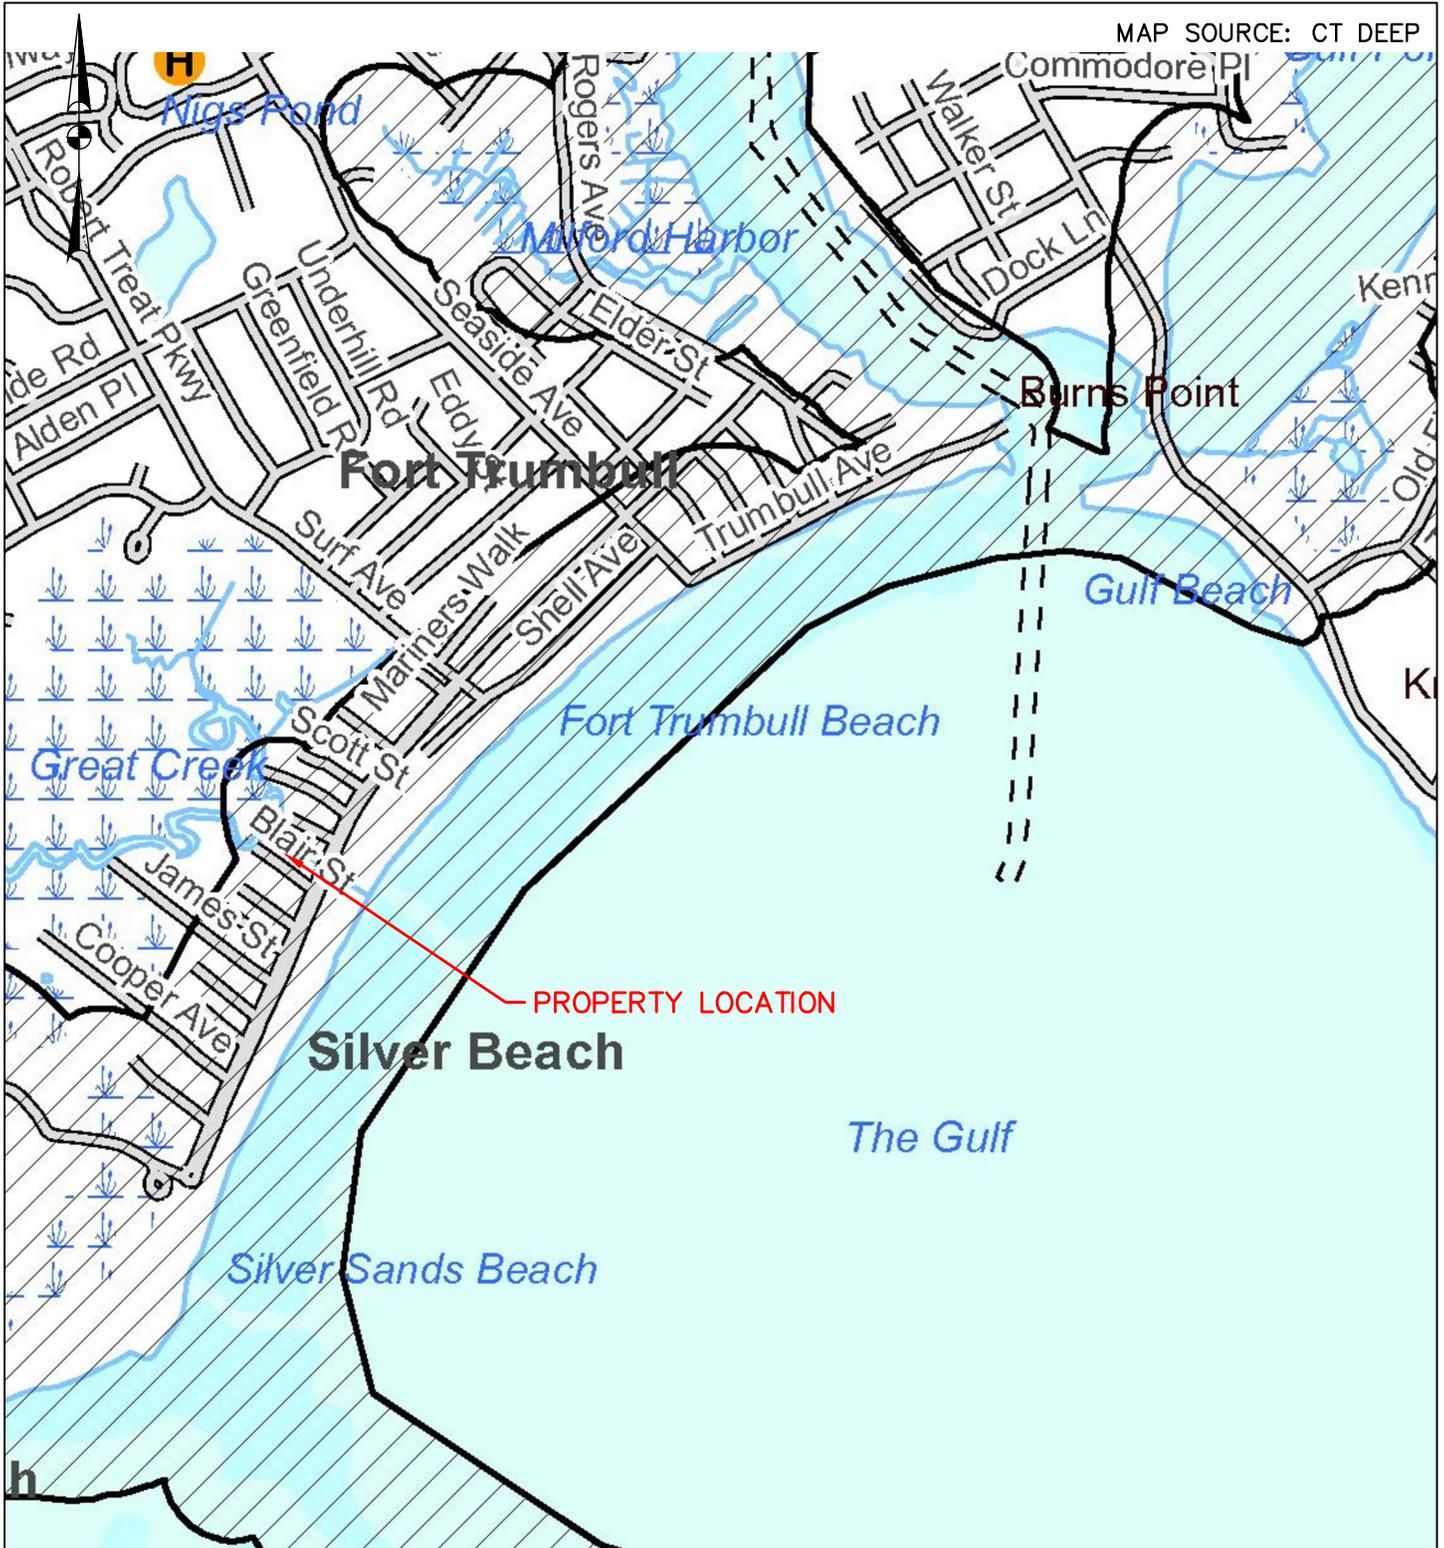
State and Federal Listed Species and Significant Natural Communities\*

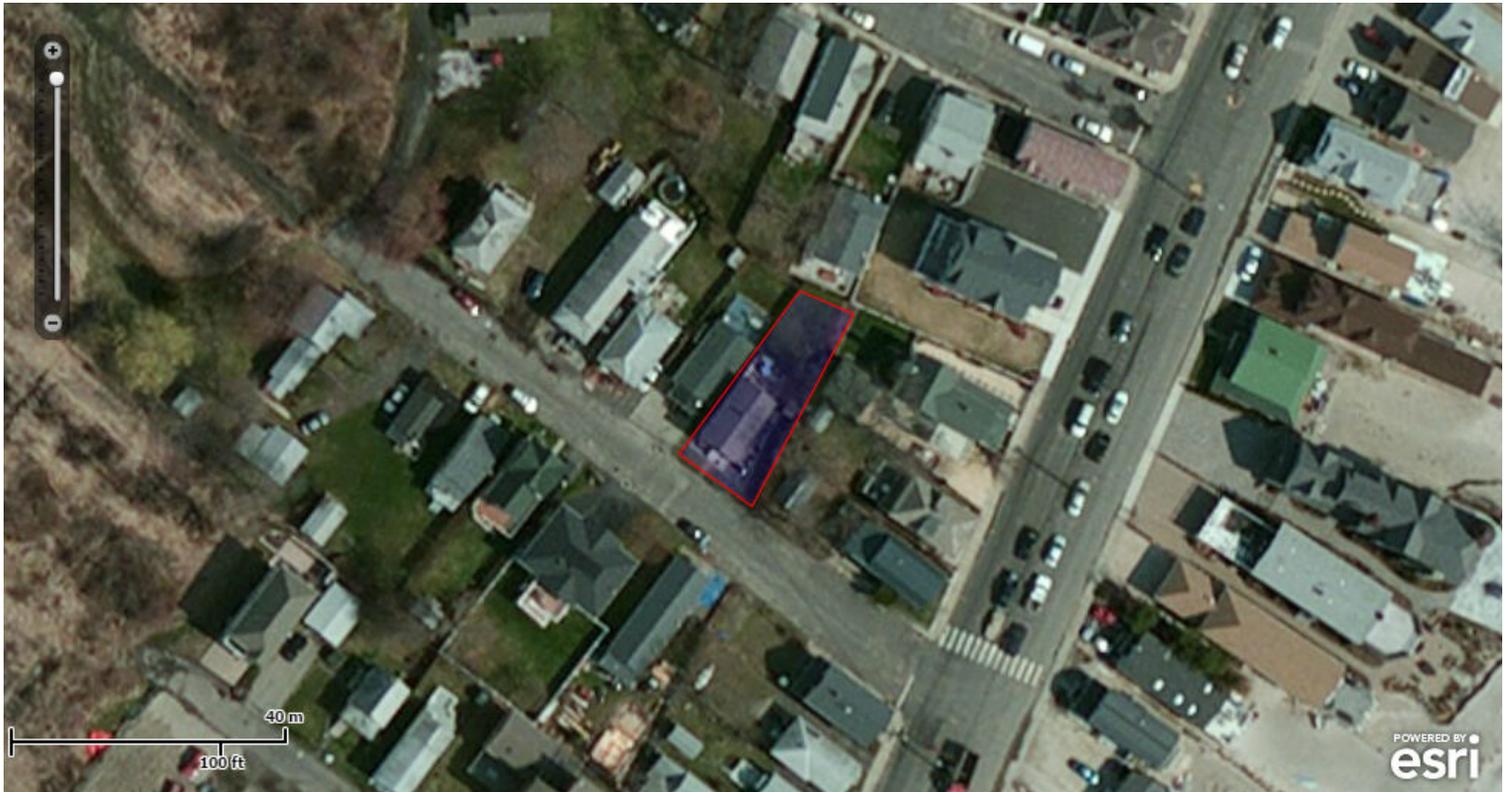
### Project Location Map:

**Project Coordinates:** MULTIPOLYGON (((-73.0630153 41.2050574, -73.0629215 41.2050272, -73.0630986 41.204775, -73.063225 41.2048436, -73.0630153 41.2050574)))

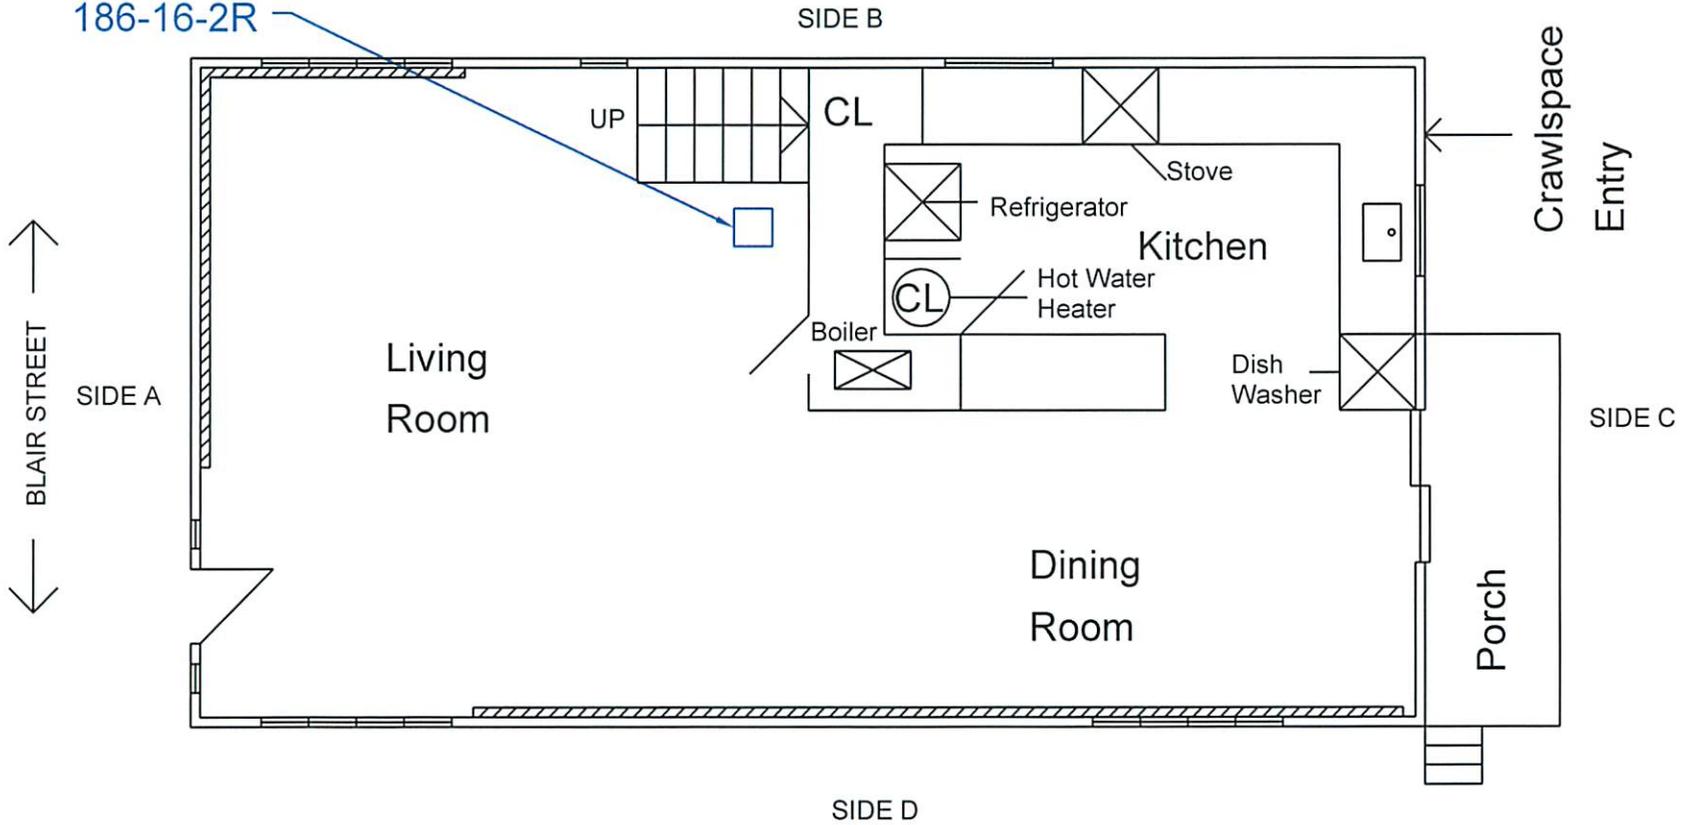
RADON AIR SAMPLE LOCATION DRAWING

186-16-1R  
 186-16-2R

#R Radon Air Sample Location
