**RE: Environmental Assessment Report  
Department of Housing  
CDBG-DR – Sandy Disaster Recovery Program  
16 Little Street  
Bridgeport, Connecticut 06413  
Application #1732  
Eagle Project No. 15-015.10T4**

This assessment and report is intended to satisfy the review process of the National Environmental Policy Act (NEPA) Statutory Checklist Sections 13C (Lead-Based Paint), 13D (Asbestos), 13E (Radon) and 13F (Mold).

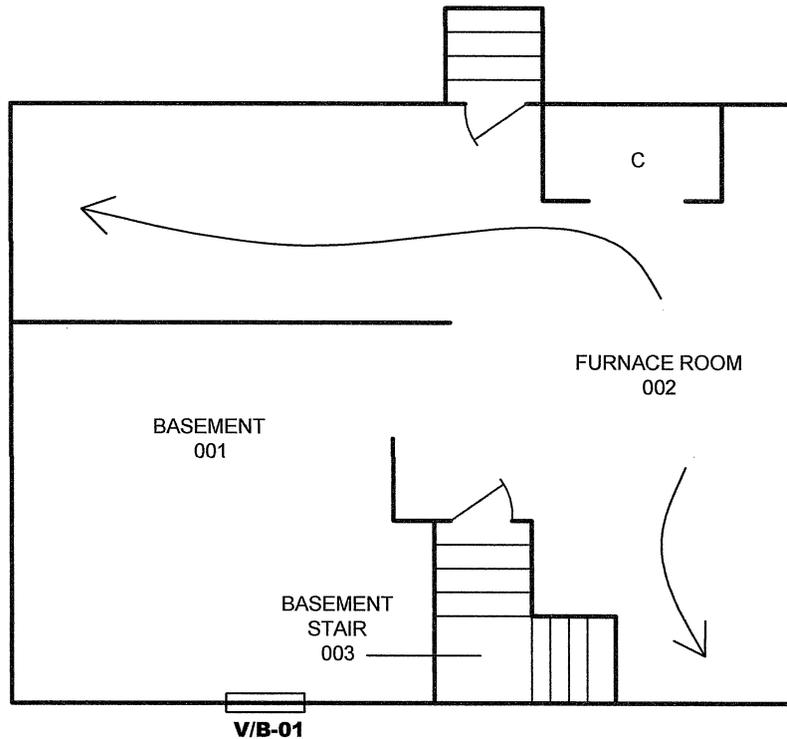
**BASEMENT PLAN**

= INACCESSIBLE  
(PHOTO TAKEN)

C = CLOSET EVALUATED  
WITH ADJACENT ROOM

FP-1 BASEMENT PLAN  
FP-2 FIRST FLOOR PLAN  
FP-3 SECOND FLOOR PLAN

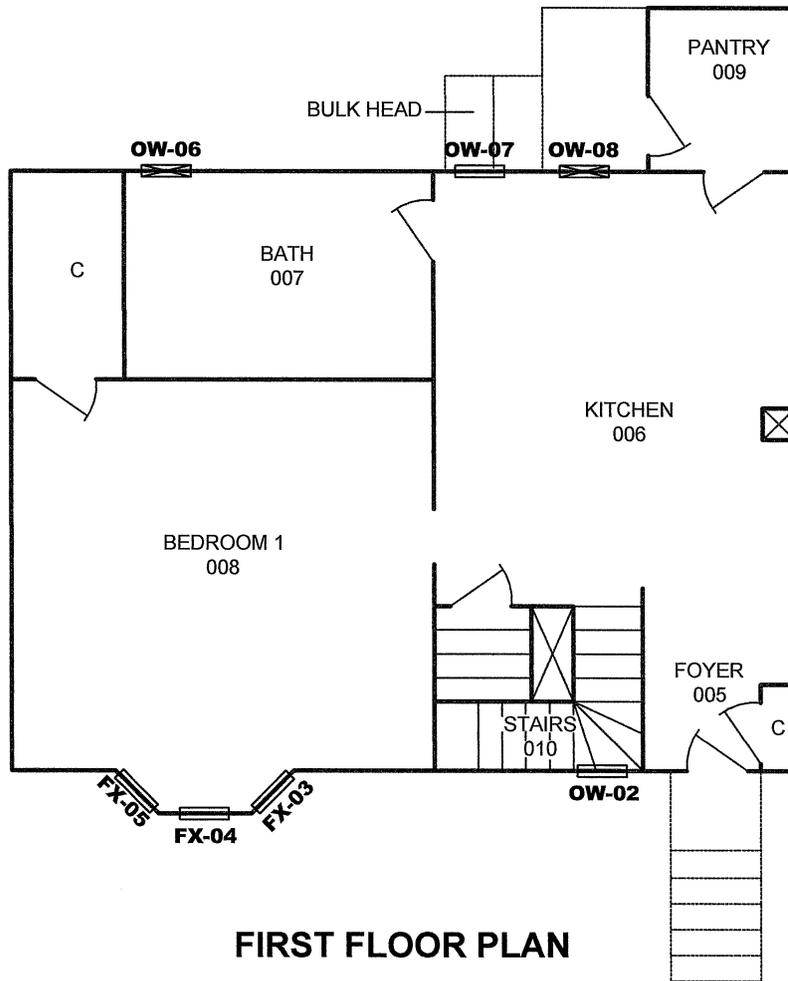
**FIRST FLOOR PLAN**

= INACCESSIBLE (PHOTO TAKEN)

C = CLOSET EVALUATED WITH ADJACENT ROOM

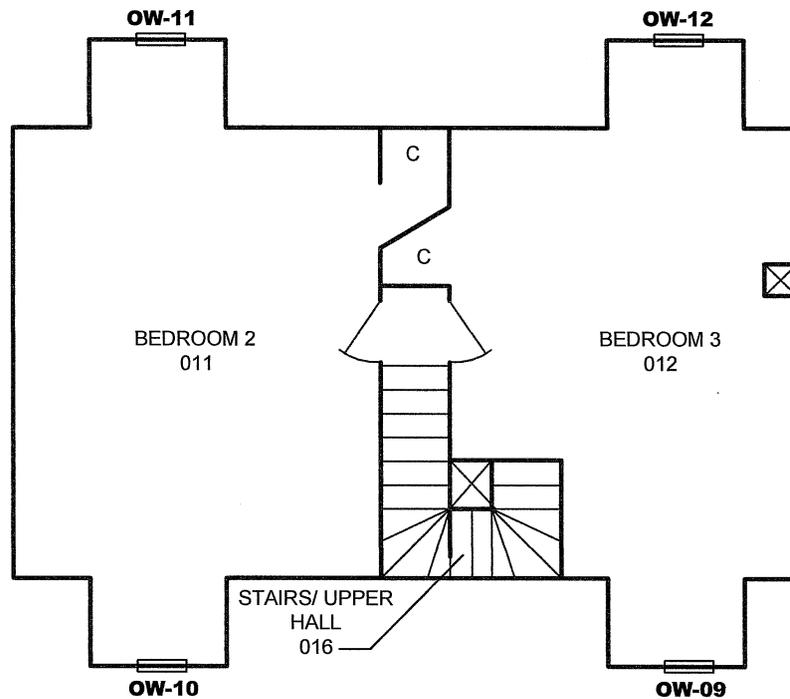
**SECOND FLOOR PLAN**

C = CLOSET EVALUATED  
WITH ADJACENT ROOM
