# EXTERIOR RESTORATION AND RELATED WORK FOR

# SEDGWICK MIDDLE SCHOOL

MARCH 6, 2020

**ELEVATIONS ABATEMENT**

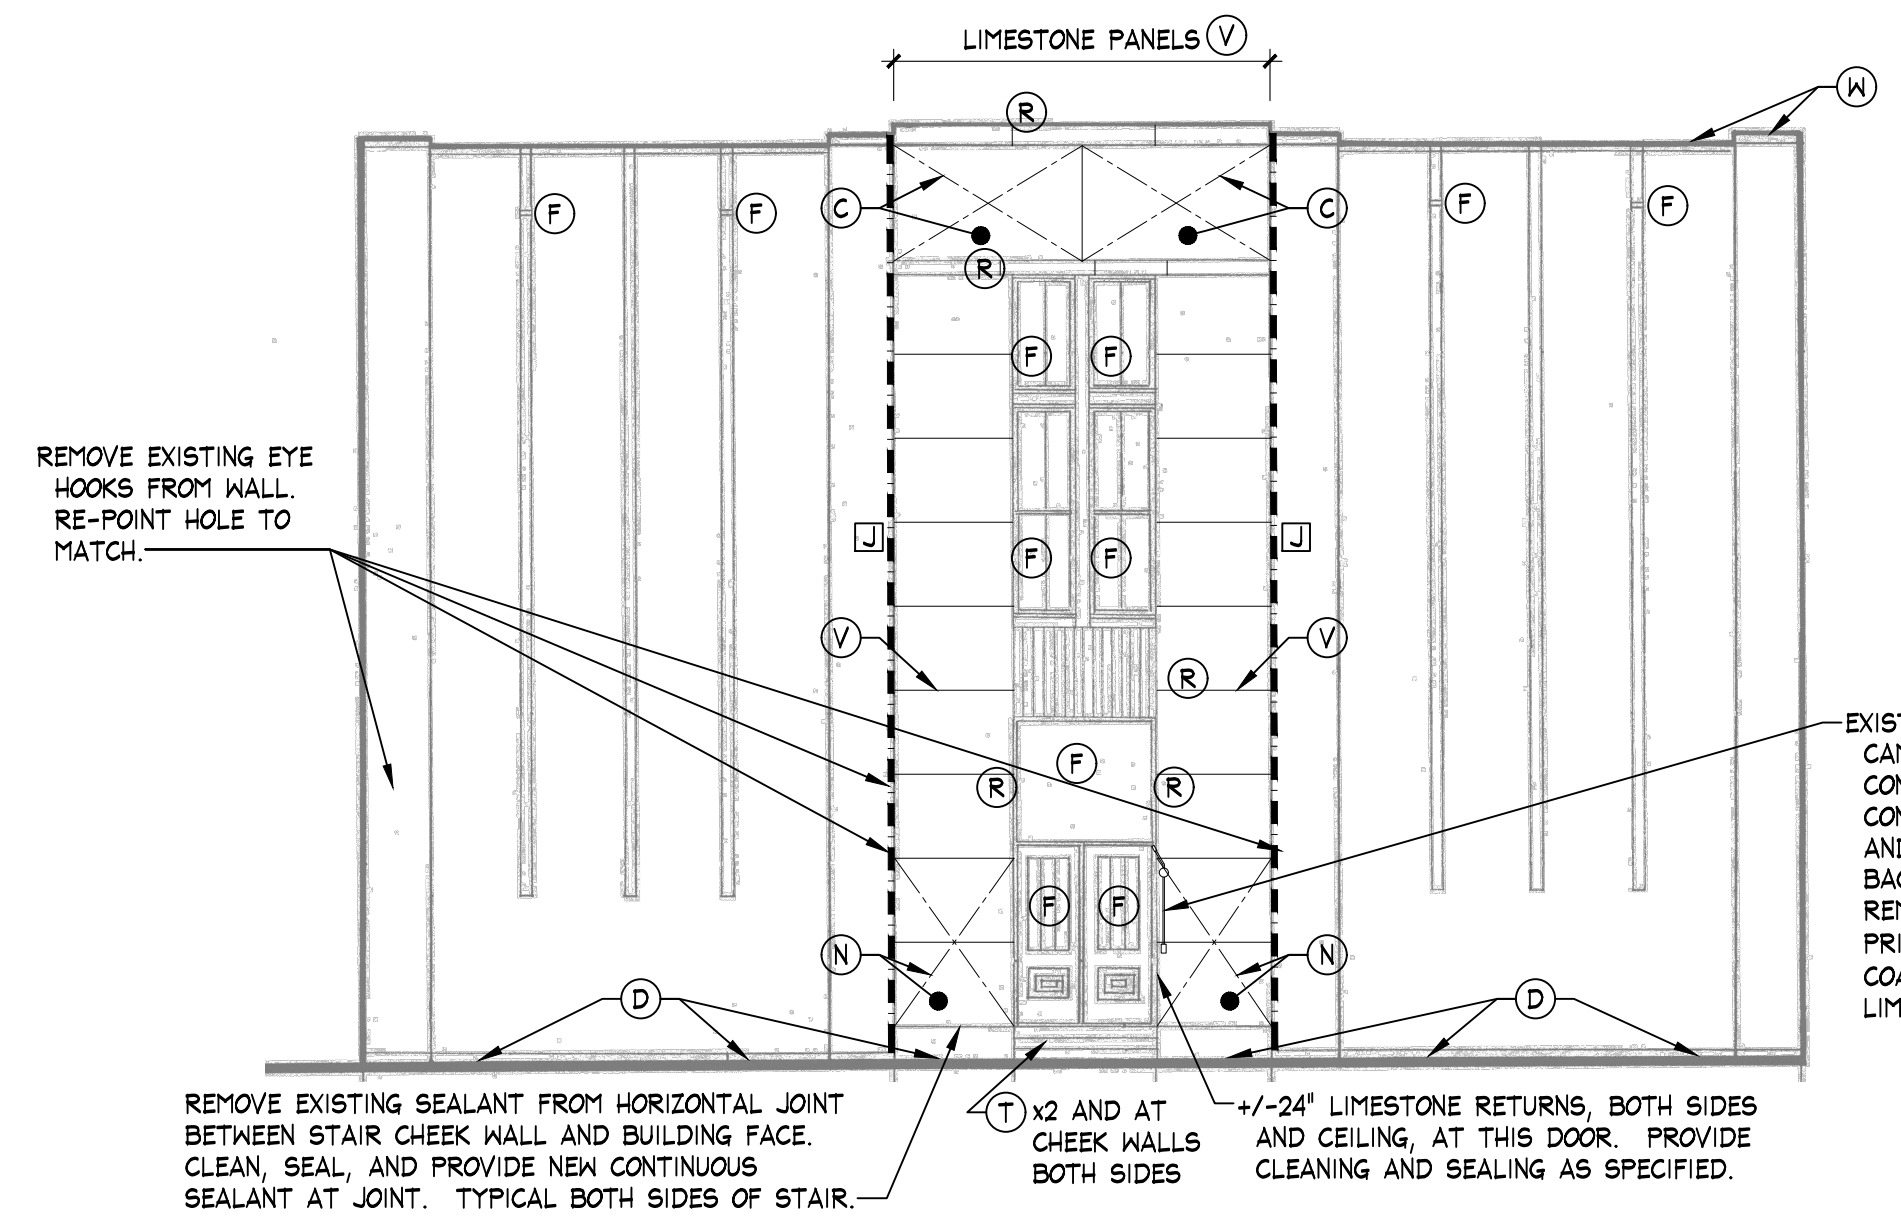
**3 PARTIAL SOUTH ELEVATION**  
SCALE: 1/8" = 1' - 0"

EXISTING SECURITY CAMERA, WIRE CONNECTION, AND JUNCTION BOX TO REMAIN. REMOVE EXISTING SEALANT AT BUILDING FACE. PROVIDE NEW CONTINUOUS SEALANT AT BUILDING FACE.

EXISTING SECURITY CAMERA, METAL CONDUIT, ACCESS CONTROL READER, AND ASSOCIATED BACK BOXES TO REMAIN. PROVIDE PRIME AND PAINT (2 COATS) TO MATCH LIMESTONE PANELS.

REMOVE EXISTING SEALANT FROM HORIZONTAL JOINT BETWEEN STAIR CHEEK WALL AND BUILDING FACE. CLEAN, SEAL, AND PROVIDE NEW CONTINUOUS SEALANT AT JOINT. TYPICAL BOTH SIDES OF STAIR.

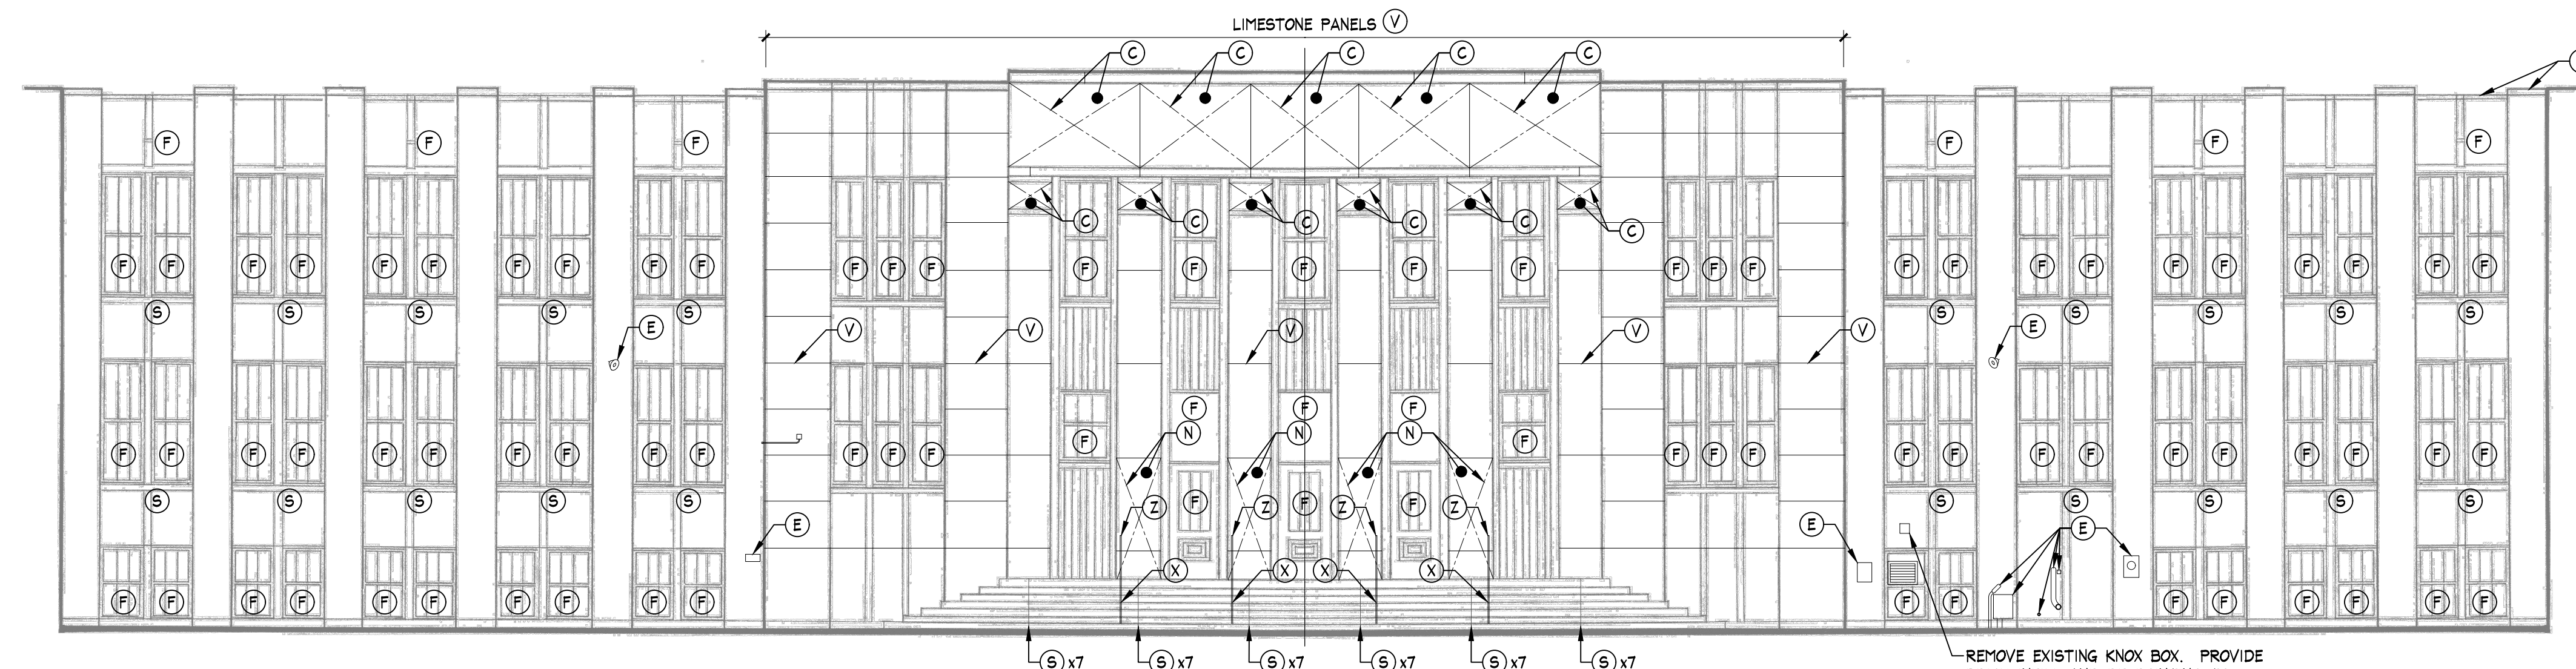
**1 PARTIAL SOUTH ELEVATION**  
SCALE: 1/8" = 1' - 0"

CEILING OF ENTRANCE PORTICO IS LIMESTONE. PROVIDE CLEANING AND SEALING AS SPECIFIED. EXISTING LIGHT FIXTURES TO REMAIN. REMOVE EXISTING SEALANT AT CEILING FACE. PROVIDE NEW CONTINUOUS SEALANT AT CEILING FACE.

TYPICAL BACKS AND SIDES OF ALL FOUR (4) COLUMNS AND ALL FOUR (4) PILASTERS TO THE HEIGHT INDICATED ON ELEVATION.

SEAL ENTIRETY OF GRANITE SURFACES OF STEPS AND PORTICO WITH SEALER AS SPECIFIED.
