Mechanical and Electrical Systems
Existing Conditions Narrative

Regional School District 13
Korn Elementary School
Durham, CT

Date: March 26, 2014

Prepared by:
Consulting Engineering Services, Inc.
811 Middle Street, Middletown, Connecticut 06457
CES PN 2013224.00

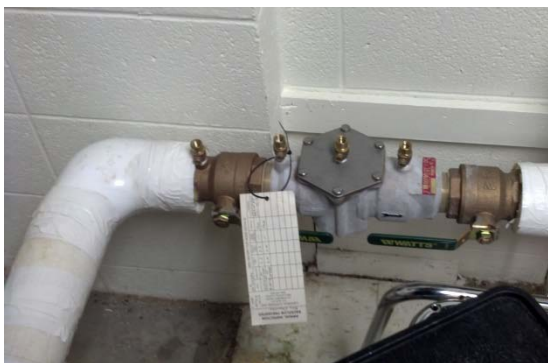
1. **Domestic Water:** The building is provided with a domestic water service that enters the building on the northeast corner. The service entrance incorporates an isolation valve, reduced pressure backflow preventer and water hammer arrestors. This service is supplied by a well water system. There are three wells located on the School campus. All three wells are piped to a domestic water pumping station located within a concrete vault near the High School. All wells are metered and manifolded together and discharge into a 15,000 gallon atmospheric tank. Outlet from the atmospheric tank is connected to a tri-plex water pump station. Pump discharges to a 5,000 gallon hydromatic tank. Both hydromatic tank and atmospheric tank bulkhead into the buried vault. System incorporates pump controls, well pump master control station and air compressor. The atmospheric tank has recently been relined. There are leaks developing at the hydro-tank where it penetrates the concrete vault. All components of the system have been installed to meet the requirements of the State of CT Department of Public Health for a central drinking water distribution system. This equipment is in good condition.

Existing Backflow Preventer

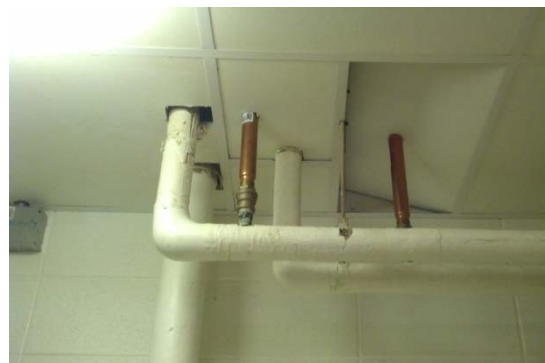
Existing Water Hammer Arrestors

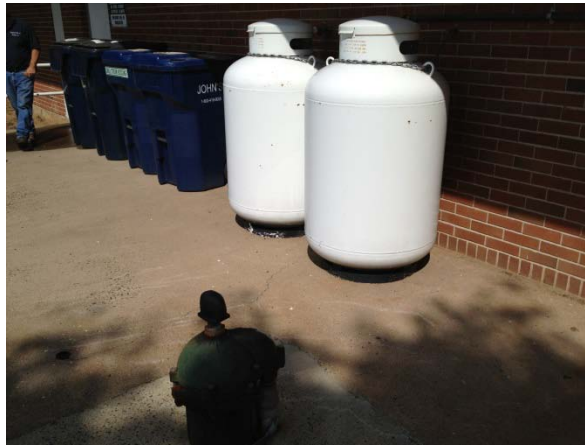
2. Propane Tanks: The building is currently served by two above ground propane tanks located on the south side of the building. The tanks have approximately 80 gallons of storage and their age is unknown. The propane tanks serve the kitchen and are in good condition.

Existing propane tanks

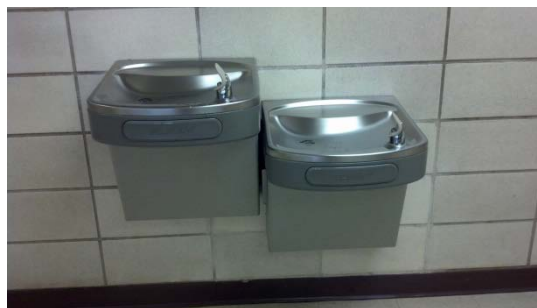
1. Water closets are wall mounted vitreous china with manual 1.6 GPF flush valves. The fixtures are in good condition and ADA compliant fixtures are provided.
2. Urinals are wall hung, vitreous china, with manual 1 GPF flush valves. The fixtures are in good condition and ADA compliant fixtures are provided.
3. Lavatories are wall hung vitreous china .5 GPM with single lever type faucets. ADA lavatories are provided with insulation wrap for exposed piping below fixture. The fixtures are in good condition and ADA compliant fixtures are provided.
4. Drinking fountains are wall mounted stainless steel water coolers. Some units are single bowl and some are bi-level double bowl units. Most units are in good condition and ADA compliant fixtures are provided.

Existing Electric Water Coolers

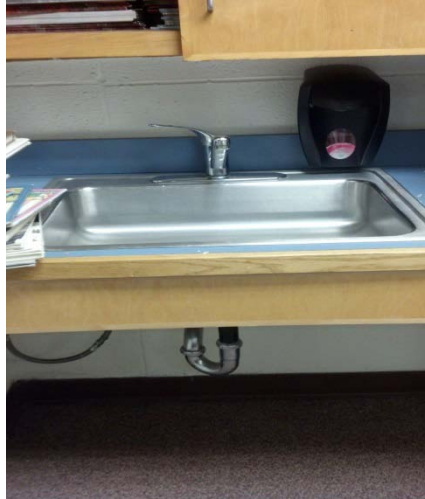
- Classroom sinks are stainless steel sinks with single lever faucets. These sinks are in good condition and are ADA compliant in some locations.

Existing ADA Sink

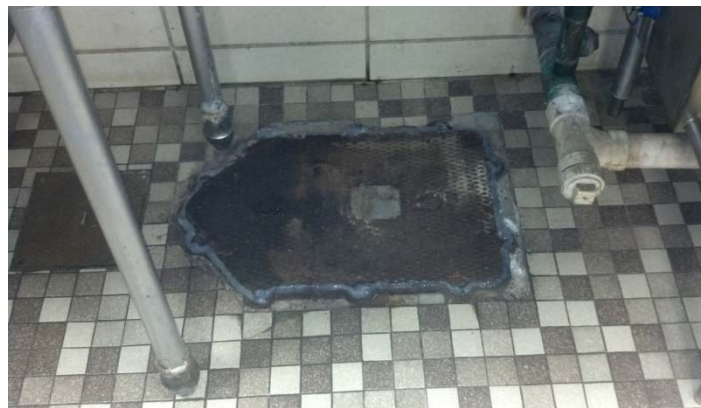
- Janitor sinks are floor mounted mop basins with two lever faucets. Faucets have integral vacuum breakers. Chemical shot feeders are provided in some custodial closets. These sinks are in good condition.
- The Kitchen has a point of use passive type grease interceptor recessed in the floor that serves the existing dishwasher. The grease interceptor cover has been silicone caulked to seal sewer gases. There are no grease interceptors at the existing three pot sink. If there is actual cooking being done and this is not a warming kitchen, a grease interceptor may be required on the three-bay sink. The actual size is based on the number of meals served per day. The silicone caulk on the existing grease interceptor indicates that the seal is compromised and should be replaced.

Existing Passive Grease Interceptor

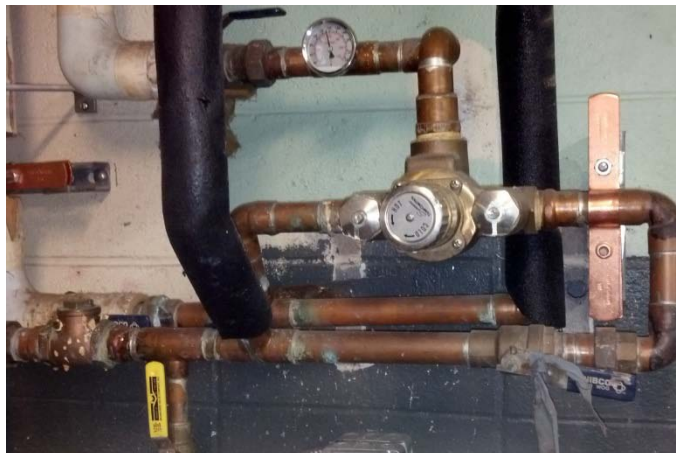
Existing Thermostatic Mixing Valve

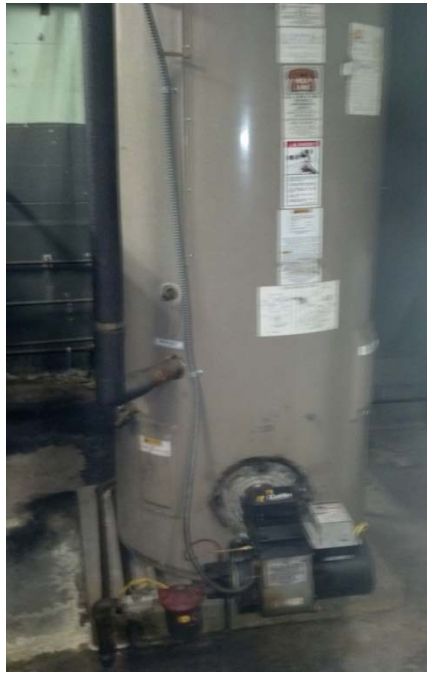
1. Domestic Hot Water System: The Schools domestic hot water is generated by an oil-fired water heater. The water heater is as manufactured by AO Smith, Model COF-199-934, rated 199,000 BTU/HR output. This water heater was installed in 2004. The existing domestic hot water system also incorporates a re-circulating pump, isolation valves and a thermostatic mixing valve. Hot water storage temperature is approximately 140 deg. F. A 140 deg. F. hot water loop is provided to serve the kitchen fixtures and does not incorporate a thermostatic mixing valve. A 110 deg. F. hot water loop serves all other plumbing fixtures throughout the building and incorporates a thermostatic mixing valve. The existing domestic hot water system is in good condition.

Existing Oil Fired Water Heater

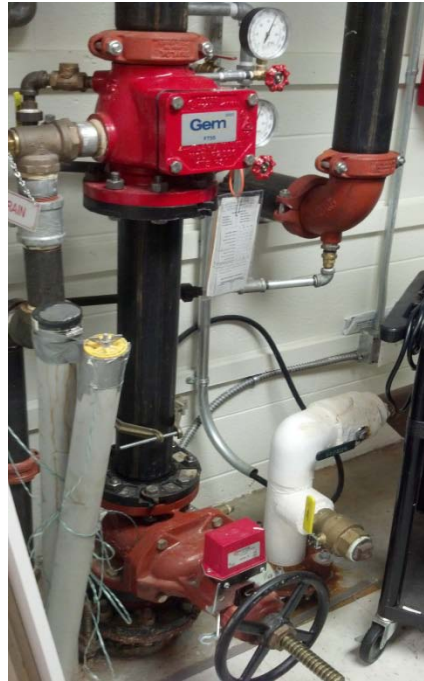
1. The building is currently served by a 6-inch fire protection service and enters the building at the northeast side of the building. The service equipment located within the building incorporates a single alarm valve riser, monitored isolation valve, gauges, bells and drains. The 6-inch main is supplied by a 36,000 gallon on site water storage tank and electric fire pump located within a buried vault. The service equipment located within the vault consists of a 750 GPM, 180psi, 120 HP electric fire pump, jockey pump, controllers, auto transfer switch, test loop, fire department connection, isolation valves, tamper switches and pressure regulating valve. The existing equipment is in fair condition.

Existing Fire Service Riser

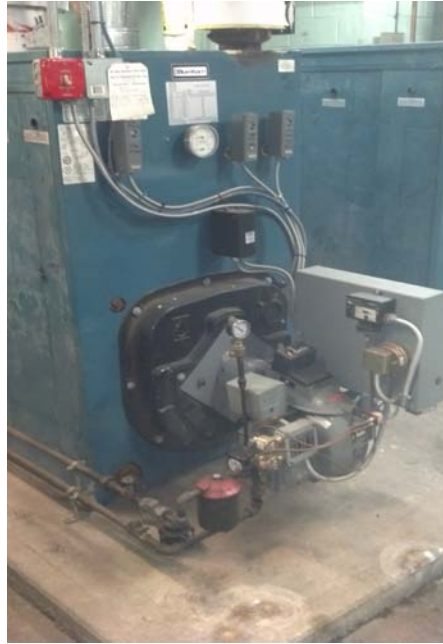
1. The building is served by (2) Burnham oil fired hot water boilers that were installed during the most recent renovation. This equipment is in good condition.

Existing Boiler

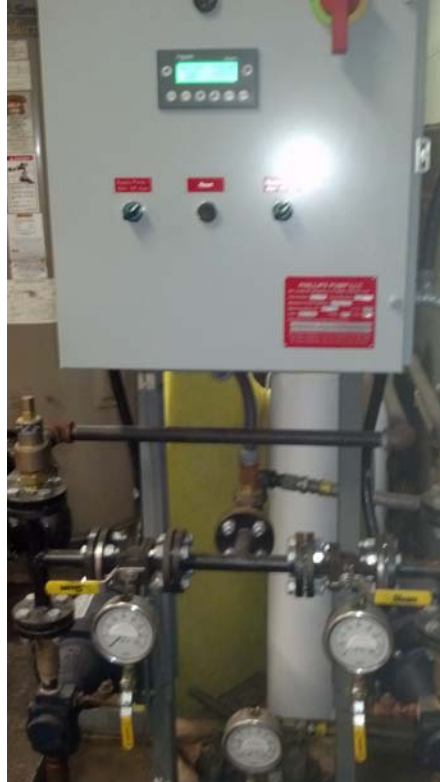
- Fuel oil is stored in a 12,500 gallon underground fuel oil storage tank. Duplex fuel oil transfer pumps are located in the boiler room providing oil to the boilers and the domestic hot water heaters. The entire fuel oil transfer system is provided with a leak detection system. The fuel oil transfer system is approximately two (2) years old and is in very good condition.

Fuel Oil Pumps

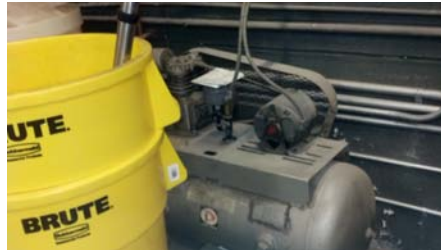
1. The building systems are controlled by a Siemens direct digital control system that is approximately ten (10) years old. This system is in good condition. Region 13 personnel noted that there are currently no issues with the control system.

Control System Compressor

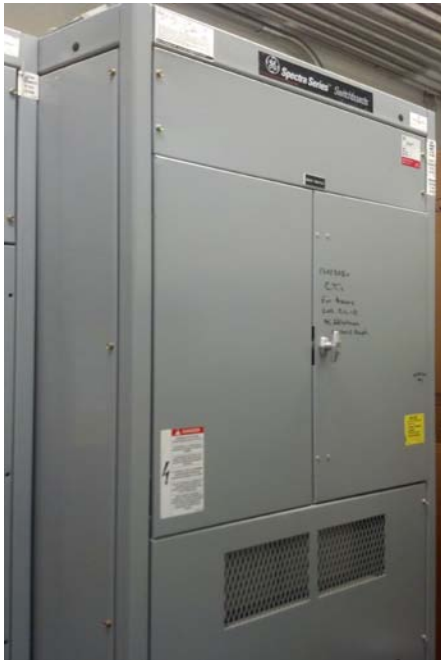
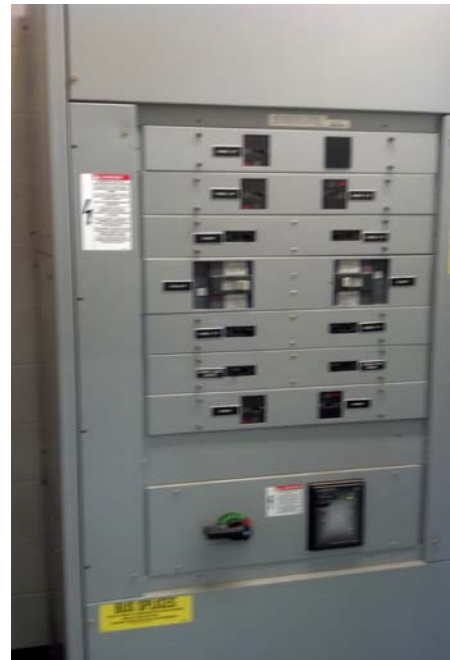
1. The building is served by a 1600A, 208/120V, 3-phase, 4-wire, main electrical service with circuit breaker distribution, CT compartment and integral TVSS. The main switchboard is located in the Main Electrical Room. This equipment is (10) years old and in good condition.

Main Electrical Switchgear

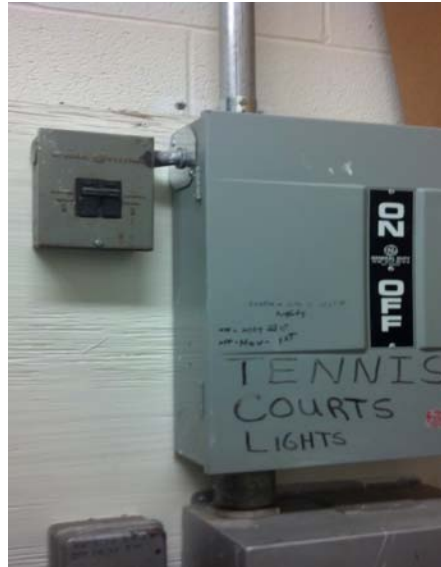
-
2. The primary electrical service is fed from a pad mounted utility company transformer located behind the school.
3. The adjacent tennis courts are powered from this facility.

Tennis Court Disconnect Switch

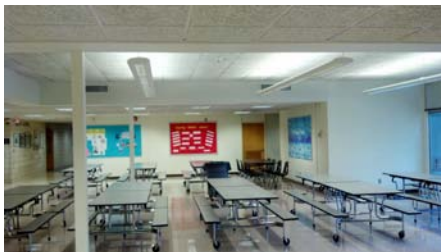
6. Lighting throughout the facility consists of a number of type of light fixtures including surface mounted 2x2 acrylic lensed fixtures, recessed acrylic lensed fixtures, recessed parabolic fixtures, fluorescent hi-bay fluorescent fixtures in the Gymnasium, and pendant mounted fixtures, etc. All of these fixtures are in good condition, however, new higher efficient types of technology such as LED lighting is now available which should be considered for replacement of existing fixtures to reduce energy consumption.

Pendant Lighting

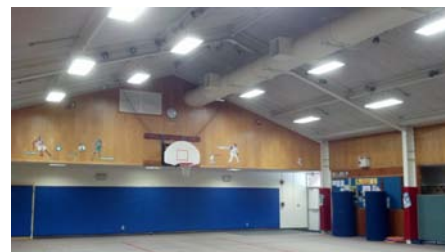
Gymnasium Lighting

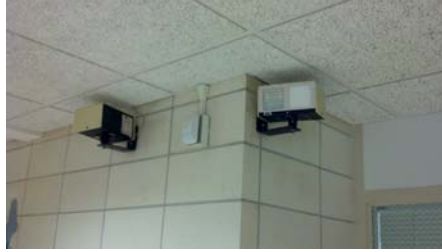
-
-
-
-
-
-
7. Motion detectors have been installed in most of the areas in the building. This equipment is in good working condition.

Typical Motion Detectors

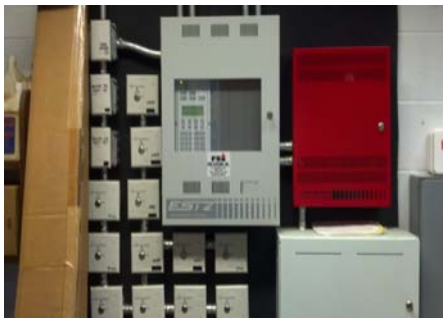
8. The fire alarm system consists of an Edwards EST-2 fire alarm control panel, remote annunciator, and manual fire alarm pull stations and horn strobes, some smoke detectors, and duct smoke detectors. The fire alarm control panel and other peripheral devices are in good condition.

Fire Alarm Control Panel

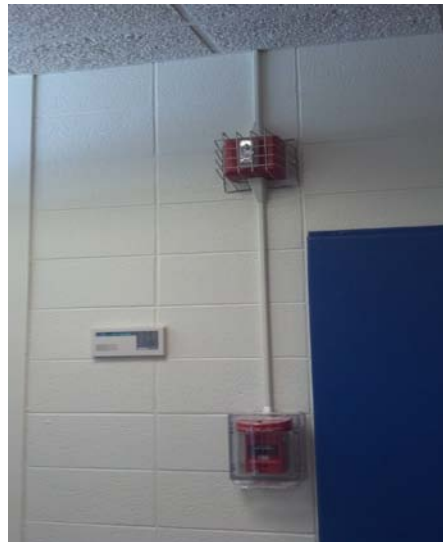
Typical Fire Alarm Pull Station and
Audio-Visual Device

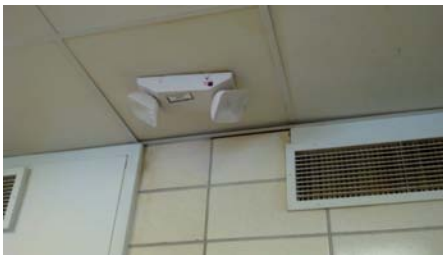
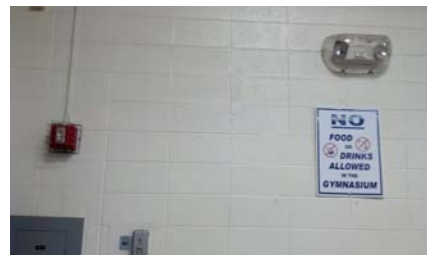
9. The exit signs throughout the building are plastic fluorescent type with integral batteries. These units are in good condition.
10. The emergency lighting in the building consists of self-contained two-head emergency battery units and of using the light fixtures in the specific area fed from the emergency generator as emergency lighting. This equipment is (10) years old and in good condition.

Typ. Emergency Lighting Fixture
