STRUCTURE NO. 03313

I-84 TR 815
over
I-84EB, RTE 72, 372, B&M RR
NEW BRITAIN

Routine & Special Inspection
on
4/22/2014

ROUTINE AND SPECIAL INSPECTION

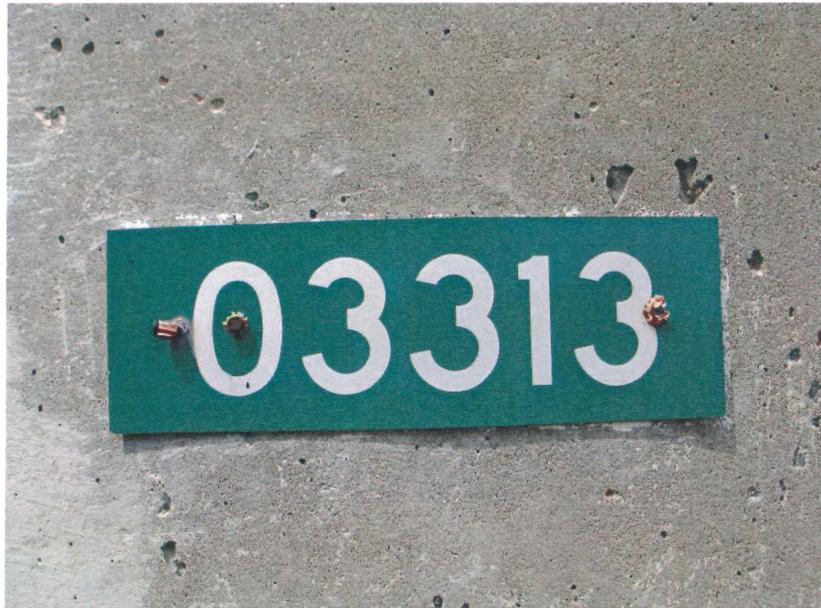
Photo # 1: Bridge Identification Number.

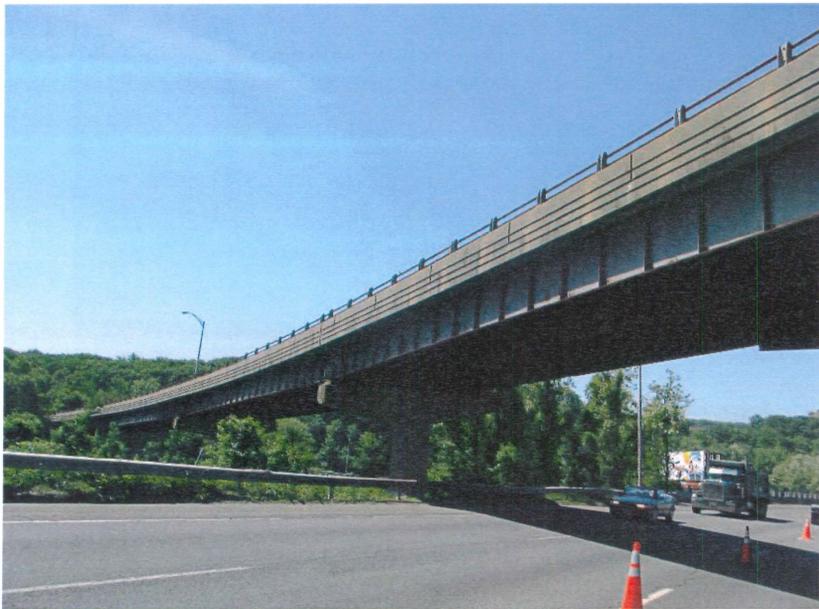
Photo # 3: East elevation.

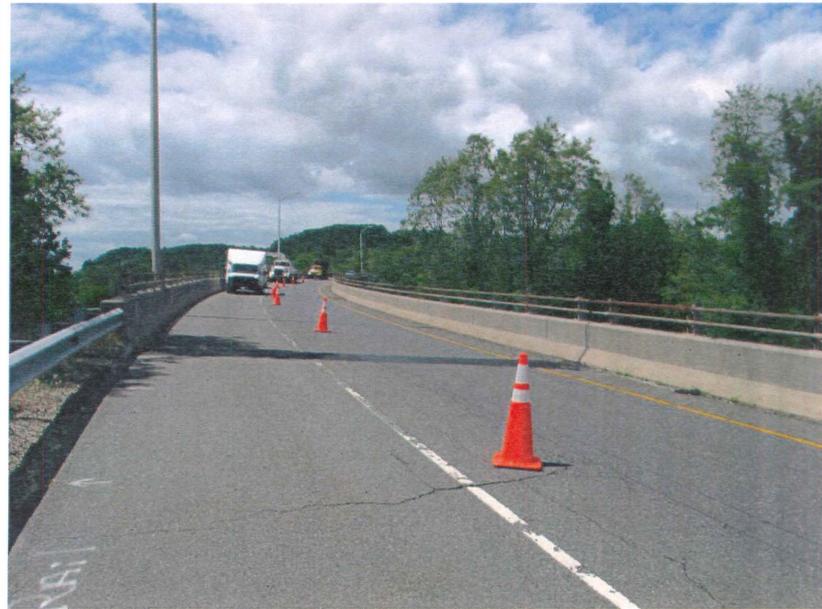
Photo # 4: Bridge from the south approach.

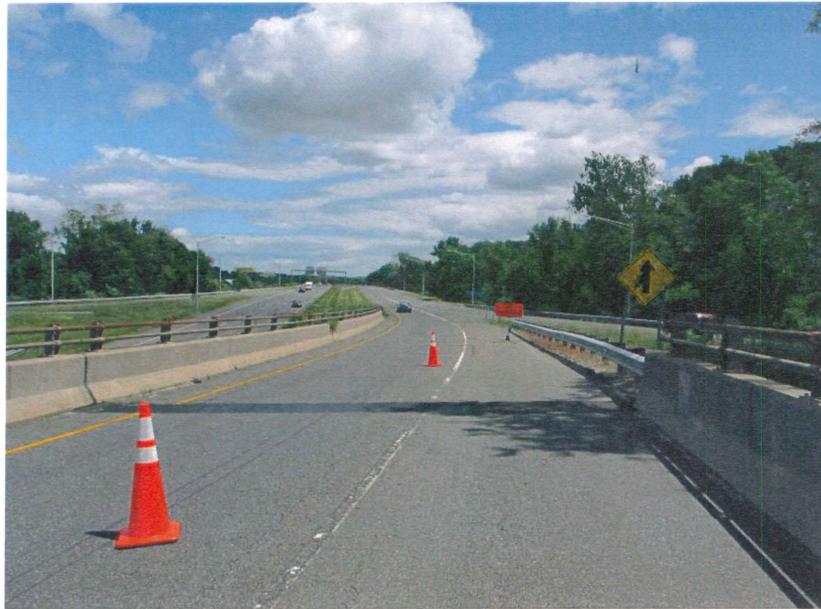
Photo # 5: South approach from the bridge.

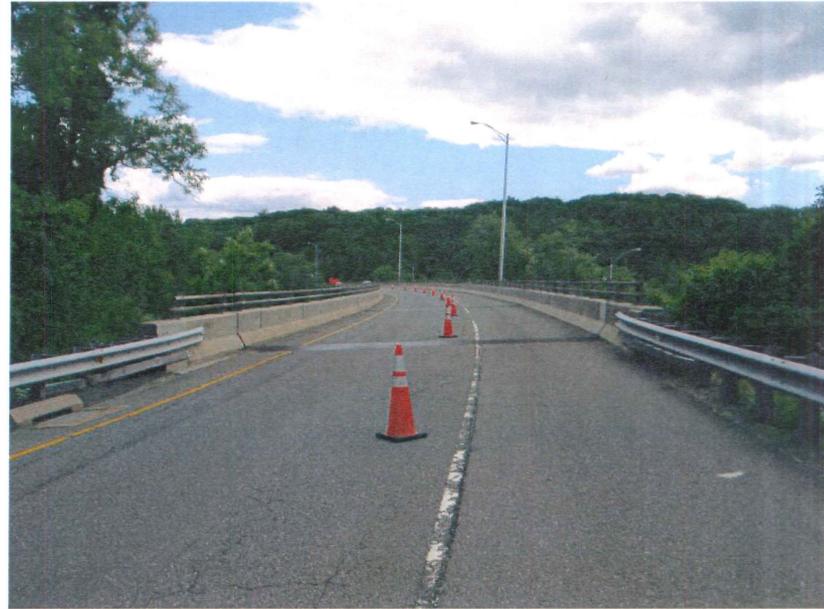
Photo # 6: Bridge from the north approach.

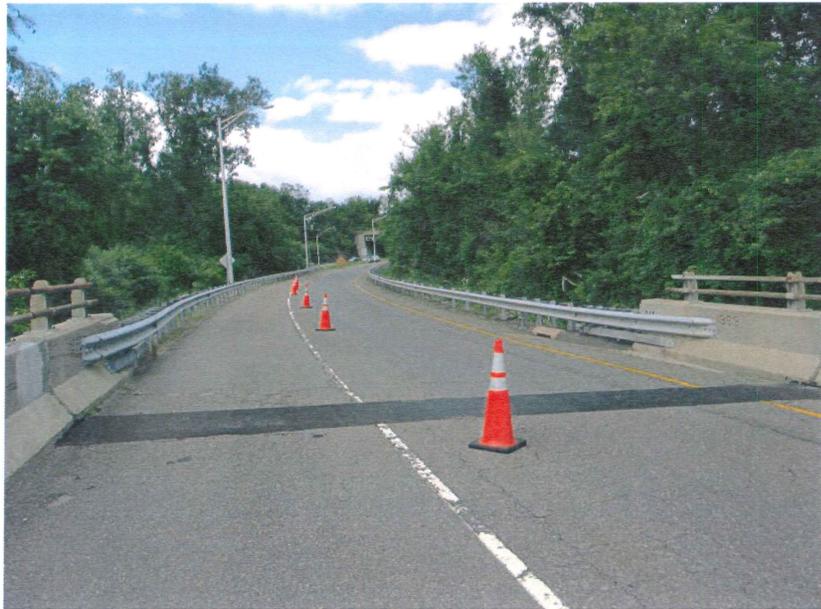
Photo # 7: North approach from the bridge.

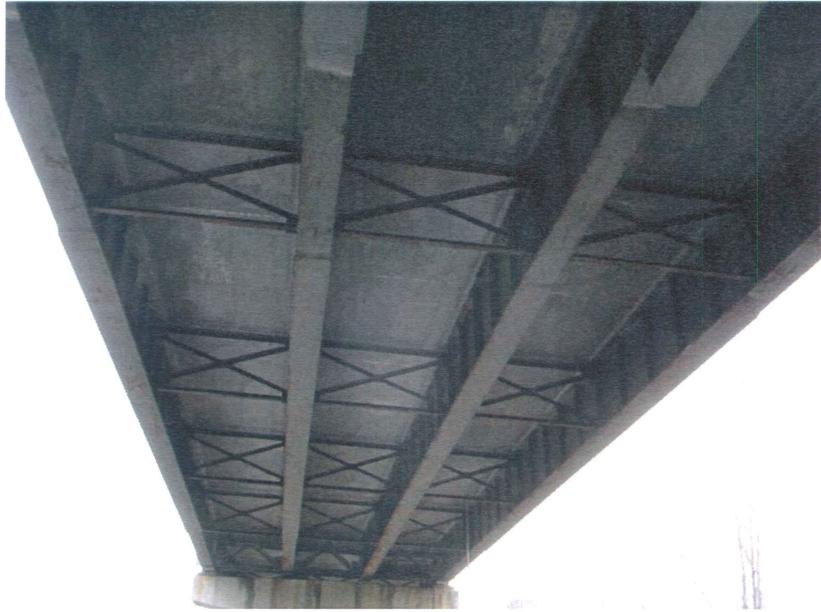
Photo # 9: Underside of the deck and framing in Span 2.

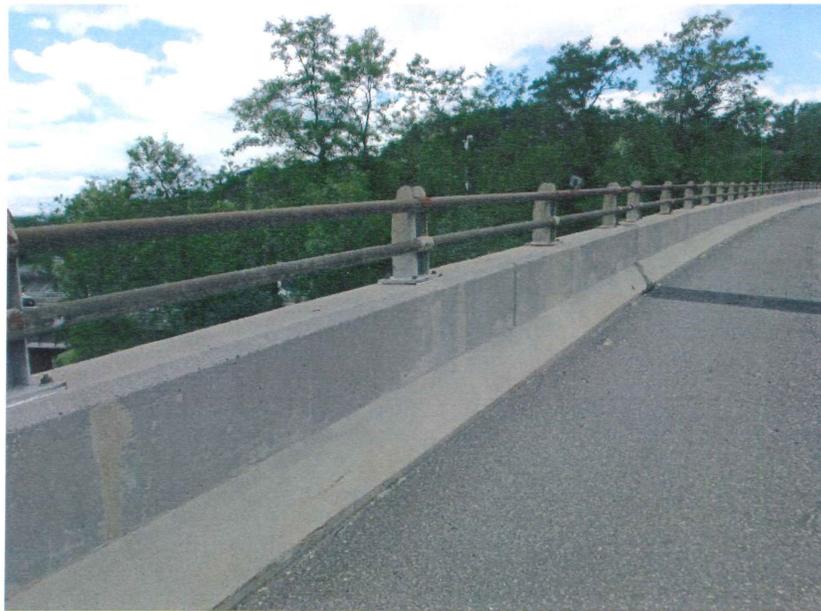
Photo # 11: Curb, parapet and railing along the west fascia in Spans 6, 7 and 8.

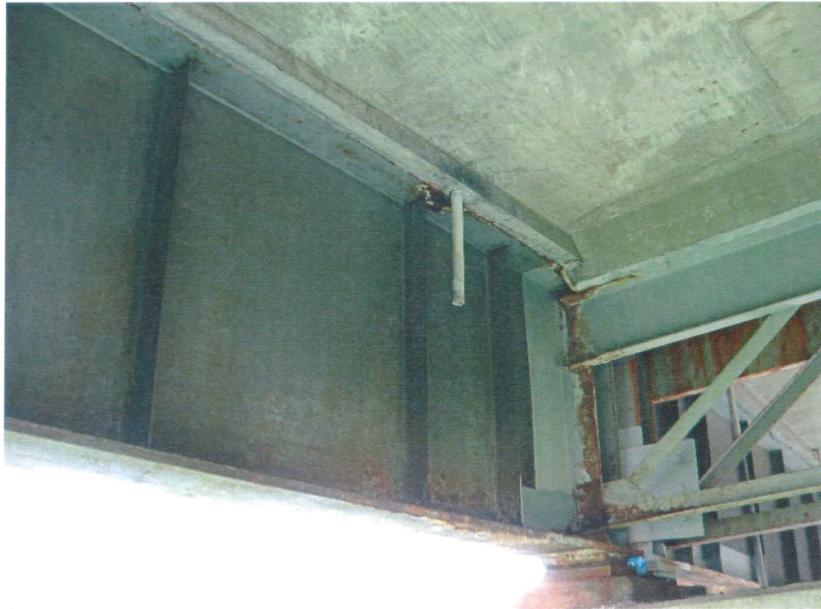
Photo # 15: West side of Girder G4 near Pier 6 in Span 7. Note the short weep pipe draining on the steel.

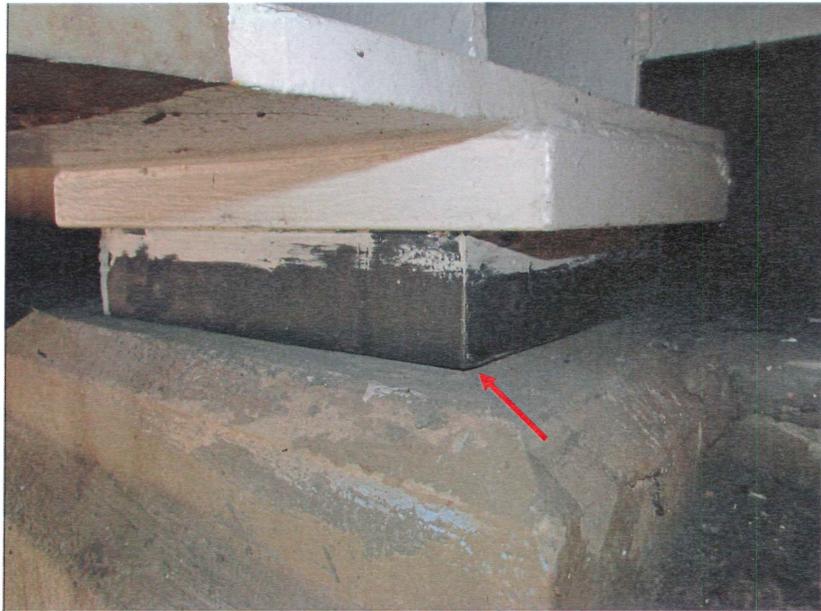
Photo # 19: Elastomeric bearing for Girder G3 at the North Abutment. Note the gap under the bearing pad.

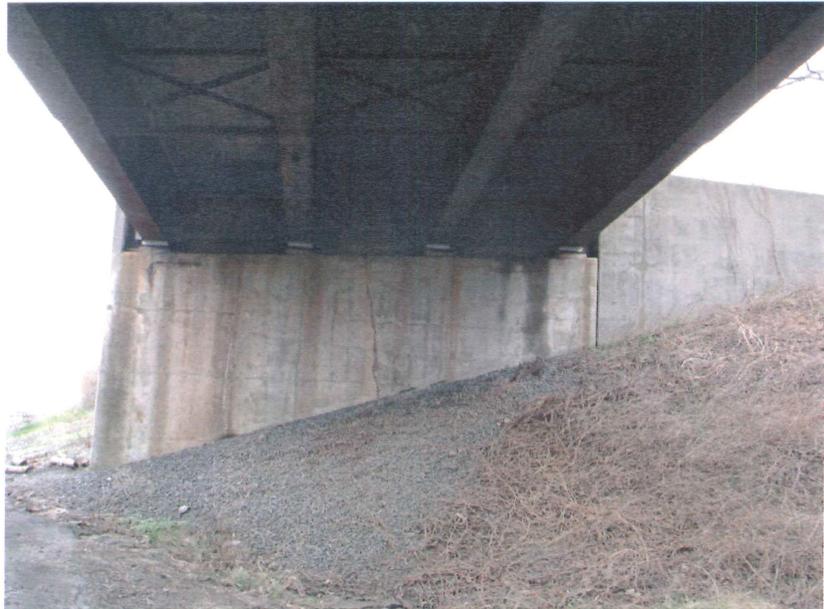
Photo # 33: South Abutment elevation.

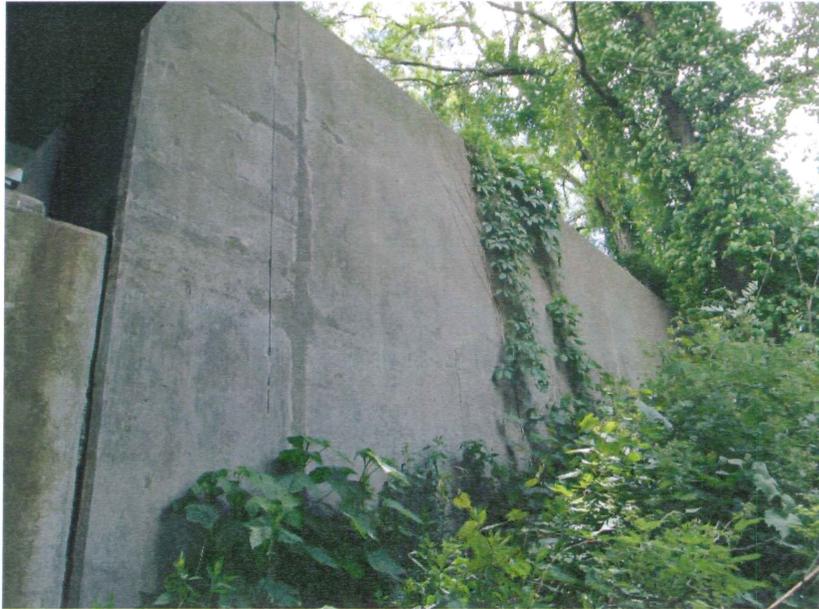
Photo # 35: Southwest Wingwall elevation.

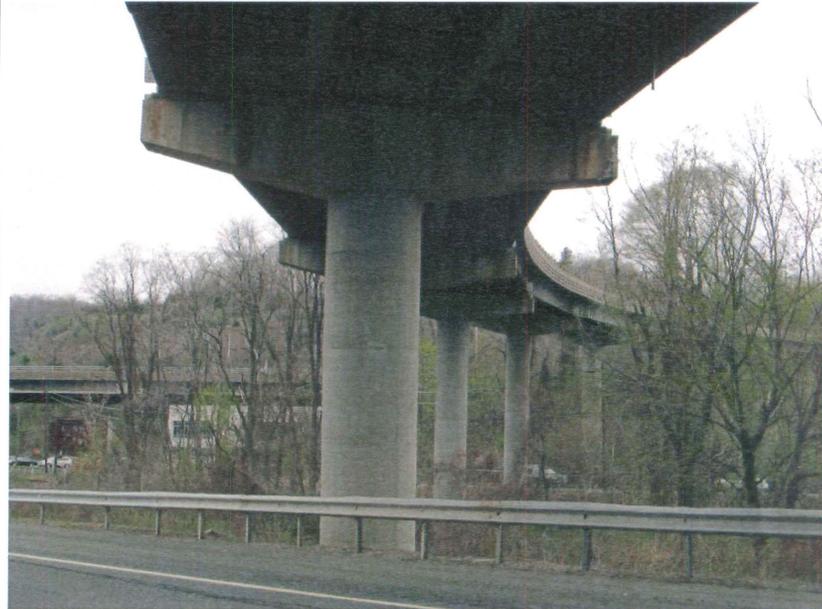
Photo # 36: South elevation of Pier 2.

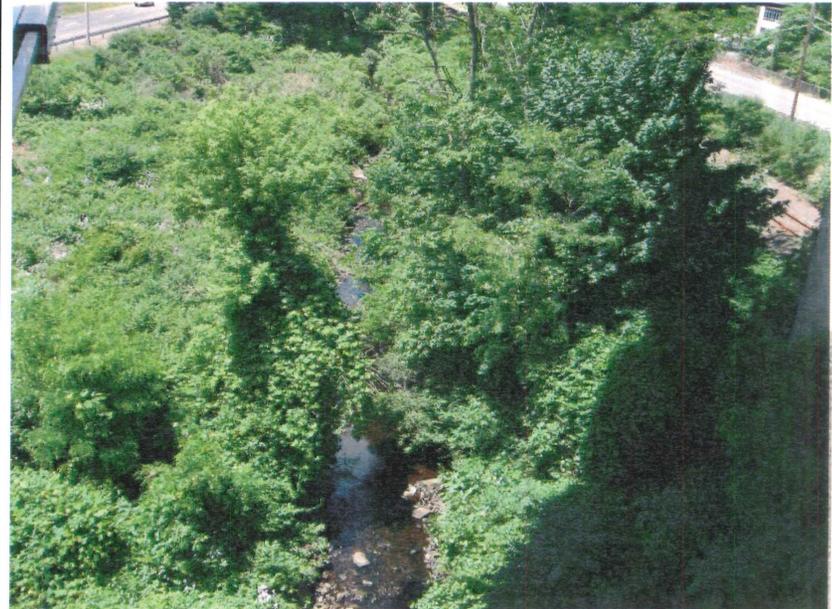
Photo # 42: Downstream view.

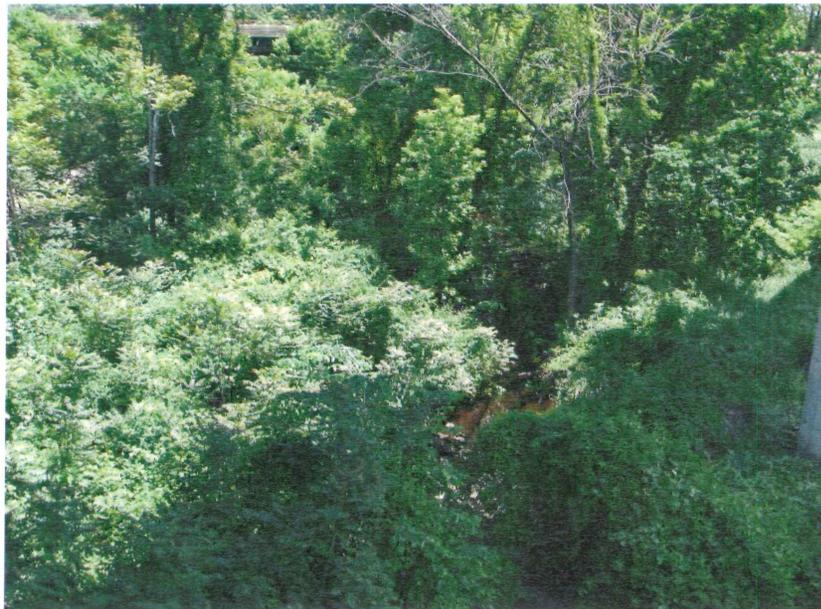
Photo # 43: Upstream view.

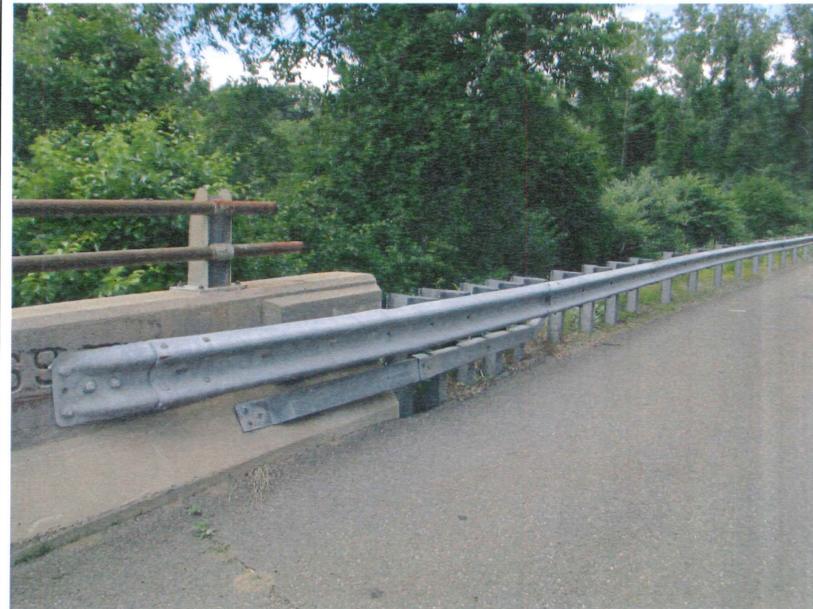
Photo # 44: Approach guiderail at the northwest corner.

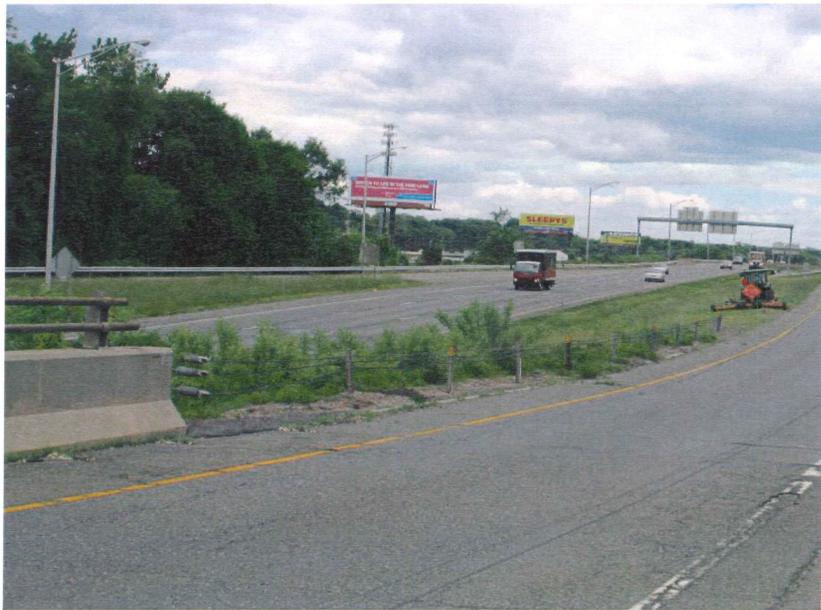
Photo # 45: Three cable guiderail at the southeast corner.

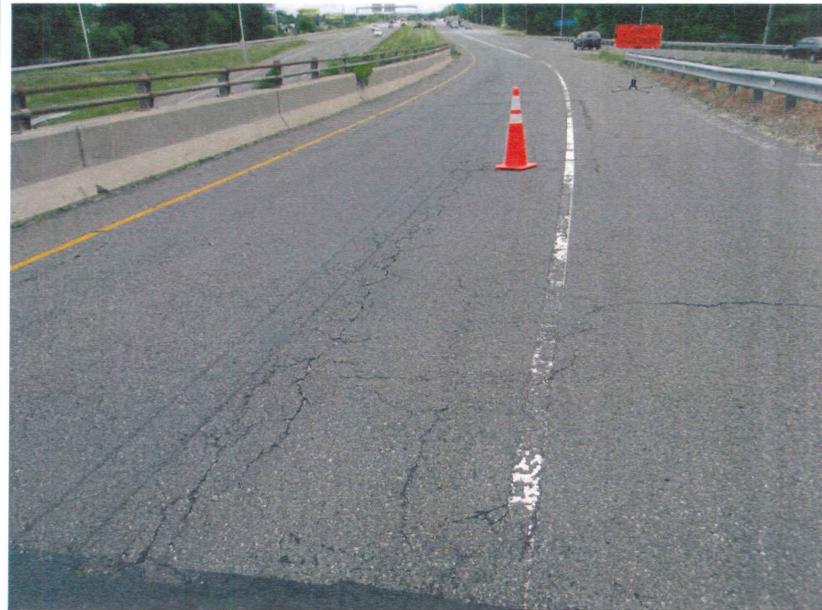
APPROACH SLAB:	6	The approach slab is paved over. The rating is based on the condition of the approach pavement. See below item entitled "APPROACH PAVEMENT".
RELIEF JOINTS:	N	Not visible.
APPROACH GUIDE RAIL:	6	There are metal beam rails located at the southwest, northwest and northeast corners. The metal beam guide rails at the north approach exhibit minor scrapes. The end of guide rail at the southwest approach has random bent/tilted anchor bolts at the concrete anchorage to the ground and anchor bolt nuts are not snug, and random washers are missing (trailing end). There is a three-cable guiderail at the southeast corner that exhibits cables with slight slack and random tipped/twisted posts. See Field Notes Sheets 8 and 12 and Photo Nos. 44 and 45.
APPROACH PAVEMENT:	6	The approach pavements exhibit areas of light raveling, minor wheel rutting and transverse and longitudinal cracks up to 1/2" wide with edge raveling up to 3" wide. There are also areas of map cracking with cracks open up to 1/2" wide. The previously noted settlement in the south approach pavement near the South Abutment has been repaired. The north approach pavement exhibits a paving seam open up to 3/4" wide. See Field Notes Sheets 8 and 12 and Photo No. 46.

Photo # 46: South approach pavement.
